## Pre-Construction Information

## New Nursery Block

## Corringham Primary School

Project Ref: A1947

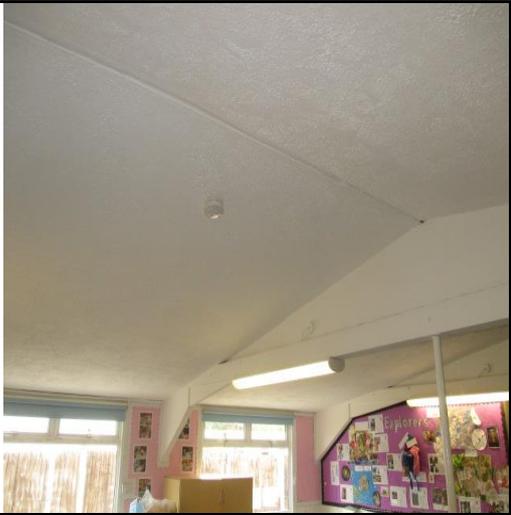
Sample Number	S001	Risk Score

Extent	170 M2			
Sample Analysis	NADIS	0		
Product Type	Textured coating	0		
Condition	good	0		
Treatment	sealed	0		
Inspection Number	Location	Risk Assessment	Product Description	Actions & Recommendations
1	Ceilings throughout the classroom	0	Non-asbestos decorative coat on all ceilings	NO ACTION REQUIRED
<b>No asbestos Detected in Sample</b>				
<b>Comments</b>				
No action required

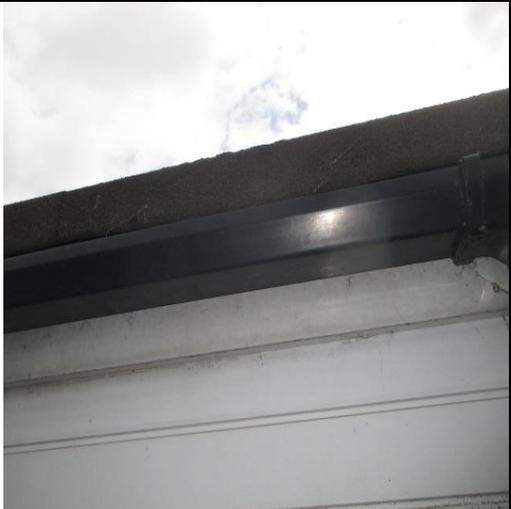
Sample Number	S002	Risk Score

Extent	170 M2			
Sample Analysis	NADIS	0		
Product Type	Bitumen roof felt	0		
Condition	good	0		
Treatment	sealed	0		
Inspection Number	Location	Risk Assessment	Product Description	Actions & Recommendations
2	High level external roof felt	0	Non-asbestos roof felt	NO ACTION REQUIRED
No asbestos Detected in Sample				
<b>Comments</b>				
No action required

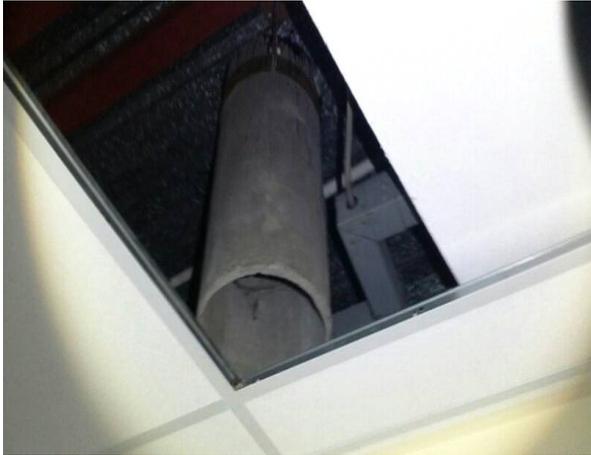
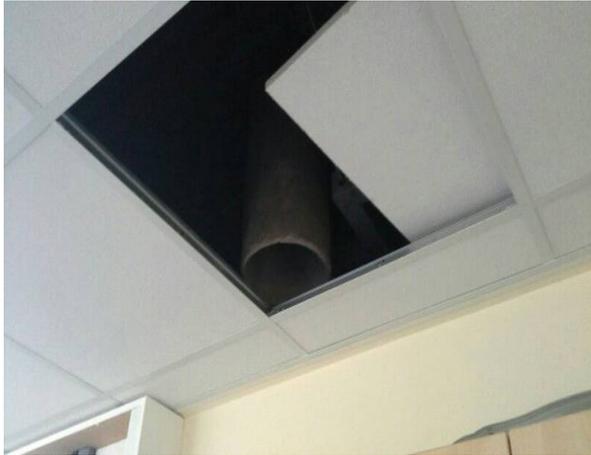
Item	Building	Level	Location / Room number	Survey Type	Quantity	Sample Reference	
1	Primary Building	Ground Floor	G.001 - Staff room	Management Survey (with MA only)	1lm	GH000184

<b>Material Description</b>				<b>Material Risk</b>			
Ceiling void – Redundant cement pipe Asbestos Cement				Product Type	1	Surface Treatment	1
				Extent of Damage	1	Asbestos Type	3
<b>Asbestos Type</b>				<b>Score - Material Risk</b>			
Chrysotile + Crocidolite				6	Low		
<b>Additional Information</b>				<b>Accessibility</b>			
N/A				Usually inaccessible or unlikely to be disturbed			
<b>Recommendations</b>				<b>Review Date</b>			
Label & Manage				May 2019

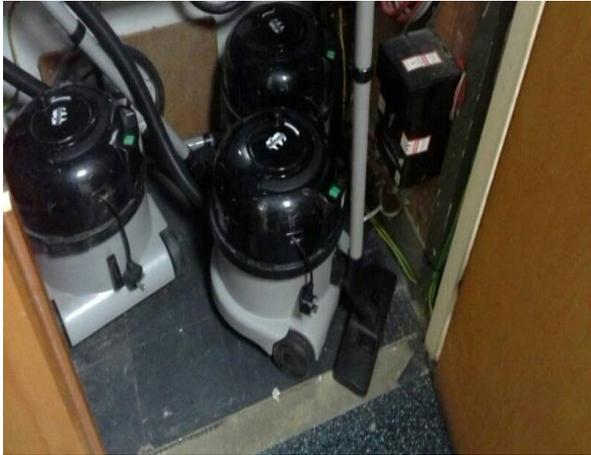
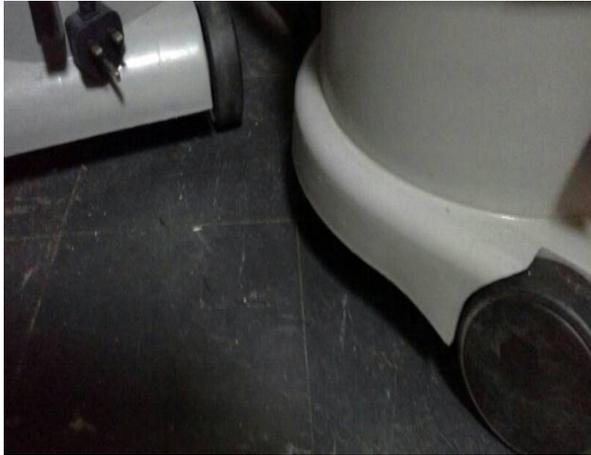
Item	Building	Level	Location / Room number	Survey Type	Quantity	Sample Reference	
19	Primary Building	Ground Floor	G.015 - Cupboard	Management Survey (with MA only)	2m <sup>2</sup>	GH000185

<b>Material Description</b>				<b>Material Risk</b>			
Floor – Grey thermoplastic floor tiles and bitumen adhesive Reinforced Composite				Product Type	1	Surface Treatment	0
				Extent of Damage	1	Asbestos Type	1
<b>Asbestos Type</b>				<b>Score - Material Risk</b>			
Chrysotile				3	Very Low		
<b>Additional Information</b>				<b>Accessibility</b>			
Asbestos identified within both the tile and the adhesive				Occasionally likely to be disturbed			
<b>Recommendations</b>				<b>Review Date</b>			
Manage				May 2019

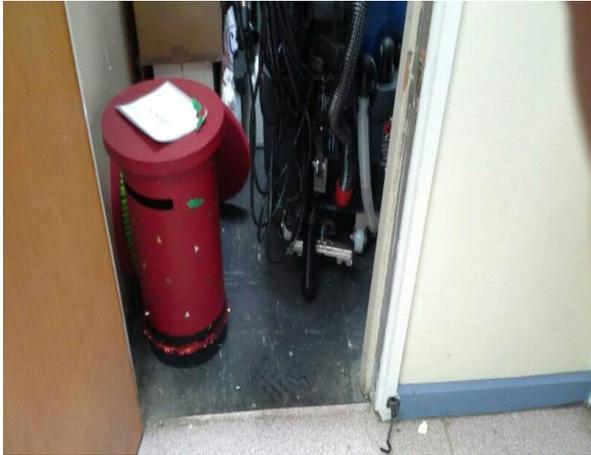
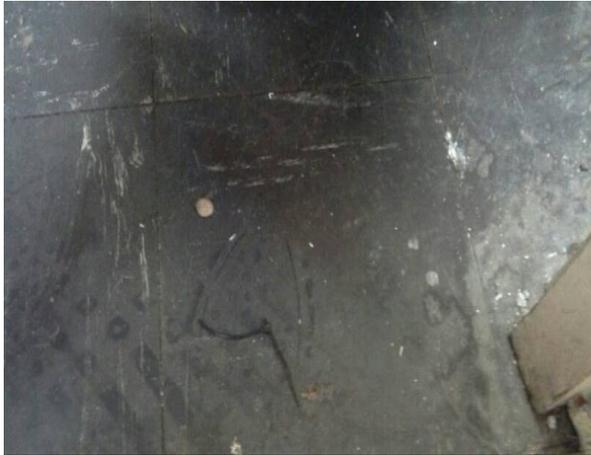
Item	Building	Level	Location / Room number	Survey Type	Quantity	Sample Reference	
29	Primary Building	Ground Floor	G.025 - Cupboard	Management Survey (with MA only)	4m <sup>2</sup>	As GH000185

<b>Material Description</b>				<b>Material Risk</b>			
Floor – Grey thermoplastic floor tiles and bitumen adhesive Reinforced Composite				Product Type	1	Surface Treatment	0
				Extent of Damage	1	Asbestos Type	1
<b>Asbestos Type</b>				<b>Score - Material Risk</b>			
Chrysotile				3	Very Low		
<b>Additional Information</b>				<b>Accessibility</b>			
Asbestos identified within both the tile and the adhesive				Occasionally likely to be disturbed			
<b>Recommendations</b>				<b>Review Date</b>			
Manage				May 2019

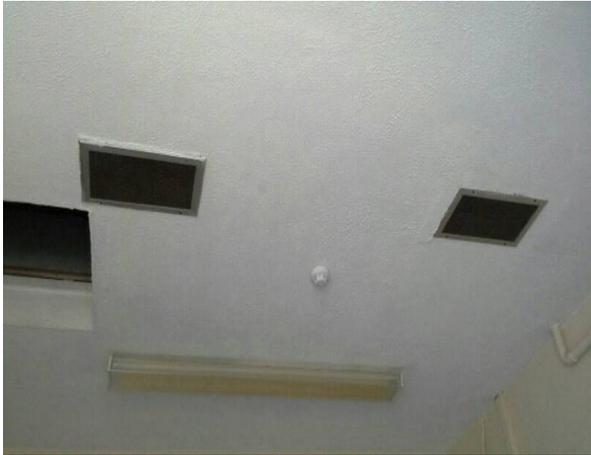
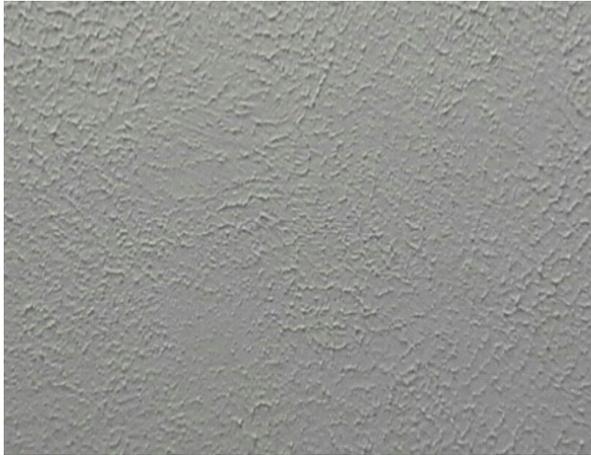
Item	Building	Level	Location / Room number	Survey Type	Quantity	Sample Reference	
41	Primary school	Ground Floor	G.006 - Lobby	Management Survey (with MA only)	16m <sup>2</sup>	GH000187

<b>Material Description</b>				<b>Material Risk</b>			
Ceiling – Textured coating Textured Coating				Product Type	1	Surface Treatment	1
				Extent of Damage	0	Asbestos Type	1
<b>Asbestos Type</b>				<b>Score - Material Risk</b>			
Chrysotile				3	Very Low		
<b>Additional Information</b>				<b>Accessibility</b>			
N/A				Usually inaccessible or unlikely to be disturbed			
<b>Recommendations</b>				<b>Review Date</b>			
Manage				May 2019

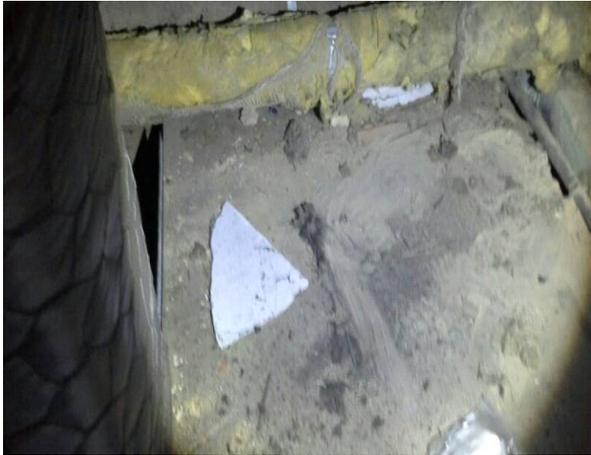
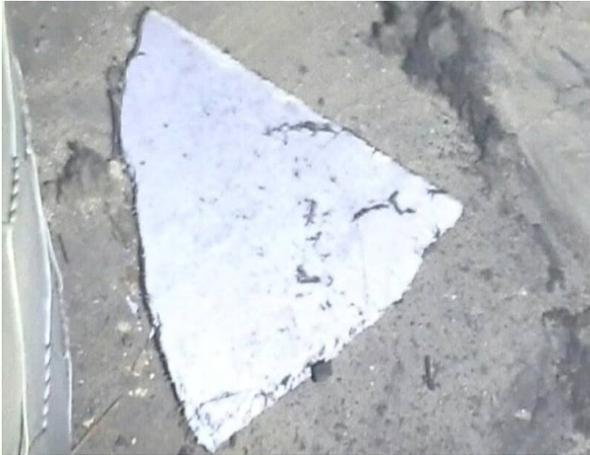
Item	Building	Level	Location / Room number	Survey Type	Quantity	Sample Reference	
42	Primary school	Roof Void	R.001 - Void	Management Survey (with MA only)	<1m <sup>2</sup>	GH000188

<b>Material Description</b>				<b>Material Risk</b>			
Debris adjacent hatch – Insulation board Asbestos Insulating Board				Product Type	2	Surface Treatment	2
				Extent of Damage	3	Asbestos Type	2
<b>Asbestos Type</b>				<b>Score - Material Risk</b>			
Amosite				9	Medium		
<b>Additional Information</b>				<b>Accessibility</b>			
N/A				Easily disturbed			
<b>Recommendations</b>				<b>Review Date</b>			
Remove				May 2019

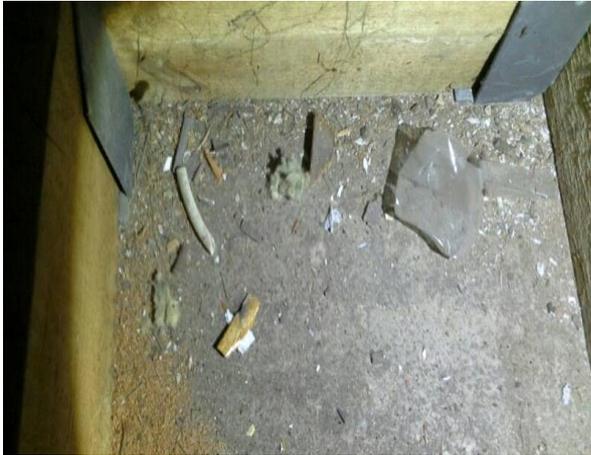
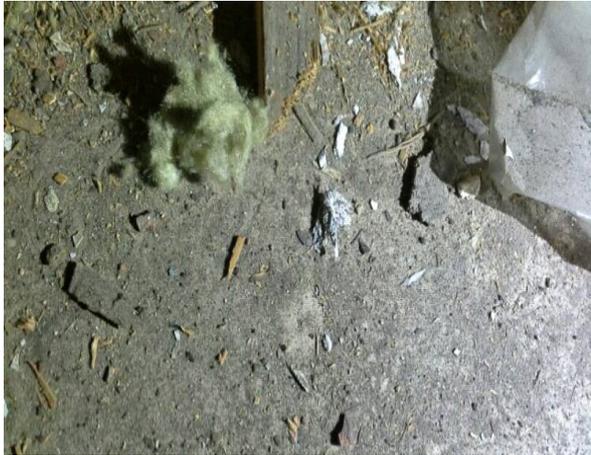
Item	Building	Level	Location / Room number	Survey Type	Quantity	Sample Reference	
43	Primary school	Roof Void	R.001 - Void	Management Survey (with MA only)	4m <sup>2</sup>	GH000189

<b>Material Description</b>				<b>Material Risk</b>			
Around hatch – Dust Asbestos Insulating Board				Product Type	2	Surface Treatment	2
				Extent of Damage	3	Asbestos Type	2
<b>Asbestos Type</b>				<b>Score - Material Risk</b>			
Amosite				9	Medium		
<b>Additional Information</b>				<b>Accessibility</b>			
N/A				Easily disturbed			
<b>Recommendations</b>				<b>Review Date</b>			
Remove				May 2019

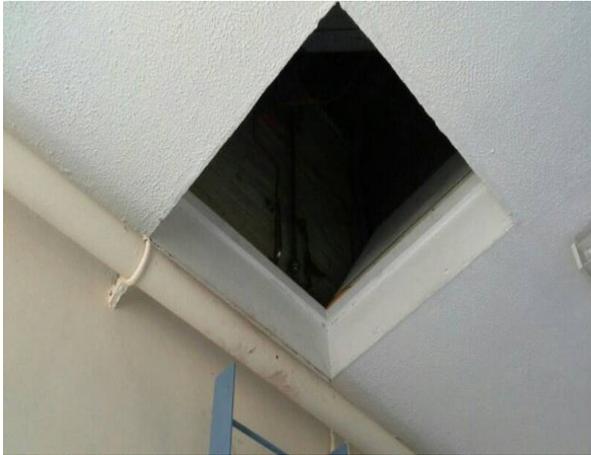
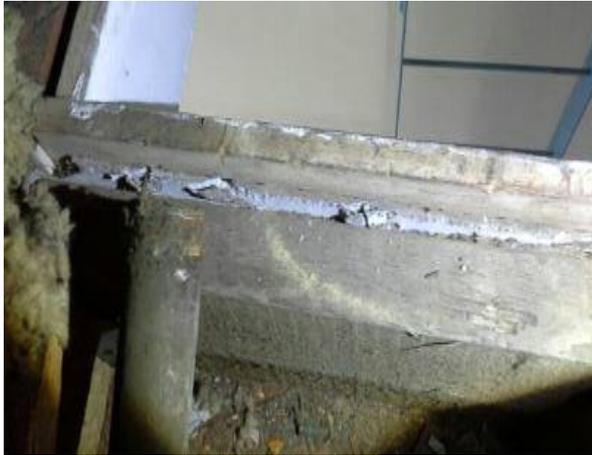
Item	Building	Level	Location / Room number	Survey Type	Quantity	Sample Reference	
44	Primary school	Roof Void	R.001 - Void	Management Survey (with MA only)	2lm	GH000190

<b>Material Description</b>				<b>Material Risk</b>			
Upstand to access hatch – Insulation board Asbestos Insulating Board				Product Type	2	Surface Treatment	2
				Extent of Damage	2	Asbestos Type	1
<b>Asbestos Type</b>				<b>Score - Material Risk</b>			
Chrysotile				7	Medium		
<b>Additional Information</b>				<b>Accessibility</b>			
N/A				Usually inaccessible or unlikely to be disturbed			
<b>Recommendations</b>				<b>Review Date</b>			
Encapsulate/Label & Manage				May 2019

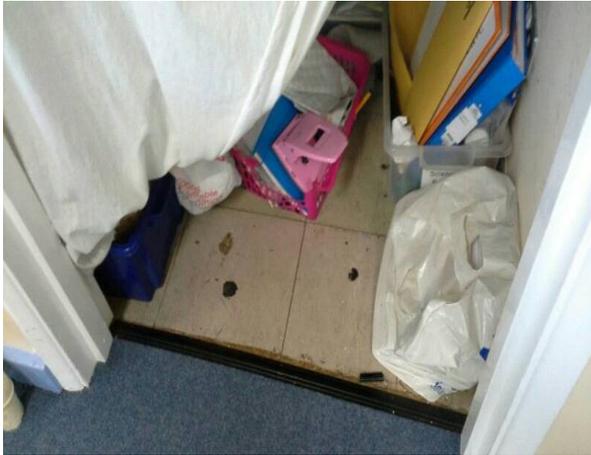
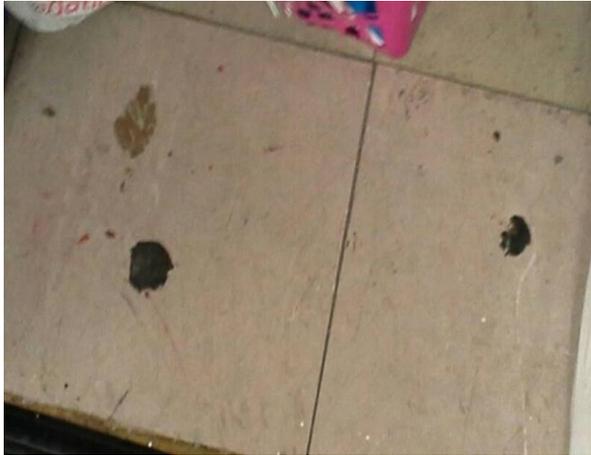
Item	Building	Level	Location / Room number	Survey Type	Quantity	Sample Reference	
63	Primary school	Ground Floor	G.019 - Cupboard	Management Survey (with MA only)	3m <sup>2</sup>	GH000192

<b>Material Description</b>				<b>Material Risk</b>			
Floor – Beige thermoplastic floor tiles and bitumen adhesive Reinforced Composite				Product Type	1	Surface Treatment	0
				Extent of Damage	1	Asbestos Type	1
<b>Asbestos Type</b>				<b>Score - Material Risk</b>			
Chrysotile				3	Very Low		
<b>Additional Information</b>				<b>Accessibility</b>			
Asbestos identified within bitumen backing only				Occasionally likely to be disturbed			
<b>Recommendations</b>				<b>Review Date</b>			
Manage				May 2019

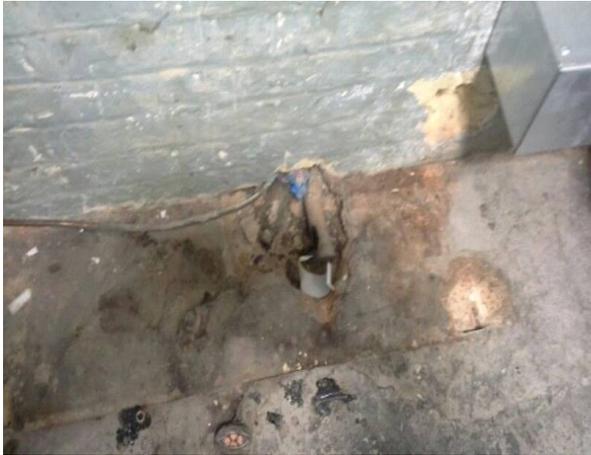
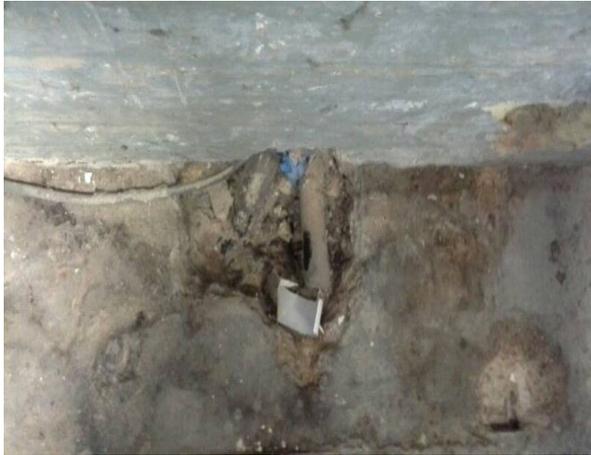
Item	Building	Level	Location / Room number	Survey Type	Quantity	Sample Reference	
74	Primary school	Ground Floor	G.026 - Electric Cupboard	Management Survey (with MA only)	<1m	Visual

<b>Material Description</b>				<b>Material Risk</b>			
Electrics – Bitumen cable wrap Reinforced Composite				Product Type	1	Surface Treatment	0
				Extent of Damage	1	Asbestos Type	1
<b>Asbestos Type</b>				<b>Score - Material Risk</b>			
Chrysotile				3	Very Low		
<b>Additional Information</b>				<b>Accessibility</b>			
Unable to sample due to live electrics				Usually inaccessible or unlikely to be disturbed			
<b>Recommendations</b>				<b>Review Date</b>			
Further Investigation & Sampling Required Prior to Disturbance				May 2019

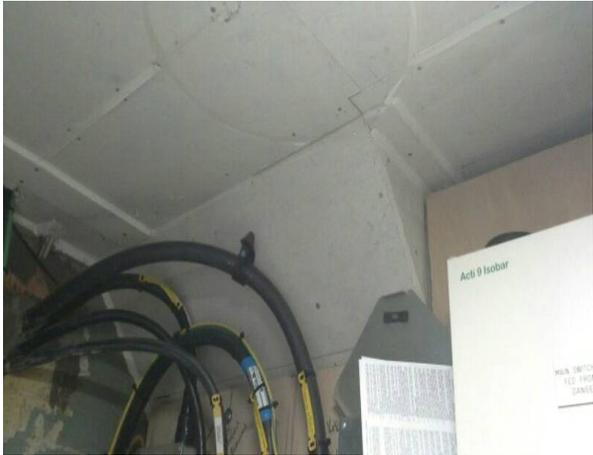
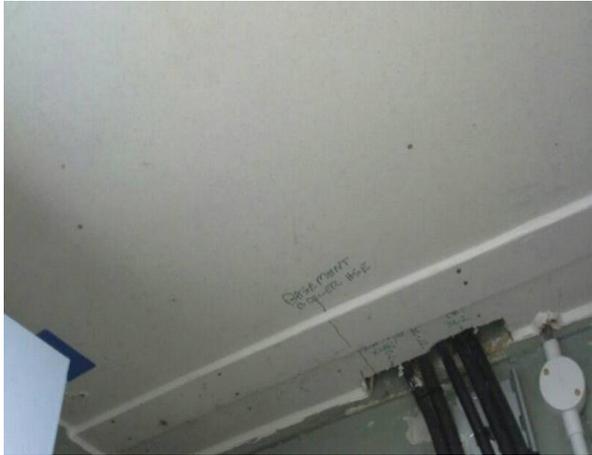
Item	Building	Level	Location / Room number	Survey Type	Quantity	Sample Reference	
75	Primary school	Ground Floor	G.026 - Electric Cupboard	Management Survey (with MA only)	N/A	GH000194

<b>Material Description</b>				<b>Material Risk</b>			
Ceiling – Insulation board Insulating Board				Product Type	N/A	Surface Treatment	N/A
				Extent of Damage	N/A	Asbestos Type	N/A
<b>Asbestos Type</b>				<b>Score - Material Risk</b>			
No Asbestos Detected				N/A		N/A	
<b>Additional Information</b>				<b>Accessibility</b>			
N/A				N/A			
<b>Recommendations</b>				<b>Review Date</b>			
No further action required				N/A

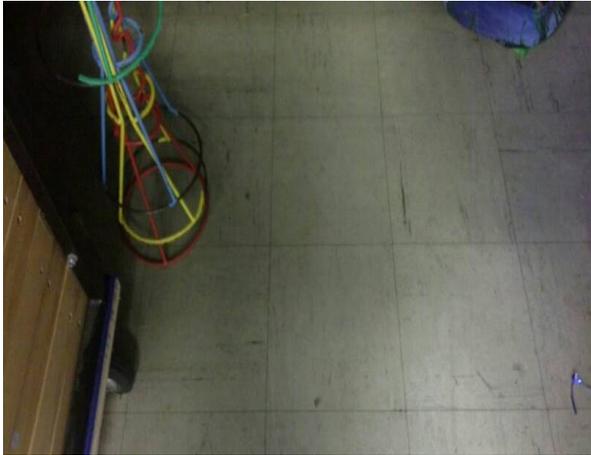
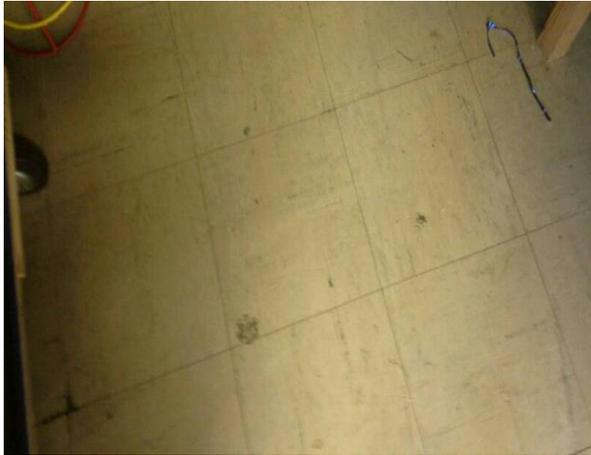
Item	Building	Level	Location / Room number	Survey Type	Quantity	Sample Reference	
90	Primary school	Ground Floor	G.041 - Store	Management Survey (with MA only)	N/A	GH000198

Material Description				Material Risk			
Floor – Beige vinyl tiles Reinforced Composite				Product Type	N/A	Surface Treatment	N/A
				Extent of Damage	N/A	Asbestos Type	N/A
Asbestos Type				Score - Material Risk			
No Asbestos Detected				N/A		N/A	
Additional Information				Accessibility			
N/A				N/A			
Recommendations				Review Date			
No further action required				N/A

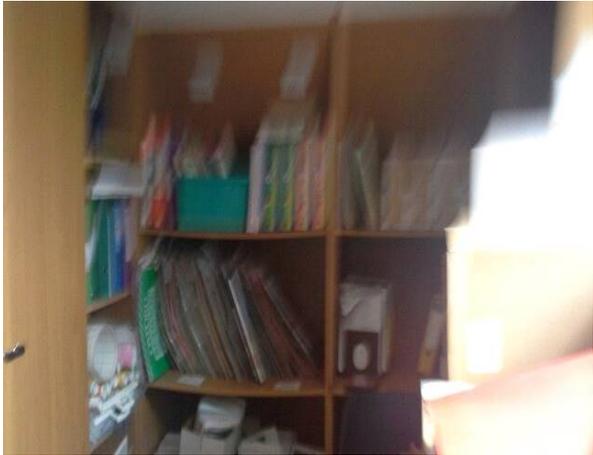
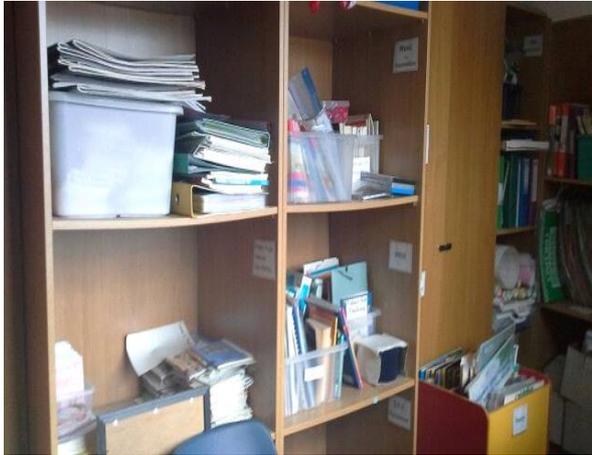
Item	Building	Level	Location / Room number	Survey Type	Quantity	Sample Reference	
92	Primary school	Roof Void	R.002 - Archive	Management Survey (with MA only)	6m <sup>2</sup>	Visual

<b>Material Description</b>				<b>Material Risk</b>			
Behind book cases – Insulation board Asbestos Insulating Board				Product Type	2	Surface Treatment	1
				Extent of Damage	0	Asbestos Type	3
<b>Asbestos Type</b>				<b>Score - Material Risk</b>			
Crocidolite (or unknown)				6	Low		
<b>Additional Information</b>				<b>Accessibility</b>			
Unable to sample due to access restrictions				Usually inaccessible or unlikely to be disturbed			
<b>Recommendations</b>				<b>Review Date</b>			
Further Investigation & Sampling Required Prior to Disturbance				May 2019

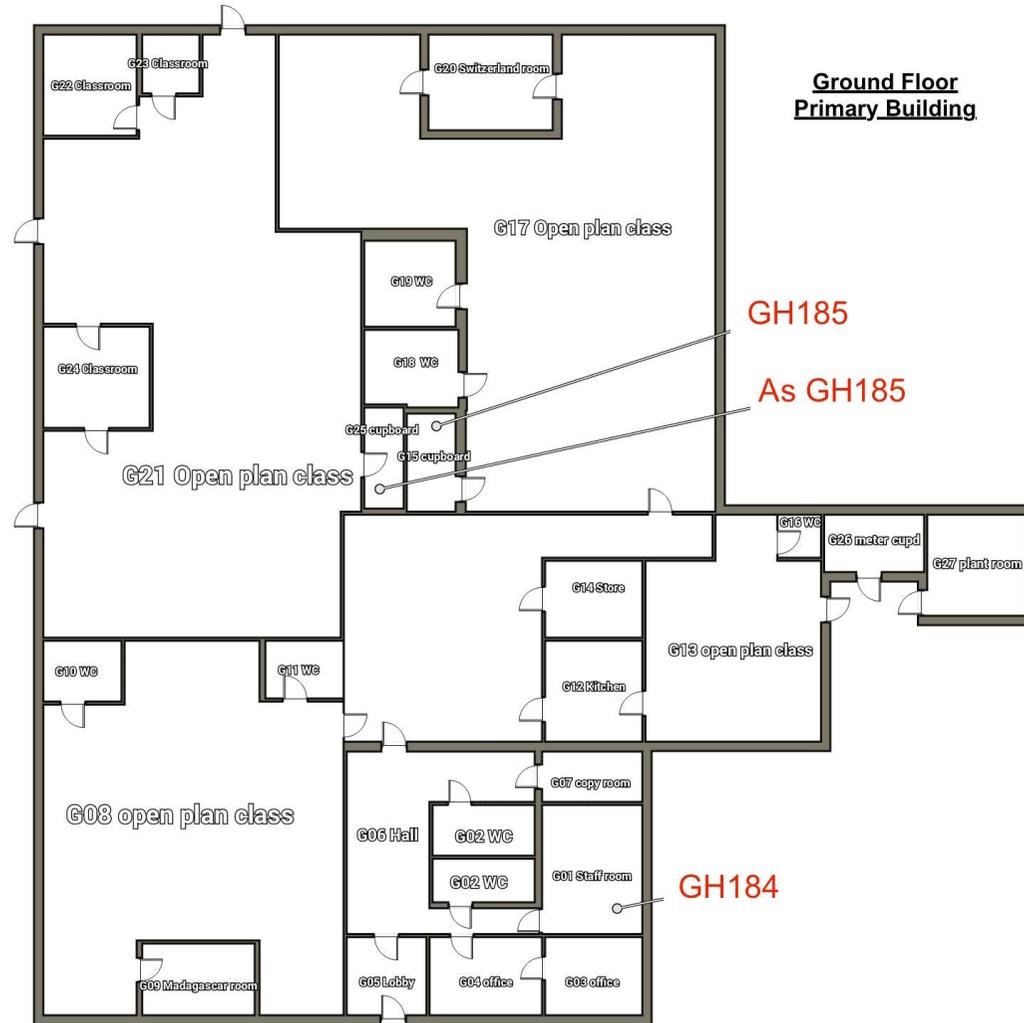
<b>SITE PLAN</b>	THIS SITE PLAN SHOULD BE READ IN CONJUNCTION WITH THE FULL ASBESTOS SURVEY REPORT	<b>KEY</b>	<b>Sample Numbers</b>	<p>9 Springfield Lyons Approach, Chelmsford, CM2 5LB.</p>	<b>NOT TO SCALE</b>	<p><u>Limitations of reported information</u></p> <p>The information contained within this report which identifies the locations of asbestos containing materials (ACMs) should not be treated as either exhaustive or definitive. It should always be assumed that there may be other ACMs present, hidden or undetected within the fabric of the building. Further investigations may be necessary when carrying out works likely to disturb the fabric of the building.</p>
		Black Text	Negative Sample Number			
		Red Text	Positive Sample Number

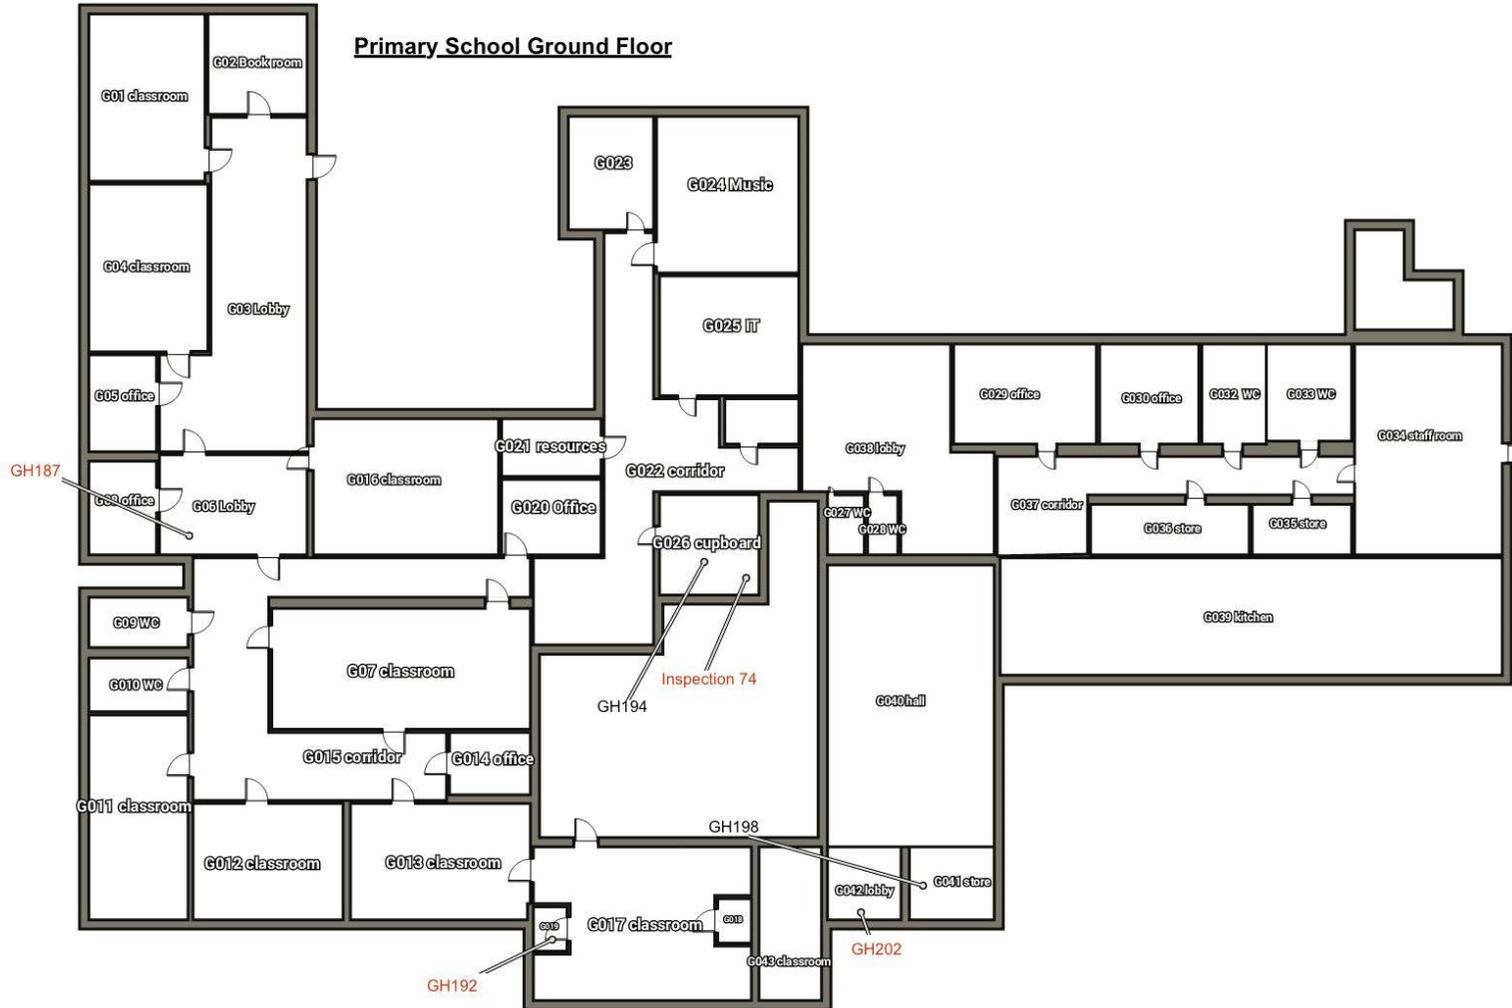
<b>SITE PLAN</b>	THIS SITE PLAN SHOULD BE READ IN CONJUNCTION WITH THE FULL ASBESTOS SURVEY REPORT	<b>KEY</b>	<b>Sample Numbers</b>

9 Springfield Lyons Approach, Chelmsford, CM2 5LB.	<b>NOT TO SCALE</b>	<p style="text-align: center;"><u>Limitations of reported information</u></p> <p>The information contained within this report which identifies the locations of asbestos containing materials (ACMs) should not be treated as either exhaustive or definitive. It should always be assumed that there may be other ACMs present, hidden or undetected within the fabric of the building. Further investigations may be necessary when carrying out works likely to disturb the fabric of the building.</p>
		Black Text	Negative Sample Number				
		Red Text	Positive Sample Number

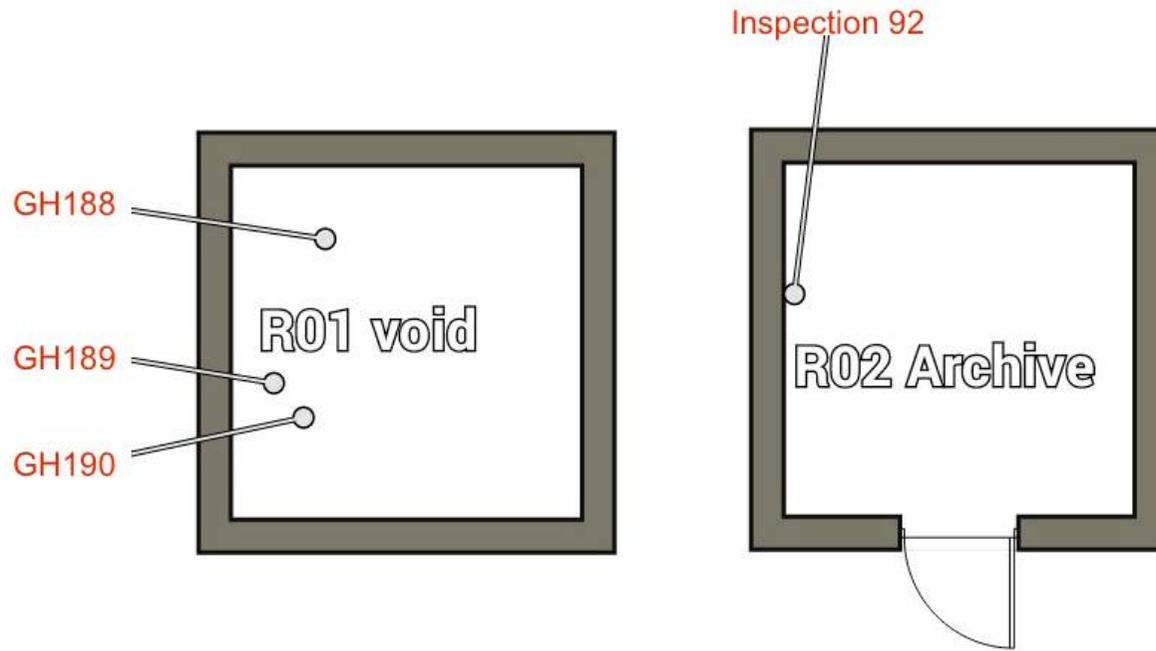
<b>SITE PLAN</b>	THIS SITE PLAN SHOULD BE READ IN CONJUNCTION WITH THE FULL ASBESTOS SURVEY REPORT	<b>KEY</b>	<b>Sample Numbers</b>

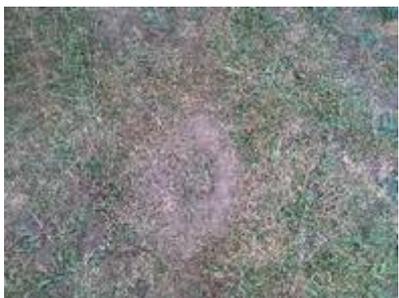
**Borehole 1 complete**

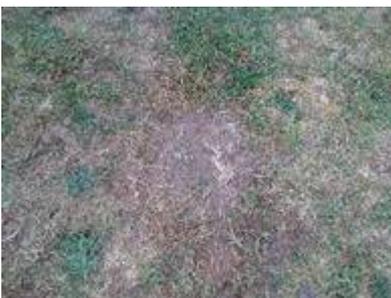
**Borehole 2 complete**

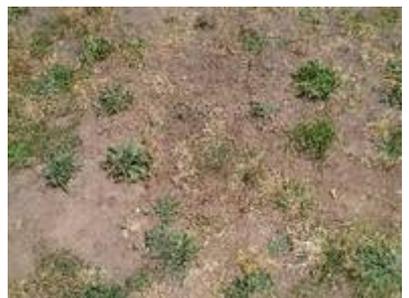
**Borehole 3 complete**

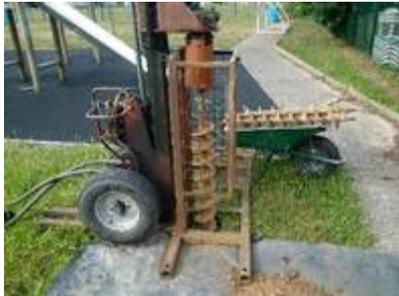
Percolation test 1

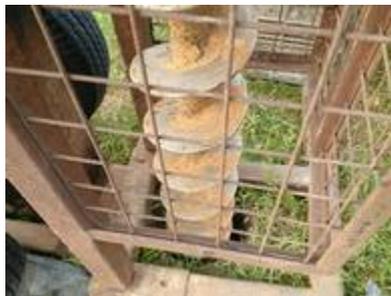
Percolation test 1

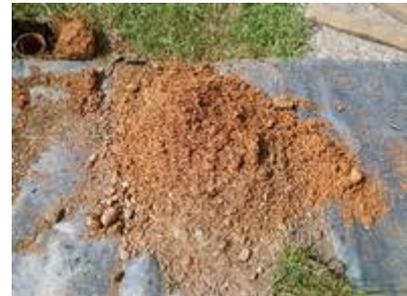
Percolation test 1

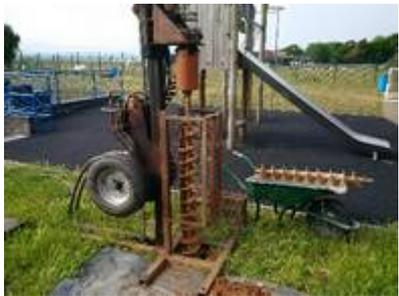
Percolation test 2

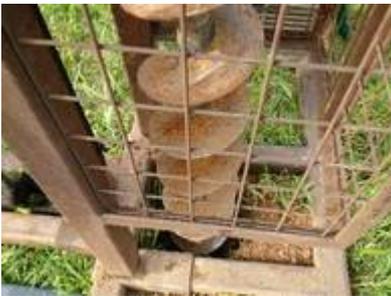
Percolation test 2

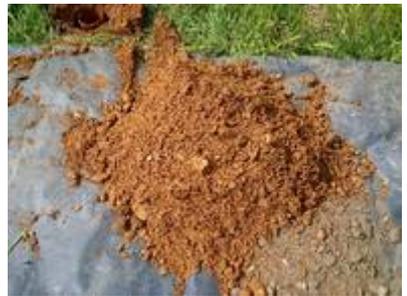
Percolation test 2

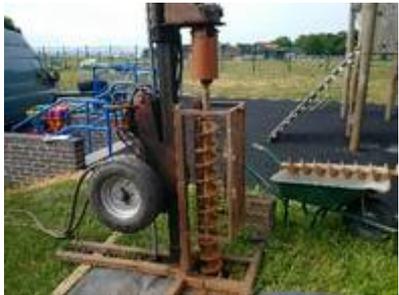
Percolation test 3

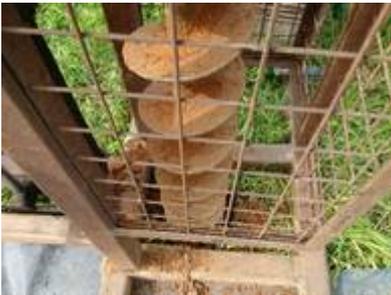
Percolation test 3

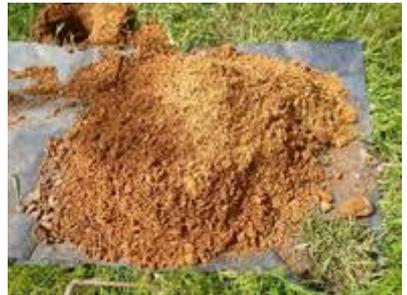
Percolation test 3

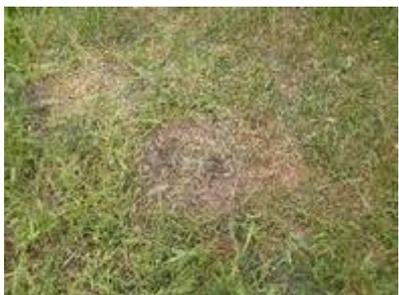
Percolation test 1 complete

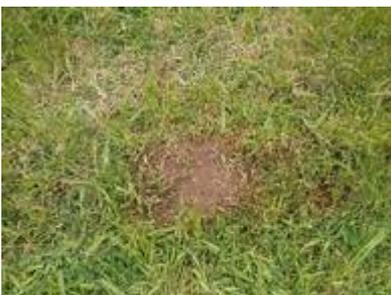
Percolation test 2 complete

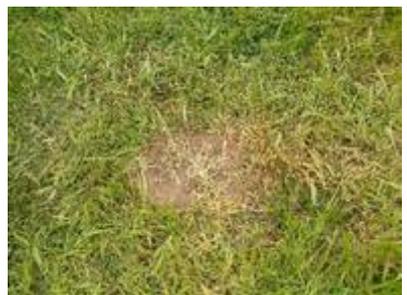
Percolation test 3 complete

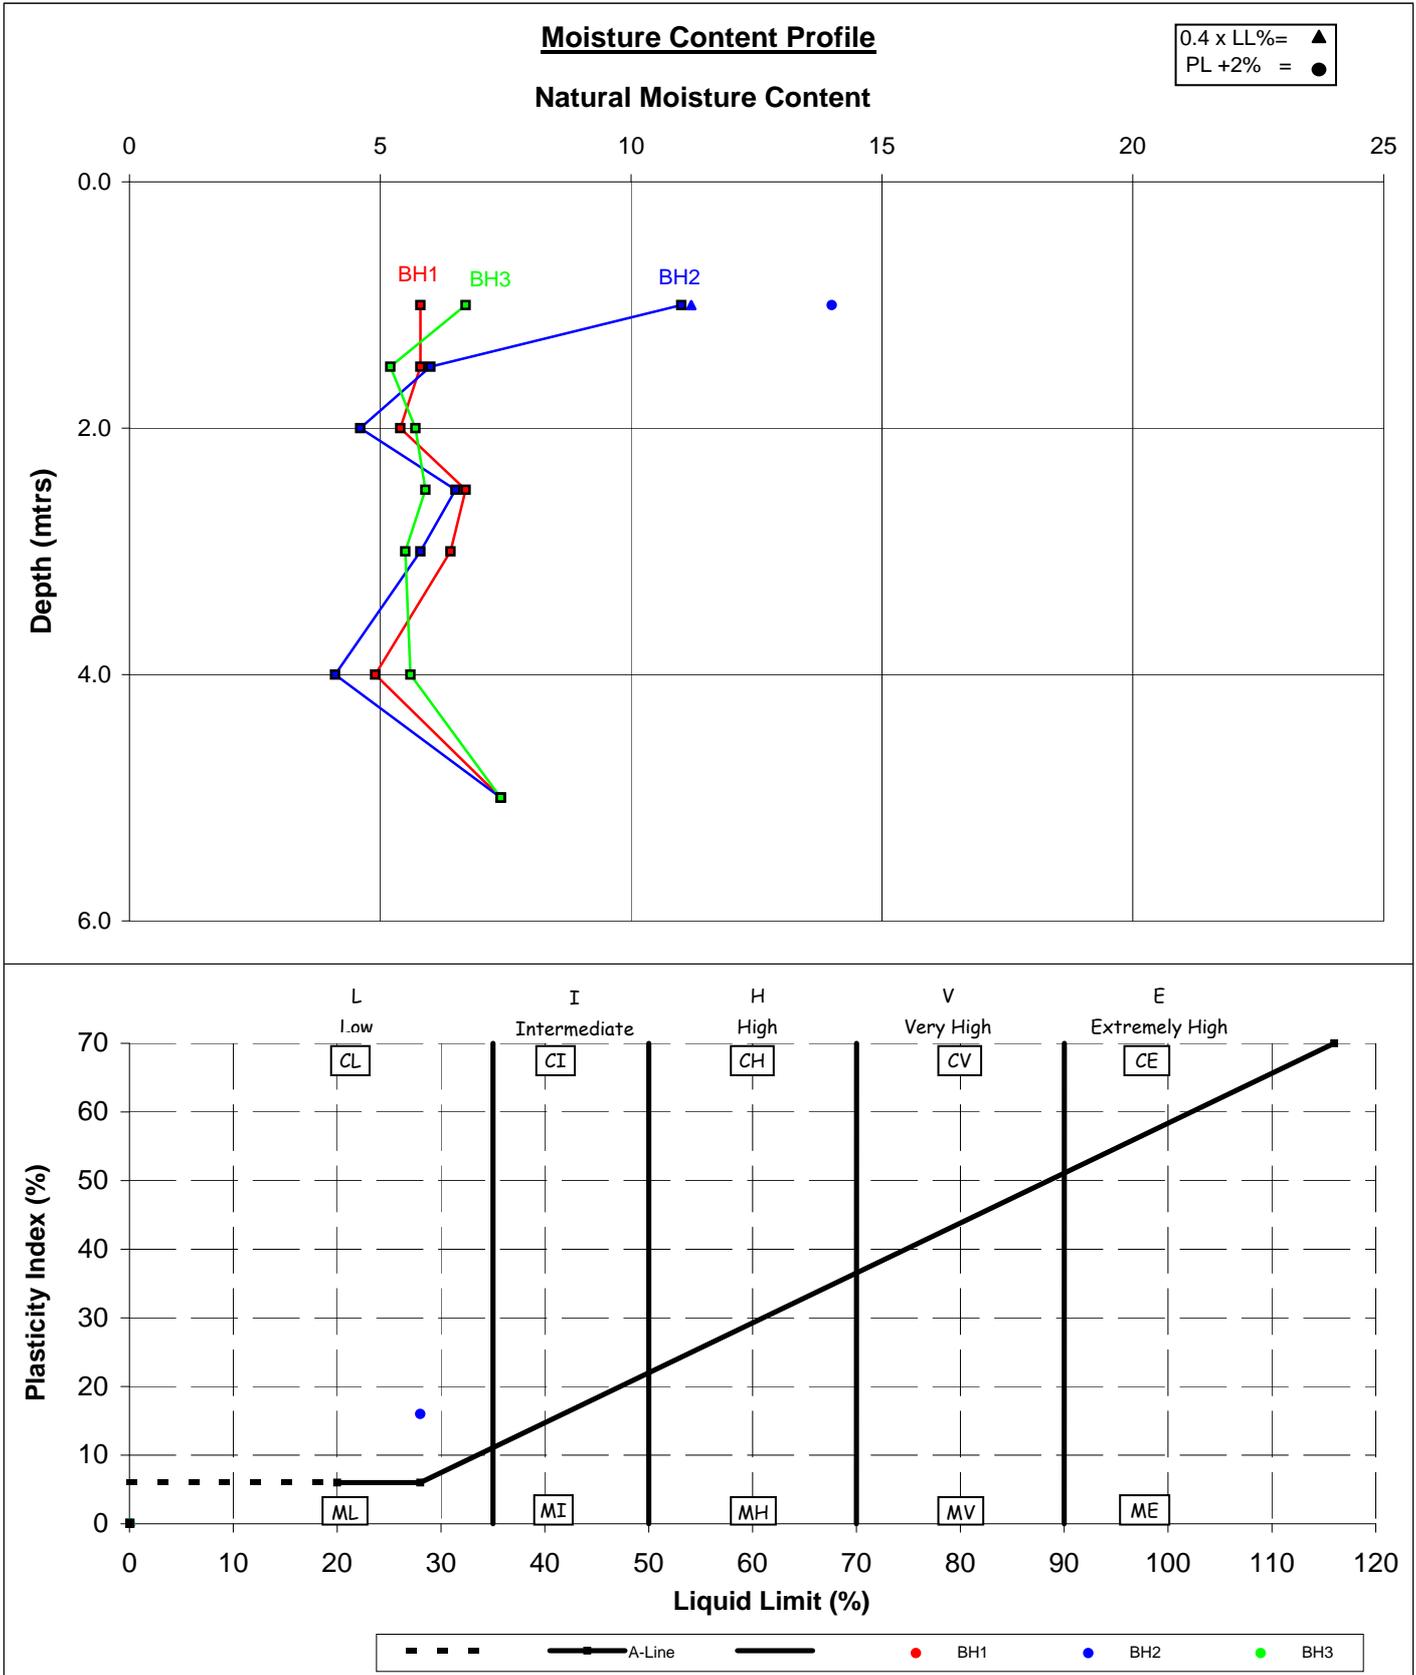
In Compliance with BS. 5930: 1982

- 1) Unless specifically noted, the profiles have not been related to a site datum
- 2) If plotted, 0.4 LL and PL + 2 (after Driscoll, 1983) should only be applied to London Clay (and similar overconsolidated clays) at shallow depths.
