LOCATION:
 M5 J25-24 NB MP 201.7-196.6
 DRAWING No.
 583 Defect Treatment Plan Sheet 1 of 6
 DRAWN: FS DATE: 22/06/2020
 DESIGN: FS DATE: 22/06/2020
 CHECKED: CC DATE: 25/06/2020

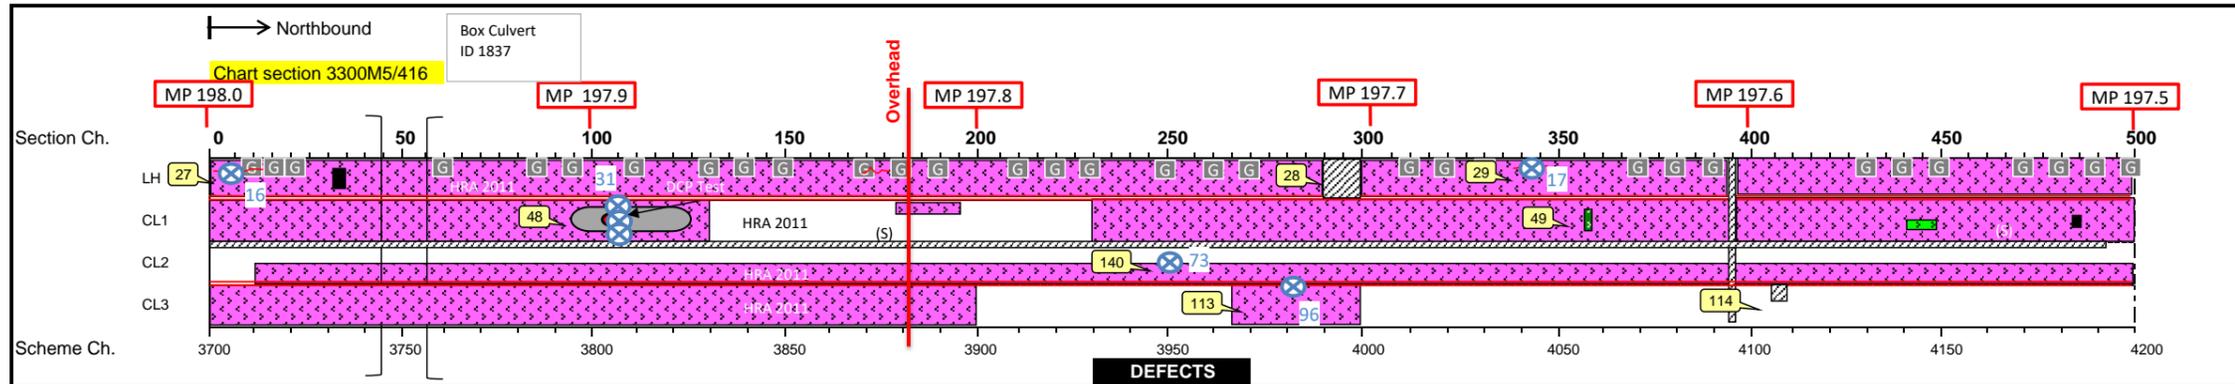
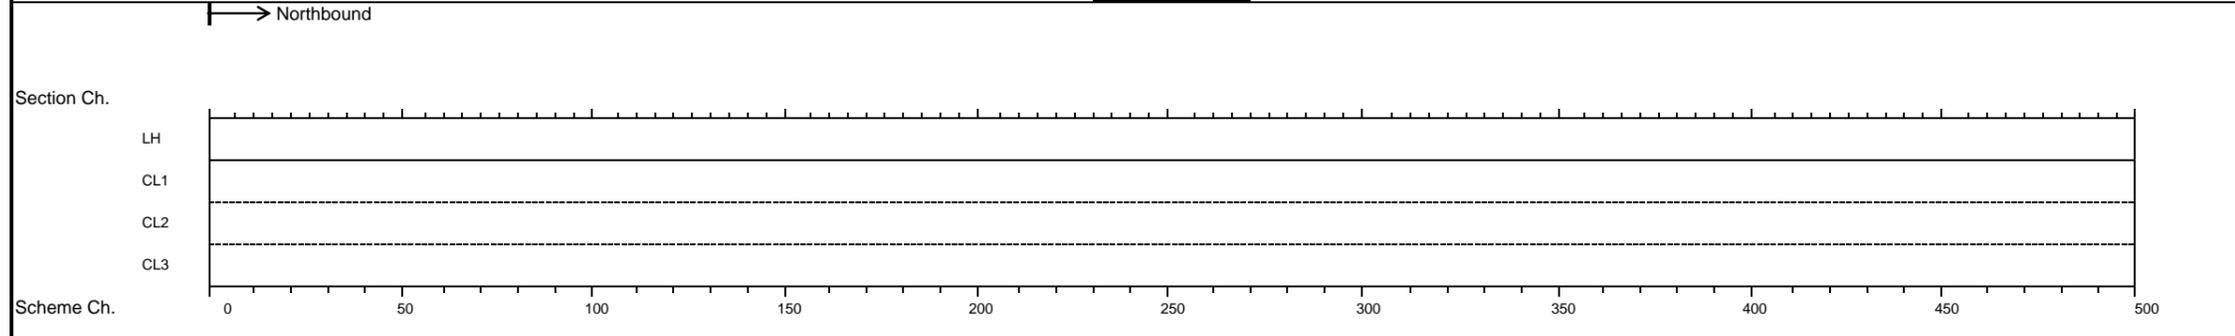
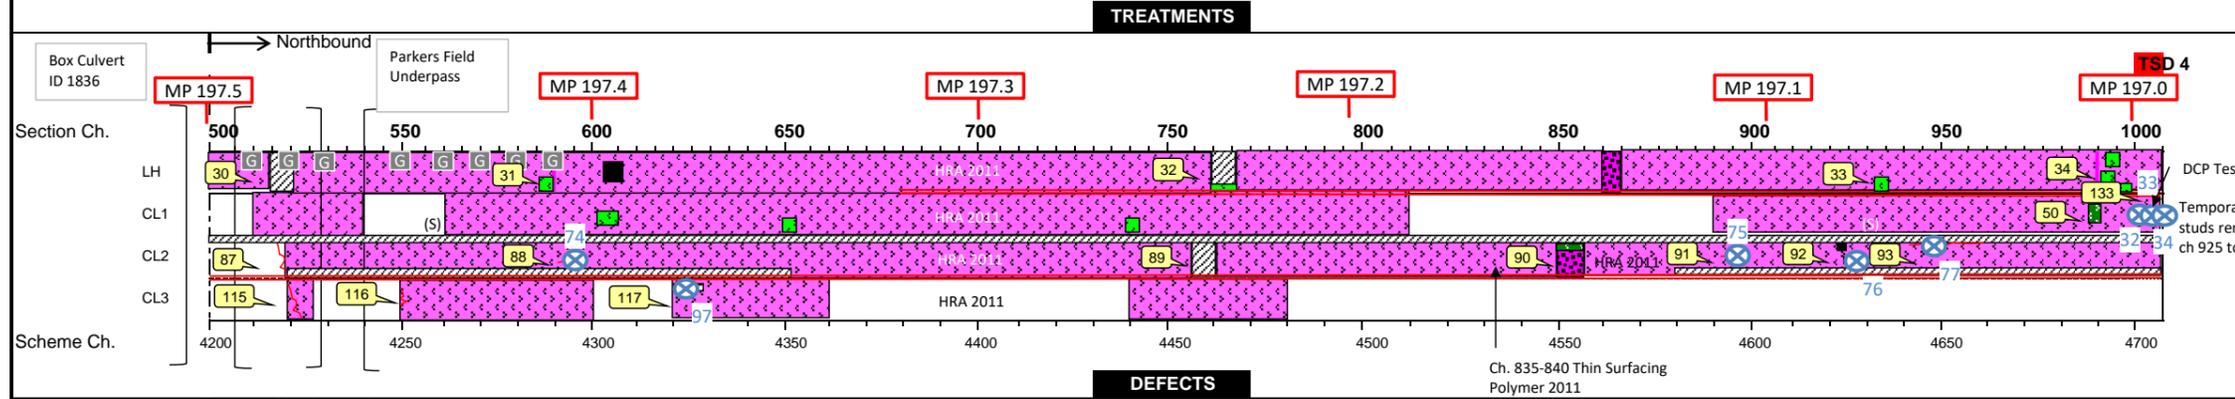
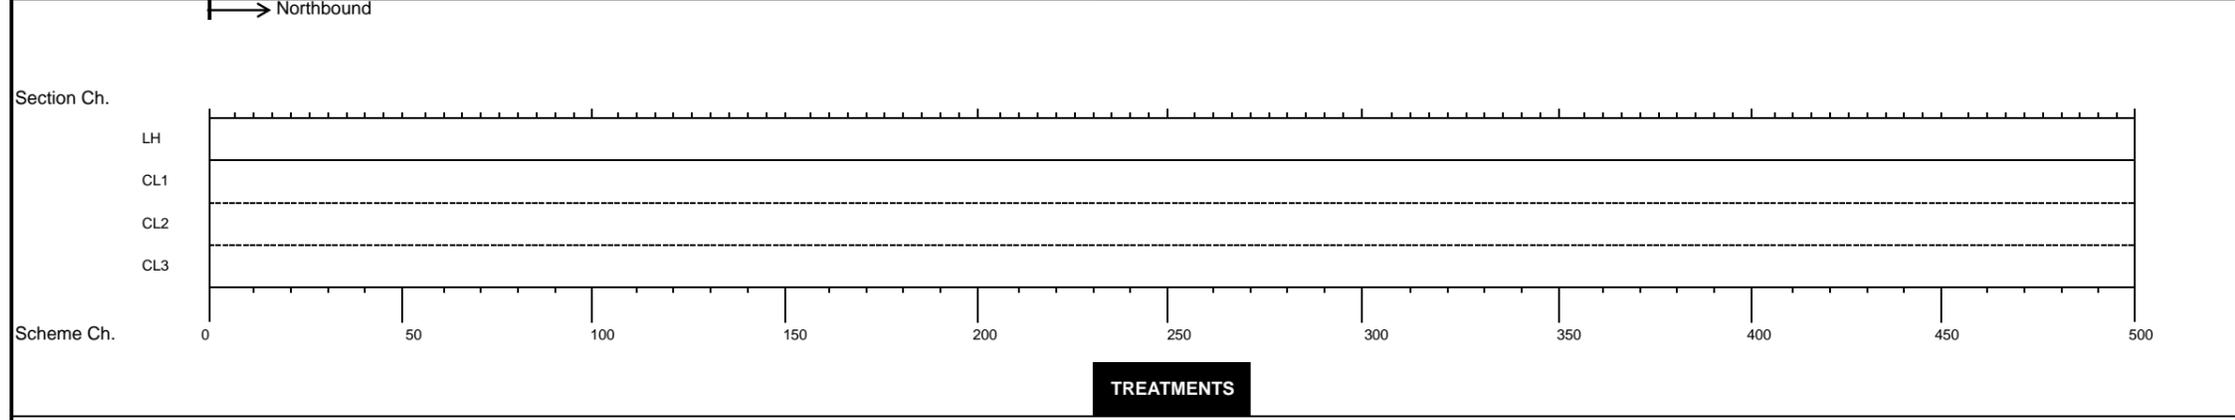
- 50mm inlay TSCS (Do Min)
- Fill and overbanding repair system for crack exceeding 5mm but not exceeding 10mm wide (Do Min)
- Deep repair/ inlay (Do Something)
