LOCATION:  
M5 J14-15 SB MP 125 - 129.5  
DRAWING No:  
572 Defect Treatment Plan Sheet 2 of 5  
DRAWN: MT DATE: 19/06/2020  
DESIGN: MT DATE: 19/06/2020  
CHECKED: CC DATE: 17/06/2020

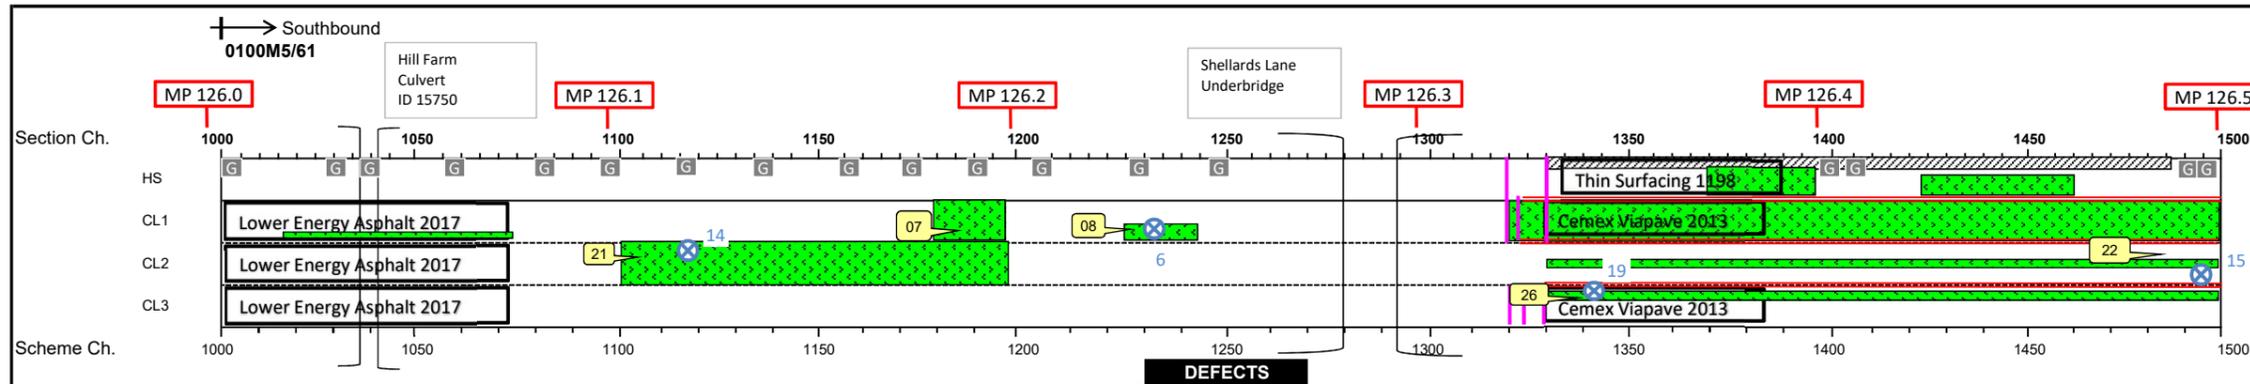
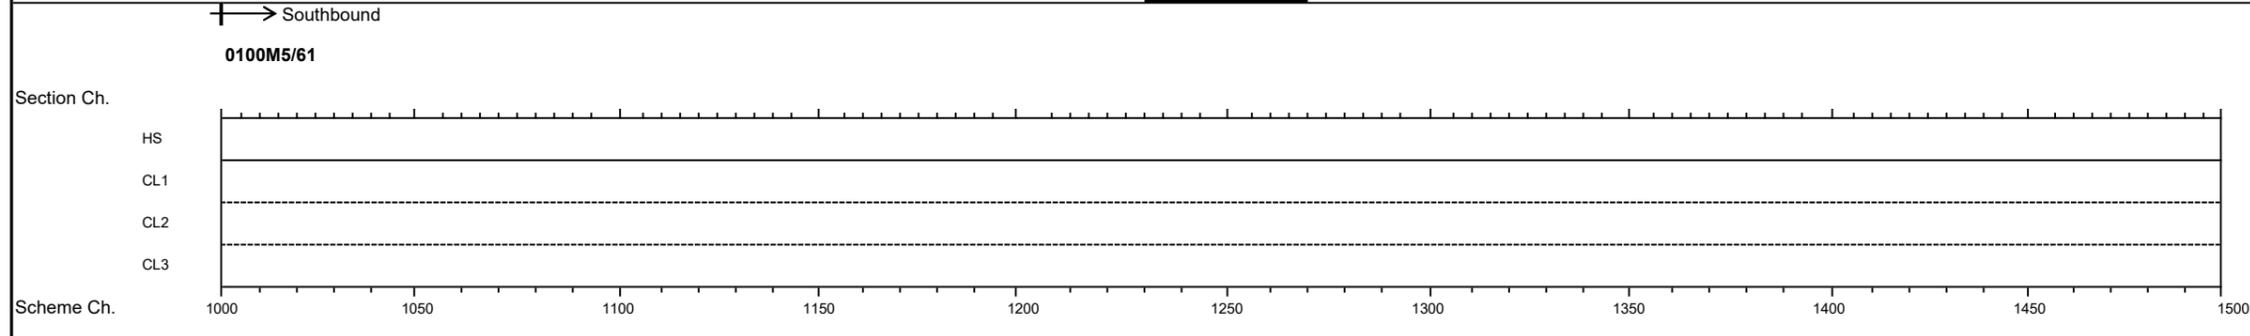
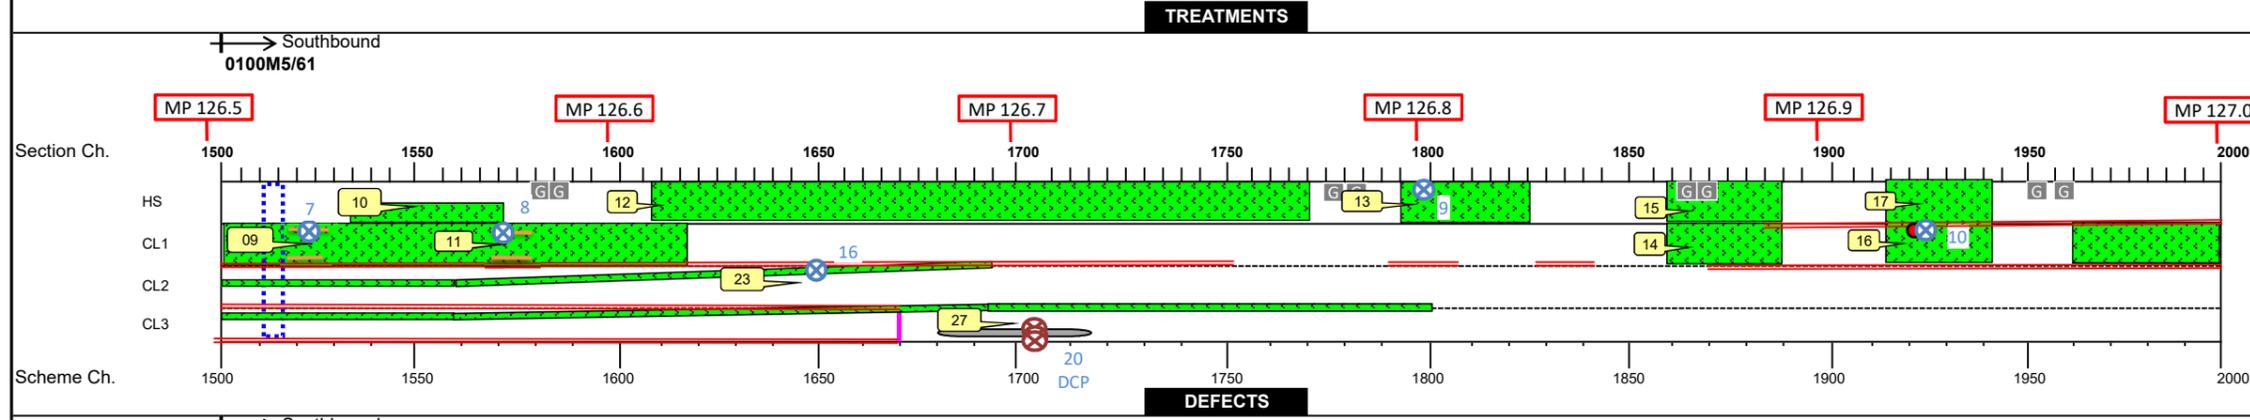
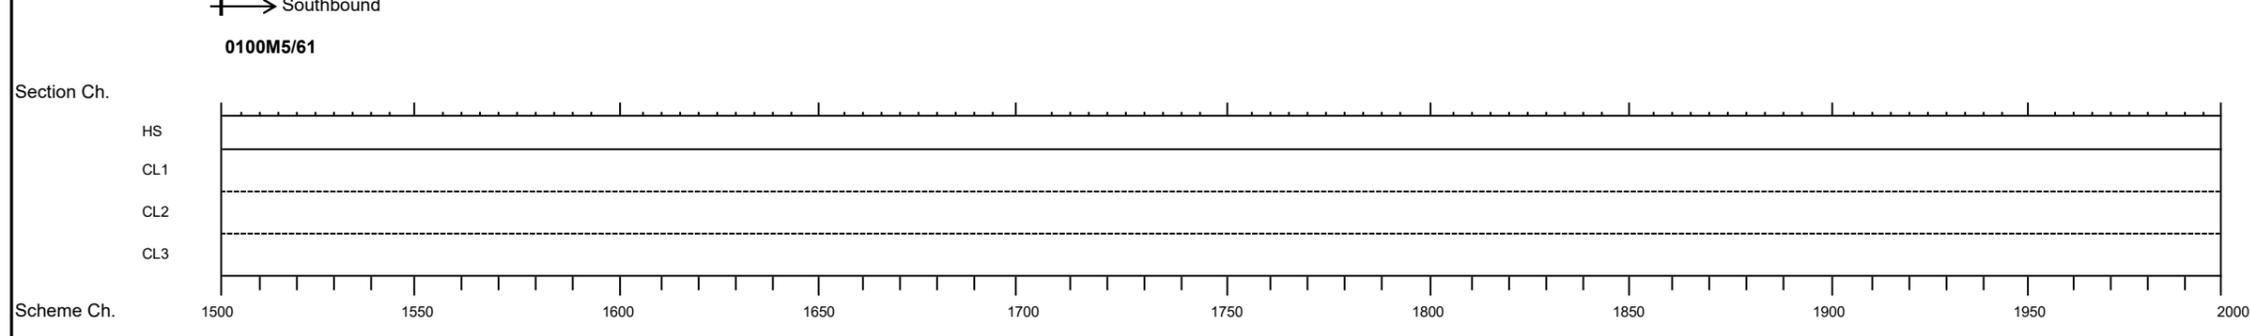
- TREATMENT KEY:**
- 50mm inlay TSCS (Do Min)
  - Fill and overbanding repair system for crack exceeding 5mm but not exceeding 10mm wide (Do Min)
  - Deep repair/ inlay (Do Something)
