Refurbishment Survey

Survey Reference Number: X-01040

9a Parsons Field
St Marys
Isles Of Scilly
TR21 0JJ

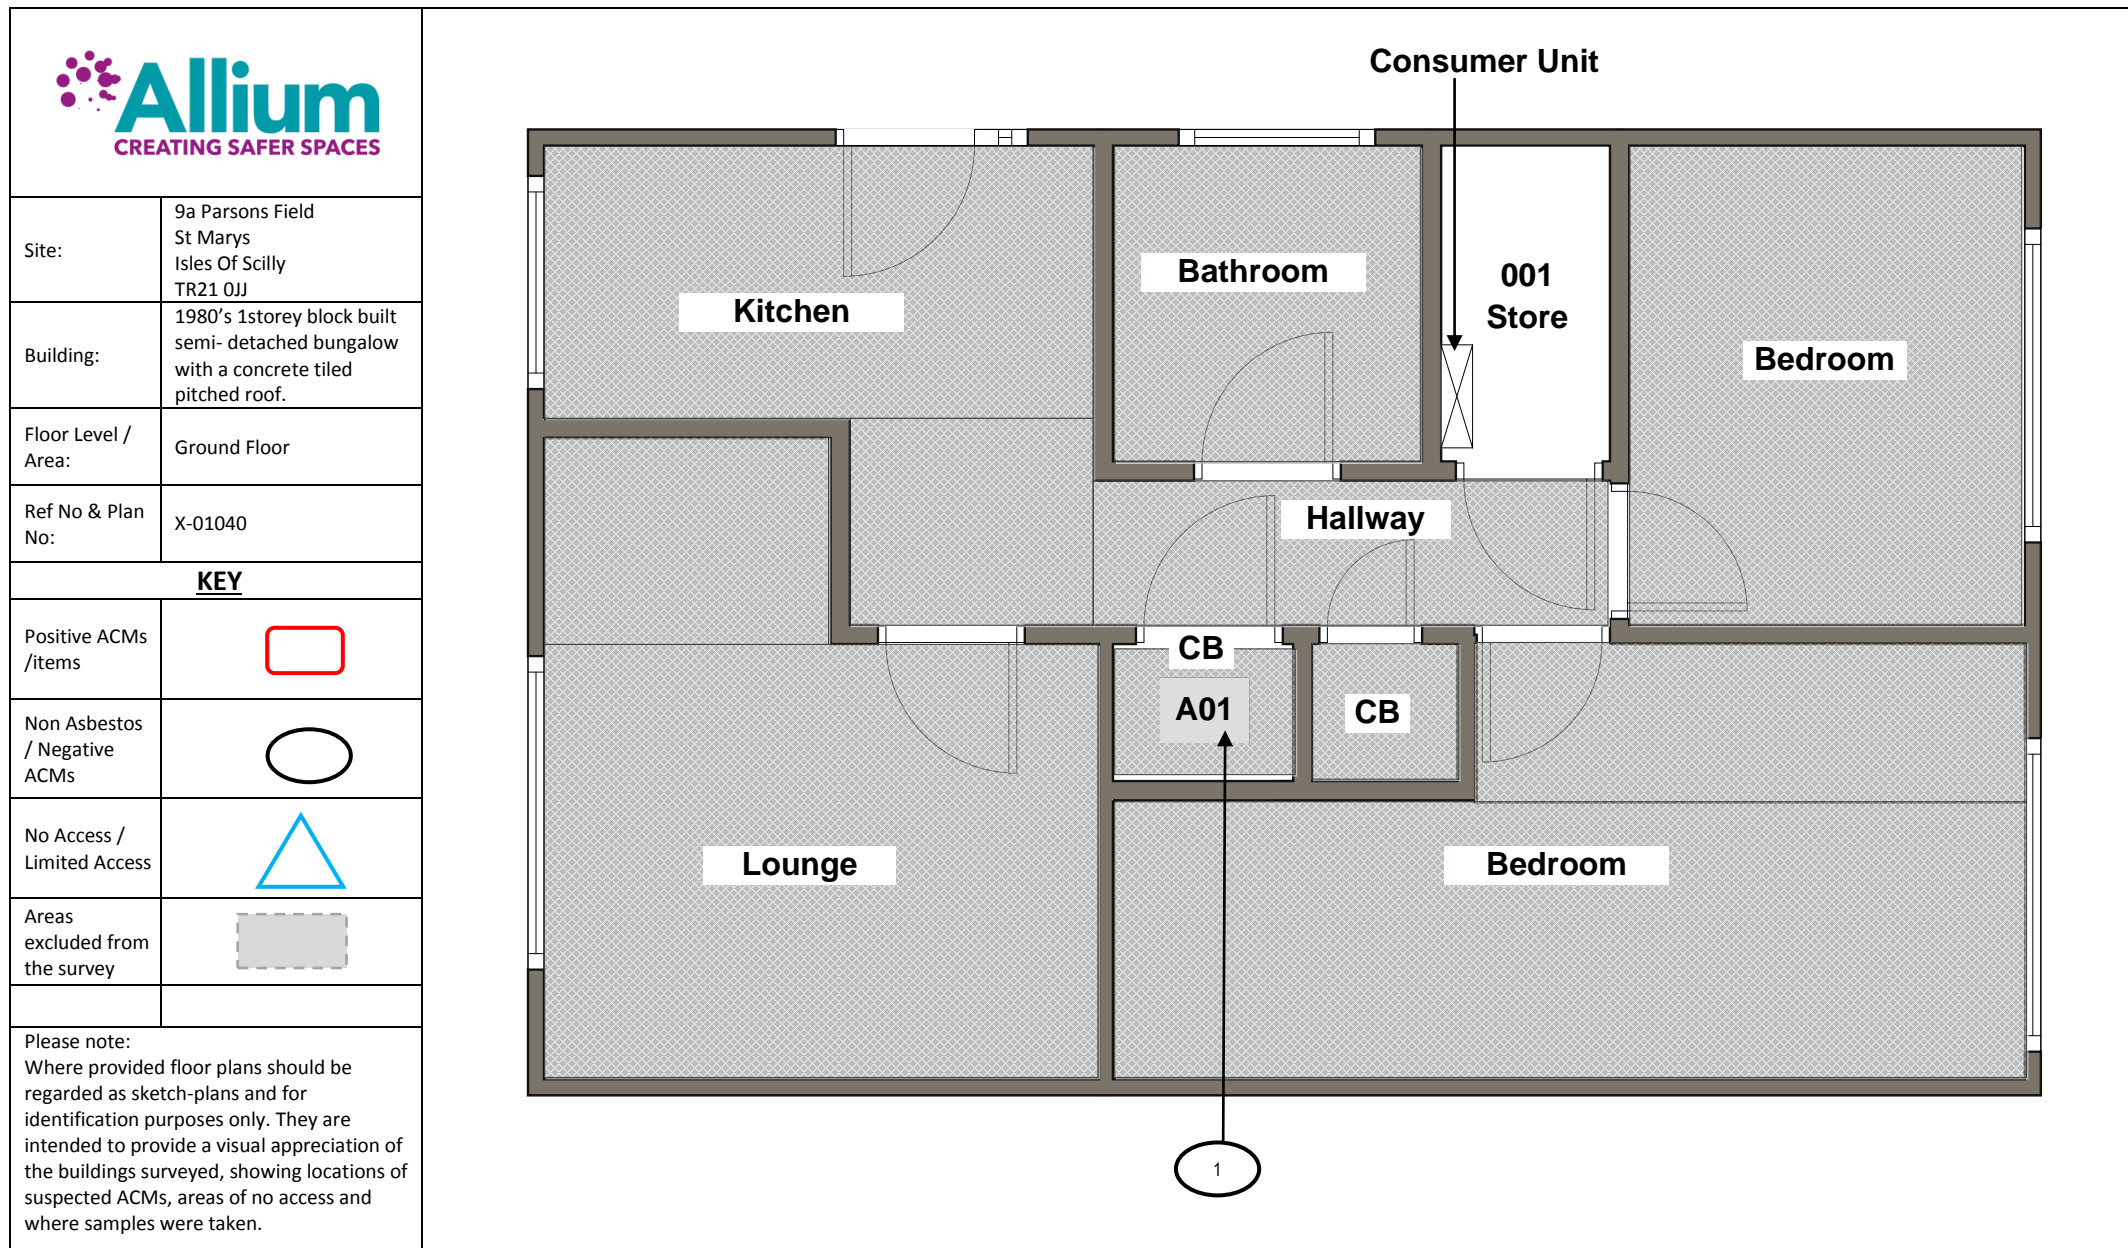
THIS PLAN SHOULD BE READ IN CONJUNCTION WITH THE MAIN BODY OF THE REPORT AND INDIVIDUAL ITEM RECORDS
