The Chantry Centre

Billericay Town Council

Job No. 600682

Pre-Construction Information (CDM Regulations 2015)

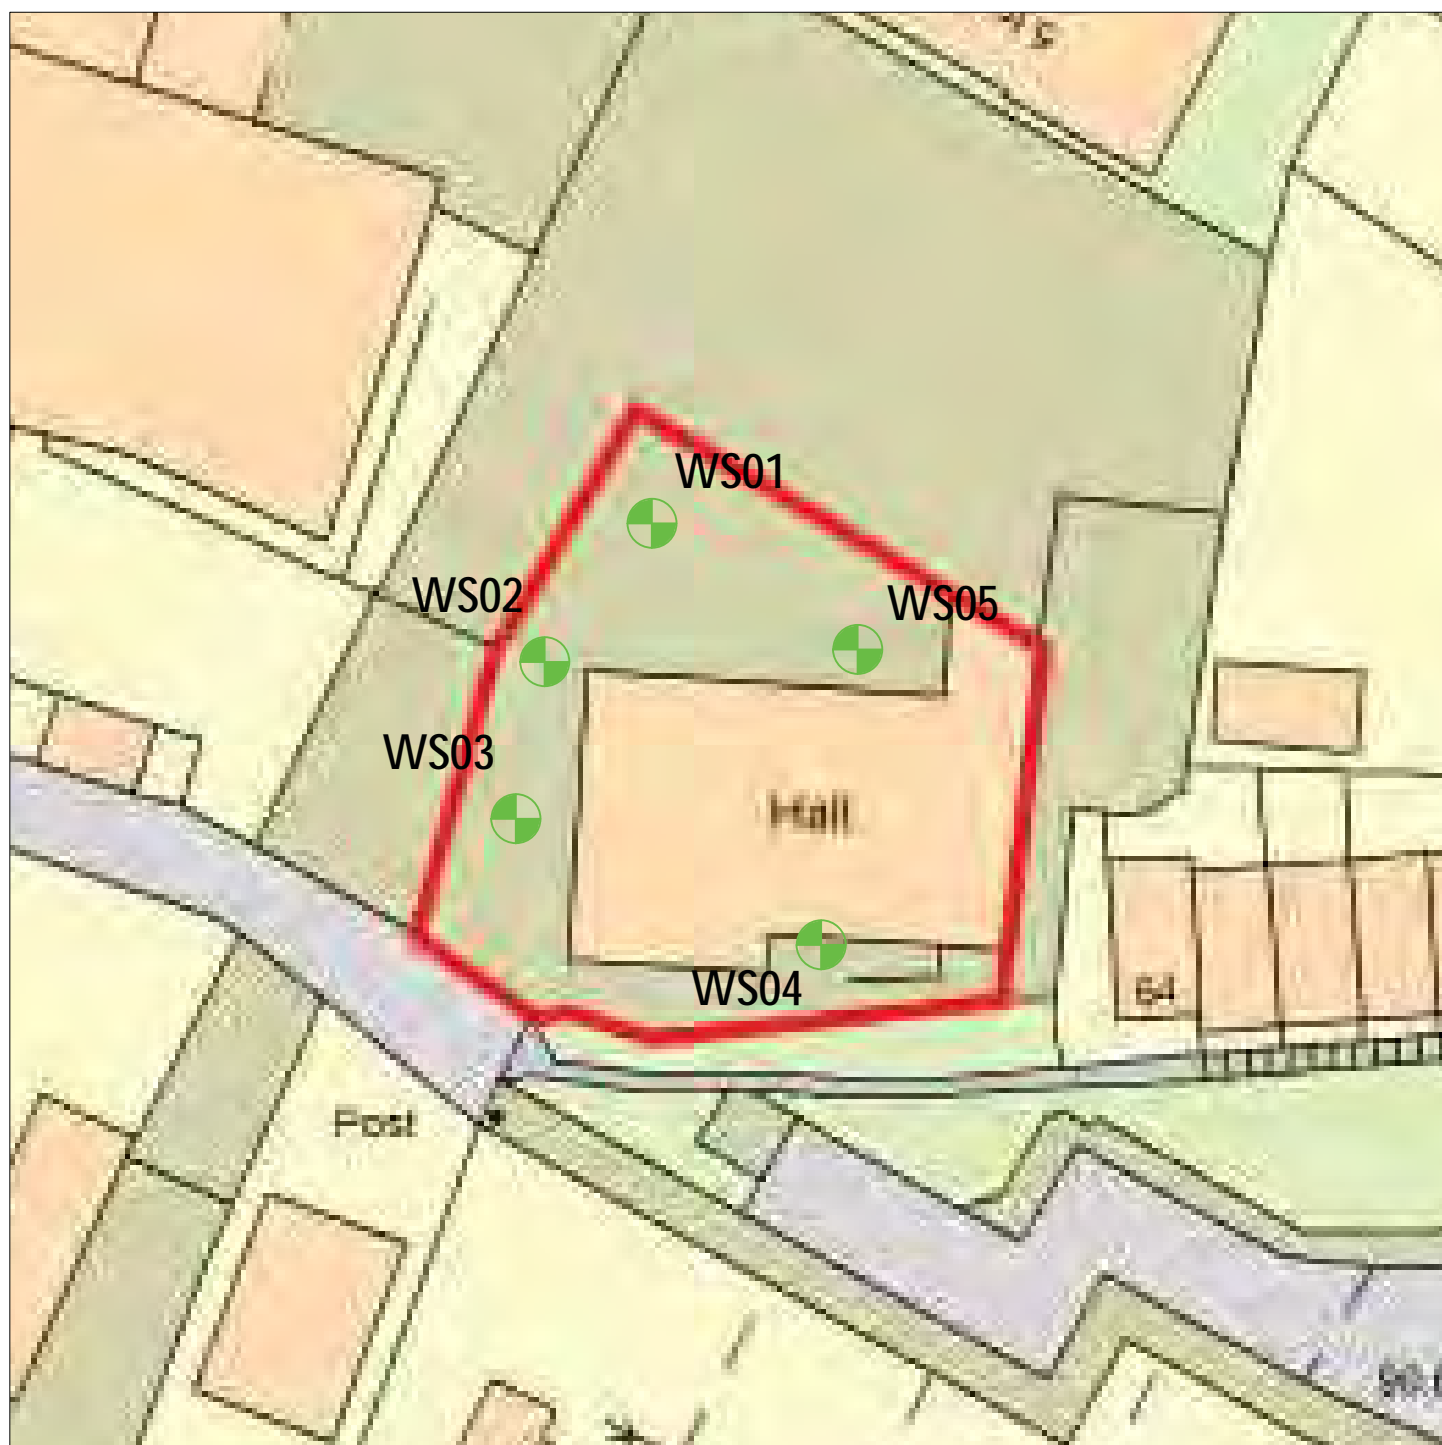
Dwg No: ChantryCentre/0618/04

A borehole location plan is presented as Figure 4.

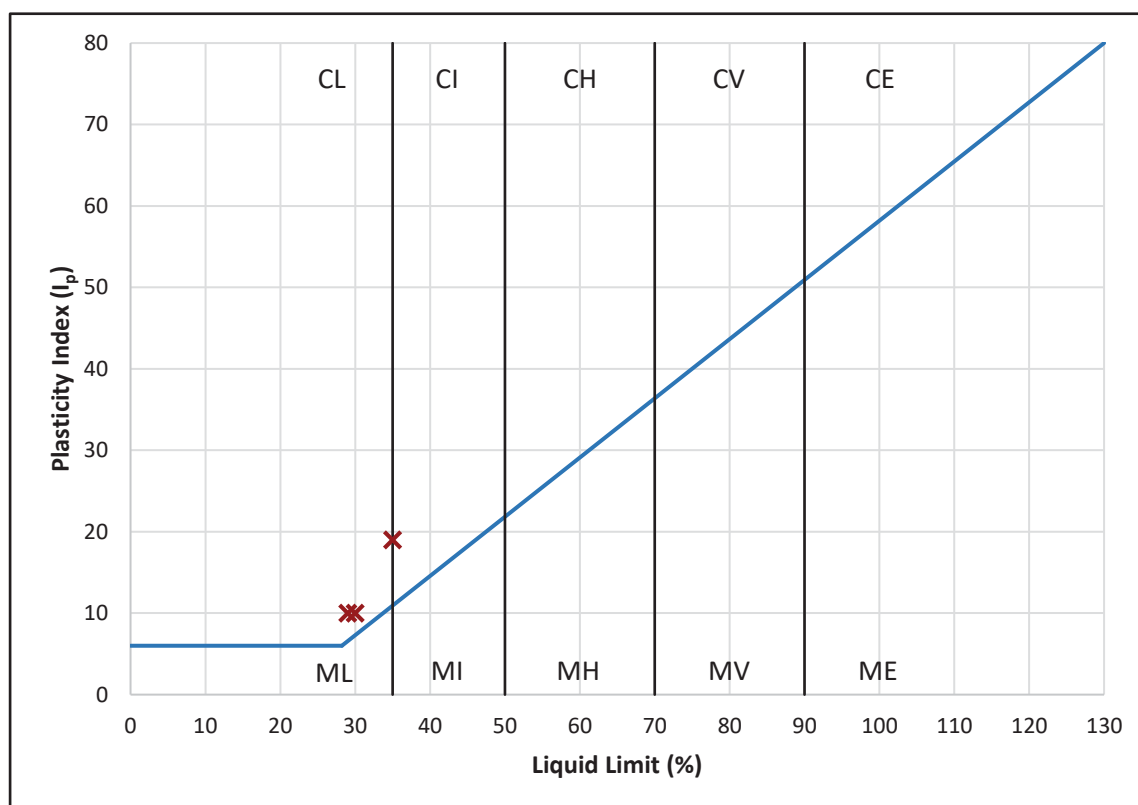
Plasticity Chart BS5930: 2015: Figure 8

PLOT OF PLASTICITY INDEX AGAINST LIQUID LIMIT USING CASAGRANDE CLASSIFICATION CHART

High	NHBC Volume Change Potential
Medium	
Low

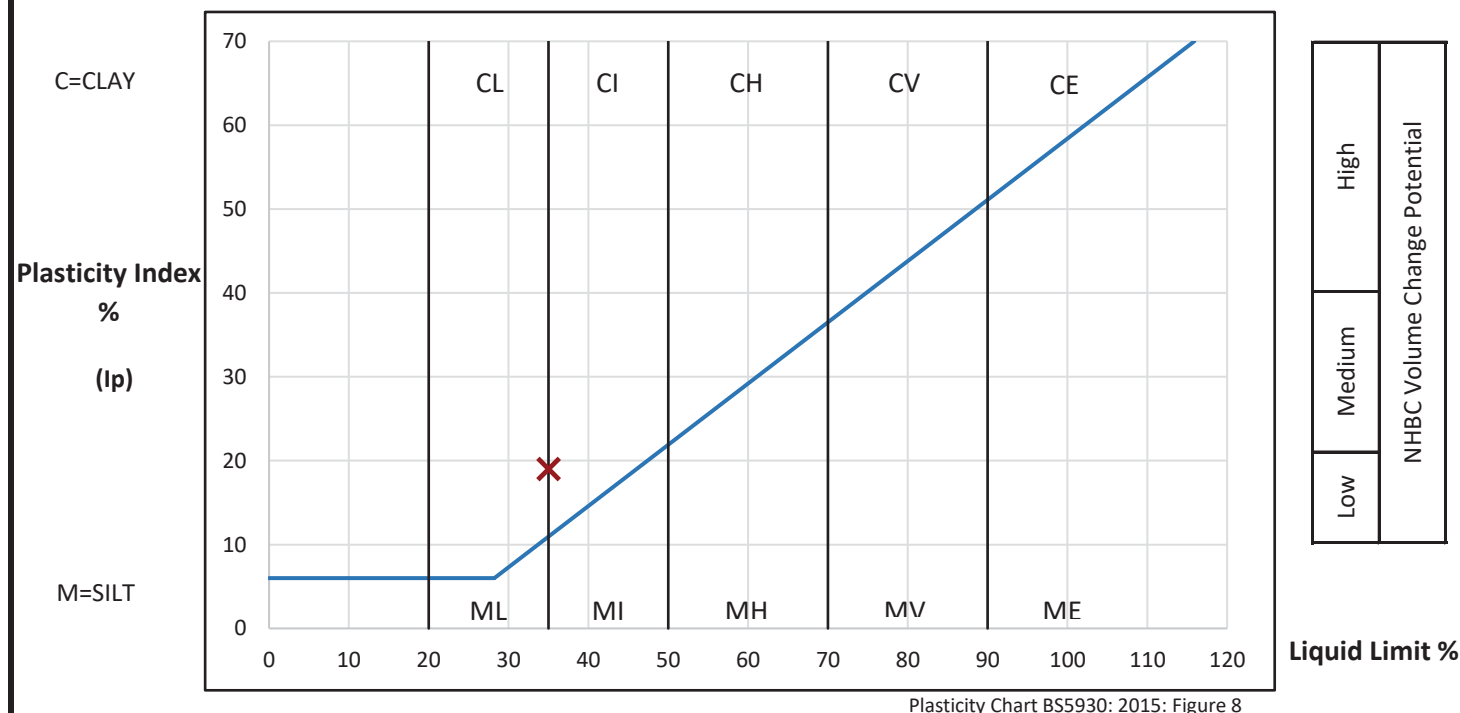
Borehole / Pit No.	Depth m	Sample Type	Sample Reference	Water Content (W) %	Description	Remarks
WS03	0.30 - 1.20	B	1	20.4	Firm orangish brown slightly gravelly slightly sandy silty CLAY with rare grey mottling. Gravel is brown, black and white fine to coarse angular to rounded chert.

PREPARATION				Liquid Limit 35 %	
Method of preparation Wet sieved over 0.425mm sieve				Plastic Limit 16 %	
Sample retained 0.425mm sieve (Measured) 16 %				Plasticity Index 19 %	
Corrected water content for material passing 0.425mm 24.3 %				Liquidity Index 0.23	
Sample retained 2mm sieve (Measured) 14 %				NHBC Modified (I'p) 16 %	
Curing time 25 hrs		Clay Content Not analysed		Derived Activity Not analysed

Method of Preparation: BS EN ISO: 17892-1: 2014 & BS 1377: Part 2: 1990: 4.2

Method of Test: BS EN ISO: 17892-1: 2014 & BS 1377: Part 2: 1990: 3.2, 4.4, 5.3, 5.4

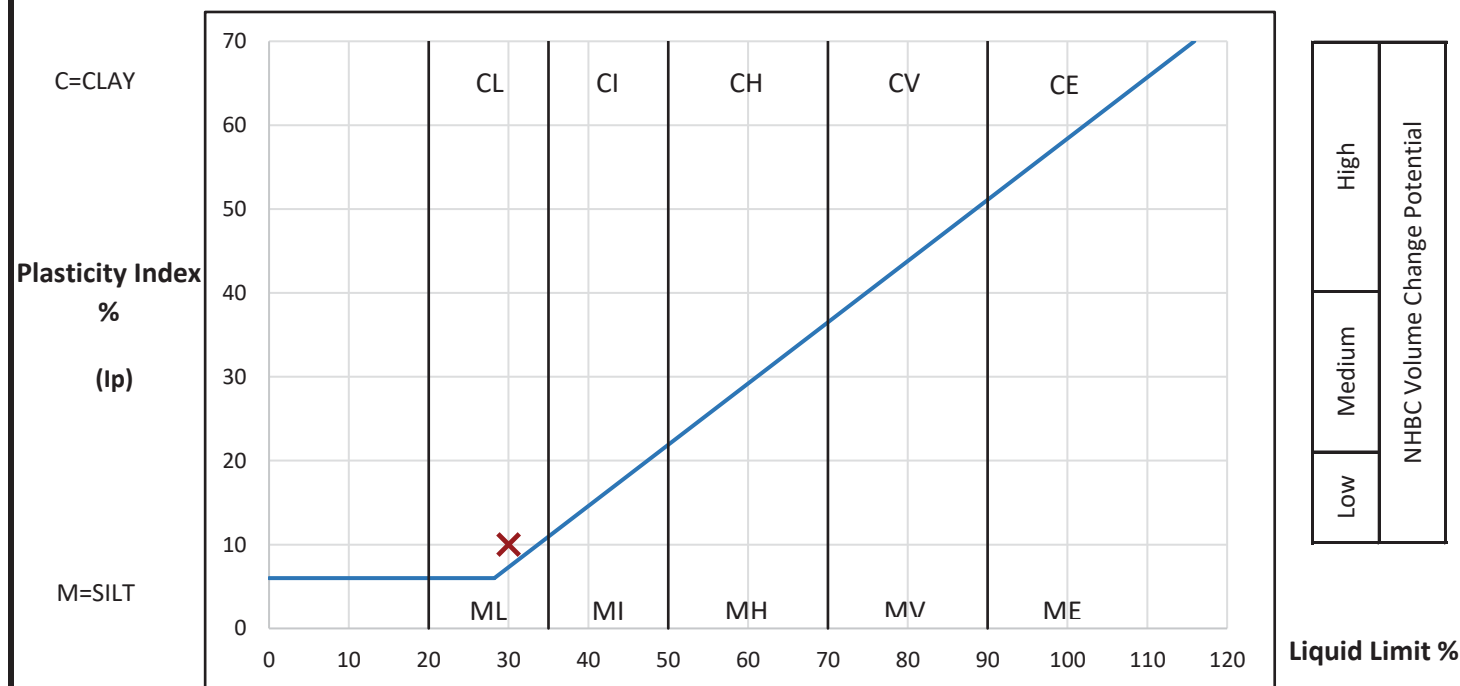
Borehole / Pit No.	Depth m	Sample		Water Content (W) %	Description	Remarks
		Type	Reference			
WS03	1.50 - 1.70	D	1	22.1	Soft orangish brown sandy silty CLAY with rare recently active roots. Sand is fine.

PREPARATION			Liquid Limit	30 %	
Method of preparation		From natural	Plastic Limit	20 %	
Sample retained 0.425mm sieve	(Assumed)	0 %	Plasticity Index	10 %	
Corrected water content for material passing 0.425mm			Liquidity Index	0.21	
Sample retained 2mm sieve	(Assumed)	0 %	NHBC Modified (I'p)	n/a	
Curing time	24 hrs	Clay Content	Not analysed	Derived Activity	Not analysed

Method of Preparation: BS EN ISO: 17892-1: 2014 & BS 1377: Part 2: 1990: 4.2
 Method of Test: BS EN ISO: 17892-1: 2014 & BS 1377: Part 2: 1990: 3.2, 4.4, 5.3, 5.4
 Type of Sample Key: U=Undisturbed, B=Bulk, D=Disturbed, J=Jar, W=Water, SPT=Split Spoon Sample, C=Core Cutter
 Comments:

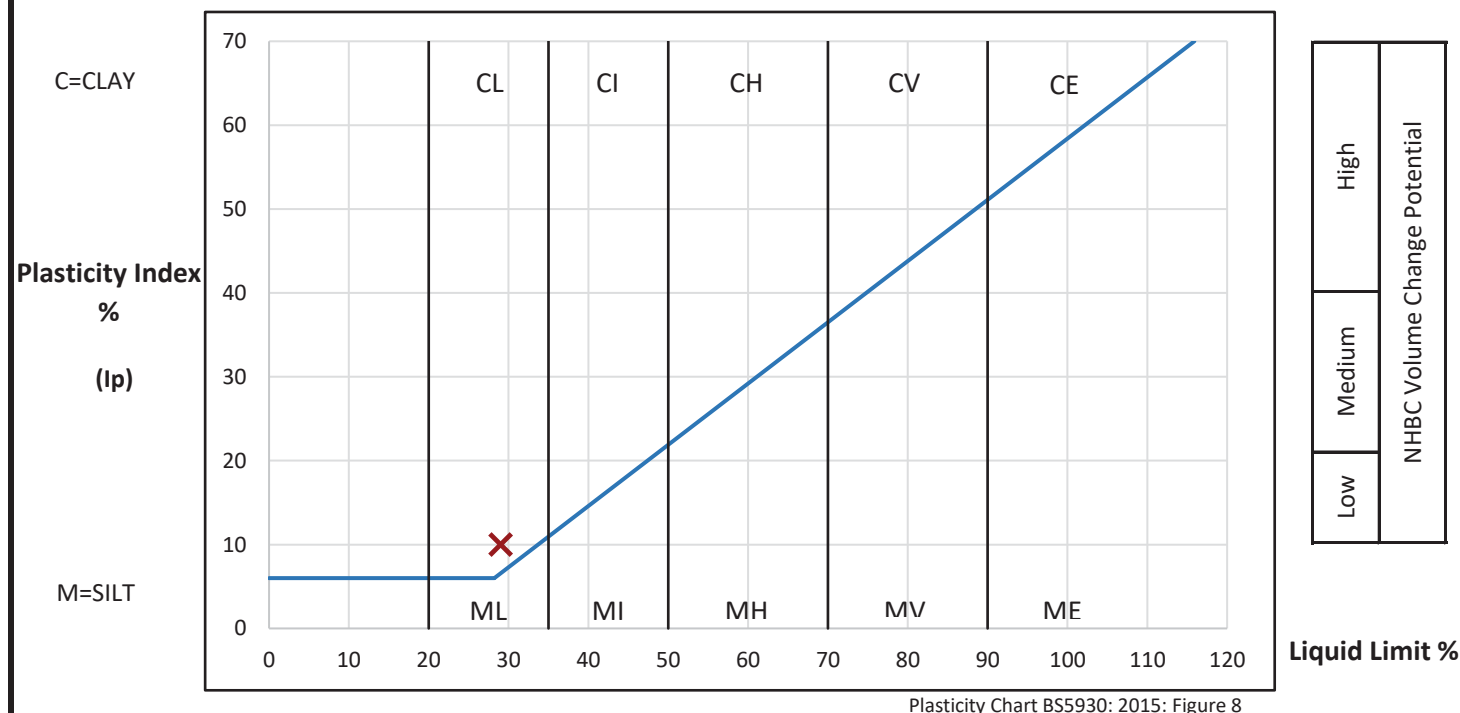
Borehole / Pit No.	Depth m	Sample Type	Sample Reference	Water Content (W) %	Description	Remarks
WS05	2.50 - 3.00	D	1	22.8	Soft yellowish brown sandy silty CLAY with occasional orangish brown mottling. Sand is fine.

PREPARATION			Liquid Limit	29 %	
Method of preparation		From natural	Plastic Limit	19 %	
Sample retained 0.425mm sieve	(Assumed)	0 %	Plasticity Index	10 %	
Corrected water content for material passing 0.425mm			Liquidity Index	0.38	
Sample retained 2mm sieve	(Assumed)	0 %	NHBC Modified (I'p)	n/a	
Curing time	24 hrs	Clay Content	Not analysed	Derived Activity	Not analysed

Method of Preparation: BS EN ISO: 17892-1: 2014 & BS 1377: Part 2: 1990: 4.2
 Method of Test: BS EN ISO: 17892-1: 2014 & BS 1377: Part 2: 1990: 3.2, 4.4, 5.3, 5.4
 Type of Sample Key: U=Undisturbed, B=Bulk, D=Disturbed, J=Jar, W=Water, SPT=Split Spoon Sample, C=Core Cutter
 Comments:

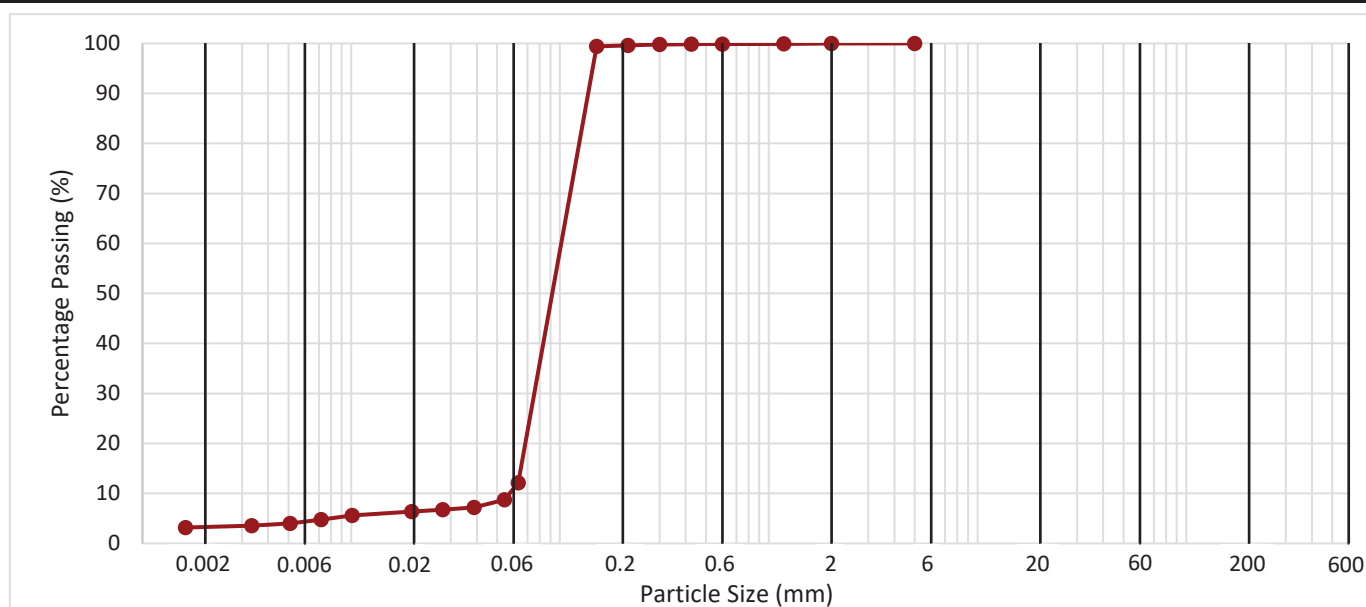
Borehole / Pit No.	Depth (m)	Sample		Description	Remarks
		Type	Reference		
WS01	1.50 - 2.00	D	1	Orange silty slightly clayey SAND.

Method of Test: Hydrometer + Pre-sieve Method of Pretreatment: Not required

Hydrometer	Particle Size (mm)	Passing (%)	Silt by Dry Mass (%)
	0.0541	9	9
	0.0387	7	
	0.0275	7	
	0.0195	6	Clay by Dry Mass (%)
	0.0101	6	
	0.0072	5	
	0.0051	4	3
	0.0033	4	
	0.0016	3

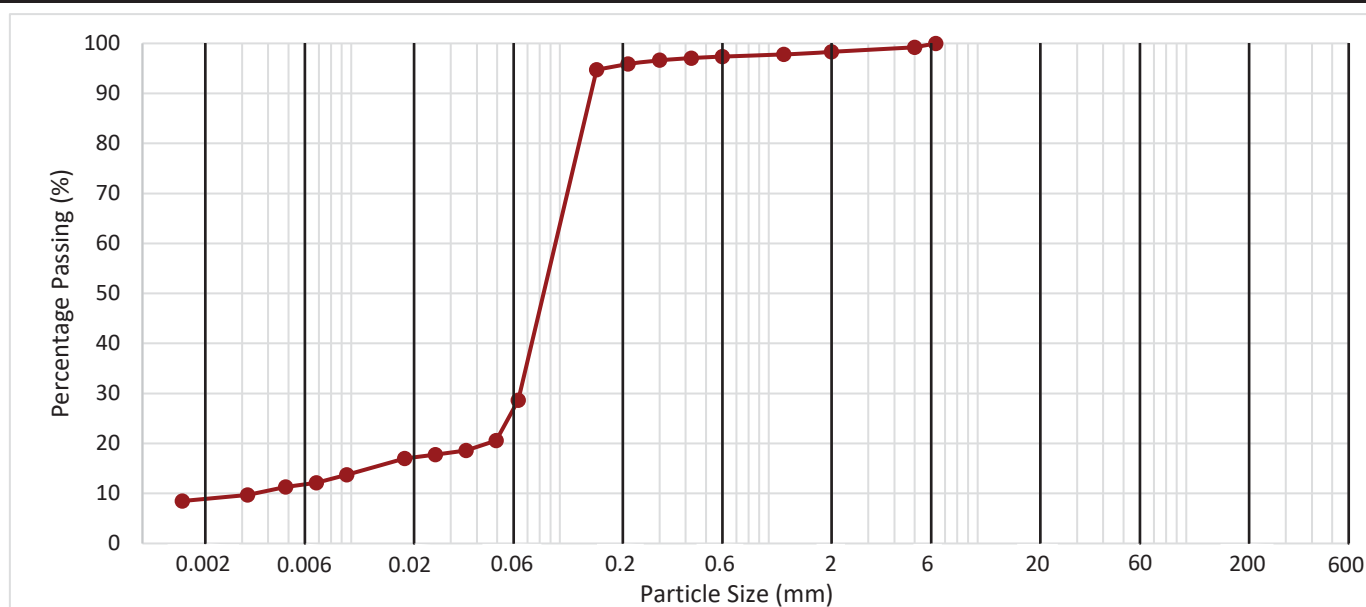
Borehole / Pit No.	Depth (m)	Sample		Description	Remarks
		Type	Reference		
WS01	3.00 - 3.50	D	2	Brownish yellow slightly gravelly very silty clayey SAND. Gravel is ferruginous sandstone/siltstone.

Method of Test: Hydrometer + Pre-sieve Method of Pretreatment: Not required

Hydrometer	Particle Size (mm)	Passing (%)	Silt by Dry Mass (%)
	0.0494	21	20
	0.0355	19	
	0.0253	18	
	0.0180	17	
	0.0095	14	Clay by Dry Mass (%)
	0.0068	12	
	0.0049	11	
	0.0032	10	
	0.0016	8	9

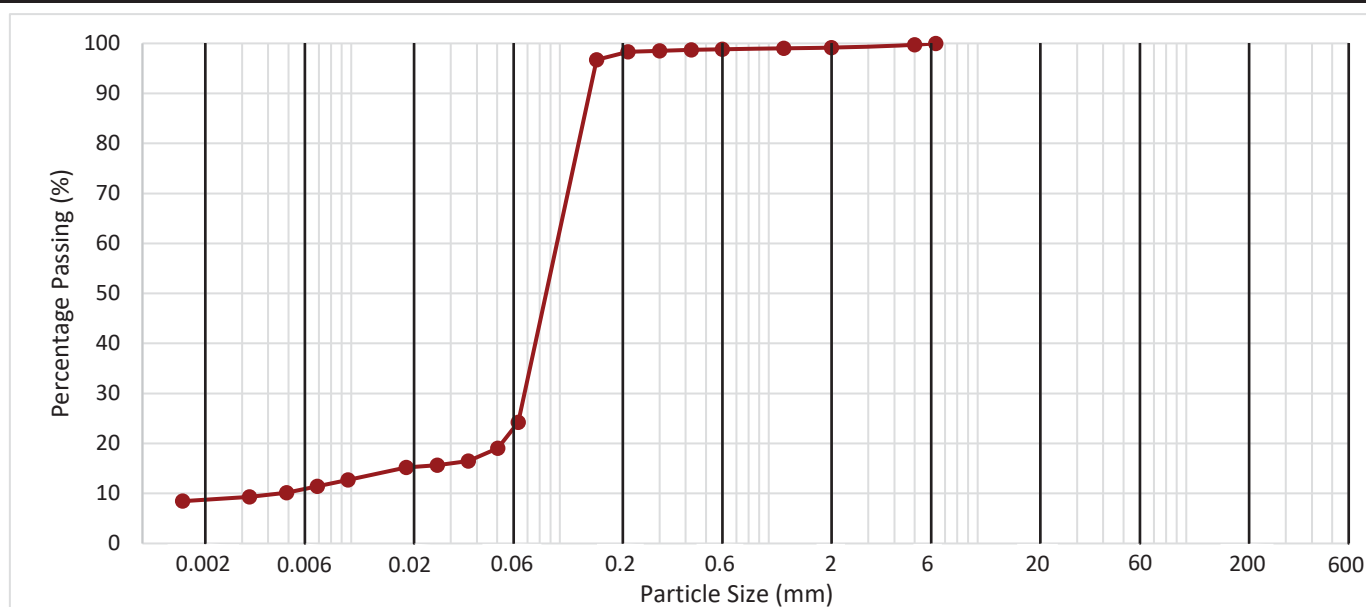
Borehole / Pit No.	Depth (m)	Sample		Description	Remarks
		Type	Reference		
WS04	3.30 - 3.60	D	1	Pale brown slightly gravelly silty clayey SAND with rare orange sand.

Method of Test: Hydrometer + Pre-sieve Method of Pretreatment: Not required

Hydrometer	Particle Size (mm)	Passing (%)	Silt by Dry Mass (%)
	0.0504	19	15
	0.0364	16	
	0.0258	16	
	0.0184	15	Clay by Dry Mass (%)
	0.0096	13	
	0.0069	11	
	0.0049	10	9
	0.0033	9	
	0.0016	8

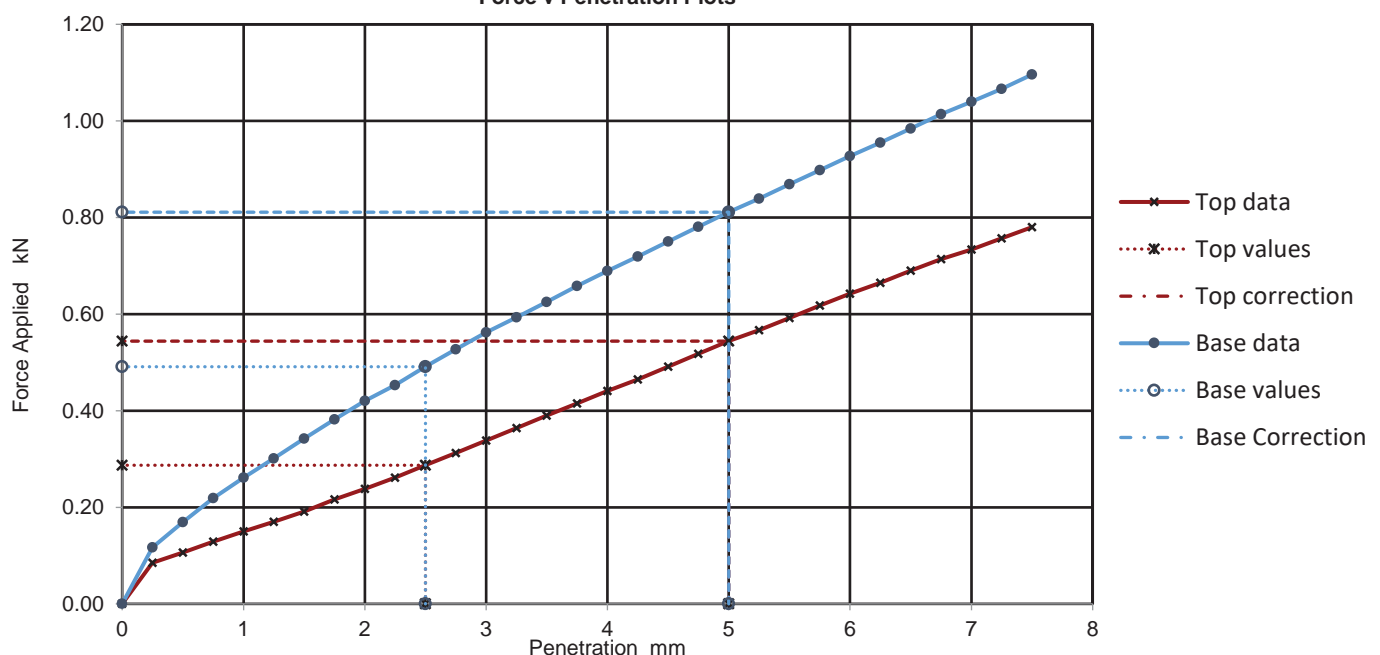
Force v Penetration Plots

Water Content (%)
18.6
19.4

Method of Preparation:	BS1377: Part1: 2016 & BS1377: Part 4: 1990: 7.2.4.4
Method of Test:	BS1377: Part 4: 1990: 7
Type of Sample Key	U = Undisturbed, B = Bulk, D = Disturbed, J = Jar, W = Water, SPT= Split Spoon Sample, C = Core Cutter
Comments:	*Only reported if the results from each end of the sample are within $\pm 10\%$ of the mean value.
Remarks to Include:	Sample disturbance, loss of moisture, variation from test procedure, location and origin of test specimen within original sample, oven drying temperature if not 105-110°C.

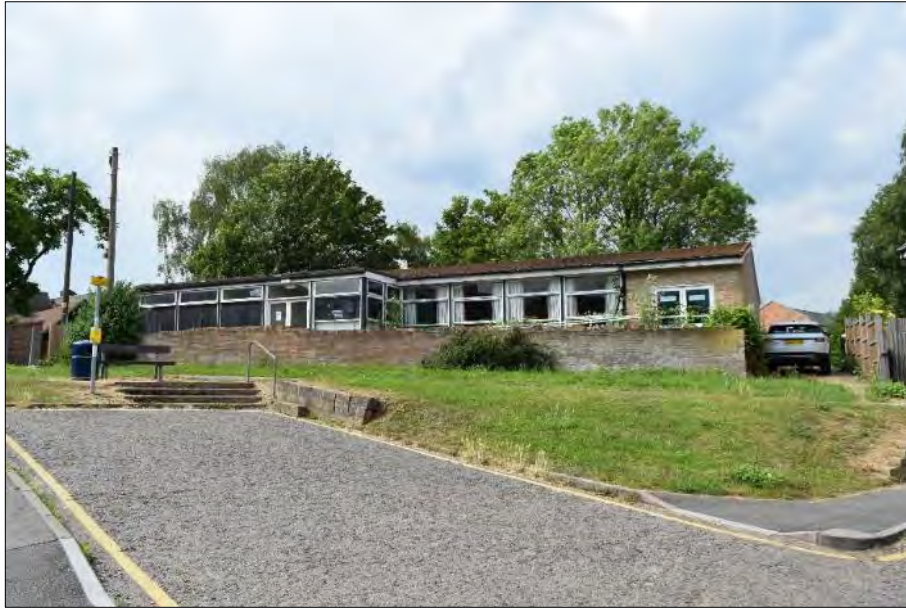
Plate 1: The hall building on the site, looking northwest

- 6.1 The site was visited by Harvey Tesseyman on Wednesday 13th June 2018. Selected photographic images taken during the site visit are reproduced below and their locations indicated on Figure 2.
- 6.2 The site is occupied by a building (Plate 1), access ramp (Plate 2) and car park off Chantry Way (Plate 3).

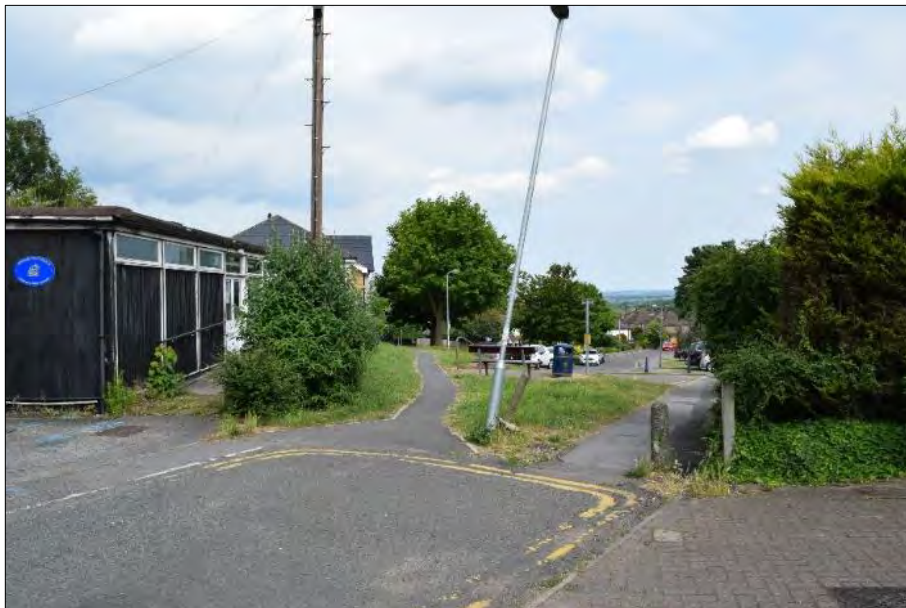
Plate 2: Footpath access to the site including an access ramp, looking east

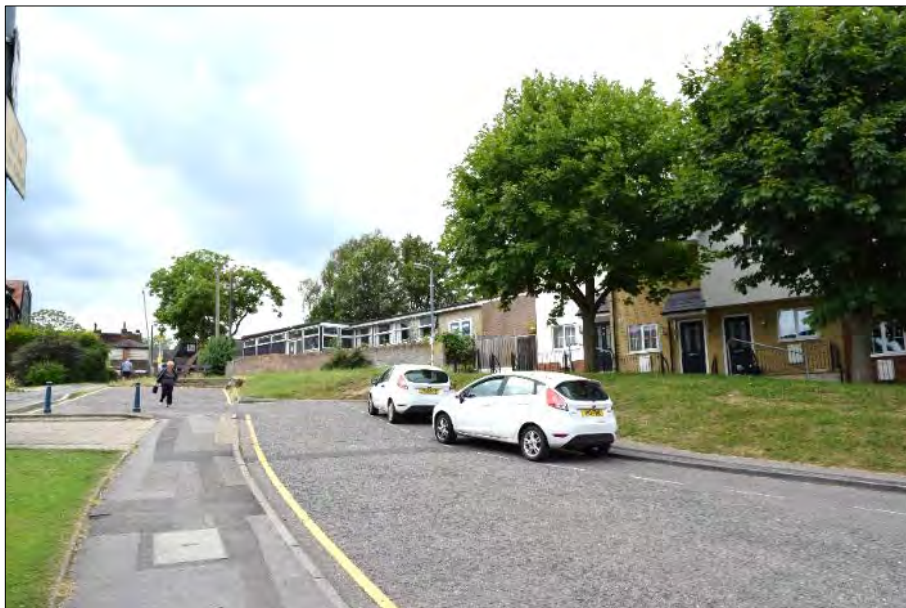
Plate 4: View of Chantry Way looking northwest towards the site

- 6.3 The ground rises up from the southeast towards the site, whereas the site itself is on what appears to be an artificially levelled terrace (Plate 4). At the western boundary, the site appears to be c.0.5m higher than the adjacent land (Plate 5).

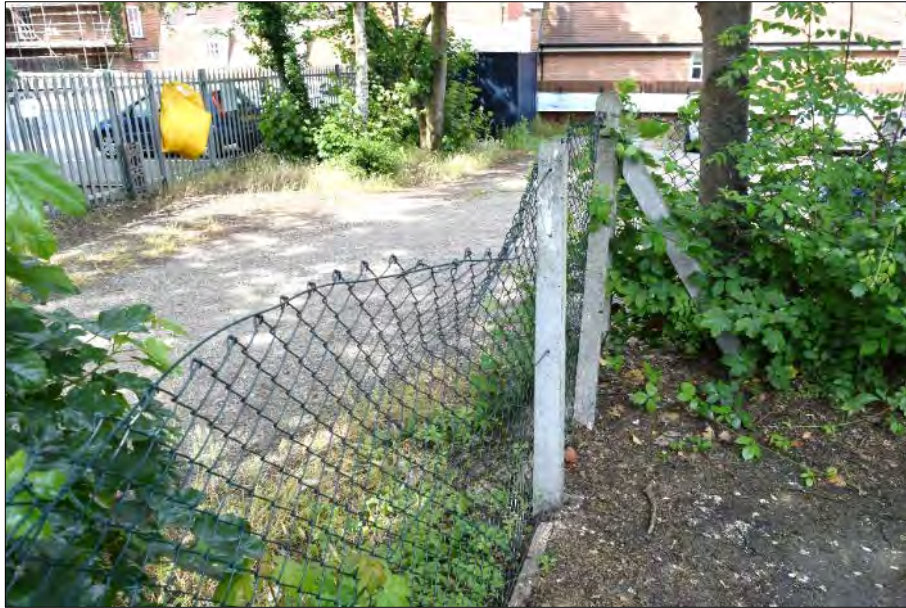
Plate 5: Height difference between site (on right) and adjacent land (on left), which is 0.5m lower

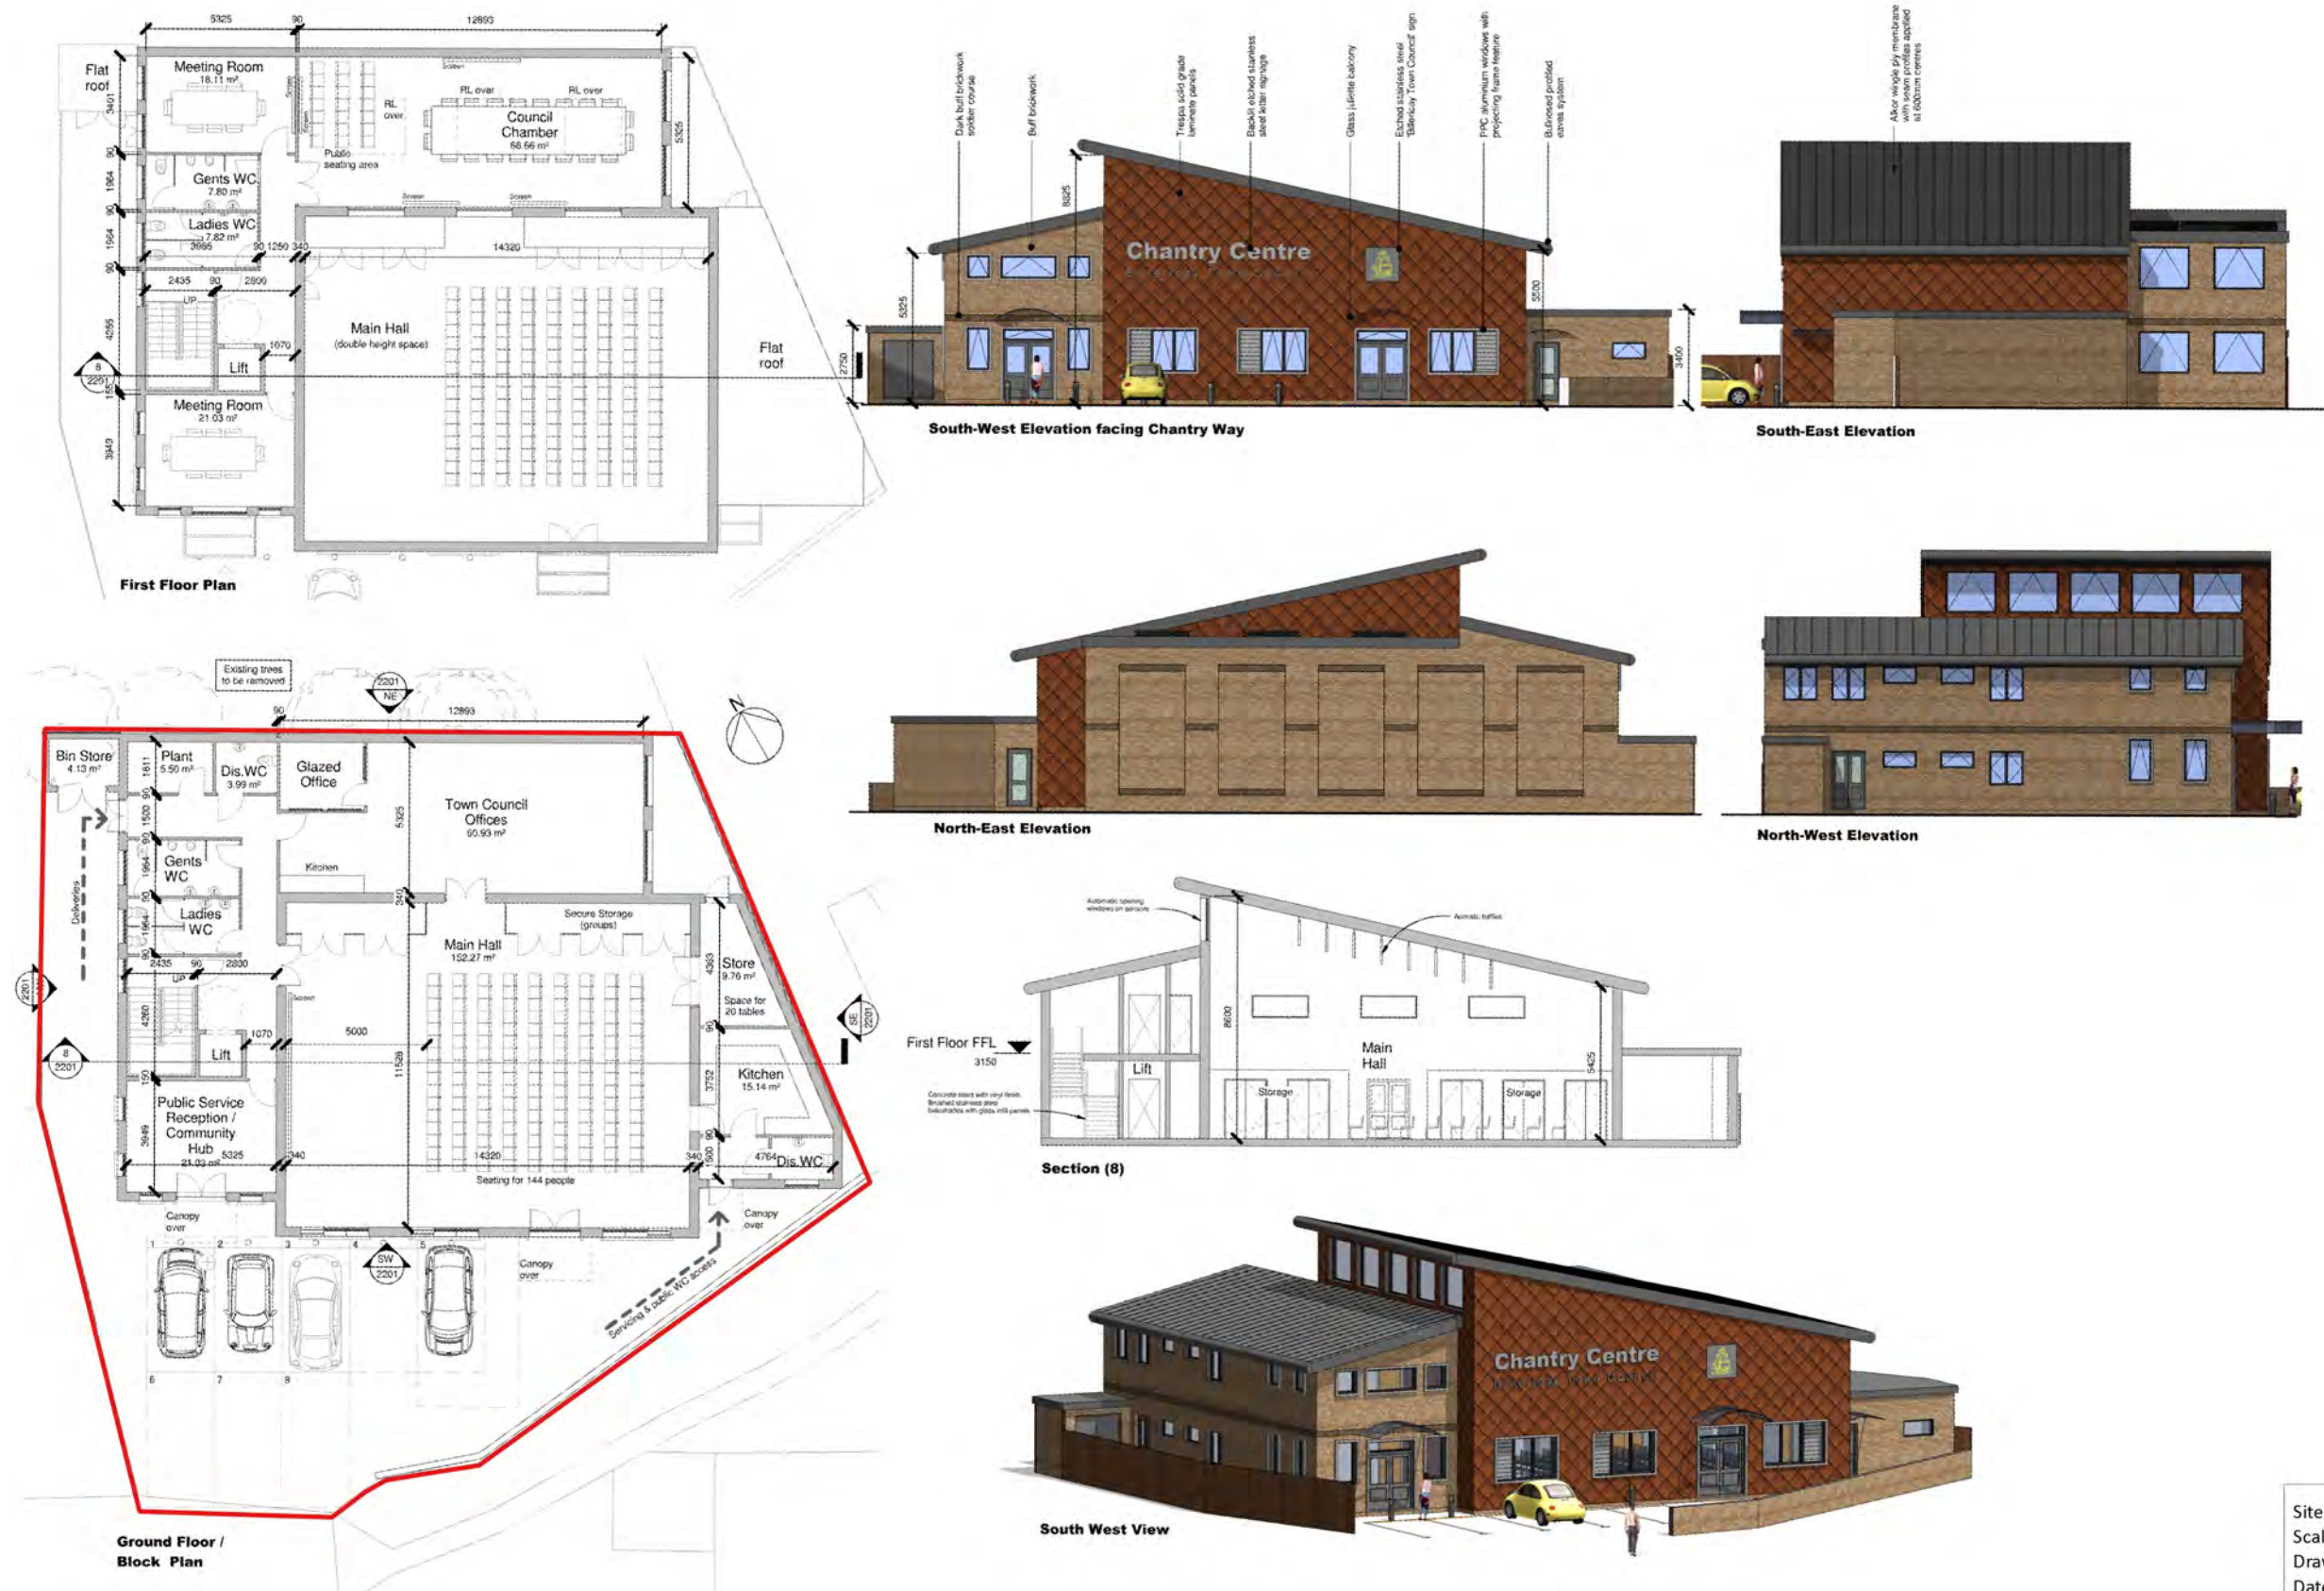
Figure 11: Proposed development plan provided by client with site outlined in red

- 7.5 The proposed development is slightly larger than the existing development, with an additional storey to incorporate the new functions of the structure (Figure 11). This has slightly increased the intervisibility between the Grade II Listed Buildings fronting the High Street (Sites 16 and 21) although the existing mature trees limit most intervisibility and the proposed new building is set back from the plot frontage, further reducing views from the High Street. The current form of buildings along High Street here are mostly of two storeys, thus the proposed two storey new development would not be out of character.

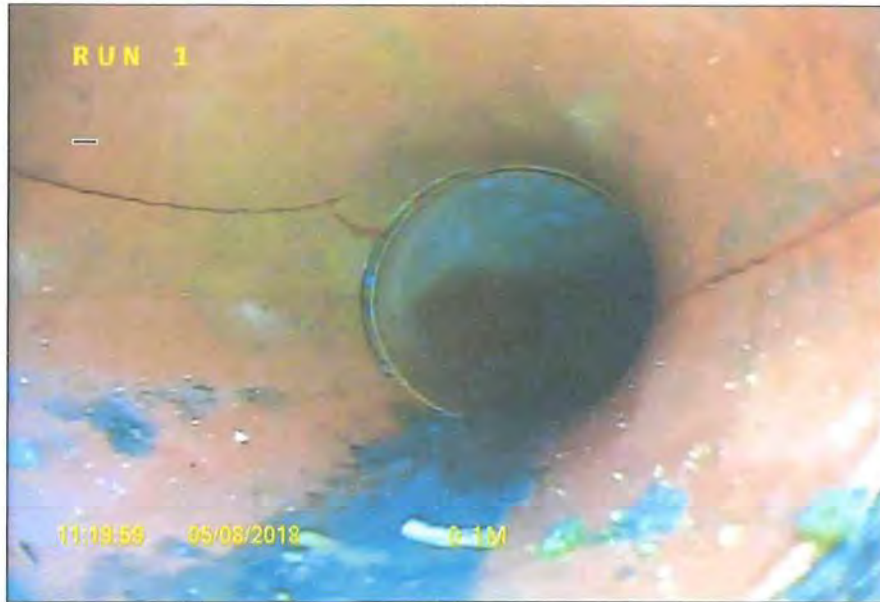
Photo: 1_1_4_A.jpg
0.1m, Crack, longitudinal at joint, at 9 o'clock

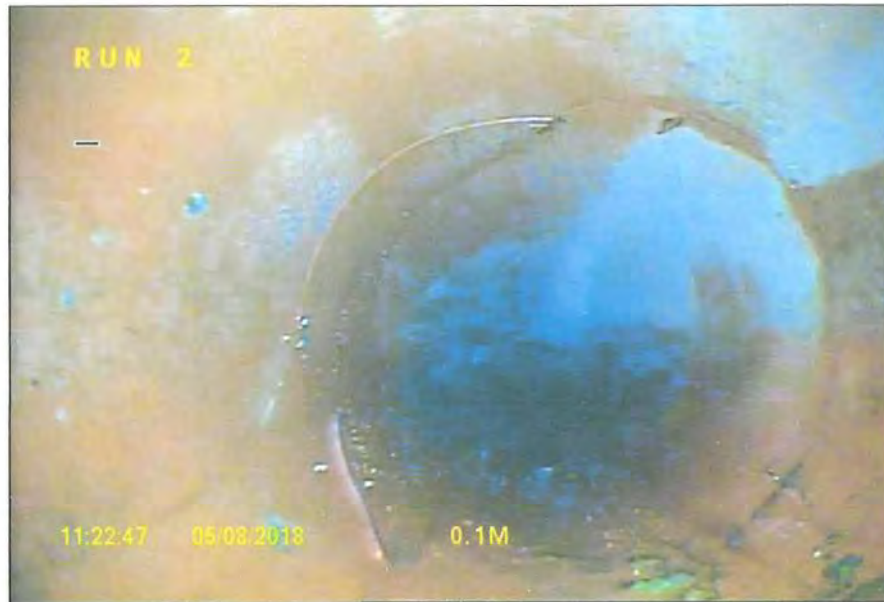
Photo: 3_3_10_A.jpg
0.1m, Crack, circumferential, from 12 to 12 o'clock

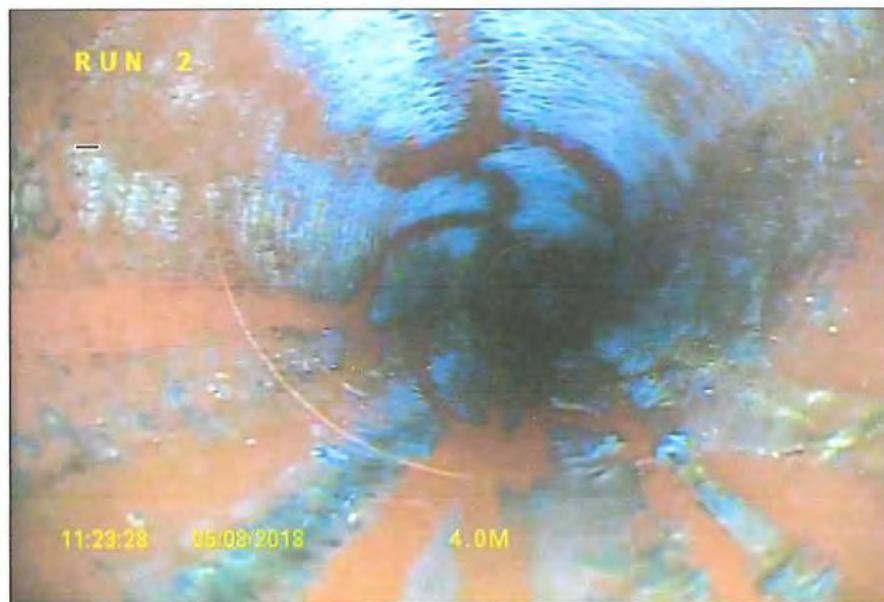
Photo: 3_3_11_A.jpg
4m, Crack, circumferential, from 6 to 9 o'clock

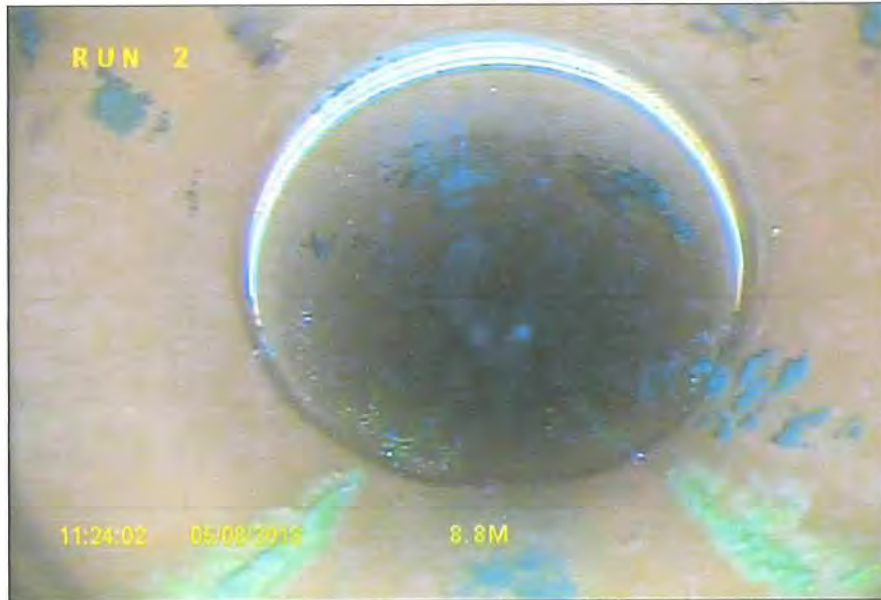
Photo: 3_3_12_A.jpg
8.8m, Joint displaced, medium (between 1.0 and 1.5 times the pipe wall thickness)

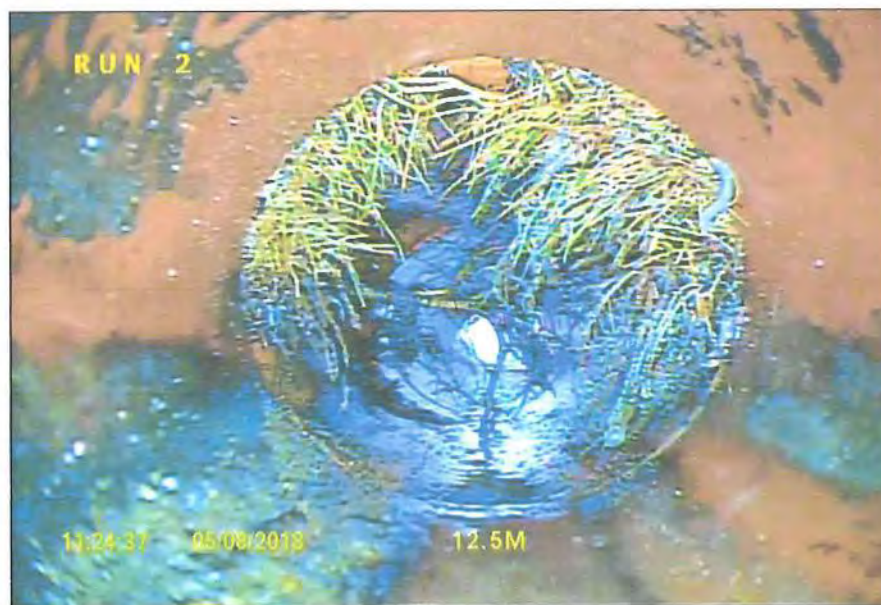
Photo: 3_3_14_A.jpg
12.5m, Roots, mass at joint, 40% cross-sectional area loss

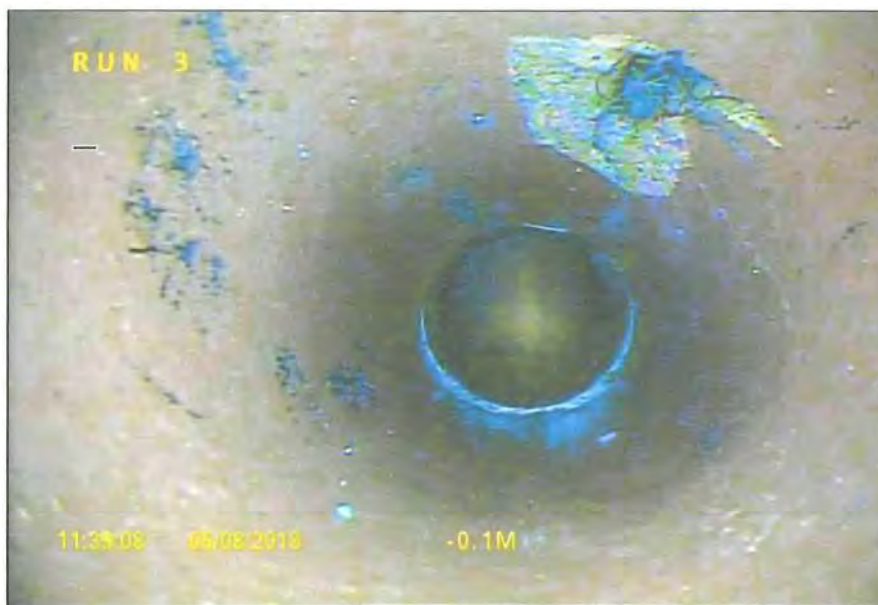
Photo: 4_4_20_A.jpg
0.1m, Hole in sewer, from 1 to 1 o'clock

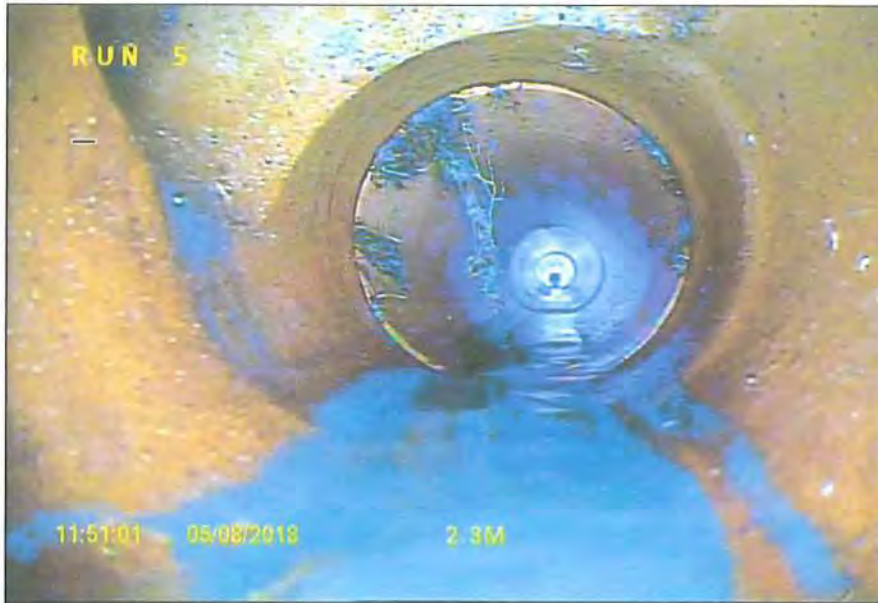
Photo: 6_6_33_A.jpg
2.3m, Roots, mass at joint, 5% cross-sectional area loss

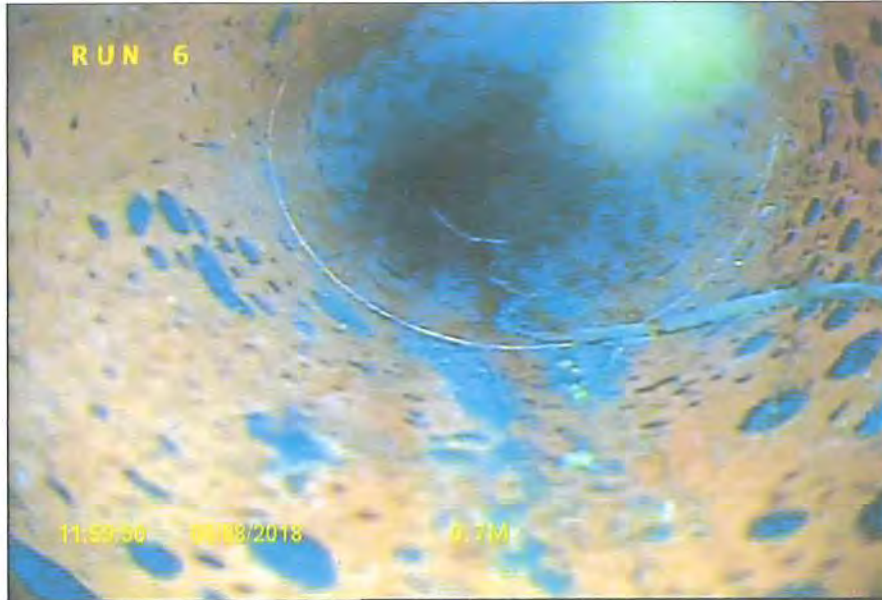
Photo: 7_7_38_A.jpg
0.7m, Crack, circumferential at joint, from 3 to 9 o'clock

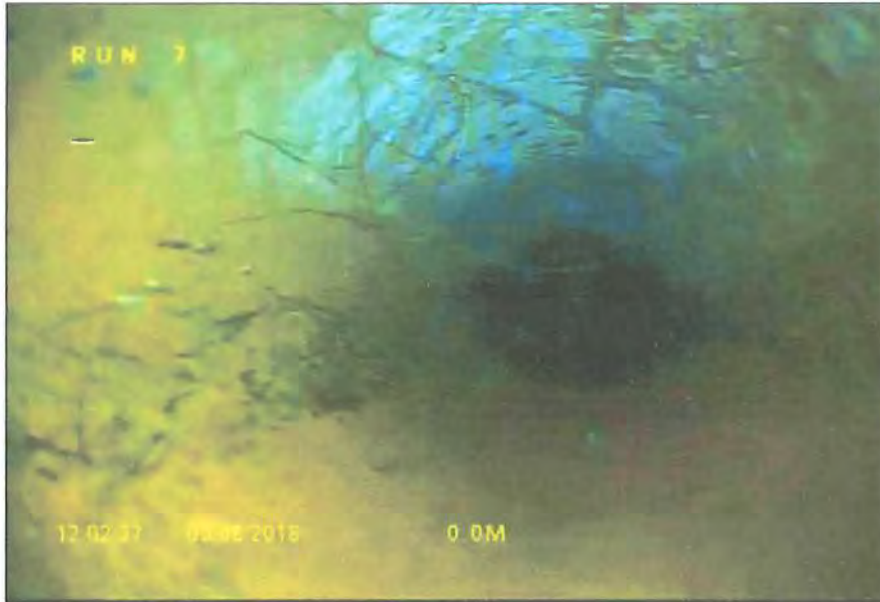
Photo: 8_8_44_A.jpg

0.1m, General observation Remarks: FINE ROOTS ATTACHED TO JOINT

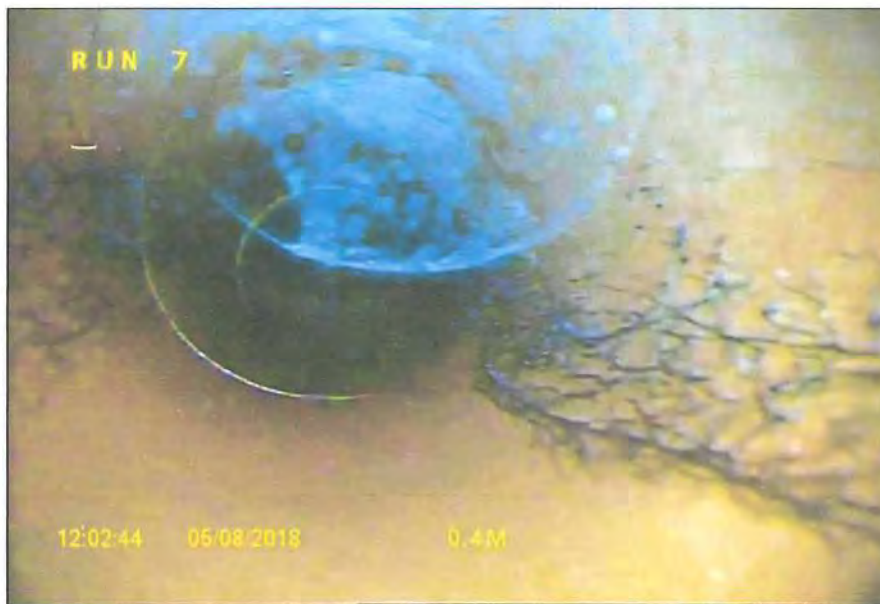
Photo: 8_8_45_A.jpg

0.4m, Crack, circumferential, from 6 to 11 o'clock
