The Chantry Centre

Billericay Town Council

Job No. 600682

Pre-Construction Information (CDM Regulations 2015)

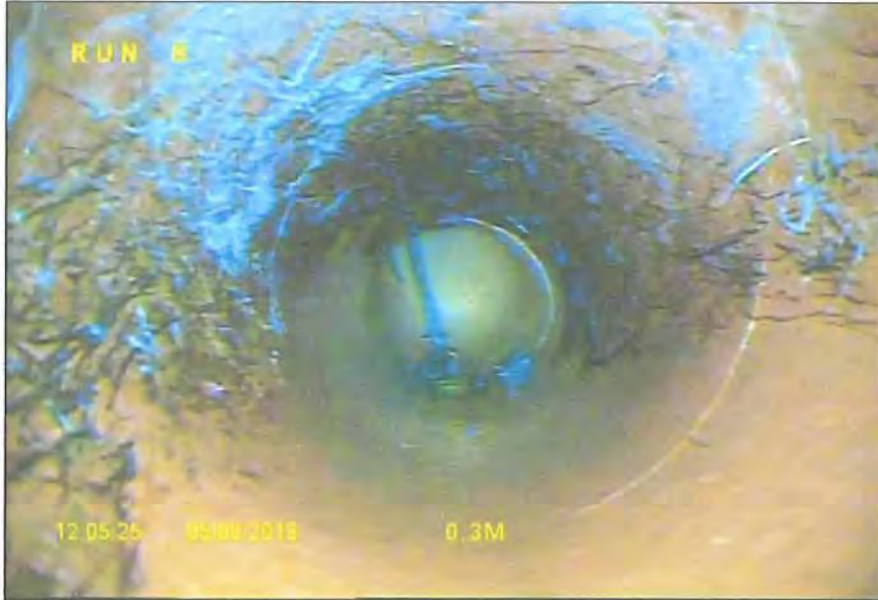
Photo: 9_9_50_A.jpg
0.3m, Crack, circumferential, from 3 to 6 o'clock

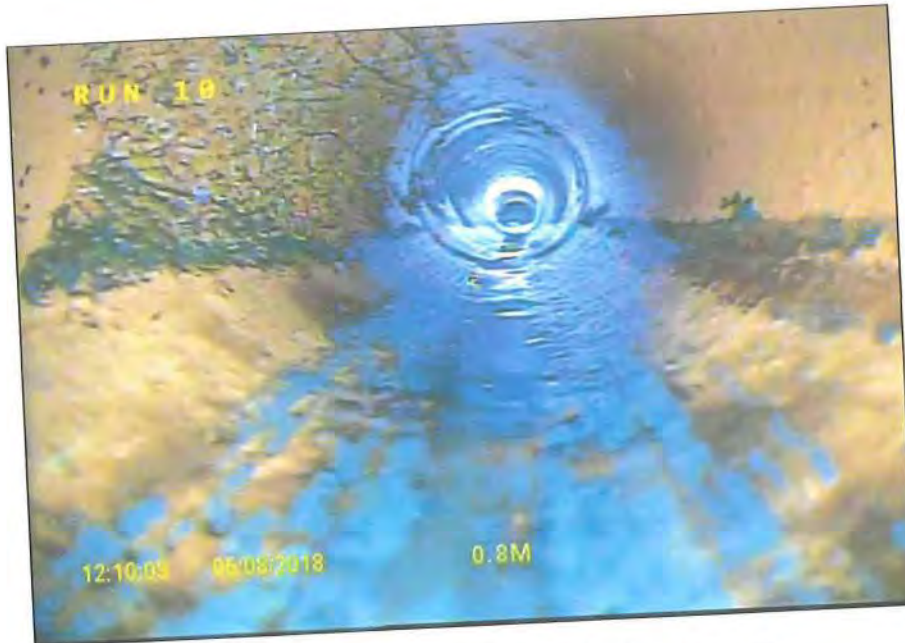
Photo: 11_11_61_A.jpg
0.8m, General observation Remarks: FINE ROOTS ATTACHED THROUGHOUT

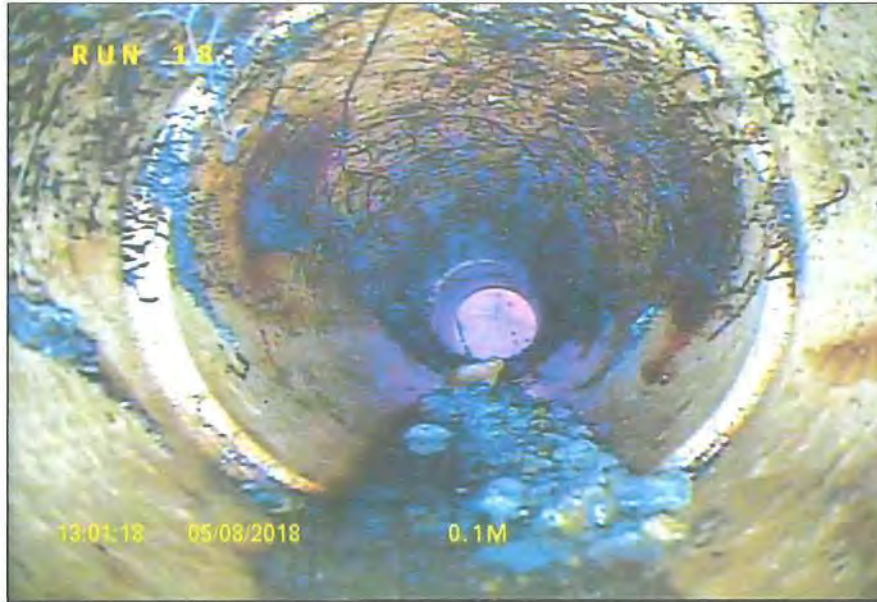
Photo: 19_19_97_A.jpg

0.3m, General observation Remarks: ROOTS CONTINUED
