The Royal Institution
of Cornwall

230794

**Roof Repair Works
(MEND) at the Royal
Cornwall Museum**
**Pre Construction
Information**

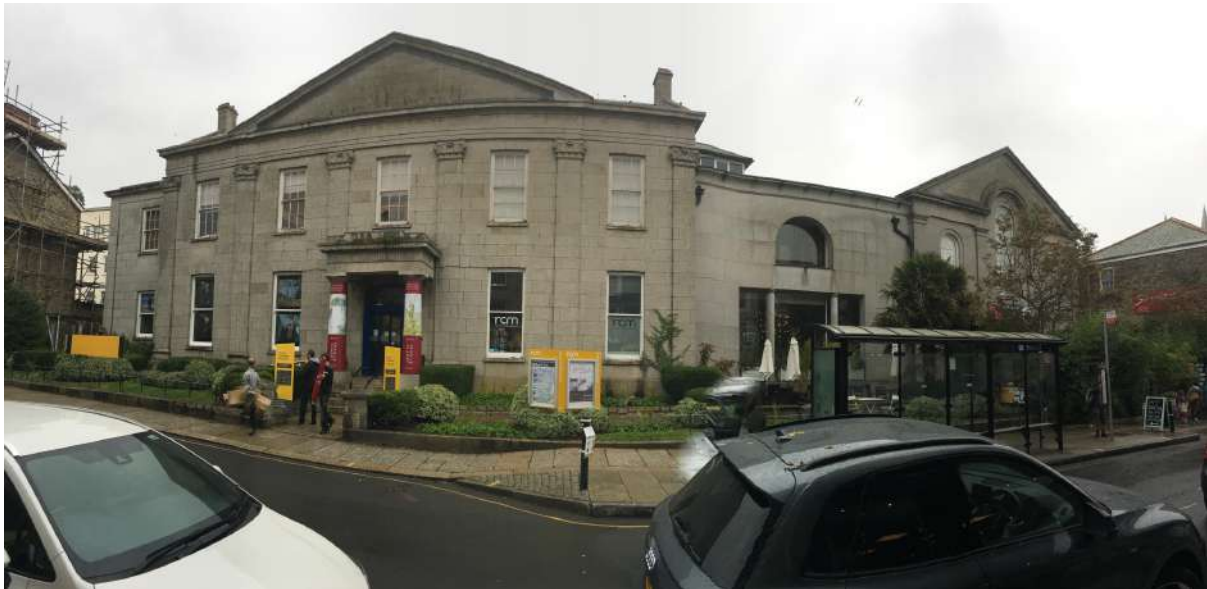
Photograph 1. South (front) elevation.

Roof No R1 is above the library and is a pitched gable roof. It has a granite front façade (Photograph 1) and granite gable (Photograph 3). There are granite cornices at the eaves (Photograph 4). These features do not allow any potential bat access points. The roof covering is natural slate with clay ridge tiles. The front roof slope was not visible from the ground. No obvious potential bat access points were observed in the rear roof slope. It was not possible to gain entry to the roof void as there was a non-weight bearing hanging ceiling. A single ceiling tile was removed so that the void could be seen. The underside of the roof covering has a fibrous insulation. This insulation is above the rafters but below the slates and is likely to block bat entry into the roof void. It is possible that bats could roost unseen beneath ridge tiles or behind slates in the void created by the battens (should potential bat access points be present). The presence or absence of bats in R1 could not be determined via a visual survey alone. R1 has been assessed as having low potential as a bat roost. Therefore, one emergence survey at dusk using two surveyors and 5 consecutive nights of remote monitoring in the roof void was recommended to prove absence of bats.

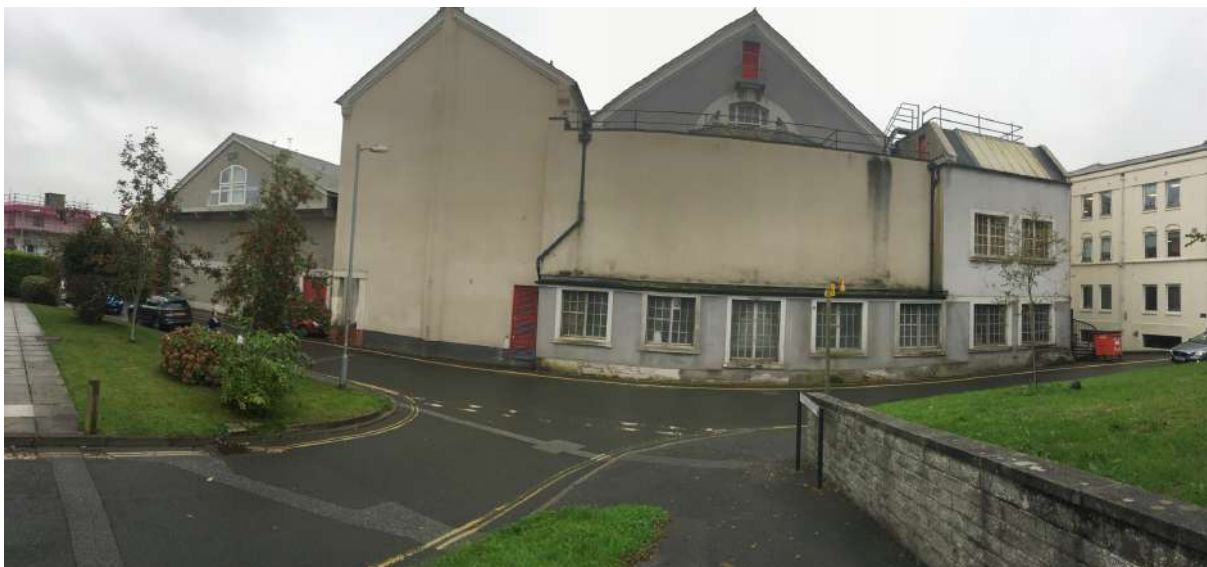
Photograph 2. North (rear) elevation.

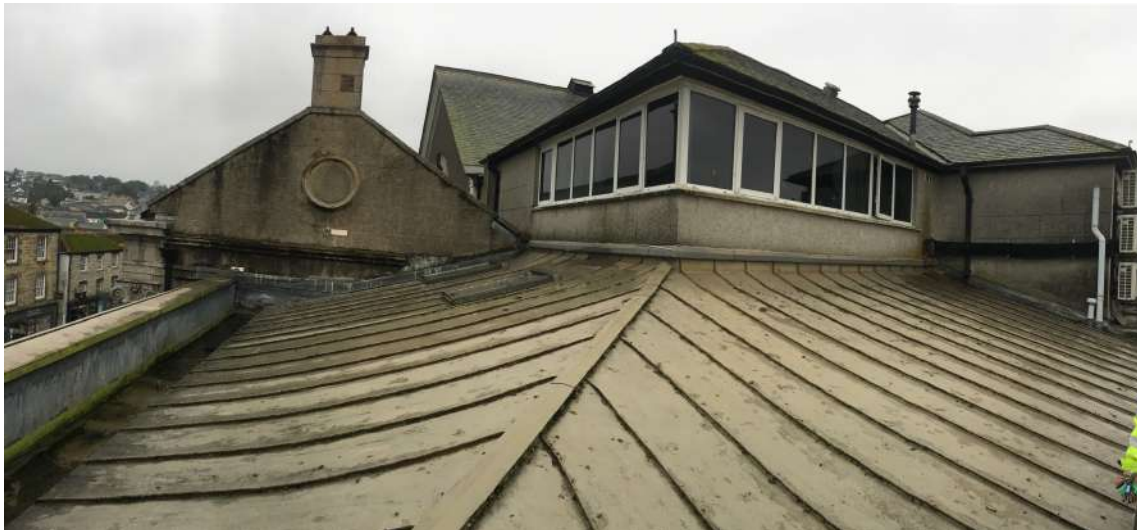
Photograph 3. Granite gable of Roof No R1 and southern parts of R4.

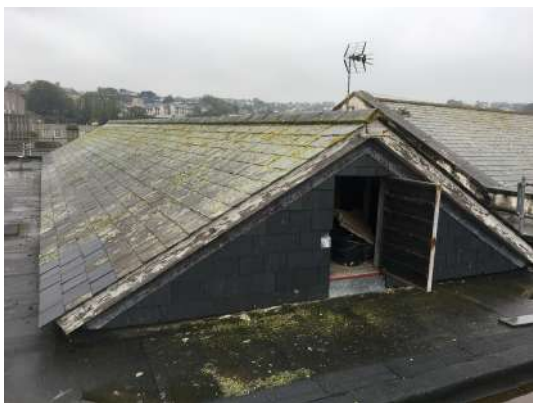
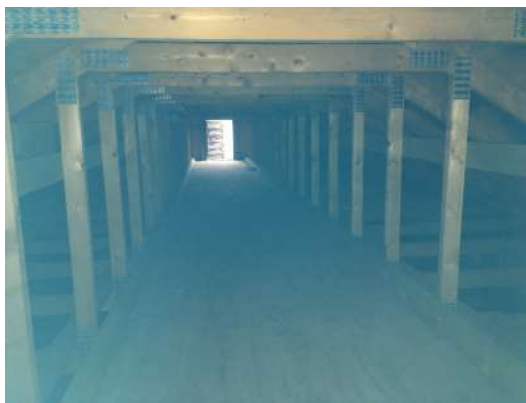
Photograph 5. Roof No R2 North and east elevations. Photograph 6. Roof No R2 internal.

Roof No R2 is pitched gable roof. It has flat roof sections at the eaves (Roof No S2). It is therefore possible to walk entirely around Roof No R2 at the flat roof height. The roof covering is natural slate with clay ridge tiles. There is a foil type membrane present. No potential bat access points were observed to allow bats to the voids between the membrane and slates nor under the ridge tiles. At each gable is a louvred metal door which could potentially allow bat access to the walk-in void within. However, a thorough search of this void was achieved and no evidence of roosting bats was found. The hanging slates on the gables do not have any potential bat access points. A through search or all areas accessible to roosting bats was carried out and no evidence was found. Roof No R2 has been assessed as having negligible potential as a bat roost and no further surveys of this roof were required.

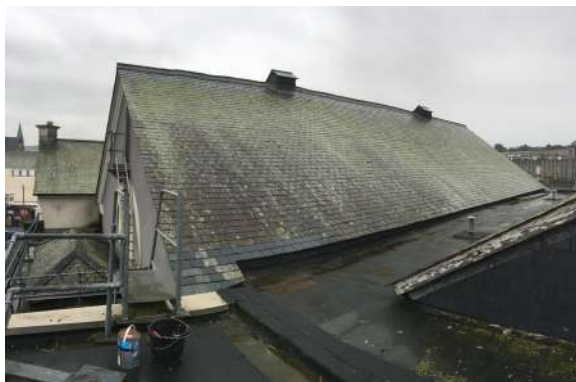
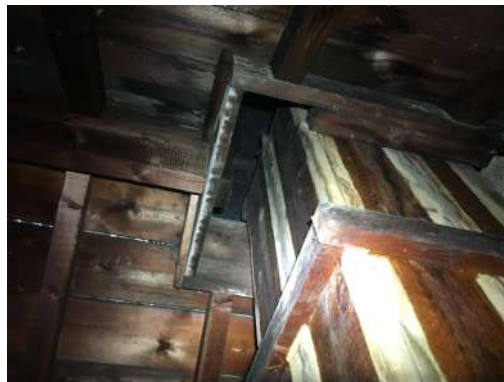
Photograph 7. Roof No R3 North and west elevations. Photograph 8. Roof vent in No R3.

Roof No R3 is above the main gallery of the museum. This part of the museum has an arched vaulted vaulting. There is a large walk-in roof void above this ceiling. The access is via a wooden louvered door on the north gable. The large pitched gable roof has a covering of natural slate with clay ridge tiles. There are wooden sarking boards beneath the slates. There are two roof vents (see photographs 7 and 8) that have gaps that could potentially allow bats to enter the roof void. Bats may also potentially enter the void via the louvered door. However, no evidence of bats was found within the void.

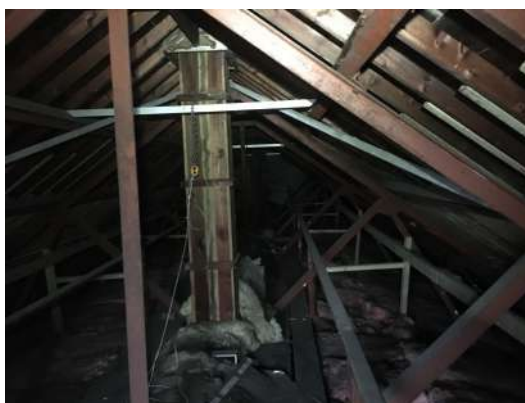
Photograph 9. Roof No R3 louvered door. Photograph 10. Roof void No R3.

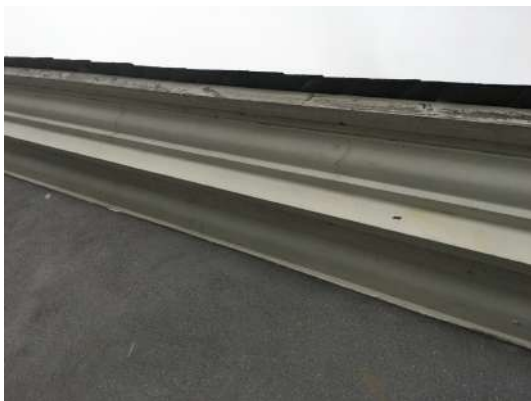
Photograph 11. Tightly fitted soffit of R3.

The soffits are tightly fitted to the render at the gables (Photograph 11), however there are gaps between the slates and the soffit that would allow bats to potentially gain access to the void between the slates and the sarking boards. There are also some lifted slates across the main part of the roof.

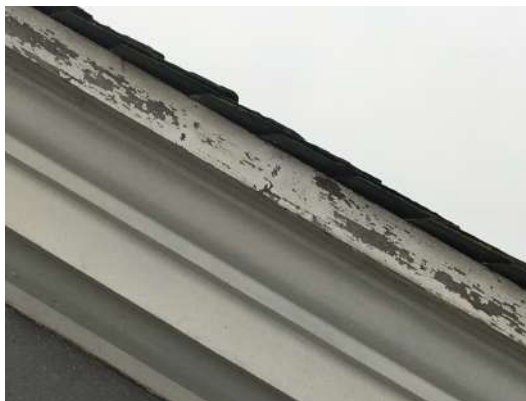
Photograph 12. Gaps between soffit and slates on R3.

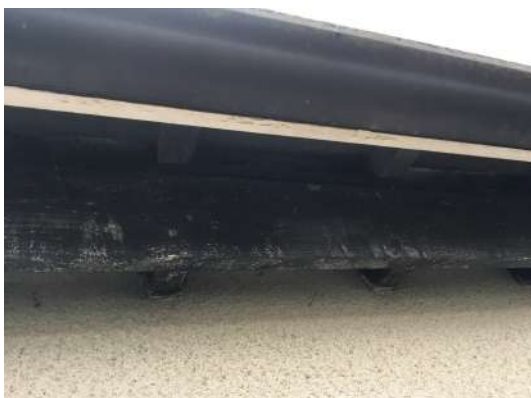
Photograph 13. Gaps between the rafters at the eaves of R4.

Roof No R4 is a complex design roof it is pitched with a gable at the north elevation, a hip at the south elevation and an intersecting roof section (see Photograph 3 and Figure 1). It has a roof covering of natural slate and clay ridges. Internally the ceiling is vaulted and there is no accessible roof void. Large gaps were observed between the rafters at the eaves (see Photograph 13). This would potentially allow bats to gain entry into the void between the roof and the vaulted ceiling.

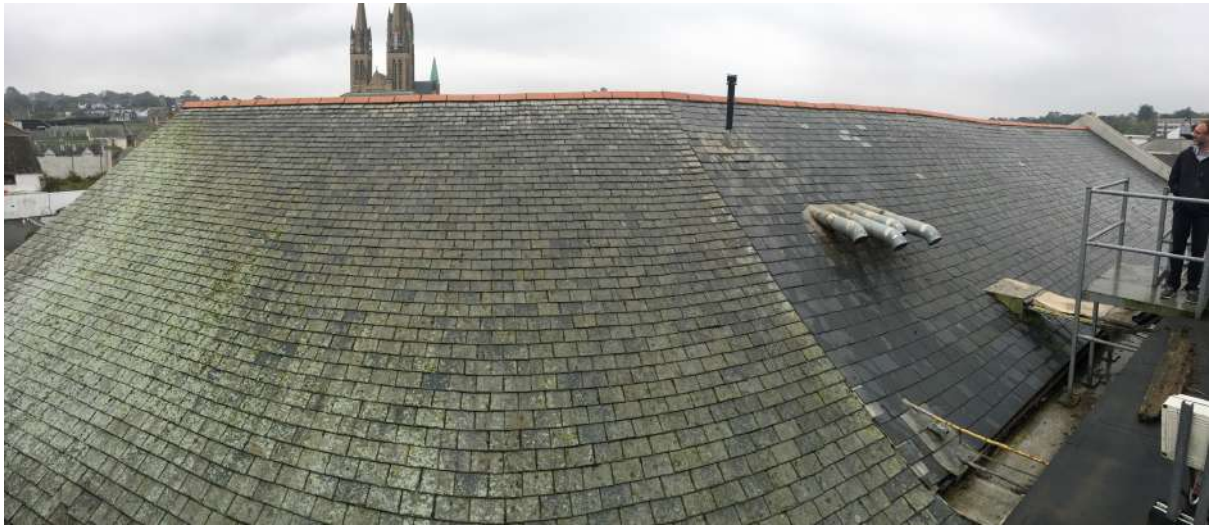
Photograph 14. West roof slope of R5.

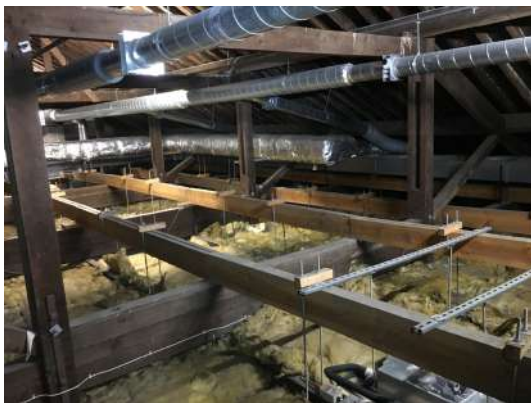
Photograph 15. Roof void of R5.

There is a small eaves void in the north east corner of R5. This has a concrete base. No evidence of bats was found within.

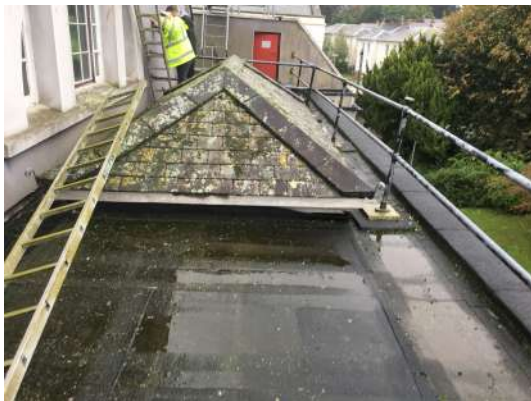
Photograph 16. Roof No S5.

There is a small hipped roof within the flat roof (S4) to the north of R3 (see Photograph 16). It is possible that this was a former light-well that has been slated. It does not have any potential for roosting bats and no further surveys of S5 were required.
