Scheme Title: A36 Serrington NB & SB MP 51.6 - 52.8 RS

Drawing Title: Defect Treatment Plan 1

Drawing No: VCS Plan 3 Rev: A

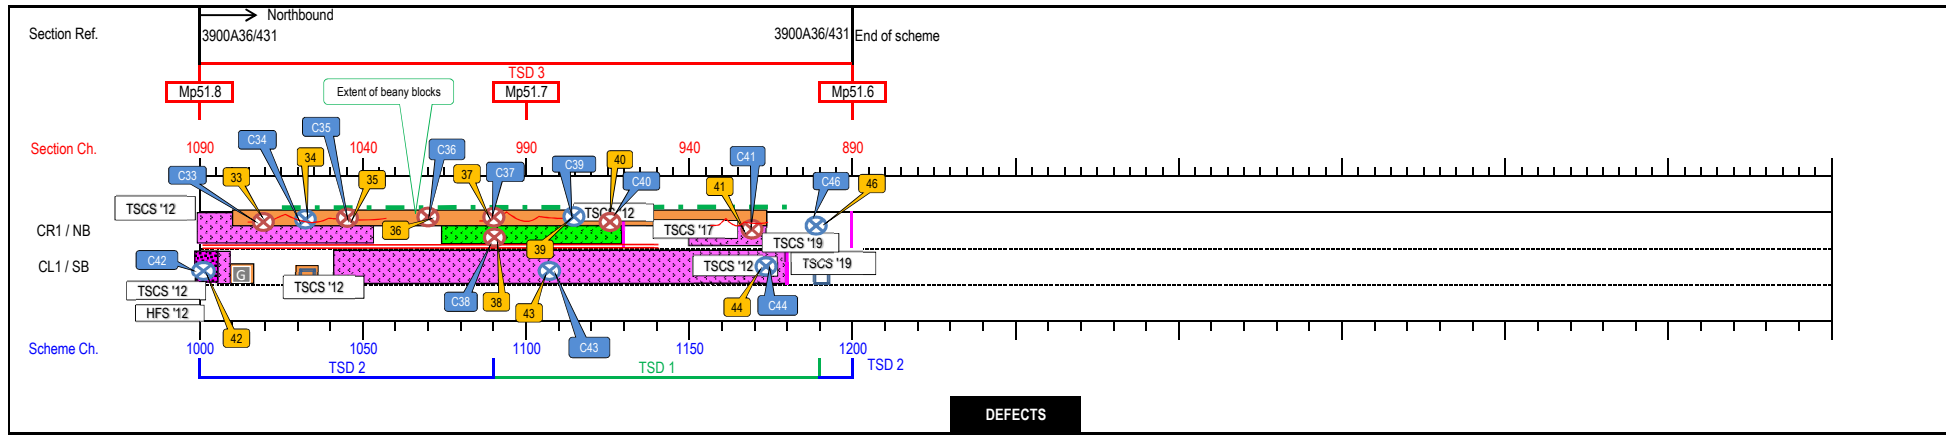
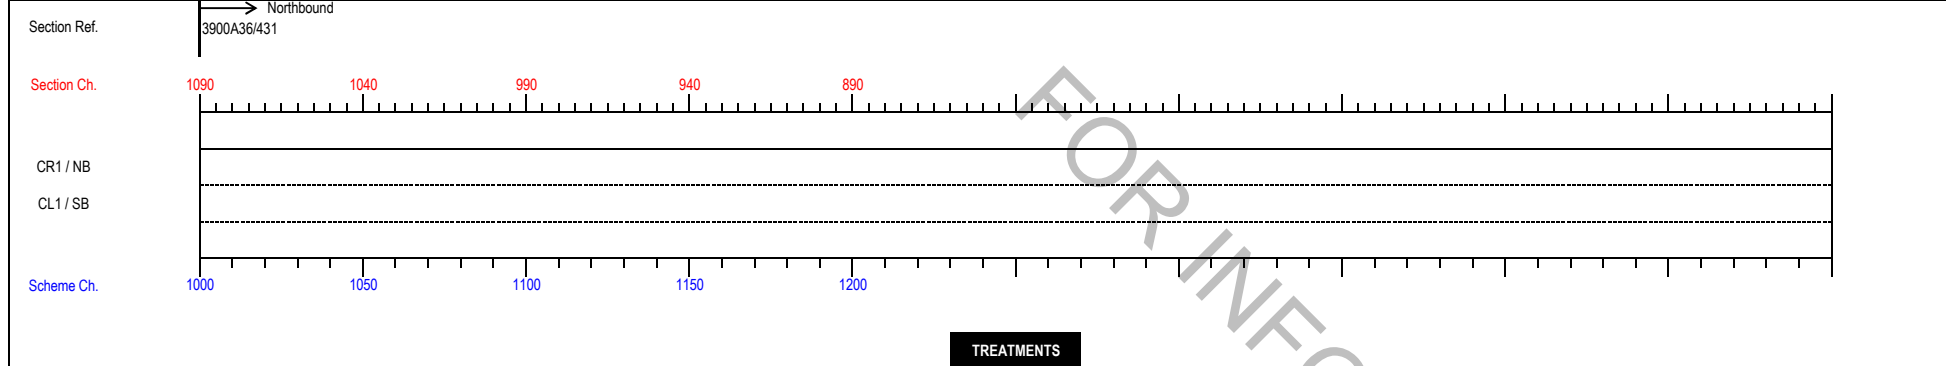
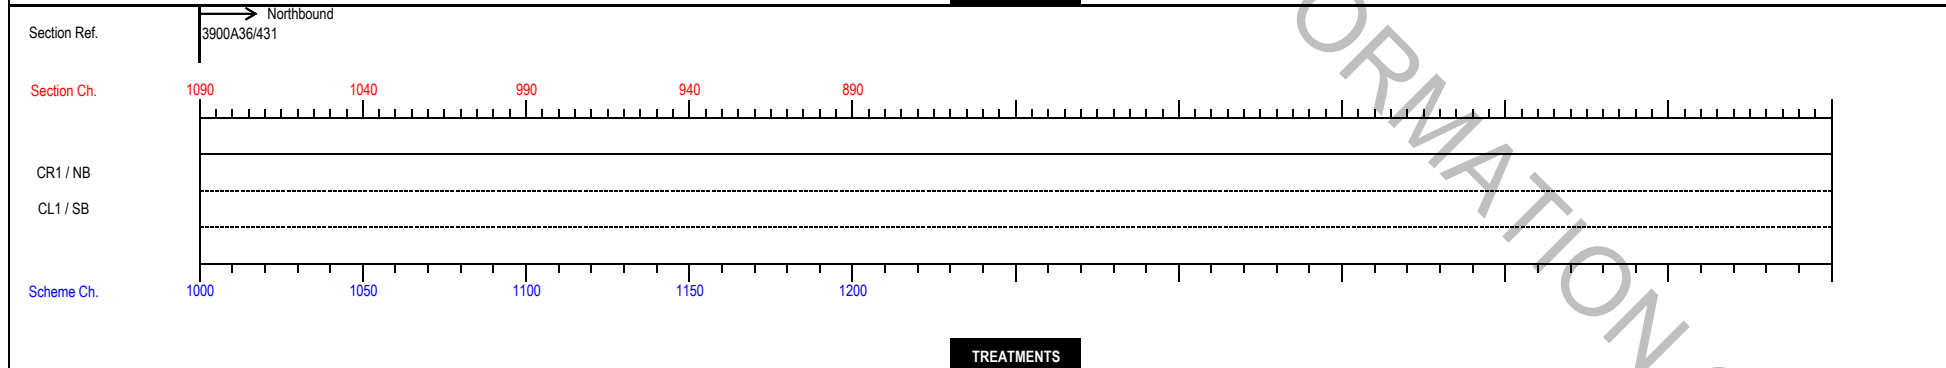
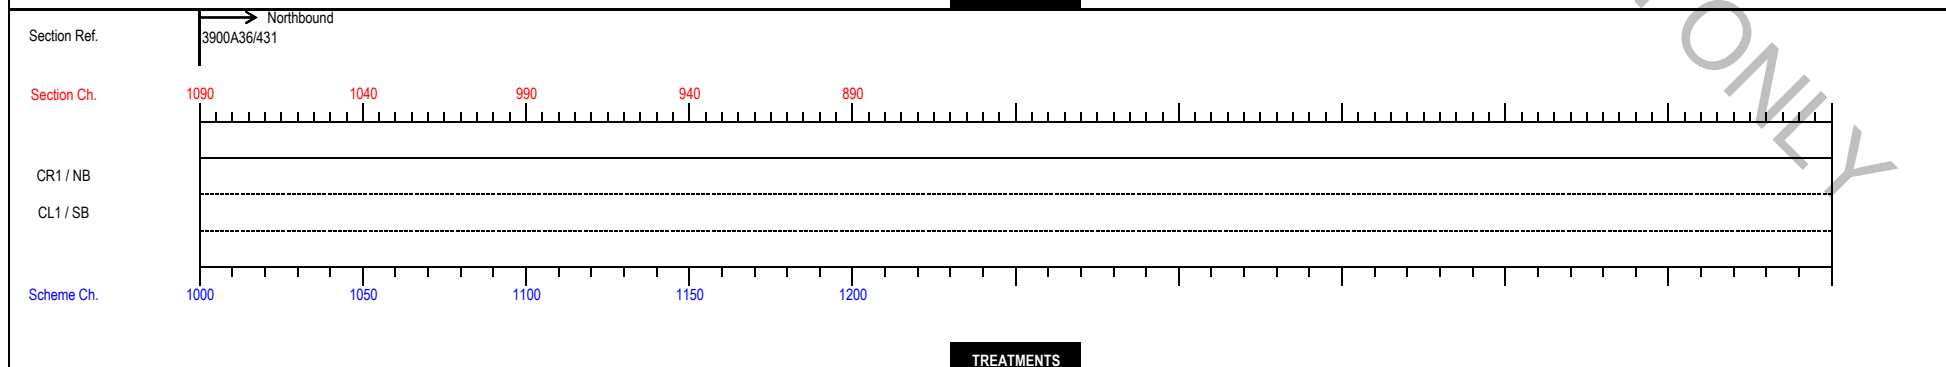
1. Dimensions are approximate and have been based on the most up-to-date video data.
2. Only overhead lines shown on the treatment plans. For other utilities, please refer to the C2 plans for the area.
3. Due to potential inaccuracy of video data regarding exact chainages, where core locations are within the vicinity of a gully, coring Contractor to adjust the location to avoid potential coring into / through carrier pipes.

- 50mm inlay TSCS (Do Min)
- Fill and overbanding repair system for crack exceeding 5mm but not exceeding 10mm wide (Do Min)
- Deep repair/ inlay (Do Something)
