**External Repairs and  
Redecoration Works**

**The Margate School  
31-33 High Street  
Margate  
CT9 1DX**

**The Margate  
School**

Our Ref: 2324/102434  
April 2024

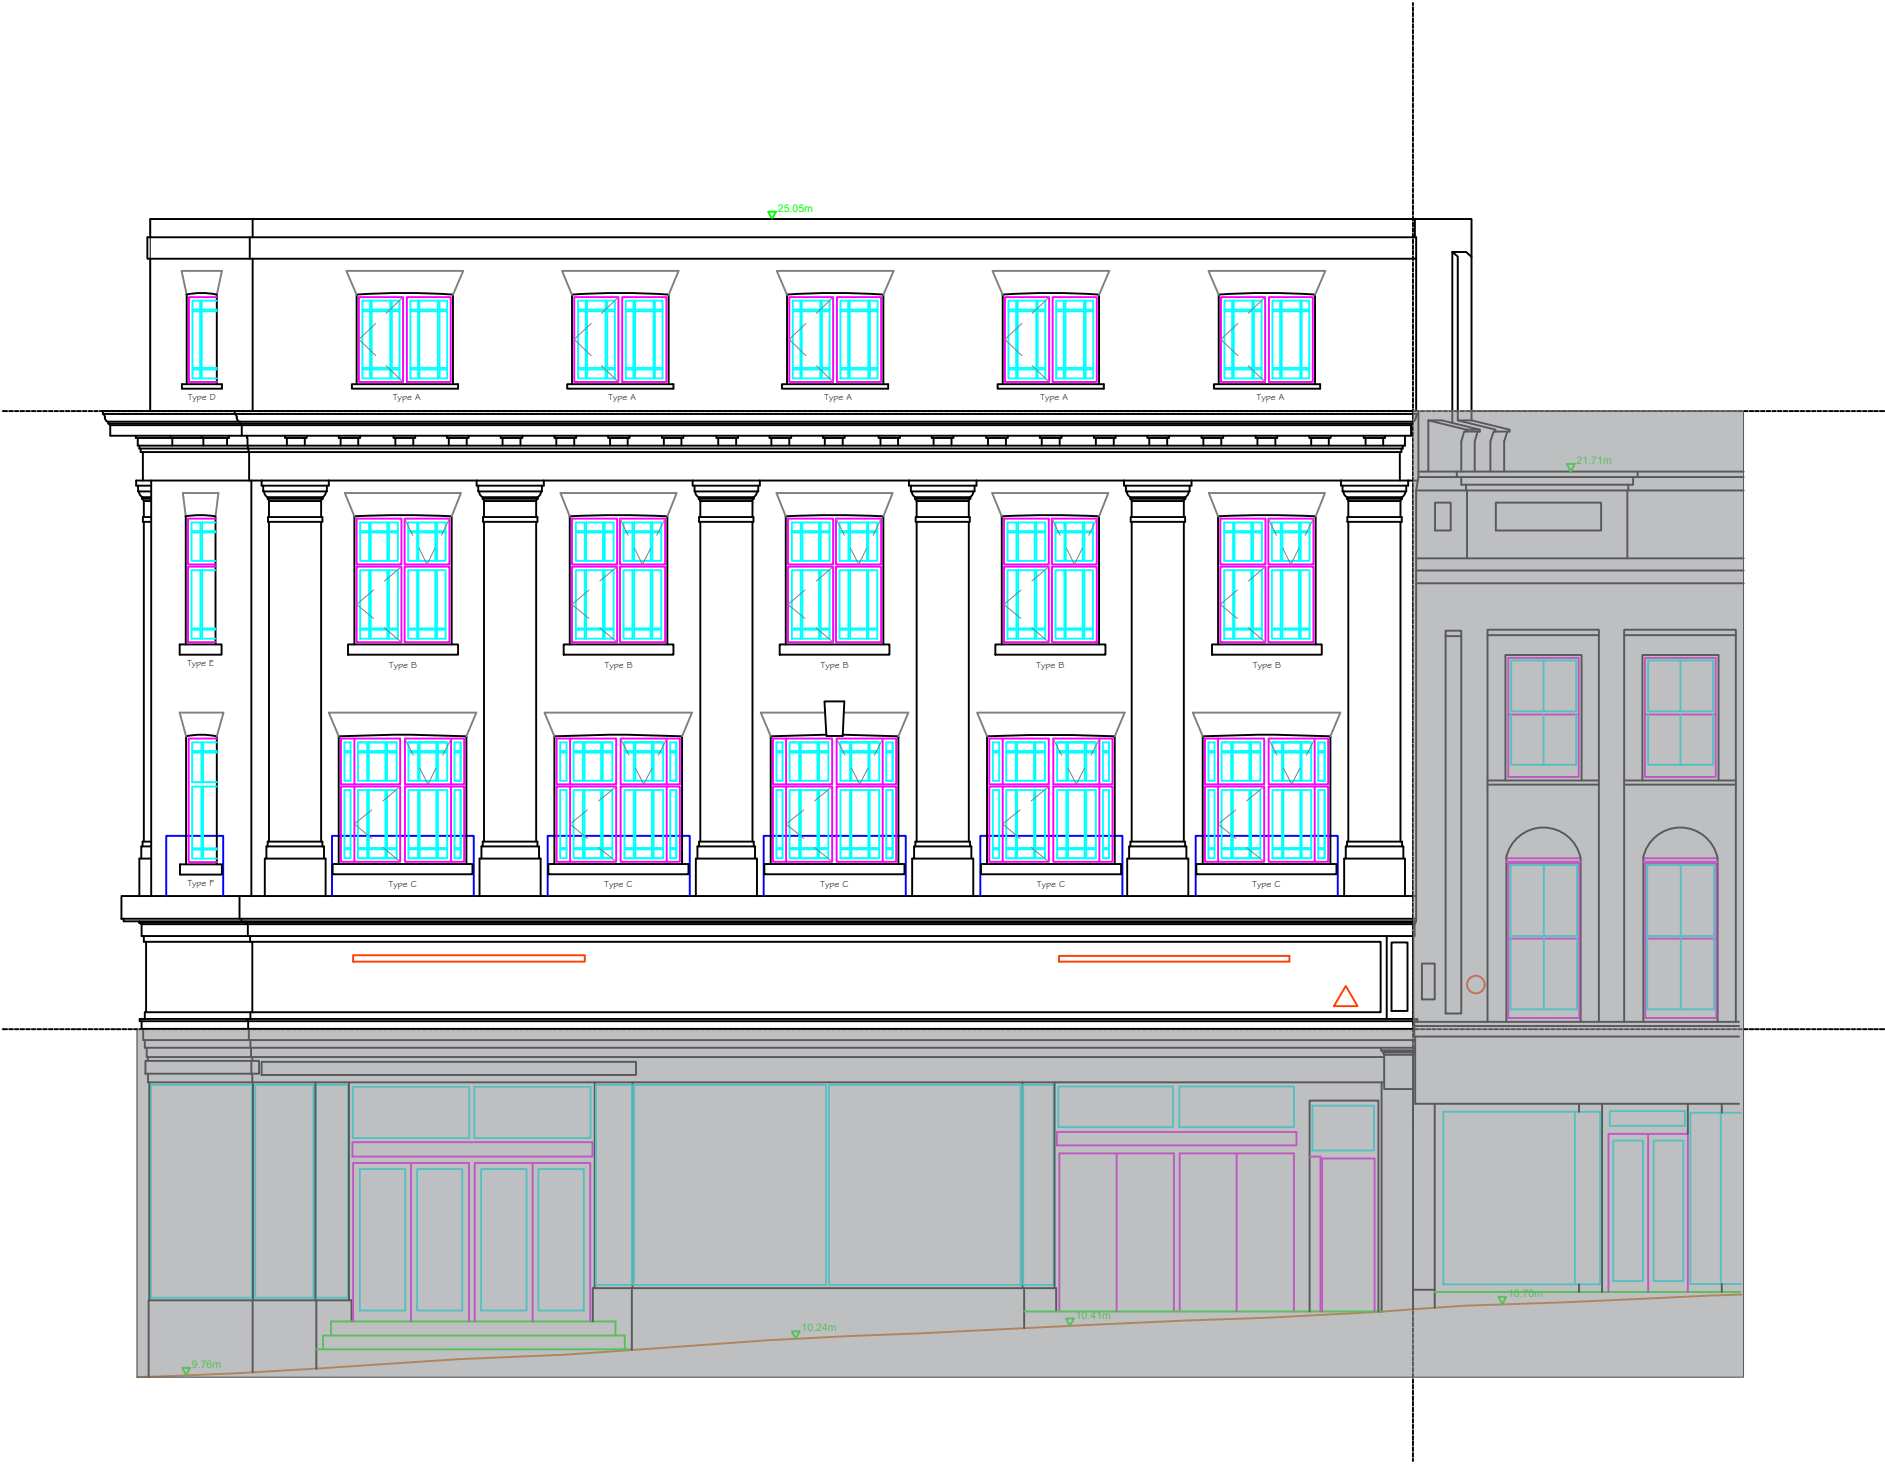
Elevation 1 (Front)

Windows D-F also shown on Elevation 2: Left Side, but are the same windows (due to corner)

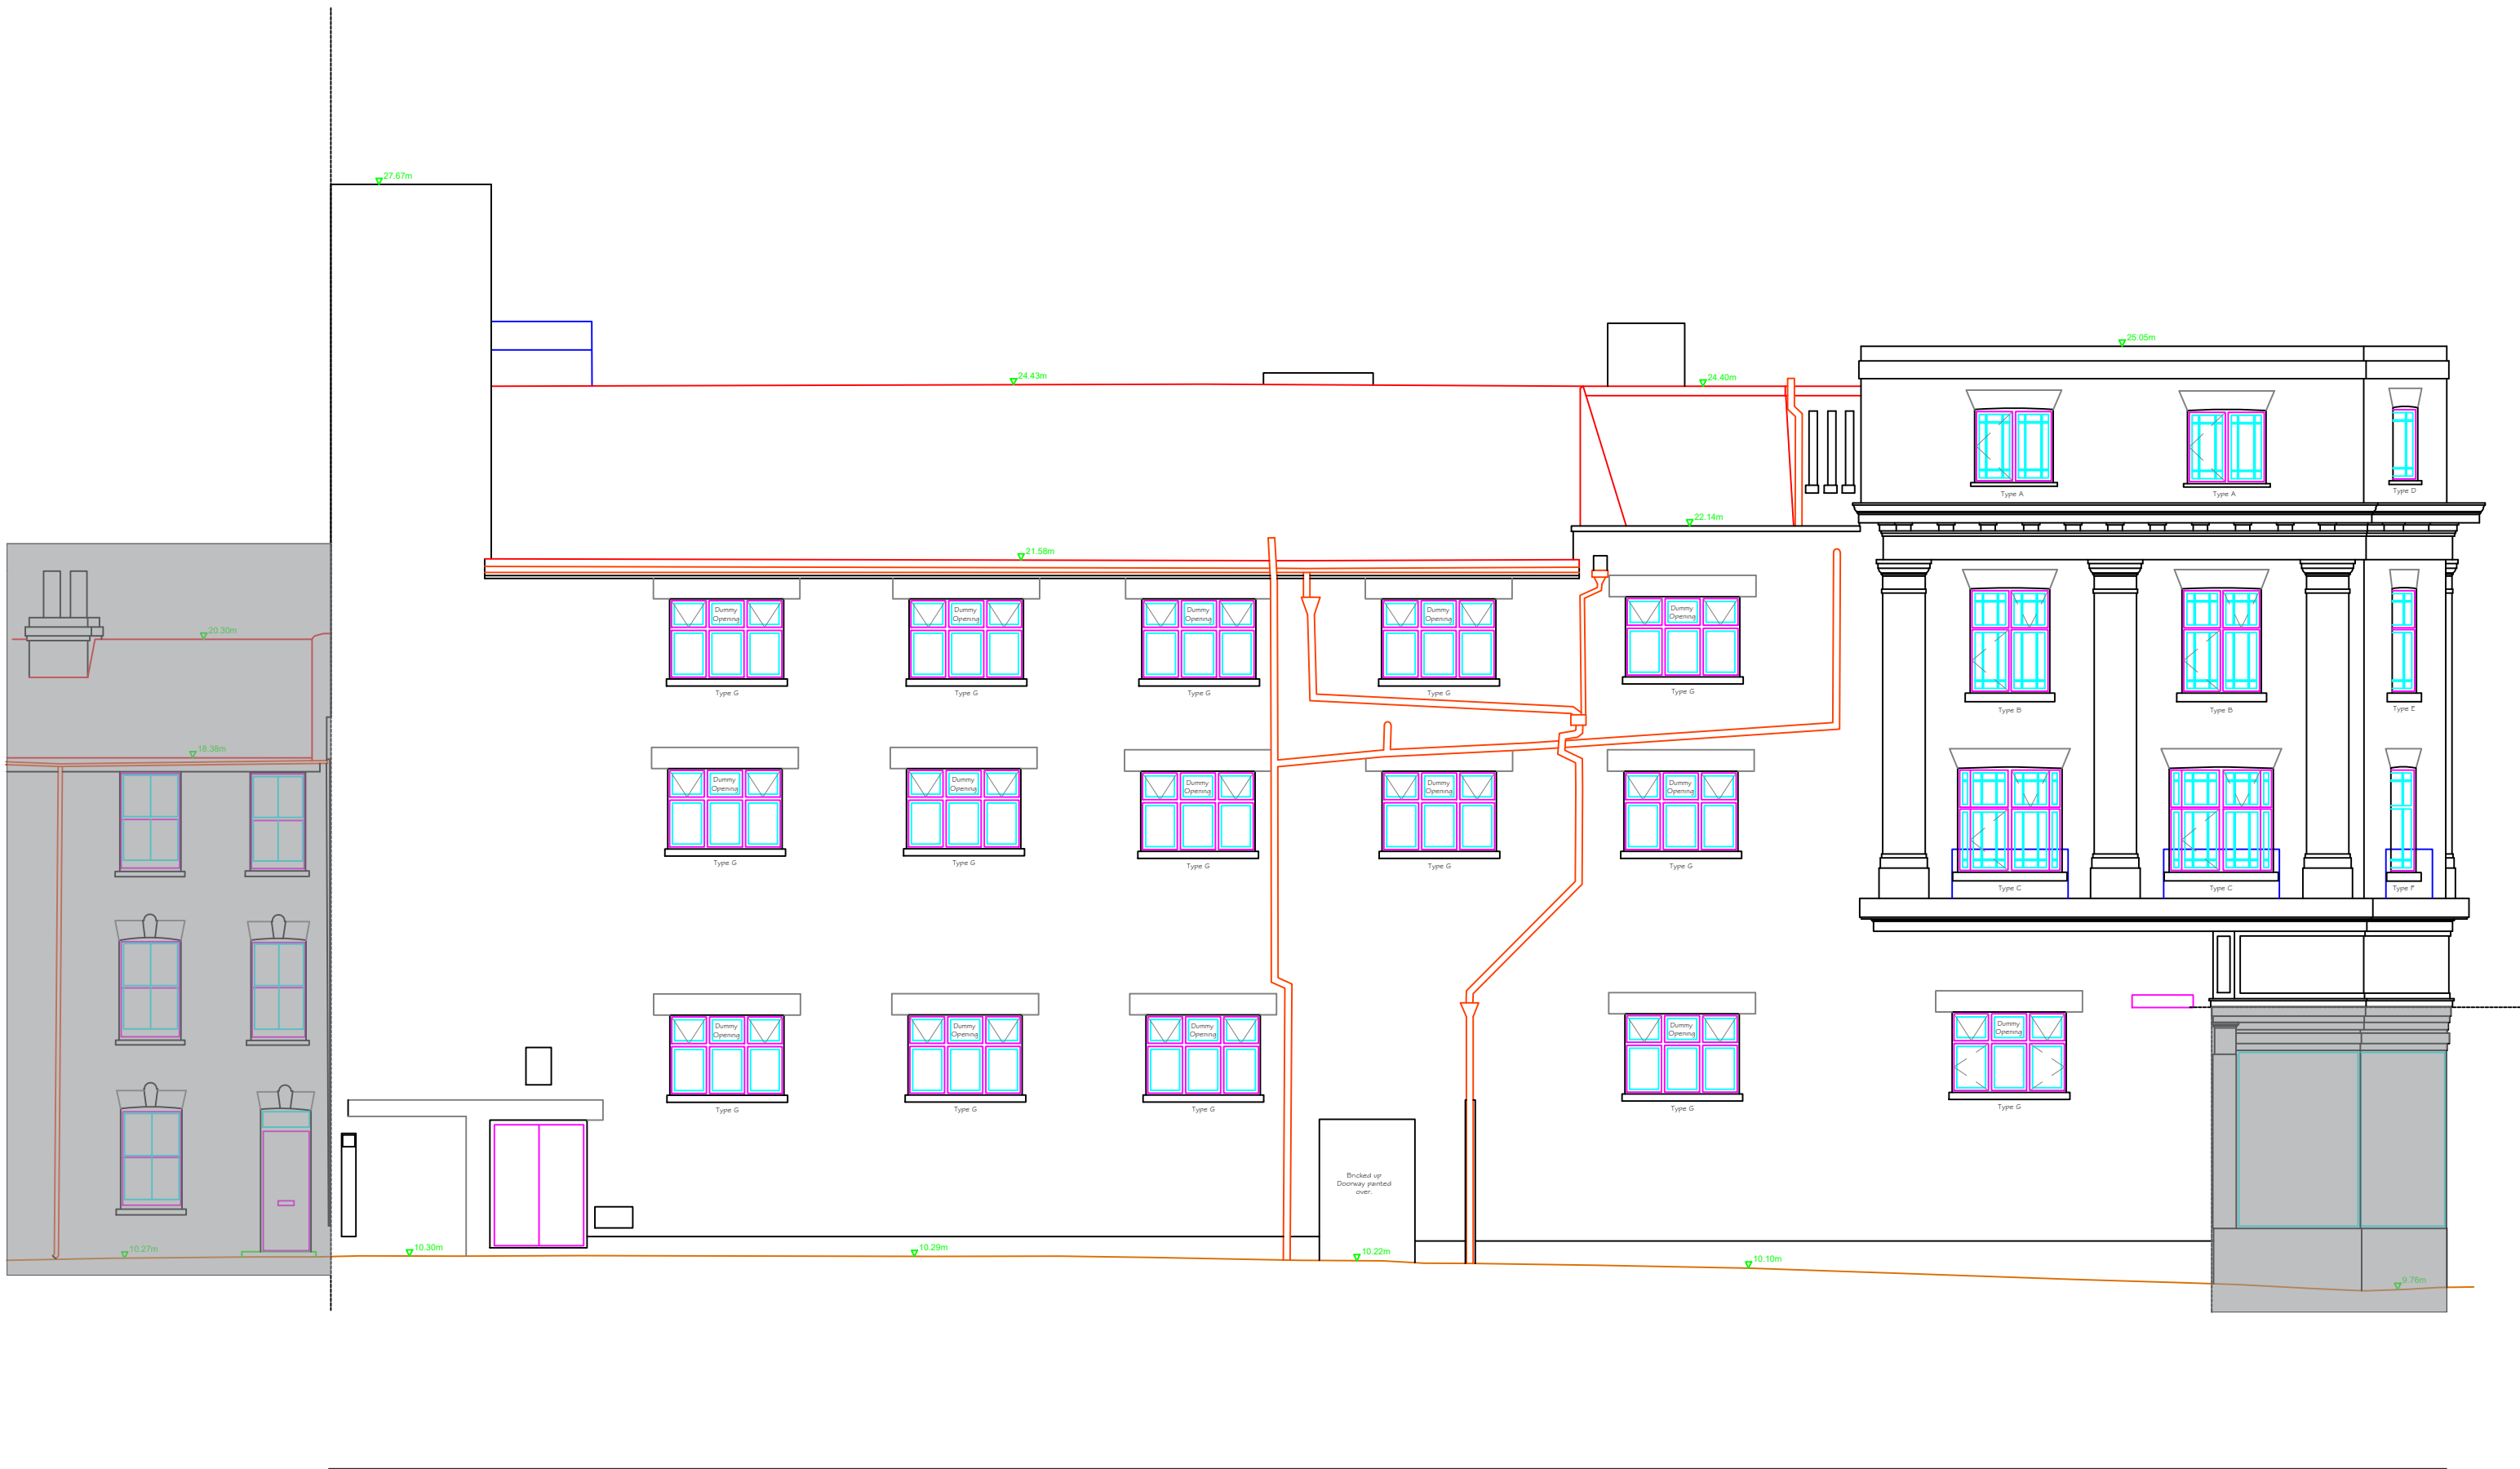
Elevation 2 (North)

Windows D-F also shown on Elevation 1: Front but are the same windows (due to corner)

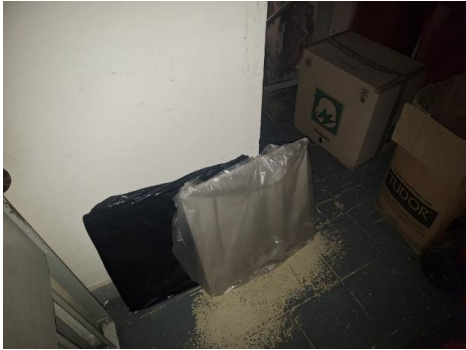
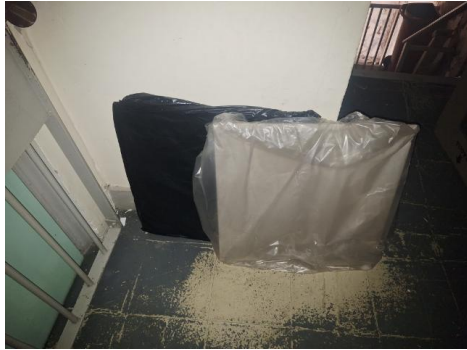
Building:	The Margate School	Floor	3rd Floor		
Location ID	001	Location	Third Floor Landing		
Sample Number	S001	Extent	1 m <sup>2</sup>		
Item / Position	Loose tiles	Material	Insulating Board		
Product Type	Asbestos insulating board, millboards, gaskets & ropes etc.	Scores	2		
Condition	Low Damage		1		
Surface Treatment	Partially Unsealed		2		
Asbestos Type	Amosite, Chrysotile		2		
Material Assessment	Medium		7		
Substrate	Wrapped in plastic bag	Accessibility	High		
Main Photo		Close Up Photo

Recommendation	<b>Remove - Licensed Material Removal by a licensed asbestos contractor. This material is licensed therefore is subject to a 14 notification to the HSE prior to removal works taking place. All works must conform to the Control of Asbestos Regulations 2012.</b>				
Comments	Area outside scope of works sampling to damaged ceiling tiles. Wrapped in plastic bag

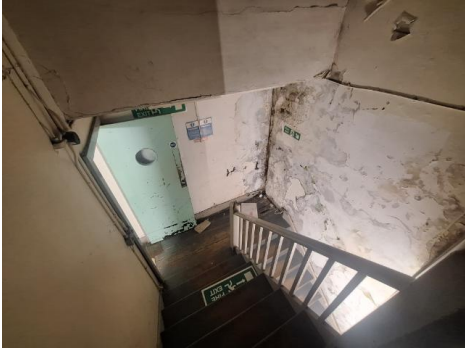
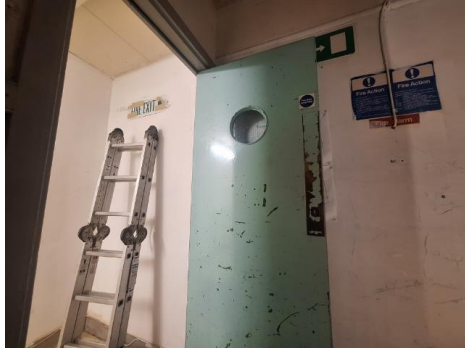
Building:	The Margate School	Floor	2nd Floor		
Location ID	002	Location	Landing		
Sample Number	X004	Extent	2 m <sup>2</sup>		
Item / Position	Lining to door	Material	Insulating Board		
Product Type	Asbestos insulating board, millboards, gaskets & ropes etc.	Scores	2		
Condition	Low Damage		1		
Surface Treatment	Partially Unsealed		2		
Asbestos Type	<b>Amosite</b>		2		
Material Assessment	Medium		7		
Substrate	No intrusions made as door in use	Accessibility	Low		
Main Photo		Close Up Photo

Recommendation	<b>Remove - Licensed Material Removal by a licensed asbestos contractor. This material is licensed therefore is subject to a 14 notification to the HSE prior to removal works taking place. All works must conform to the Control of Asbestos Regulations 2012.</b>				
Comments	Internal door and frame made of timber. No intrusions made as door in use

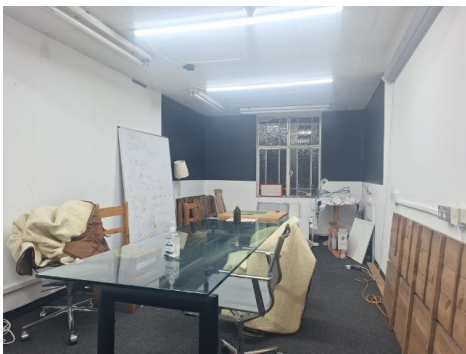
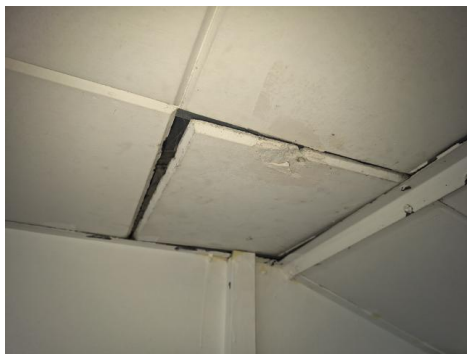
Building:	The Margate School	Floor	2nd Floor		
Location ID	003	Location	Seminar Room		
Sample Number	S002	Extent	45 m <sup>2</sup>		
Item / Position	Ceiling Tiles	Material	Insulating Board		
Product Type	Asbestos insulating board, millboards, gaskets & ropes etc.	Scores	2		
Condition	Medium Damage		2		
Surface Treatment	Partially Unsealed		2		
Asbestos Type	<b>Amosite, Chrysotile</b>		2		
Material Assessment	Medium		8		
Substrate	Nailed to timber above.	Accessibility	High		
Main Photo		Close Up Photo

Recommendation	<b>Remove - Licensed Material Removal by a licensed asbestos contractor. This material is licensed therefore is subject to a 14 notification to the HSE prior to removal works taking place. All works must conform to the Control of Asbestos Regulations 2012.</b>				
Comments	Internal door and frame made of timber. Pipework to radiator made of bare metal penetrating wall. External window frame made of metal. Nailed to timber above.

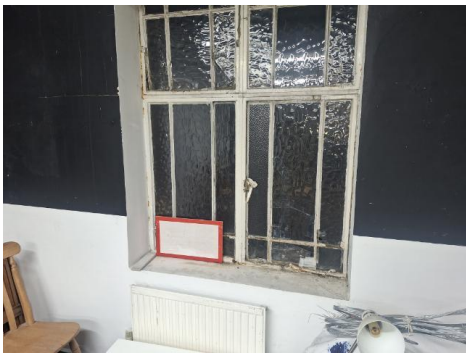
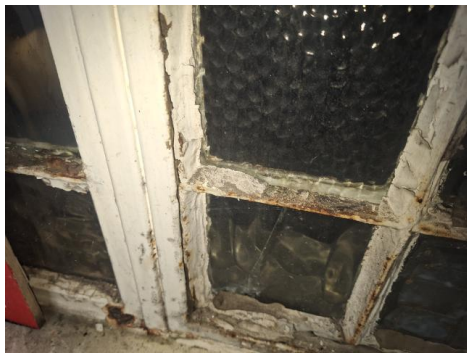
Building:	The Margate School	Floor	2nd Floor		
Location ID	003	Location	Seminar Room		
Sample Number	S003	Extent	2 lin m		
Item / Position	Window putty	Material	Mastic		
Product Type		Scores	-		
Condition			-		
Surface Treatment			-		
Asbestos Type	No asbestos detected		-		
Material Assessment	N/A				
Substrate	Attached to metal frame	Accessibility	-		
Main Photo		Close Up Photo

Recommendation	No action required				
Comments	Attached to metal frame

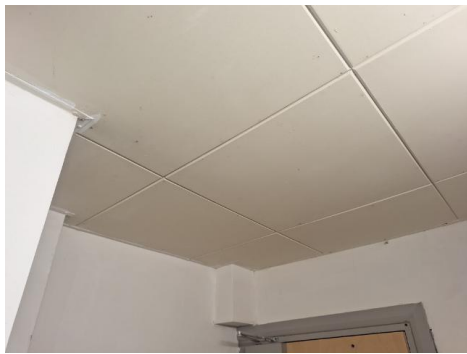
Building:	The Margate School	Floor	2nd Floor		
Location ID	004	Location	Hallway		
Sample Number	X002	Extent	6 m <sup>2</sup>		
Item / Position	Ceiling Tiles	Material	Insulating Board		
Product Type	Asbestos insulating board, millboards, gaskets & ropes etc.	Scores	2		
Condition	Medium Damage		2		
Surface Treatment	Partially Unsealed		2		
Asbestos Type	<b>Amosite, Chrysotile</b>		2		
Material Assessment	Medium		8		
Substrate	Nailed to timber above.	Accessibility	High		
Main Photo		Close Up Photo

Recommendation	<b>Remove - Licensed Material Removal by a licensed asbestos contractor. This material is licensed therefore is subject to a 14 notification to the HSE prior to removal works taking place. All works must conform to the Control of Asbestos Regulations 2012.</b>				
Comments	Pipework to radiator made of bare metal penetrating wall. Nailed to timber above.

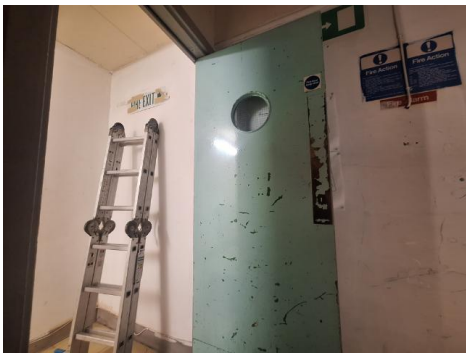
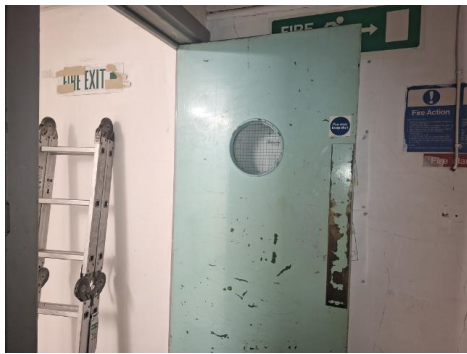
Building:	The Margate School	Floor	2nd Floor		
Location ID	004	Location	Hallway		
Sample Number	X004	Extent	2 m <sup>2</sup>		
Item / Position	Lining to doors	Material	Insulating Board		
Product Type	Asbestos insulating board, millboards, gaskets & ropes etc.	Scores	2		
Condition	Low Damage		1		
Surface Treatment	Partially Unsealed		2		
Asbestos Type	<b>Amosite</b>		2		
Material Assessment	Medium		7		
Substrate	No intrusions made as door in use	Accessibility	Medium		
Main Photo		Close Up Photo

Recommendation	<b>Remove - Licensed Material Removal by a licensed asbestos contractor. This material is licensed therefore is subject to a 14 notification to the HSE prior to removal works taking place. All works must conform to the Control of Asbestos Regulations 2012.</b>				
Comments	No intrusions made as door in use

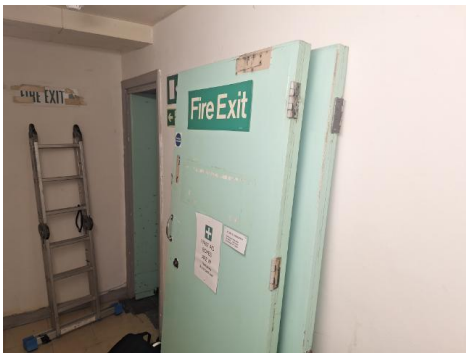
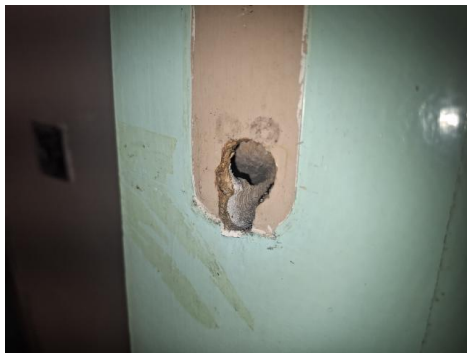
Building:	The Margate School	Floor	2nd Floor		
Location ID	004	Location	Hallway		
Sample Number	S004	Extent	2 m <sup>2</sup>		
Item / Position	Lining to redundant doors	Material	Insulating Board		
Product Type	Asbestos insulating board, millboards, gaskets & ropes etc.	Scores	2		
Condition	Low Damage		1		
Surface Treatment	Partially Unsealed		2		
Asbestos Type	<b>Amosite</b>		2		
Material Assessment	Medium		7		
Substrate	AIB visible within door	Accessibility	Medium		
Main Photo		Close Up Photo

Recommendation	<b>Remove - Licensed Material Removal by a licensed asbestos contractor. This material is licensed therefore is subject to a 14 notification to the HSE prior to removal works taking place. All works must conform to the Control of Asbestos Regulations 2012.</b>				
Comments	AIB visible within door

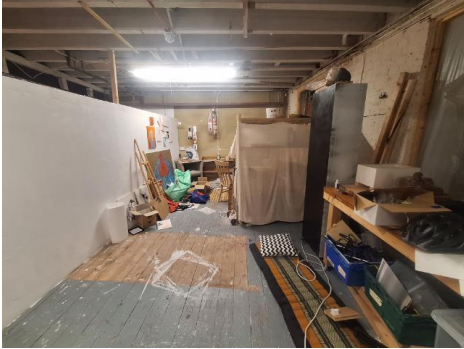
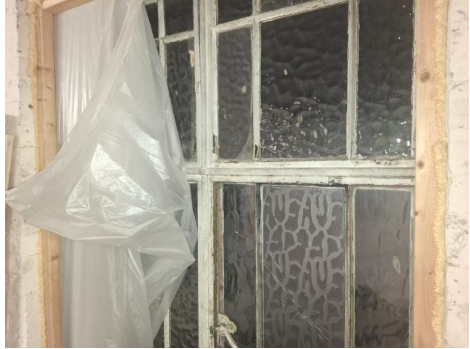
Building:	The Margate School	Floor	2nd Floor		
Location ID	005	Location	Sectioned Workspace		
Sample Number	X003	Extent	2 lin m		
Item / Position	Window putty	Material	Mastic		
Product Type		Scores	-		
Condition			-		
Surface Treatment			-		
Asbestos Type	No asbestos detected		-		
Material Assessment	N/A				
Substrate	Attached to metal frame	Accessibility	-		
Main Photo		Close Up Photo

Recommendation	No action required				
Comments	External window frame made of metal. Pipework to high level penetrating floor and ceiling made of bare metal. Partition wall made of plasterboard. Attached to metal frame

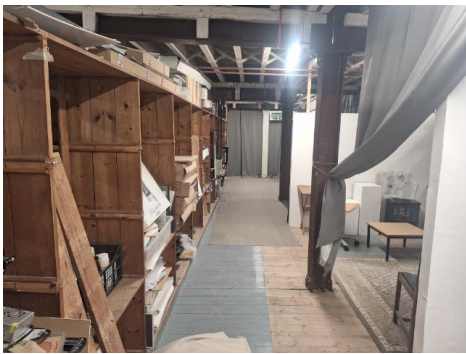
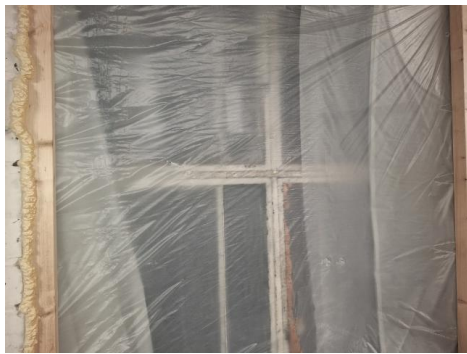
Building:	The Margate School	Floor	2nd Floor		
Location ID	008	Location	Hallway		
Sample Number	X003	Extent	2 lin m		
Item / Position	Window putty	Material	Mastic		
Product Type		Scores	-		
Condition			-		
Surface Treatment			-		
Asbestos Type	No asbestos detected		-		
Material Assessment	N/A				
Substrate	Attached to metal frame	Accessibility	-		
Main Photo		Close Up Photo

Recommendation	No action required				
Comments	<p>External window frame made of metal.</p> <p>Pipework to high level penetrating floor and ceiling made of bare metal.</p> <p>Partition wall made of plasterboard.</p> <p>Attached to metal frame</p>

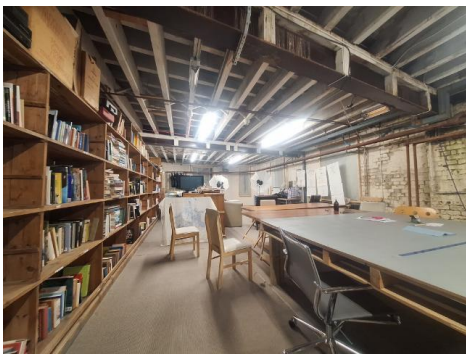
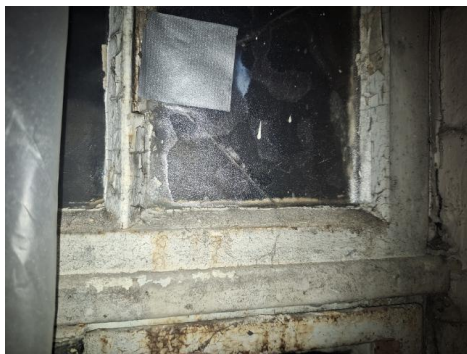
Building:	The Margate School	Floor	2nd Floor		
Location ID	009	Location	Learning Space		
Sample Number	X003	Extent	10 lin m		
Item / Position	Window putty	Material	Mastic		
Product Type		Scores	-		
Condition			-		
Surface Treatment			-		
Asbestos Type	No asbestos detected		-		
Material Assessment	N/A				
Substrate	Attached to metal frame	Accessibility	-		
Main Photo		Close Up Photo

Recommendation	No action required				
Comments	<p>External window frame made of metal.</p> <p>Pipework to high level penetrating floor and ceiling made of bare metal.</p> <p>Pipework to radiator made of bare metal penetrating floor.</p> <p>Cable conduits to wall made of metal.</p> <p>Steel columns to high level.</p> <p>Electrical unit to far wall open with modern fuses.</p> <p>Attached to metal frame</p>

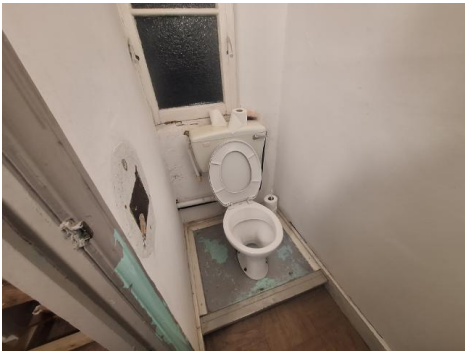
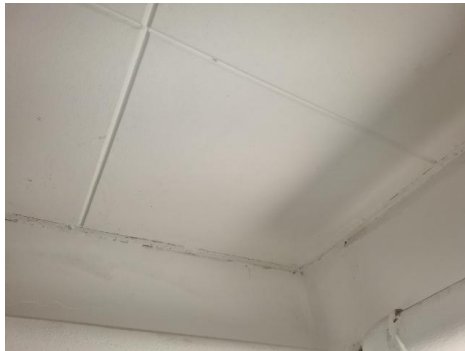
Building:	The Margate School	Floor	2nd Floor		
Location ID	010	Location	WC		
Sample Number	X002	Extent	2 m <sup>2</sup>		
Item / Position	Ceiling Tiles	Material	Insulating Board		
Product Type	Asbestos insulating board, millboards, gaskets & ropes etc.	Scores	2		
Condition	Medium Damage		2		
Surface Treatment	Partially Unsealed		2		
Asbestos Type	Amosite, Chrysotile		2		
Material Assessment	Medium		8		
Substrate	Nailed to timber above.	Accessibility	High		
Main Photo		Close Up Photo

Recommendation	Remove - Licensed Material Removal by a licensed asbestos contractor. This material is licensed therefore is subject to a 14 notification to the HSE prior to removal works taking place. All works must conform to the Control of Asbestos Regulations 2012.				
Comments	Pipework to radiator made of bare metal penetrating wall. External window made of timber. Toilets cistern made of plastic with metal and plastic pipework attached. Stair nosing made of rubber. Nailed to timber above.

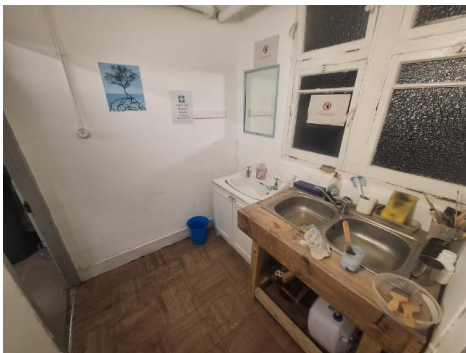
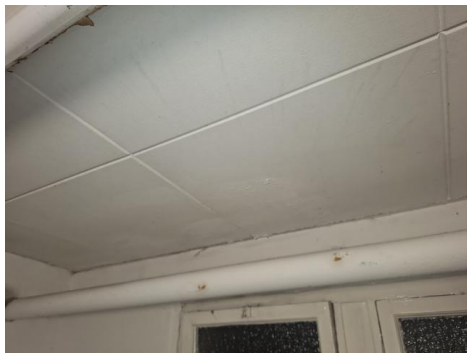
Building:	The Margate School	Floor	2nd Floor		
Location ID	011	Location	Clean Up Area		
Sample Number	X002	Extent	4 m <sup>2</sup>		
Item / Position	Ceiling Tiles	Material	Insulating Board		
Product Type	Asbestos insulating board, millboards, gaskets & ropes etc.	Scores	2		
Condition	Medium Damage		2		
Surface Treatment	Partially Unsealed		2		
Asbestos Type	<b>Amosite, Chrysotile</b>		2		
Material Assessment	Medium		8		
Substrate	Nailed to timber above.	Accessibility	High		
Main Photo		Close Up Photo

Recommendation	<b>Remove - Licensed Material Removal by a licensed asbestos contractor. This material is licensed therefore is subject to a 14 notification to the HSE prior to removal works taking place. All works must conform to the Control of Asbestos Regulations 2012.</b>				
Comments	External window made of timber. Pipework to sink made of metal and plastic. Nailed to timber above.

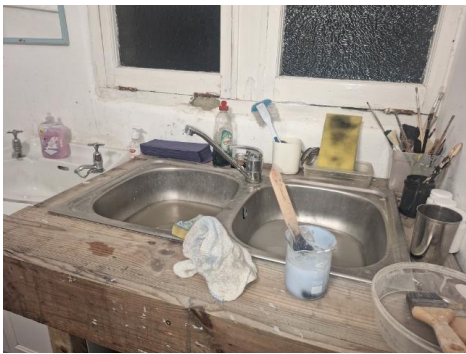
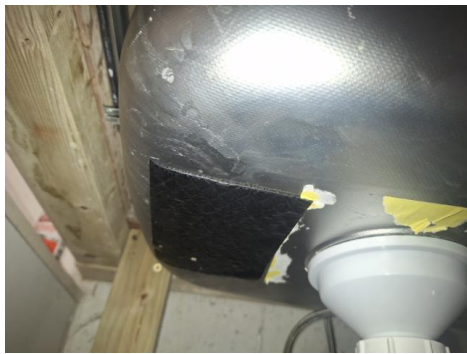
Building:	The Margate School	Floor	2nd Floor		
Location ID	011	Location	Clean Up Area		
Sample Number	S006	Extent	2 no		
Item / Position	Sinkpad	Material	Bituminous Product		
Product Type		Scores	-		
Condition			-		
Surface Treatment			-		
Asbestos Type	No asbestos detected		-		
Material Assessment	N/A				
Substrate	Bonded to underside of sink	Accessibility	-		
Main Photo		Close Up Photo

Recommendation	No action required				
Comments	Bonded to underside of sink

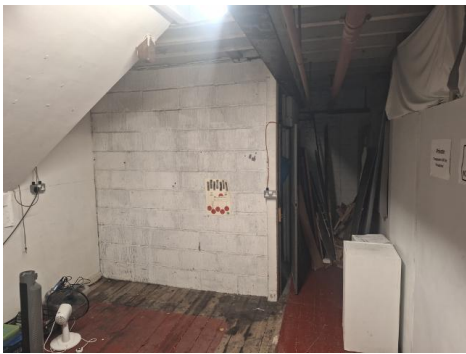
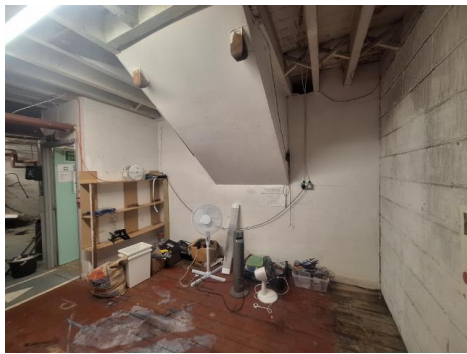
Building:	The Margate School	Floor	2nd Floor		
Location ID	018	Location	Storage Section		
Sample Number	S007	Extent	18 m <sup>2</sup>		
Item / Position	Panel to stairwell and wall	Material	Insulating Board		
Product Type		Scores	-		
Condition			-		
Surface Treatment			-		
Asbestos Type	No asbestos detected		-		
Material Assessment	N/A				
Substrate	Nailed to timber	Accessibility	-		
Main Photo		Close Up Photo

Recommendation	No action required				
Comments	Pipework to high level penetrating floor and ceiling made of bare metal. Partition wall made of plasterboard. Debris in corner consists of timber and plasterboard. Nailed to timber

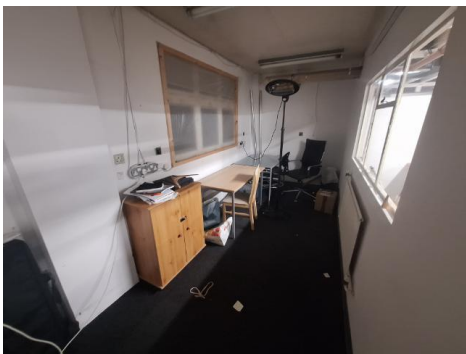
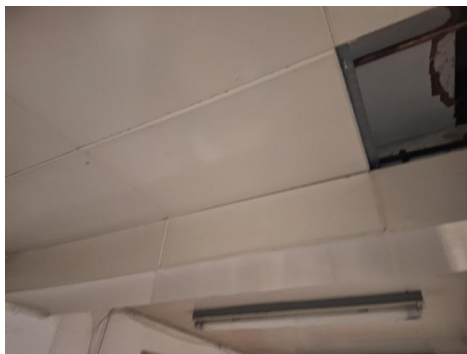
Building:	The Margate School	Floor	2nd Floor		
Location ID	020	Location	Office		
Sample Number	X002	Extent	8 m <sup>2</sup>		
Item / Position	Ceiling Tiles	Material	Insulating Board		
Product Type	Asbestos insulating board, millboards, gaskets & ropes etc.	Scores	2		
Condition	Medium Damage		2		
Surface Treatment	Partially Unsealed		2		
Asbestos Type	<b>Amosite, Chrysotile</b>		2		
Material Assessment	Medium		8		
Substrate	Nailed to timber above.	Accessibility	High		
Main Photo		Close Up Photo

Recommendation	<b>Remove - Licensed Material Removal by a licensed asbestos contractor. This material is licensed therefore is subject to a 14 notification to the HSE prior to removal works taking place. All works must conform to the Control of Asbestos Regulations 2012.</b>				
Comments	Pipework to radiator made of bare metal penetrating wall. External window made of metal. Internal door made of timber. Nailed to timber above.

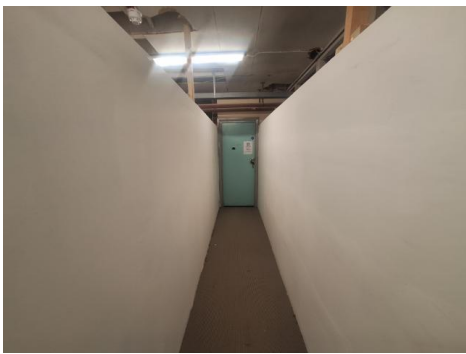
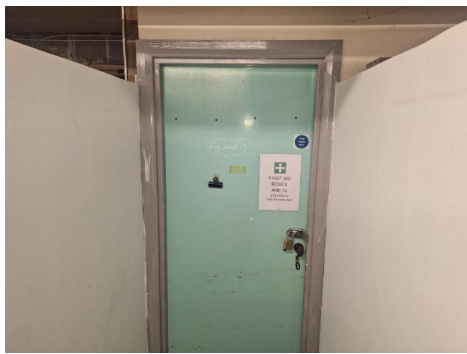
Building:	The Margate School	Floor	2nd Floor		
Location ID	021	Location	Hallway		
Sample Number	X004	Extent	2 m <sup>2</sup>		
Item / Position	Door lining panel	Material	Insulating Board		
Product Type	Asbestos insulating board, millboards, gaskets & ropes etc.	Scores	2		
Condition	Low Damage		1		
Surface Treatment	Sealed		1		
Asbestos Type	<b>Amosite</b>		2		
Material Assessment	Low		6		
Substrate	Unable to made intrusions as door still in use.	Accessibility	Low		
Main Photo		Close Up Photo

Recommendation	<b>Remove - Licensed Material Removal by a licensed asbestos contractor. This material is licensed therefore is subject to a 14 notification to the HSE prior to removal works taking place. All works must conform to the Control of Asbestos Regulations 2012.</b>				
Comments	Unable to made intrusions as door still in use.

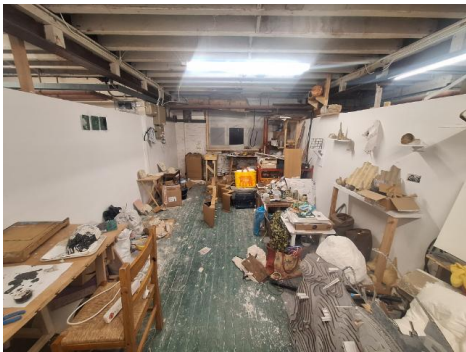
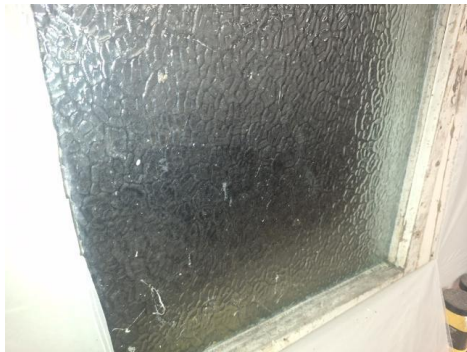
Building:	The Margate School	Floor	2nd Floor		
Location ID	023	Location	Sectioned Workspace		
Sample Number	X003	Extent	2 lin m		
Item / Position	Window putty	Material	Mastic		
Product Type		Scores	-		
Condition			-		
Surface Treatment			-		
Asbestos Type	No asbestos detected		-		
Material Assessment	N/A				
Substrate	Attached to metal frame	Accessibility	-		
Main Photo		Close Up Photo

Recommendation	No action required				
Comments	External window frame made of metal. Pipework to high level penetrating floor and ceiling made of bare metal. Partition wall made of plasterboard. Electrical unit to wall modern metal unit. Attached to metal frame

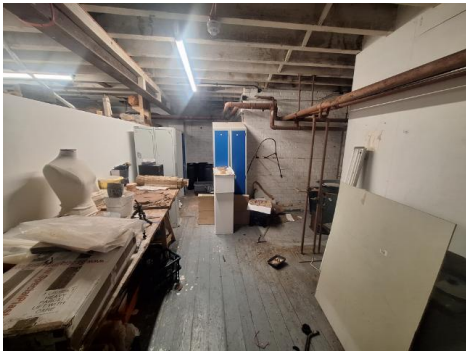
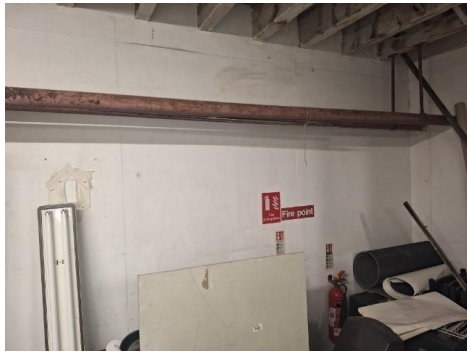
Building:	The Margate School	Floor	2nd Floor		
Location ID	025	Location	Storage Section		
Sample Number	X007	Extent	18 m <sup>2</sup>		
Item / Position	Panel to stairwell wall	Material	Insulating Board		
Product Type		Scores	-		
Condition			-		
Surface Treatment			-		
Asbestos Type	No asbestos detected		-		
Material Assessment	N/A				
Substrate	Nailed to timber	Accessibility	-		
Main Photo		Close Up Photo

Recommendation	No action required				
Comments	<p>Pipework to high level penetrating floor and ceiling made of bare metal.</p> <p>Partition wall made of plasterboard.</p> <p>Pipework insulation to riser pipework made of cloth wrapped man made mineral fibre.</p> <p>Nailed to timber</p>

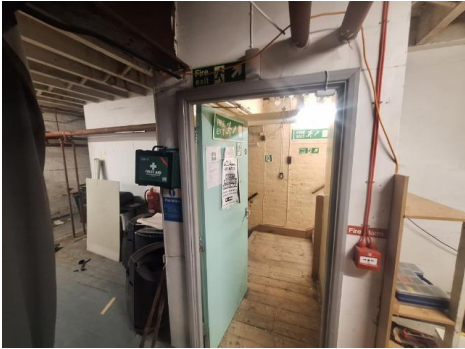
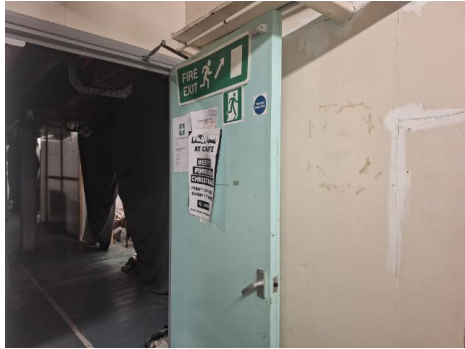
Building:	The Margate School	Floor	2nd Floor		
Location ID	026	Location	Hallway		
Sample Number	X004	Extent	2 m <sup>2</sup>		
Item / Position	Door lining panel	Material	Insulating Board		
Product Type	Asbestos insulating board, millboards, gaskets & ropes etc.	Scores	2		
Condition	Low Damage		1		
Surface Treatment	Sealed		1		
Asbestos Type	<b>Amosite</b>		2		
Material Assessment	Low		6		
Substrate	Unable to made intrusions as door still in use.	Accessibility	Low		
Main Photo		Close Up Photo

Recommendation	<b>Remove - Licensed Material Removal by a licensed asbestos contractor. This material is licensed therefore is subject to a 14 notification to the HSE prior to removal works taking place. All works must conform to the Control of Asbestos Regulations 2012.</b>				
Comments	Unable to made intrusions as door still in use.

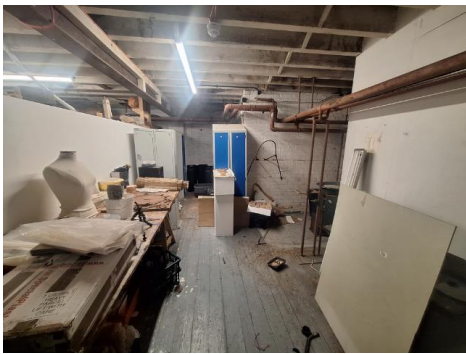
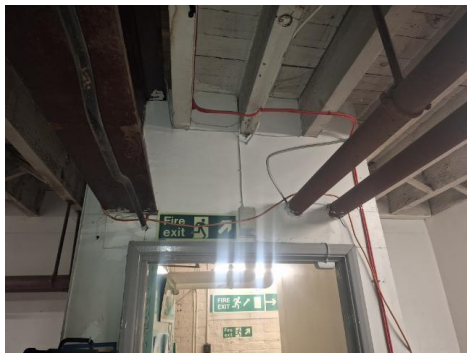
Building:	The Margate School	Floor	2nd Floor		
Location ID	026	Location	Circulation		
Sample Number	X007	Extent	6 m <sup>2</sup>		
Item / Position	Panel to stairwell wall	Material	Insulating Board		
Product Type		Scores	-		
Condition			-		
Surface Treatment			-		
Asbestos Type	No asbestos detected		-		
Material Assessment	N/A				
Substrate	Nailed to timber	Accessibility	-		
Main Photo		Close Up Photo

Recommendation	No action required				
Comments	Pipework to high level penetrating floor and ceiling made of bare metal. Partition wall made of plasterboard. Partition curtains made of modern fabric. Nailed to timber

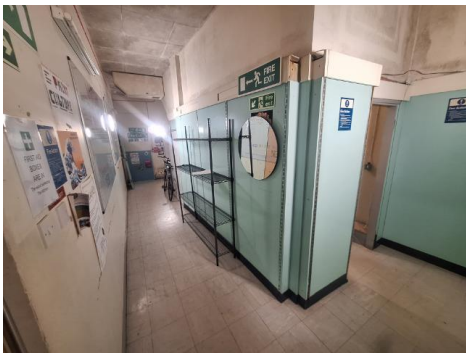
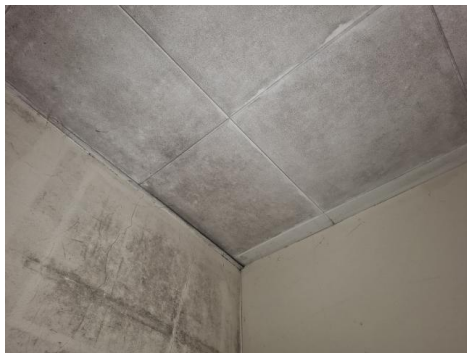
Building:	The Margate School	Floor	2nd Floor		
Location ID	027	Location	Stairwell		
Sample Number	X002	Extent	13 m <sup>2</sup>		
Item / Position	Ceiling Tiles	Material	Insulating Board		
Product Type	Asbestos insulating board, millboards, gaskets & ropes etc.	Scores	2		
Condition	Medium Damage		2		
Surface Treatment	Partially Unsealed		2		
Asbestos Type	<b>Amosite, Chrysotile</b>		2		
Material Assessment	Medium		8		
Substrate	Nailed to timber above.	Accessibility	High		
Main Photo		Close Up Photo

Recommendation	<b>Remove - Licensed Material Removal by a licensed asbestos contractor. This material is licensed therefore is subject to a 14 notification to the HSE prior to removal works taking place. All works must conform to the Control of Asbestos Regulations 2012.</b>				
Comments	Pipework to radiator made of bare metal penetrating wall. Internal door and frame made of timber. Redundant door made of solid timber. Ventilation ductwork metal penetrating ceiling tiles. Panels to wall made of plastic clad timber. Banister panel made of timber. Nailed to timber above.

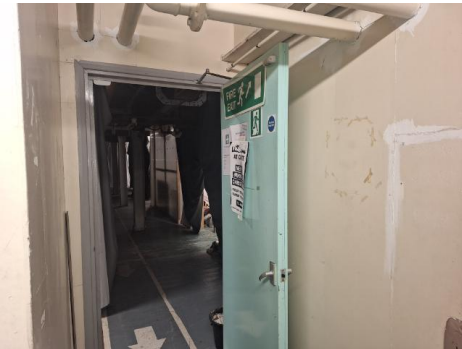
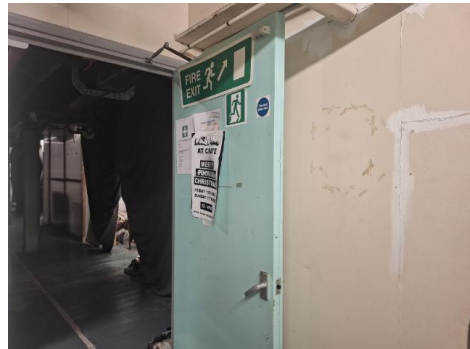
Building:	The Margate School	Floor	2nd Floor		
Location ID	027	Location	Hallway		
Sample Number	X004	Extent	2 m <sup>2</sup>		
Item / Position	Door lining panel	Material	Insulating Board		
Product Type	Asbestos insulating board, millboards, gaskets & ropes etc.	Scores	2		
Condition	Low Damage		1		
Surface Treatment	Sealed		1		
Asbestos Type	Amosite		2		
Material Assessment	Low		6		
Substrate	Unable to made intrusions as door still in use.	Accessibility	Low		
Main Photo		Close Up Photo

Recommendation	Remove - Licensed Material Removal by a licensed asbestos contractor. This material is licensed therefore is subject to a 14 notification to the HSE prior to removal works taking place. All works must conform to the Control of Asbestos Regulations 2012.				
Comments	Unable to made intrusions as door still in use.

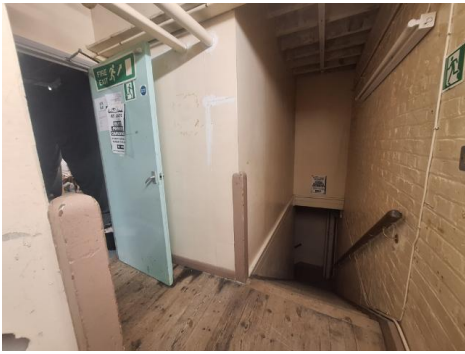
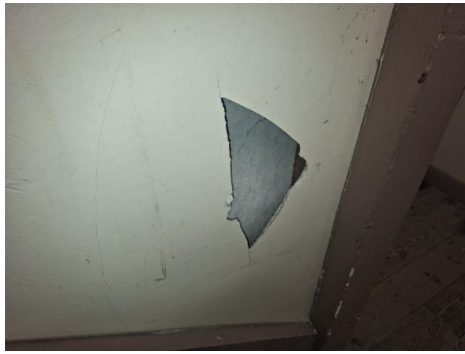
Building:	The Margate School	Floor	2nd Floor		
Location ID	027	Location	Stairwell		
Sample Number	X007	Extent	18 m <sup>2</sup>		
Item / Position	Panel to stairwell wall	Material	Insulating Board		
Product Type		Scores	-		
Condition			-		
Surface Treatment			-		
Asbestos Type	No asbestos detected		-		
Material Assessment	N/A				
Substrate	Nailed to timber	Accessibility	-		
Main Photo		Close Up Photo

Recommendation	No action required				
Comments	Pipework to high level penetrating floor and ceiling made of bare metal. Partition wall made of plasterboard. Partition curtains made of modern fabric. Nailed to timber

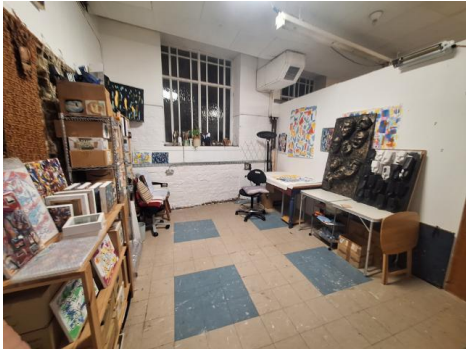
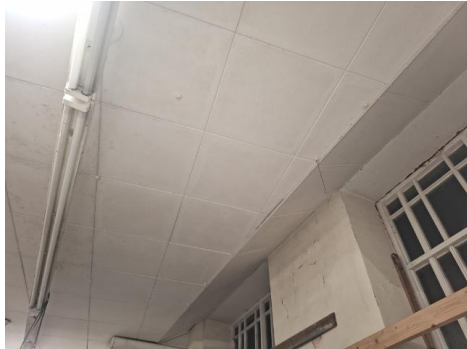
Building:	The Margate School	Floor	1st Floor		
Location ID	028	Location	Workspace		
Sample Number	X002	Extent	18 m <sup>2</sup>		
Item / Position	Ceiling Tiles	Material	Insulating Board		
Product Type	Asbestos insulating board, millboards, gaskets & ropes etc.	Scores	2		
Condition	Medium Damage		2		
Surface Treatment	Partially Unsealed		2		
Asbestos Type	Amosite, Chrysotile		2		
Material Assessment	Medium		8		
Substrate	Nailed to timber above.	Accessibility	High		
Main Photo		Close Up Photo

Recommendation	<b>Remove - Licensed Material Removal by a licensed asbestos contractor. This material is licensed therefore is subject to a 14 notification to the HSE prior to removal works taking place. All works must conform to the Control of Asbestos Regulations 2012.</b>				
Comments	Ventilation ductwork metal penetrating ceiling tiles. External window frame made of timber. Ventilation ductwork penetrating ceiling tiles made of metal. Partition wall made of plasterboard. Nailed to timber above.

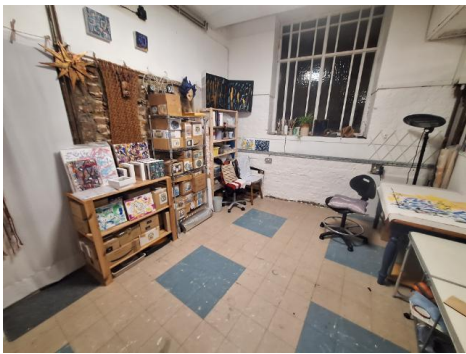
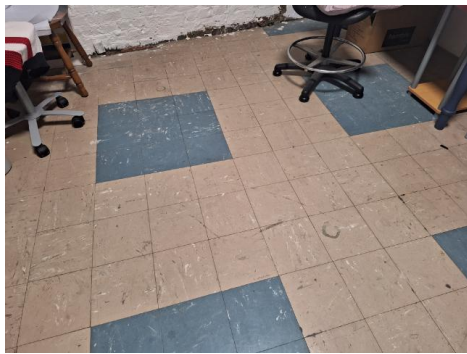
Building:	The Margate School	Floor	1st Floor		
Location ID	028	Location	Workspace		
Sample Number	X008	Extent	18 m <sup>2</sup>		
Item / Position	Floor tiles	Material	Thermoplastic Floor Tile		
Product Type	Asbestos reinforced composites etc.	Scores	1		
Condition	Low Damage		1		
Surface Treatment	Self Sealed		0		
Asbestos Type	<b>Chrysotile</b>		1		
Material Assessment	Very Low		3		
Substrate	Laid on timber.	Accessibility	High		
Main Photo		Close Up Photo

Recommendation	<b>Remove - NON-Licensed Material Removal by an asbestos contractor. This material is not licensed however may still be notifiable to the HSE prior to removal works taking place. All works must conform to the Control of Asbestos Regulations 2012.</b>				
Comments	Laid on timber.

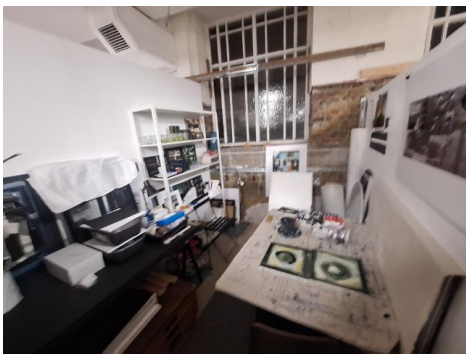
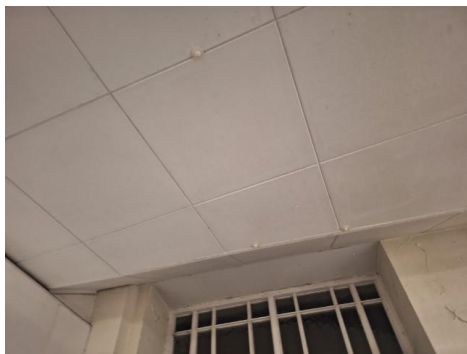
Building:	The Margate School	Floor	1st Floor		
Location ID	029	Location	Workspace		
Sample Number	X002	Extent	8 m²		
Item / Position	Ceiling Tiles	Material	Insulating Board		
Product Type	Asbestos insulating board, millboards, gaskets & ropes etc.	Scores	2		
Condition	Medium Damage		2		
Surface Treatment	Partially Unsealed		2		
Asbestos Type	Amosite, Chrysotile		2		
Material Assessment	Medium		8		
Substrate	Nailed to timber above.	Accessibility	High		
Main Photo		Close Up Photo

Recommendation	Remove - Licensed Material Removal by a licensed asbestos contractor. This material is licensed therefore is subject to a 14 notification to the HSE prior to removal works taking place. All works must conform to the Control of Asbestos Regulations 2012.				
Comments	<p>Ventilation ductwork metal penetrating ceiling tiles.</p> <p>External window frame made of timber.</p> <p>Ventilation ductwork penetrating ceiling tiles made of metal.</p> <p>Partition wall made of plasterboard.</p> <p>Nailed to timber above.</p>

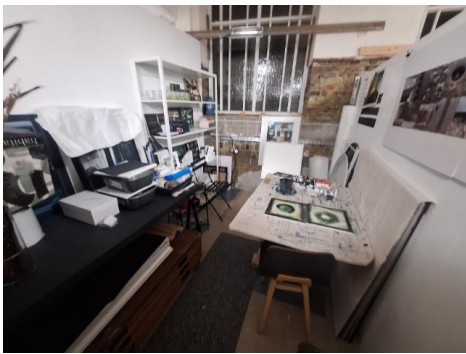
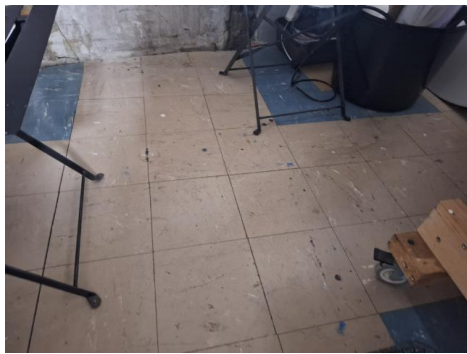
Building:	The Margate School	Floor	1st Floor		
Location ID	029	Location	Workspace		
Sample Number	X008	Extent	8 m <sup>2</sup>		
Item / Position	Floor tiles	Material	Thermoplastic Floor Tile		
Product Type	Asbestos reinforced composites etc.	Scores	1		
Condition	Low Damage		1		
Surface Treatment	Self Sealed		0		
Asbestos Type	<b>Chrysotile</b>		1		
Material Assessment	Very Low		3		
Substrate	Laid on timber.	Accessibility	High		
Main Photo		Close Up Photo

Recommendation	<b>Remove - NON-Licensed Material Removal by an asbestos contractor. This material is not licensed however may still be notifiable to the HSE prior to removal works taking place. All works must conform to the Control of Asbestos Regulations 2012.</b>				
Comments	Laid on timber.

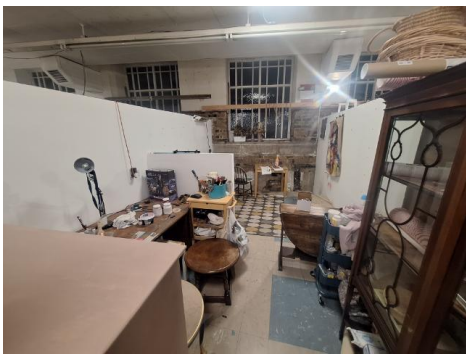
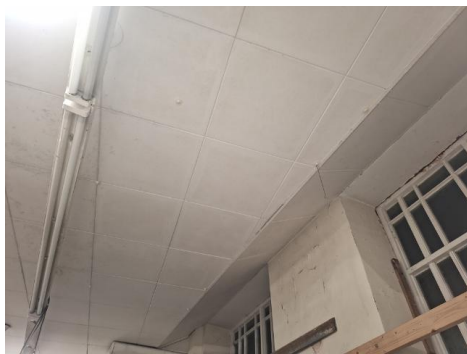
Building:	The Margate School	Floor	1st Floor		
Location ID	030	Location	Workspace		
Sample Number	X002	Extent	18 m <sup>2</sup>		
Item / Position	Ceiling Tiles	Material	Insulating Board		
Product Type	Asbestos insulating board, millboards, gaskets & ropes etc.	Scores	2		
Condition	Medium Damage		2		
Surface Treatment	Partially Unsealed		2		
Asbestos Type	<b>Amosite, Chrysotile</b>		2		
Material Assessment	Medium		8		
Substrate	Nailed to timber above.	Accessibility	High		
Main Photo		Close Up Photo

Recommendation	<b>Remove - Licensed Material Removal by a licensed asbestos contractor. This material is licensed therefore is subject to a 14 notification to the HSE prior to removal works taking place. All works must conform to the Control of Asbestos Regulations 2012.</b>				
Comments	Ventilation ductwork metal penetrating ceiling tiles. External window frame made of timber. Ventilation ductwork penetrating ceiling tiles made of metal. Partition wall made of plasterboard. Nailed to timber above.

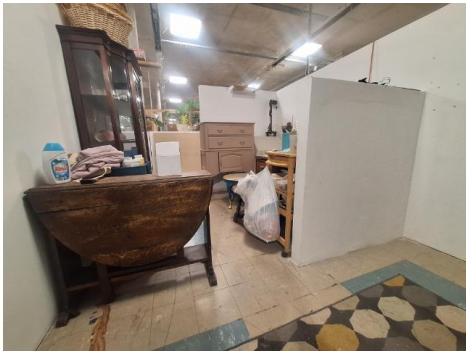
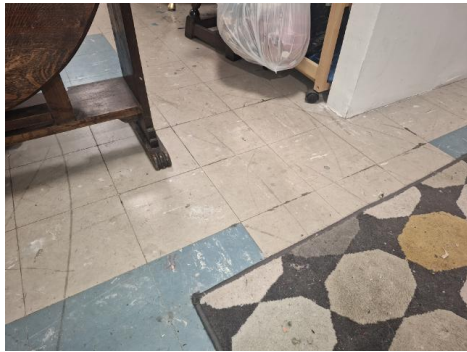
Building:	The Margate School	Floor	1st Floor		
Location ID	030	Location	Workspace		
Sample Number	S008	Extent	18 m <sup>2</sup>		
Item / Position	Floor tiles	Material	Thermoplastic Floor Tile		
Product Type	Asbestos reinforced composites etc.	Scores	1		
Condition	Low Damage		1		
Surface Treatment	Self Sealed		0		
Asbestos Type	<b>Chrysotile</b>		1		
Material Assessment	Very Low		3		
Substrate	Laid on timber.	Accessibility	High		
Main Photo		Close Up Photo

Recommendation	<b>Remove - NON-Licensed Material Removal by an asbestos contractor. This material is not licensed however may still be notifiable to the HSE prior to removal works taking place. All works must conform to the Control of Asbestos Regulations 2012.</b>				
Comments	Laid on timber.
