**External Repairs and  
Redecoration Works**

**The Margate School  
31-33 High Street  
Margate  
CT9 1DX**

**The Margate  
School**

Our Ref: 2324/102434  
April 2024

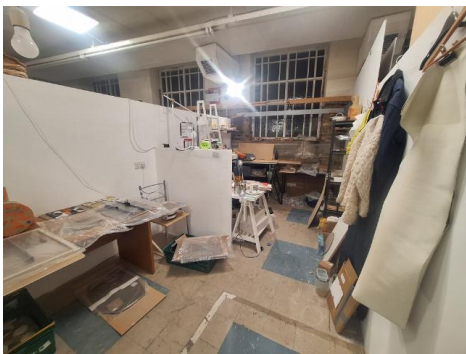
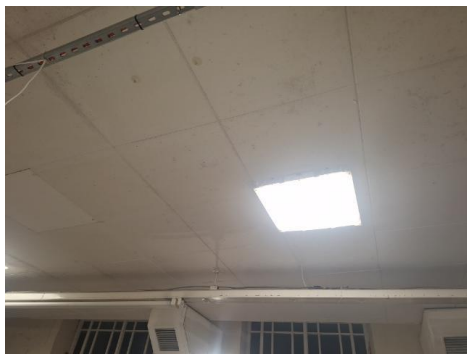
Building:	The Margate School	Floor	1st Floor		
Location ID	031	Location	Workspace		
Sample Number	X002	Extent	18 m <sup>2</sup>		
Item / Position	Ceiling Tiles	Material	Insulating Board		
Product Type	Asbestos insulating board, millboards, gaskets & ropes etc.	Scores	2		
Condition	Medium Damage		2		
Surface Treatment	Partially Unsealed		2		
Asbestos Type	<b>Amosite, Chrysotile</b>		2		
Material Assessment	Medium		8		
Substrate	Nailed to timber above.	Accessibility	High		
Main Photo		Close Up Photo

Recommendation	<b>Remove - Licensed Material Removal by a licensed asbestos contractor. This material is licensed therefore is subject to a 14 notification to the HSE prior to removal works taking place. All works must conform to the Control of Asbestos Regulations 2012.</b>				
Comments	Ventilation ductwork metal penetrating ceiling tiles. External window frame made of timber. Ventilation ductwork penetrating ceiling tiles made of metal. Partition wall made of plasterboard. Nailed to timber above.

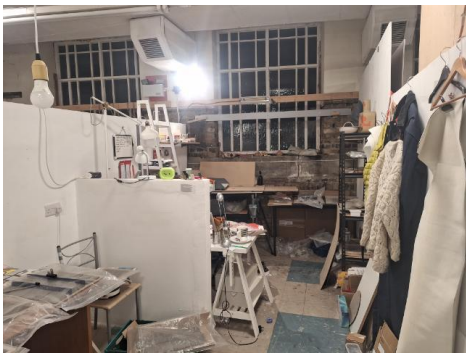
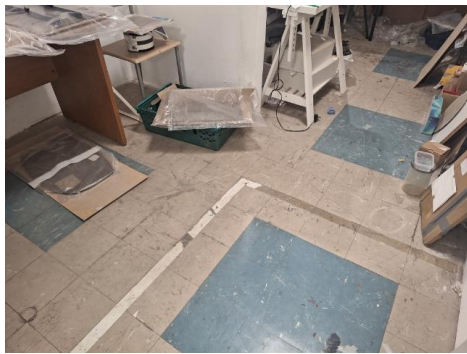
Building:	The Margate School	Floor	1st Floor		
Location ID	031	Location	Workspace		
Sample Number	X008	Extent	18 m <sup>2</sup>		
Item / Position	Floor tiles	Material	Thermoplastic Floor Tile		
Product Type	Asbestos reinforced composites etc.	Scores	1		
Condition	Low Damage		1		
Surface Treatment	Self Sealed		0		
Asbestos Type	<b>Chrysotile</b>		1		
Material Assessment	Very Low		3		
Substrate	Laid on timber.	Accessibility	High		
Main Photo		Close Up Photo

Recommendation	<b>Remove - NON-Licensed Material Removal by an asbestos contractor. This material is not licensed however may still be notifiable to the HSE prior to removal works taking place. All works must conform to the Control of Asbestos Regulations 2012.</b>				
Comments	Laid on timber.

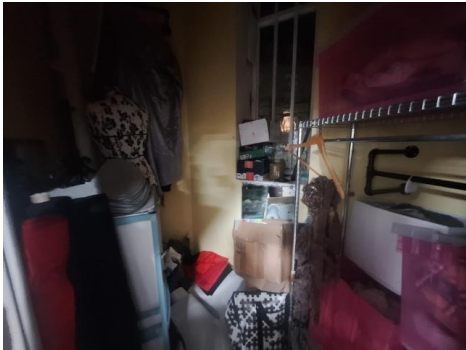
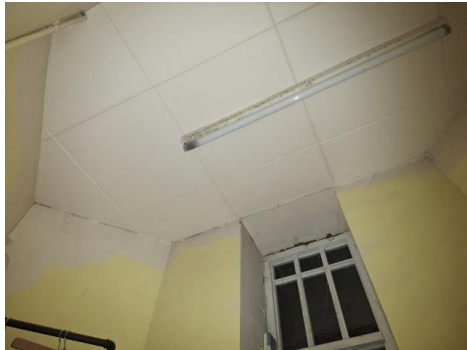
Building:	The Margate School	Floor	1st Floor		
Location ID	032	Location	Workspace Storage		
Sample Number	X002	Extent	3 m <sup>2</sup>		
Item / Position	Ceiling Tiles	Material	Insulating Board		
Product Type	Asbestos insulating board, millboards, gaskets & ropes etc.	Scores	2		
Condition	Medium Damage		2		
Surface Treatment	Partially Unsealed		2		
Asbestos Type	<b>Amosite, Chrysotile</b>		2		
Material Assessment	Medium		8		
Substrate	Nailed to timber above.	Accessibility	High		
Main Photo		Close Up Photo

Recommendation	<b>Remove - Licensed Material Removal by a licensed asbestos contractor. This material is licensed therefore is subject to a 14 notification to the HSE prior to removal works taking place. All works must conform to the Control of Asbestos Regulations 2012.</b>				
Comments	External window frame made of timber. Partition wall made of plasterboard. Nailed to timber above.

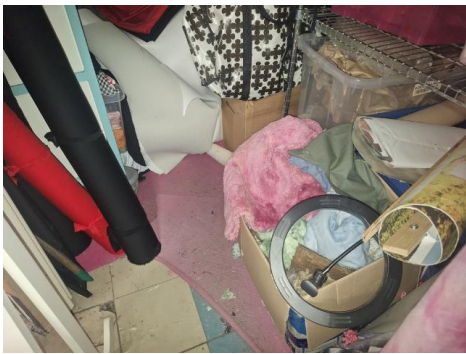
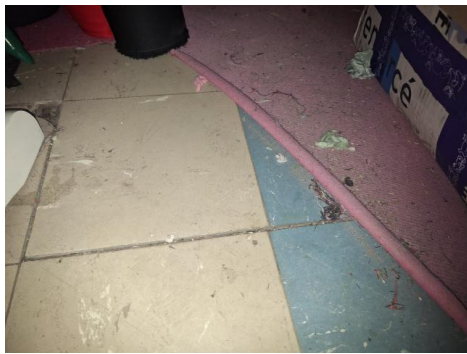
Building:	The Margate School	Floor	1st Floor		
Location ID	032	Location	Workspace		
Sample Number	X008	Extent	3 m <sup>2</sup>		
Item / Position	Floor tiles	Material	Thermoplastic Floor Tile		
Product Type	Asbestos reinforced composites etc.	Scores	1		
Condition	Low Damage		1		
Surface Treatment	Self Sealed		0		
Asbestos Type	<b>Chrysotile</b>		1		
Material Assessment	Very Low		3		
Substrate	Laid on timber.	Accessibility	High		
Main Photo		Close Up Photo

Recommendation	<b>Remove - NON-Licensed Material Removal by an asbestos contractor. This material is not licensed however may still be notifiable to the HSE prior to removal works taking place. All works must conform to the Control of Asbestos Regulations 2012.</b>				
Comments	Laid on timber.

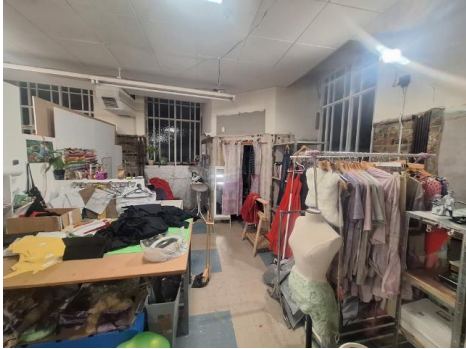
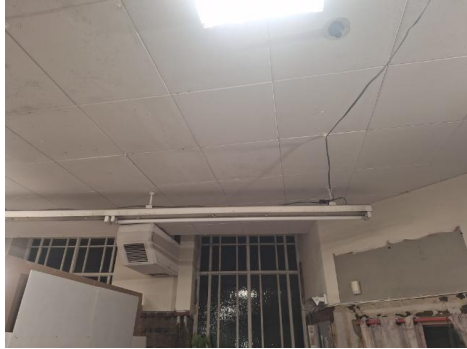
Building:	The Margate School	Floor	1st Floor		
Location ID	033	Location	Workspace		
Sample Number	X002	Extent	18 m <sup>2</sup>		
Item / Position	Ceiling Tiles	Material	Insulating Board		
Product Type	Asbestos insulating board, millboards, gaskets & ropes etc.	Scores	2		
Condition	Medium Damage		2		
Surface Treatment	Partially Unsealed		2		
Asbestos Type	<b>Amosite, Chrysotile</b>		2		
Material Assessment	Medium		8		
Substrate	Nailed to timber above.	Accessibility	High		
Main Photo		Close Up Photo

Recommendation	<b>Remove - Licensed Material Removal by a licensed asbestos contractor. This material is licensed therefore is subject to a 14 notification to the HSE prior to removal works taking place. All works must conform to the Control of Asbestos Regulations 2012.</b>				
Comments	Ventilation ductwork metal penetrating ceiling tiles. External window frame made of timber. Ventilation ductwork penetrating ceiling tiles made of metal. Partition wall made of plasterboard. Electrical unit to wall made of metal with modern fuses. Boxing beside electrical unit made of fibreboard. Nailed to timber above.

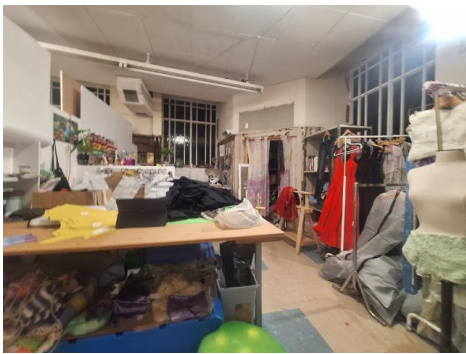
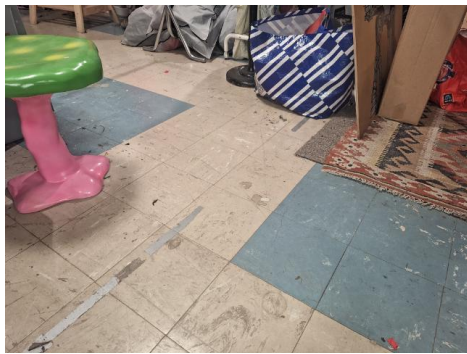
Building:	The Margate School	Floor	1st Floor		
Location ID	033	Location	Workspace		
Sample Number	X008	Extent	18 m <sup>2</sup>		
Item / Position	Floor tiles	Material	Thermoplastic Floor Tile		
Product Type	Asbestos reinforced composites etc.	Scores	1		
Condition	Low Damage		1		
Surface Treatment	Self Sealed		0		
Asbestos Type	<b>Chrysotile</b>		1		
Material Assessment	Very Low		3		
Substrate	Laid on timber.	Accessibility	High		
Main Photo		Close Up Photo

Recommendation	<b>Remove - NON-Licensed Material Removal by an asbestos contractor. This material is not licensed however may still be notifiable to the HSE prior to removal works taking place. All works must conform to the Control of Asbestos Regulations 2012.</b>				
Comments	Laid on timber.

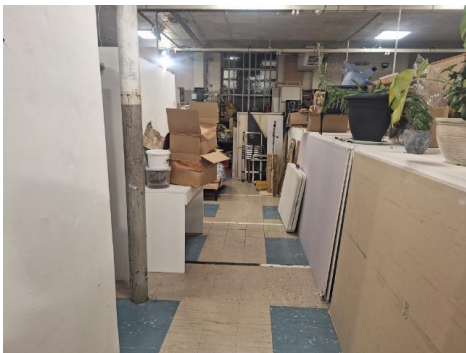
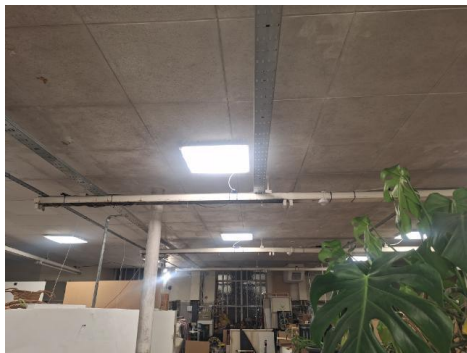
Building:	The Margate School	Floor	1st Floor		
Location ID	034	Location	Circulation		
Sample Number	X002	Extent	26 m <sup>2</sup>		
Item / Position	Ceiling Tiles	Material	Insulating Board		
Product Type	Asbestos insulating board, millboards, gaskets & ropes etc.	Scores	2		
Condition	Medium Damage		2		
Surface Treatment	Partially Unsealed		2		
Asbestos Type	<b>Amosite, Chrysotile</b>		2		
Material Assessment	Medium		8		
Substrate	Nailed to timber above.	Accessibility	High		
Main Photo		Close Up Photo

Recommendation	<b>Remove - Licensed Material Removal by a licensed asbestos contractor. This material is licensed therefore is subject to a 14 notification to the HSE prior to removal works taking place. All works must conform to the Control of Asbestos Regulations 2012.</b>				
Comments	Partition wall made of plasterboard. Internal door and frame made of timber. Nailed to timber above.

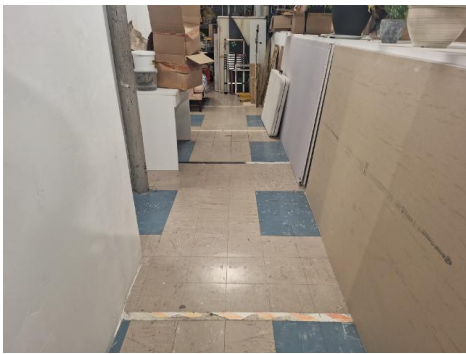
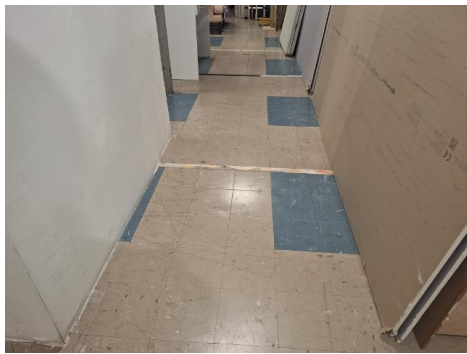
Building:	The Margate School	Floor	1st Floor		
Location ID	034	Location	Circulation		
Sample Number	X008	Extent	26 m²		
Item / Position	Floor tiles	Material	Thermoplastic Floor Tile		
Product Type	Asbestos reinforced composites etc.	Scores	1		
Condition	Low Damage		1		
Surface Treatment	Self Sealed		0		
Asbestos Type	Chrysotile		1		
Material Assessment	Very Low		3		
Substrate	Laid on timber.	Accessibility	High		
Main Photo		Close Up Photo

Recommendation	Remove - NON-Licensed Material Removal by an asbestos contractor. This material is not licensed however may still be notifiable to the HSE prior to removal works taking place. All works must conform to the Control of Asbestos Regulations 2012.				
Comments	Laid on timber.

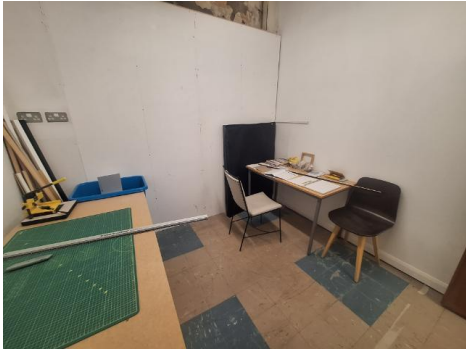
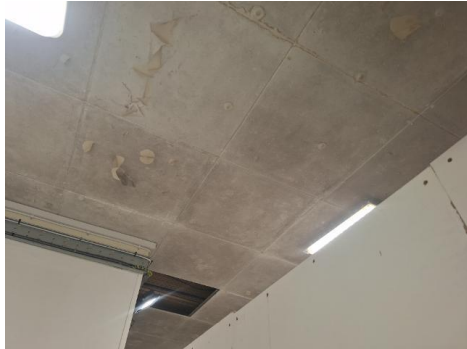
Building:	The Margate School	Floor	1st Floor		
Location ID	035	Location	Workstations		
Sample Number	X002	Extent	9 m <sup>2</sup>		
Item / Position	Ceiling Tiles	Material	Insulating Board		
Product Type	Asbestos insulating board, millboards, gaskets & ropes etc.	Scores	2		
Condition	Medium Damage		2		
Surface Treatment	Partially Unsealed		2		
Asbestos Type	<b>Amosite, Chrysotile</b>		2		
Material Assessment	Medium		8		
Substrate	Nailed to timber above.	Accessibility	High		
Main Photo		Close Up Photo

Recommendation	<b>Remove - Licensed Material Removal by a licensed asbestos contractor. This material is licensed therefore is subject to a 14 notification to the HSE prior to removal works taking place. All works must conform to the Control of Asbestos Regulations 2012.</b>				
Comments	Partition walls made of plasterboard. Internal door and frame made of timber. Pipework metal with fibreboard boxing. Nailed to timber above.

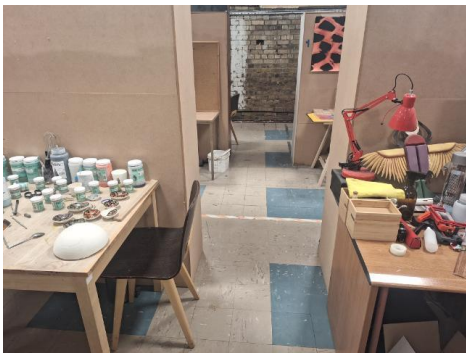
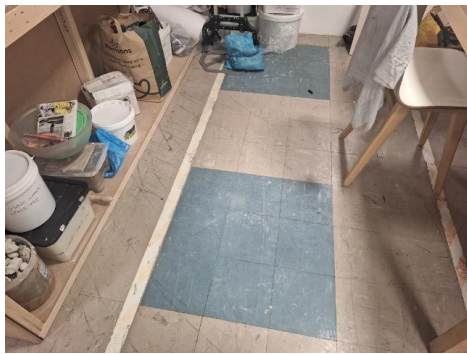
Building:	The Margate School	Floor	1st Floor		
Location ID	035	Location	Workstation		
Sample Number	X008	Extent	9 m <sup>2</sup>		
Item / Position	Floor tiles	Material	Thermoplastic Floor Tile		
Product Type	Asbestos reinforced composites etc.	Scores	1		
Condition	Low Damage		1		
Surface Treatment	Self Sealed		0		
Asbestos Type	<b>Chrysotile</b>		1		
Material Assessment	Very Low		3		
Substrate	Laid on timber.	Accessibility	High		
Main Photo		Close Up Photo

Recommendation	<b>Remove - NON-Licensed Material Removal by an asbestos contractor. This material is not licensed however may still be notifiable to the HSE prior to removal works taking place. All works must conform to the Control of Asbestos Regulations 2012.</b>				
Comments	Laid on timber.

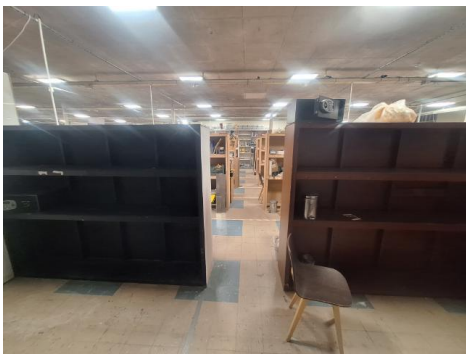
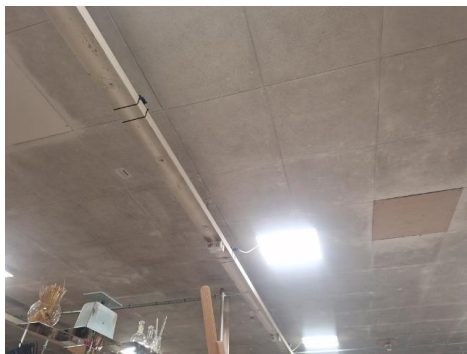
Building:	The Margate School	Floor	1st Floor		
Location ID	036	Location	Workstations		
Sample Number	X002	Extent	77 m <sup>2</sup>		
Item / Position	Ceiling Tiles	Material	Insulating Board		
Product Type	Asbestos insulating board, millboards, gaskets & ropes etc.	Scores	2		
Condition	Medium Damage		2		
Surface Treatment	Partially Unsealed		2		
Asbestos Type	<b>Amosite, Chrysotile</b>		2		
Material Assessment	Medium		8		
Substrate	Nailed to timber above.	Accessibility	High		
Main Photo		Close Up Photo

Recommendation	<b>Remove - Licensed Material Removal by a licensed asbestos contractor. This material is licensed therefore is subject to a 14 notification to the HSE prior to removal works taking place. All works must conform to the Control of Asbestos Regulations 2012.</b>				
Comments	Partition walls made of plasterboard. External window frames made of timber. Pipework metal with fibreboard boxing. Nailed to timber above.

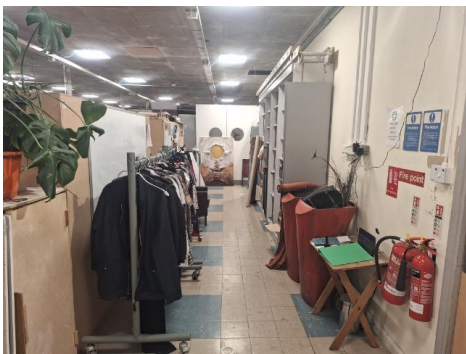
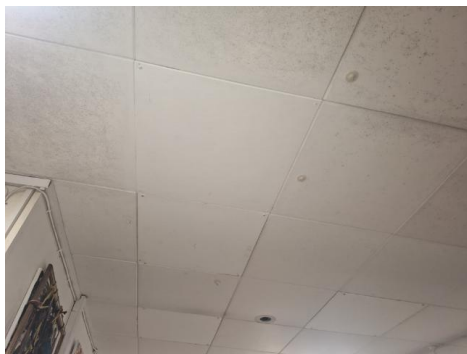
Building:	The Margate School	Floor	1st Floor		
Location ID	037	Location	Circulation		
Sample Number	X002	Extent	36 m <sup>2</sup>		
Item / Position	Ceiling Tiles	Material	Insulating Board		
Product Type	Asbestos insulating board, millboards, gaskets & ropes etc.	Scores	2		
Condition	Medium Damage		2		
Surface Treatment	Partially Unsealed		2		
Asbestos Type	<b>Amosite, Chrysotile</b>		2		
Material Assessment	Medium		8		
Substrate	Nailed to timber above.	Accessibility	High		
Main Photo		Close Up Photo

Recommendation	<b>Remove - Licensed Material Removal by a licensed asbestos contractor. This material is licensed therefore is subject to a 14 notification to the HSE prior to removal works taking place. All works must conform to the Control of Asbestos Regulations 2012.</b>				
Comments	Partition walls made of plasterboard. Internal door and frame made of timber. Pipework metal with fibreboard boxing. Nailed to timber above.

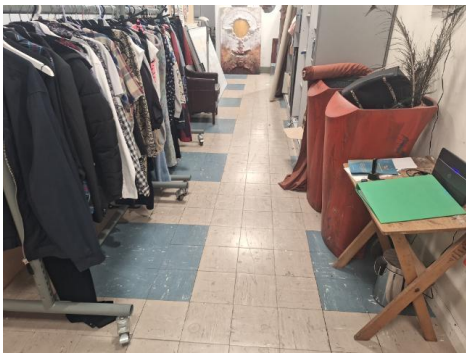
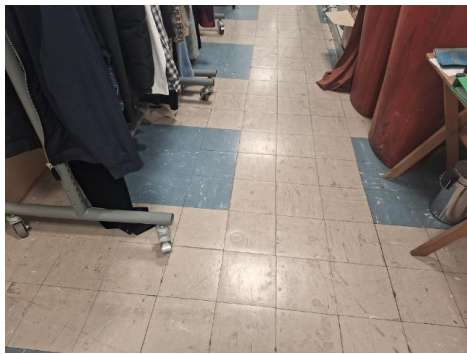
Building:	The Margate School	Floor	1st Floor		
Location ID	037	Location	Circulation		
Sample Number	X008	Extent	9 m <sup>2</sup>		
Item / Position	Floor tiles	Material	Thermoplastic Floor Tile		
Product Type	Asbestos reinforced composites etc.	Scores	1		
Condition	Low Damage		1		
Surface Treatment	Self Sealed		0		
Asbestos Type	<b>Chrysotile</b>		1		
Material Assessment	Very Low		3		
Substrate	Laid on timber.	Accessibility	High		
Main Photo		Close Up Photo

Recommendation	<b>Remove - NON-Licensed Material Removal by an asbestos contractor. This material is not licensed however may still be notifiable to the HSE prior to removal works taking place. All works must conform to the Control of Asbestos Regulations 2012.</b>				
Comments	Laid on timber.

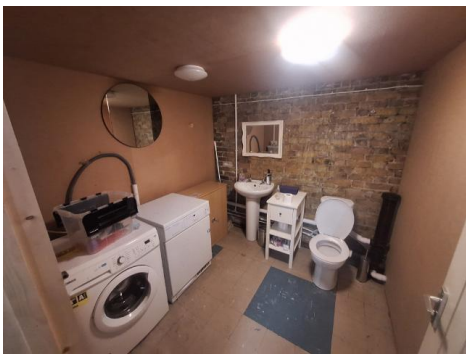
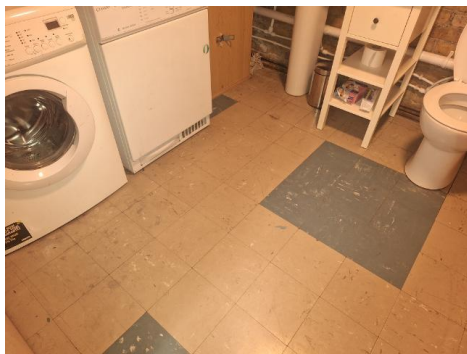
Building:	The Margate School	Floor	1st Floor		
Location ID	038	Location	WC		
Sample Number	X008	Extent	9 m²		
Item / Position	Floor tiles	Material	Thermoplastic Floor Tile		
Product Type	Asbestos reinforced composites etc.	Scores	1		
Condition	Low Damage		1		
Surface Treatment	Self Sealed		0		
Asbestos Type	Chrysotile		1		
Material Assessment	Very Low		3		
Substrate	Laid on timber.	Accessibility	High		
Main Photo		Close Up Photo

Recommendation	Remove - NON-Licensed Material Removal by an asbestos contractor. This material is not licensed however may still be notifiable to the HSE prior to removal works taking place. All works must conform to the Control of Asbestos Regulations 2012.				
Comments	Toilet cistern made of ceramic material with plastic and metal. Internal door and frame made of timber. Laid on timber.

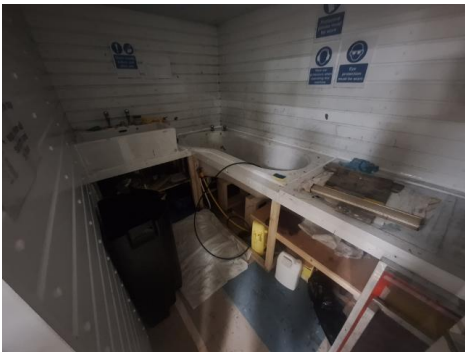
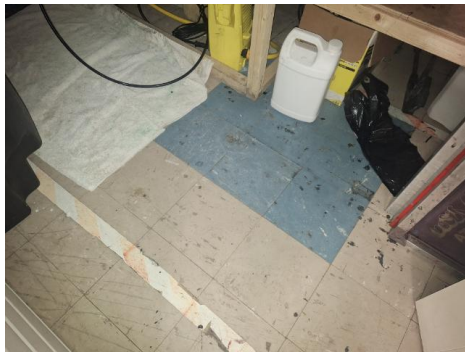
Building:	The Margate School	Floor	1st Floor		
Location ID	039	Location	Wet Room		
Sample Number	X008	Extent	9 m <sup>2</sup>		
Item / Position	Floor tiles	Material	Thermoplastic Floor Tile		
Product Type	Asbestos reinforced composites etc.	Scores	1		
Condition	Low Damage		1		
Surface Treatment	Self Sealed		0		
Asbestos Type	<b>Chrysotile</b>		1		
Material Assessment	Very Low		3		
Substrate	Laid on timber.	Accessibility	High		
Main Photo		Close Up Photo

Recommendation	<b>Remove - NON-Licensed Material Removal by an asbestos contractor. This material is not licensed however may still be notifiable to the HSE prior to removal works taking place. All works must conform to the Control of Asbestos Regulations 2012.</b>				
Comments	Toilet cistern made of ceramic material with plastic and metal. Internal door and frame made of timber. Cladding to wall made of plastic. Laid on timber.

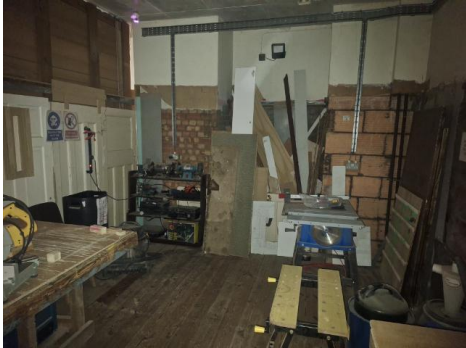
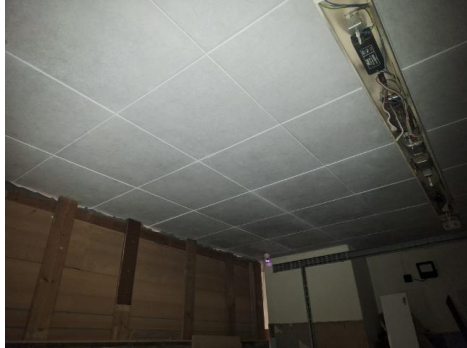
Building:	The Margate School	Floor	1st Floor		
Location ID	040	Location	Circulation		
Sample Number	X002	Extent	20 m <sup>2</sup>		
Item / Position	Ceiling Tiles	Material	Insulating Board		
Product Type	Asbestos insulating board, millboards, gaskets & ropes etc.	Scores	2		
Condition	Medium Damage		2		
Surface Treatment	Partially Unsealed		2		
Asbestos Type	<b>Amosite, Chrysotile</b>		2		
Material Assessment	Medium		8		
Substrate	Nailed to timber above.	Accessibility	High		
Main Photo		Close Up Photo

Recommendation	<b>Remove - Licensed Material Removal by a licensed asbestos contractor. This material is licensed therefore is subject to a 14 notification to the HSE prior to removal works taking place. All works must conform to the Control of Asbestos Regulations 2012.</b>				
Comments	Partition walls made of timber. Pipework metal with fibreboard boxing. Nailed to timber above.

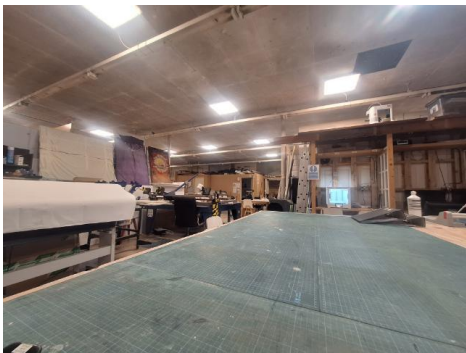
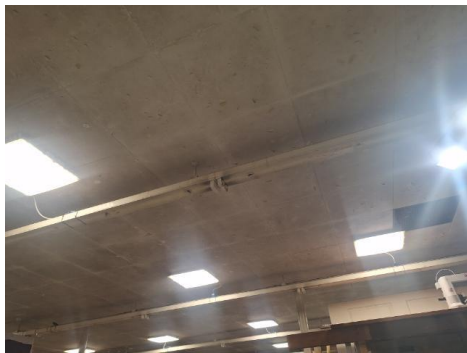
Building:	The Margate School	Floor	1st Floor		
Location ID	041	Location	Workstation		
Sample Number	X002	Extent	110 m <sup>2</sup>		
Item / Position	Ceiling Tiles	Material	Insulating Board		
Product Type	Asbestos insulating board, millboards, gaskets & ropes etc.	Scores	2		
Condition	Medium Damage		2		
Surface Treatment	Partially Unsealed		2		
Asbestos Type	<b>Amosite, Chrysotile</b>		2		
Material Assessment	Medium		8		
Substrate	Nailed to timber above.	Accessibility	High		
Main Photo		Close Up Photo

Recommendation	<b>Remove - Licensed Material Removal by a licensed asbestos contractor. This material is licensed therefore is subject to a 14 notification to the HSE prior to removal works taking place. All works must conform to the Control of Asbestos Regulations 2012.</b>				
Comments	Partition walls made of timber. Pipework metal with fibreboard boxing. Nailed to timber above.

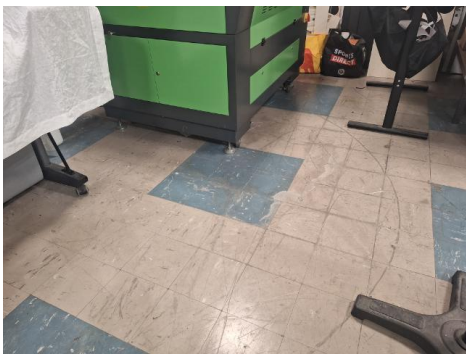
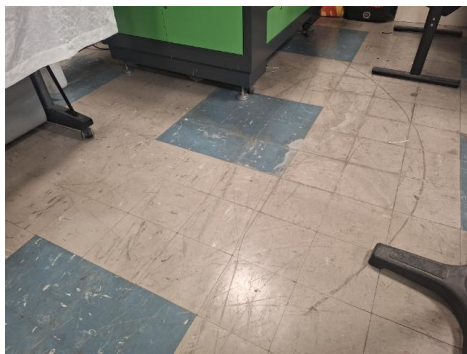
Building:	The Margate School	Floor	1st Floor		
Location ID	041	Location	Wet Room		
Sample Number	X008	Extent	100 m <sup>2</sup>		
Item / Position	Floor tiles	Material	Thermoplastic Floor Tile		
Product Type	Asbestos reinforced composites etc.	Scores	1		
Condition	Low Damage		1		
Surface Treatment	Self Sealed		0		
Asbestos Type	<b>Chrysotile</b>		1		
Material Assessment	Very Low		3		
Substrate	Laid on timber.	Accessibility	High		
Main Photo		Close Up Photo

Recommendation	<b>Remove - NON-Licensed Material Removal by an asbestos contractor. This material is not licensed however may still be notifiable to the HSE prior to removal works taking place. All works must conform to the Control of Asbestos Regulations 2012.</b>				
Comments	Toilet cistern made of ceramic material with plastic and metal. Internal door and frame made of timber. Cladding to wall made of plastic. Laid on timber.

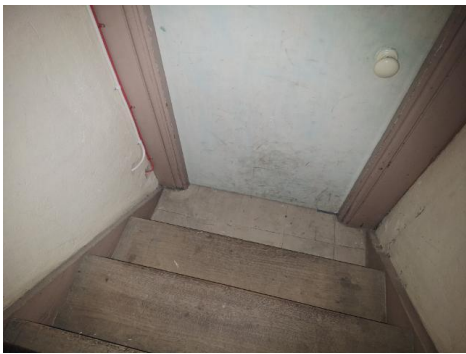
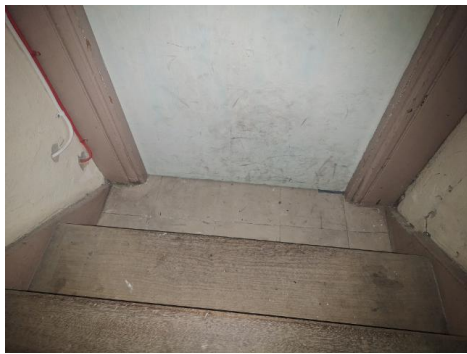
Building:	The Margate School	Floor	1st Floor		
Location ID	043	Location	Stairwell		
Sample Number	X008	Extent	1 m <sup>2</sup>		
Item / Position	Floor tiles	Material	Thermoplastic Floor Tile		
Product Type	Asbestos reinforced composites etc.	Scores	1		
Condition	Low Damage		1		
Surface Treatment	Self Sealed		0		
Asbestos Type	<b>Chrysotile</b>		1		
Material Assessment	Very Low		3		
Substrate	Laid on timber.	Accessibility	High		
Main Photo		Close Up Photo

Recommendation	<b>Remove - NON-Licensed Material Removal by an asbestos contractor. This material is not licensed however may still be notifiable to the HSE prior to removal works taking place. All works must conform to the Control of Asbestos Regulations 2012.</b>				
Comments	Laid on timber.

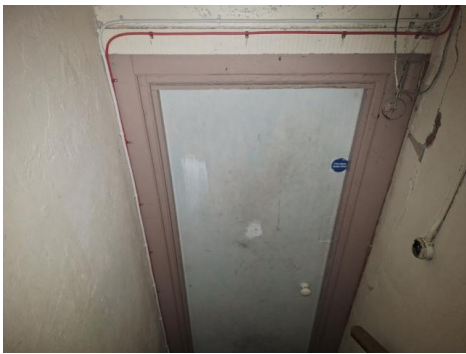
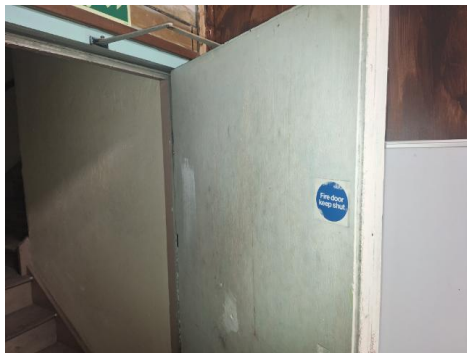
Building:	The Margate School	Floor	1st Floor		
Location ID	043	Location	Stairwell		
Sample Number	S009	Extent	2 m <sup>2</sup>		
Item / Position	Door panel	Material	Insulating Board		
Product Type	Asbestos insulating board, millboards, gaskets & ropes etc.	Scores	2		
Condition	Low Damage		1		
Surface Treatment	Partially Unsealed		2		
Asbestos Type	<b>Amosite</b>		2		
Material Assessment	Medium		7		
Substrate	Nailed to timber	Accessibility	High		
Main Photo		Close Up Photo

Recommendation	<b>Remove - Licensed Material Removal by a licensed asbestos contractor. This material is licensed therefore is subject to a 14 notification to the HSE prior to removal works taking place. All works must conform to the Control of Asbestos Regulations 2012.</b>				
Comments	Nailed to timber

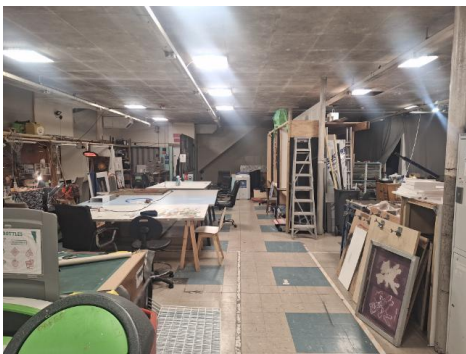
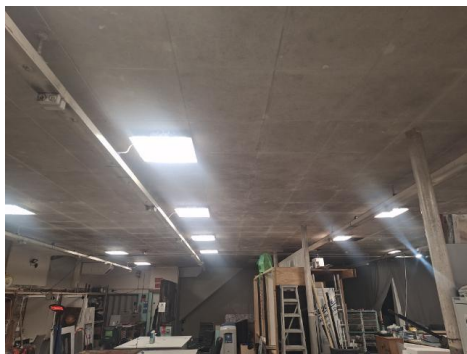
Building:	The Margate School	Floor	1st Floor		
Location ID	044	Location	Workspace		
Sample Number	X002	Extent	120 m <sup>2</sup>		
Item / Position	Ceiling Tiles	Material	Insulating Board		
Product Type	Asbestos insulating board, millboards, gaskets & ropes etc.	Scores	2		
Condition	Medium Damage		2		
Surface Treatment	Partially Unsealed		2		
Asbestos Type	<b>Amosite, Chrysotile</b>		2		
Material Assessment	Medium		8		
Substrate	Nailed to timber above.	Accessibility	High		
Main Photo		Close Up Photo

Recommendation	<b>Remove - Licensed Material Removal by a licensed asbestos contractor. This material is licensed therefore is subject to a 14 notification to the HSE prior to removal works taking place. All works must conform to the Control of Asbestos Regulations 2012.</b>				
Comments	Partition walls made of timber. Pipework metal with fibreboard boxing. Internal door and frame made of timber. External window made of timber. Nailed to timber above.

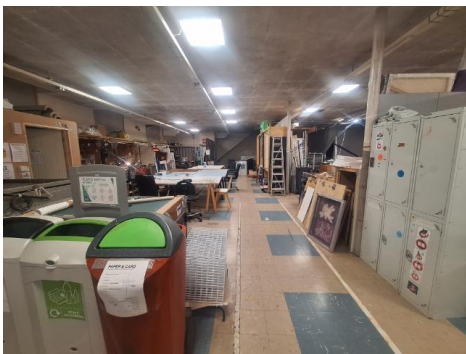
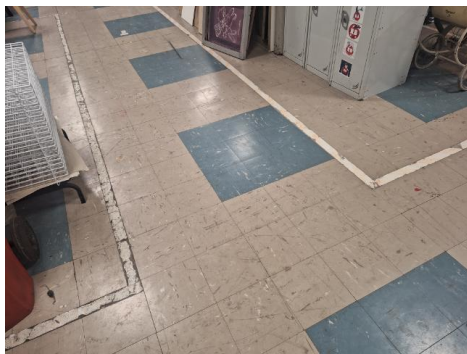
Building:	The Margate School	Floor	1st Floor		
Location ID	044	Location	Workshop		
Sample Number	X008	Extent	120 m <sup>2</sup>		
Item / Position	Floor tiles	Material	Thermoplastic Floor Tile		
Product Type	Asbestos reinforced composites etc.	Scores	1		
Condition	Low Damage		1		
Surface Treatment	Self Sealed		0		
Asbestos Type	<b>Chrysotile</b>		1		
Material Assessment	Very Low		3		
Substrate	Laid on timber.	Accessibility	High		
Main Photo		Close Up Photo

Recommendation	<b>Remove - NON-Licensed Material Removal by an asbestos contractor. This material is not licensed however may still be notifiable to the HSE prior to removal works taking place. All works must conform to the Control of Asbestos Regulations 2012.</b>				
Comments	Toilet cistern made of ceramic material with plastic and metal. Internal door and frame made of timber. Cladding to wall made of plastic. Laid on timber.

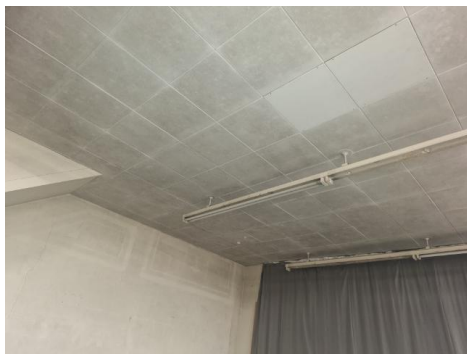
Building:	The Margate School	Floor	1st Floor		
Location ID	045	Location	Workspace		
Sample Number	X002	Extent	90 m <sup>2</sup>		
Item / Position	Ceiling Tiles	Material	Insulating Board		
Product Type	Asbestos insulating board, millboards, gaskets & ropes etc.	Scores	2		
Condition	Medium Damage		2		
Surface Treatment	Partially Unsealed		2		
Asbestos Type	<b>Amosite, Chrysotile</b>		2		
Material Assessment	Medium		8		
Substrate	Nailed to timber above.	Accessibility	High		
Main Photo		Close Up Photo

Recommendation	<b>Remove - Licensed Material Removal by a licensed asbestos contractor. This material is licensed therefore is subject to a 14 notification to the HSE prior to removal works taking place. All works must conform to the Control of Asbestos Regulations 2012.</b>				
Comments	Banister panels made of timber. Stair nosing made of rubber. Ventilation ductwork to ceiling made of metal. Nailed to timber above.

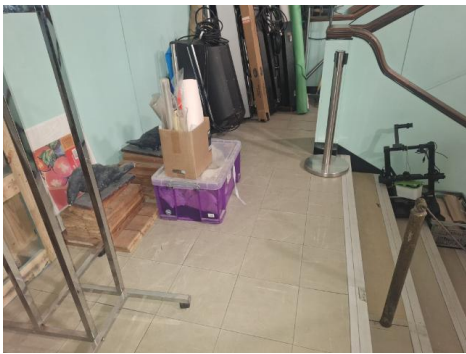
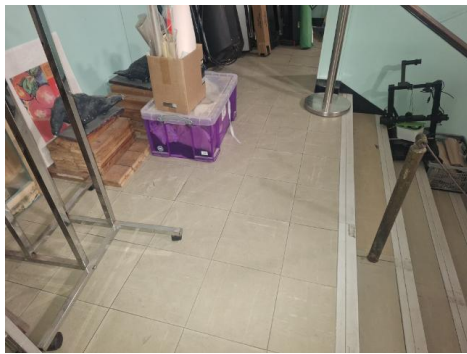
Building:	The Margate School	Floor	1st Floor		
Location ID	045	Location	Stairwell		
Sample Number	S010	Extent	12 m <sup>2</sup>		
Item / Position	Floor tiles to half level	Material	Thermoplastic Floor Tile		
Product Type	Asbestos reinforced composites etc.	Scores	1		
Condition	Low Damage		1		
Surface Treatment	Self Sealed		0		
Asbestos Type	<b>Chrysotile</b>		1		
Material Assessment	Very Low		3		
Substrate	Laid on concrete	Accessibility	High		
Main Photo		Close Up Photo

Recommendation	<b>Remove - NON-Licensed Material Removal by an asbestos contractor. This material is not licensed however may still be notifiable to the HSE prior to removal works taking place. All works must conform to the Control of Asbestos Regulations 2012.</b>				
Comments	Laid on concrete

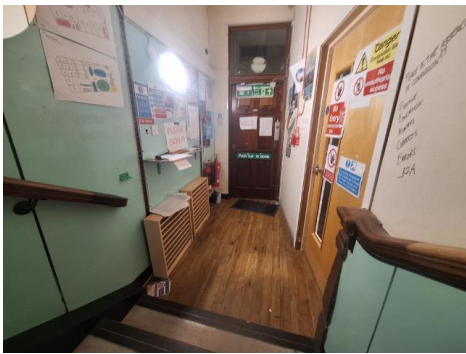
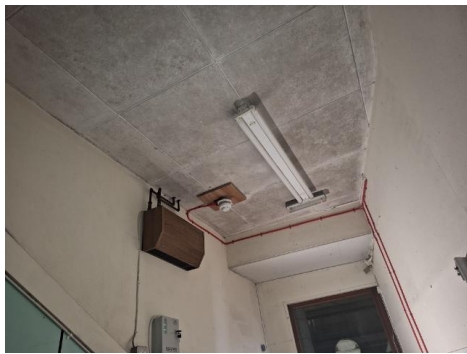
Building:	The Margate School	Floor	Ground Floor		
Location ID	046	Location	Entrance Lobby		
Sample Number	X002	Extent	16 m <sup>2</sup>		
Item / Position	Ceiling Tiles	Material	Insulating Board		
Product Type	Asbestos insulating board, millboards, gaskets & ropes etc.	Scores	2		
Condition	Medium Damage		2		
Surface Treatment	Partially Unsealed		2		
Asbestos Type	<b>Amosite, Chrysotile</b>		2		
Material Assessment	Medium		8		
Substrate	Nailed to timber above.	Accessibility	High		
Main Photo		Close Up Photo

Recommendation	<b>Remove - Licensed Material Removal by a licensed asbestos contractor. This material is licensed therefore is subject to a 14 notification to the HSE prior to removal works taking place. All works must conform to the Control of Asbestos Regulations 2012.</b>				
Comments	Banister panels made of timber. Stair nosing made of rubber. External door and frame made of timber. Internal door and frame made of timber. Boxing above entrance door made of timber. Heater unit to wall no asbestos observed. Nailed to timber above.

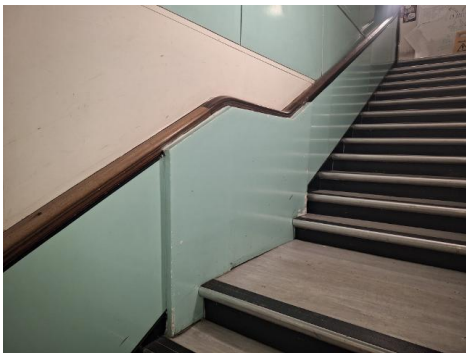
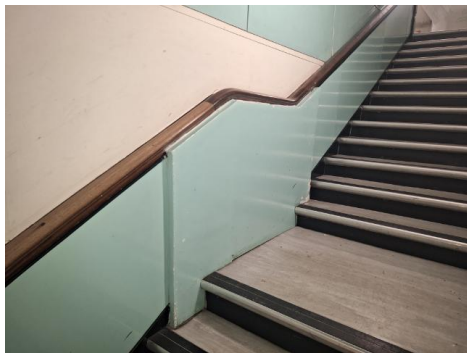
Building:	The Margate School	Floor	Ground Floor		
Location ID	046	Location	Entrance Lobby		
Sample Number	S011	Extent	2 m <sup>2</sup>		
Item / Position	Panel to banister	Material	Insulating Board		
Product Type		Scores	-		
Condition			-		
Surface Treatment			-		
Asbestos Type	No asbestos detected		-		
Material Assessment	N/A				
Substrate	Attached to frame.	Accessibility	-		
Main Photo		Close Up Photo

Recommendation	No action required				
Comments	Attached to frame.

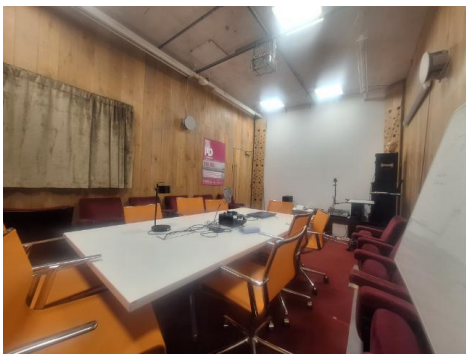
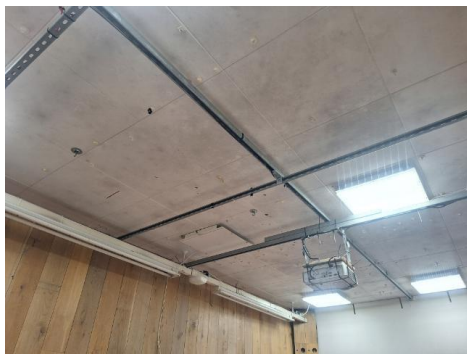
Building:	The Margate School	Floor	Ground Floor		
Location ID	048	Location	Meeting Room		
Sample Number	X002	Extent	18 m <sup>2</sup>		
Item / Position	Ceiling Tiles	Material	Insulating Board		
Product Type	Asbestos insulating board, millboards, gaskets & ropes etc.	Scores	2		
Condition	Low Damage		1		
Surface Treatment	Partially Unsealed		2		
Asbestos Type	Amosite, Chrysotile		2		
Material Assessment	Medium		7		
Substrate	Nailed to timber above.	Accessibility	High		
Main Photo		Close Up Photo

Recommendation	<b>Remove - Licensed Material Removal by a licensed asbestos contractor. This material is licensed therefore is subject to a 14 notification to the HSE prior to removal works taking place. All works must conform to the Control of Asbestos Regulations 2012.</b>				
Comments	Internal door and frame made of timber. Partition walls made of timber. Sound proofing above desk made of modern material. Nailed to timber above.

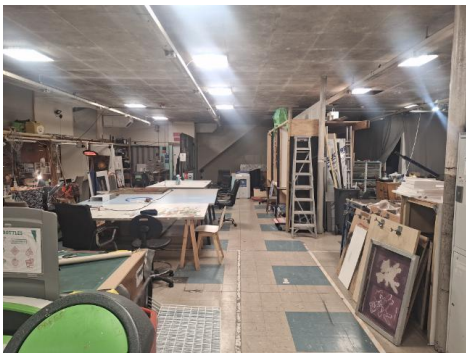
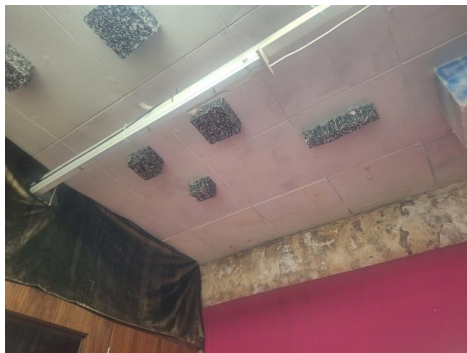
Building:	The Margate School	Floor	Ground Floor		
Location ID	049	Location	Soundroom Lobby		
Sample Number	X002	Extent	18 m <sup>2</sup>		
Item / Position	Ceiling Tiles including above soundroom	Material	Insulating Board		
Product Type	Asbestos insulating board, millboards, gaskets & ropes etc.	Scores	2		
Condition	Medium Damage		2		
Surface Treatment	Partially Unsealed		2		
Asbestos Type	<b>Amosite, Chrysotile</b>		2		
Material Assessment	Medium		8		
Substrate	Nailed to timber above.	Accessibility	High		
Main Photo		Close Up Photo

Recommendation	<b>Remove - Licensed Material Removal by a licensed asbestos contractor. This material is licensed therefore is subject to a 14 notification to the HSE prior to removal works taking place. All works must conform to the Control of Asbestos Regulations 2012.</b>				
Comments	Internal door and frame made of timber. Partition wall to sound room made of timber. Nailed to timber above.

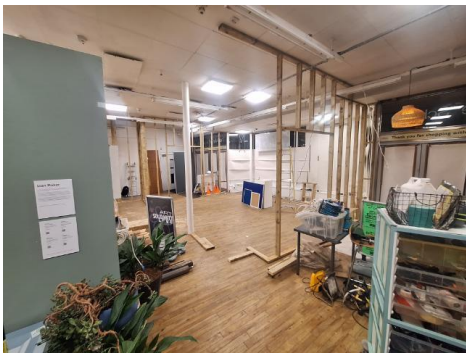
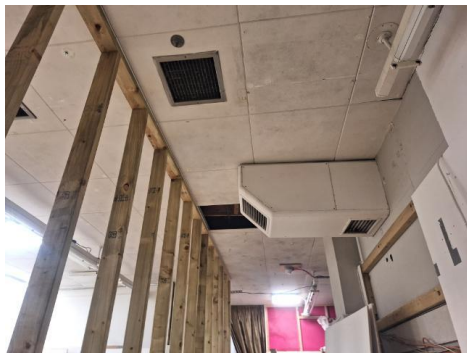
Building:	The Margate School	Floor	Ground Floor		
Location ID	050	Location	Front of house		
Sample Number	X002	Extent	180 m <sup>2</sup>		
Item / Position	Ceiling Tiles	Material	Insulating Board		
Product Type	Asbestos insulating board, millboards, gaskets & ropes etc.	Scores	2		
Condition	Medium Damage		2		
Surface Treatment	Partially Unsealed		2		
Asbestos Type	<b>Amosite, Chrysotile</b>		2		
Material Assessment	Medium		8		
Substrate	Nailed to timber above.	Accessibility	High		
Main Photo		Close Up Photo

Recommendation	<b>Remove - Licensed Material Removal by a licensed asbestos contractor. This material is licensed therefore is subject to a 14 notification to the HSE prior to removal works taking place. All works must conform to the Control of Asbestos Regulations 2012.</b>				
Comments	Internal door and frame made of timber. Ventilation ductwork made of metal penetrating plasterboard wall and ceiling tiles. Bulkhead at front of area made of timber. External windows to front made of metal. Boxing behind bar timber with modern electrical units within. Windows to side made of timber. Nailed to timber above.

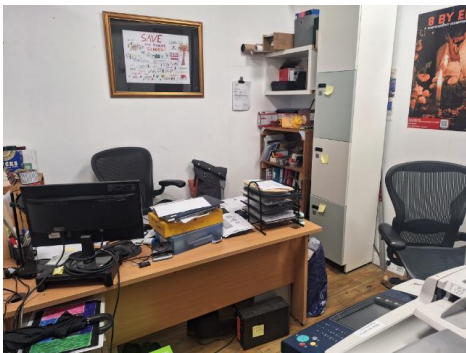
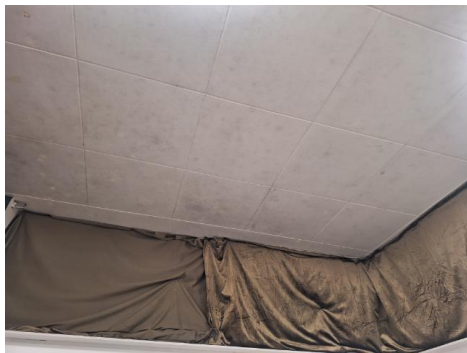
Building:	The Margate School	Floor	Ground Floor		
Location ID	051	Location	Mayor's Staff Office		
Sample Number	X002	Extent	9 m <sup>2</sup>		
Item / Position	Ceiling Tiles	Material	Insulating Board		
Product Type	Asbestos insulating board, millboards, gaskets & ropes etc.	Scores	2		
Condition	Medium Damage		2		
Surface Treatment	Partially Unsealed		2		
Asbestos Type	Amosite, Chrysotile		2		
Material Assessment	Medium		8		
Substrate	Nailed to timber above.	Accessibility	High		
Main Photo		Close Up Photo

Recommendation	Remove - Licensed Material Removal by a licensed asbestos contractor. This material is licensed therefore is subject to a 14 notification to the HSE prior to removal works taking place. All works must conform to the Control of Asbestos Regulations 2012.				
Comments	Internal door and frame made of timber. Internal window frames made of timber. Nailed to timber above.

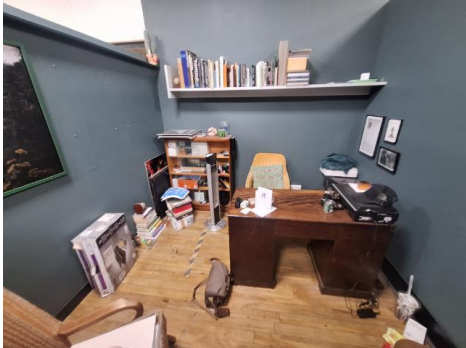
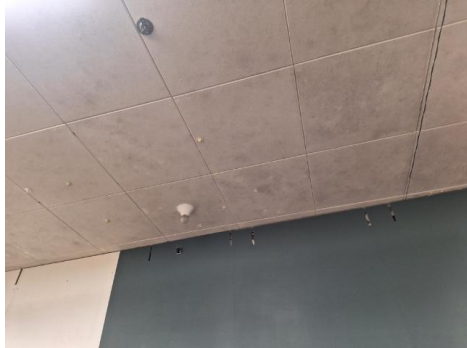
Building:	The Margate School	Floor	Ground Floor		
Location ID	052	Location	Office		
Sample Number	X002	Extent	9 m <sup>2</sup>		
Item / Position	Ceiling Tiles	Material	Insulating Board		
Product Type	Asbestos insulating board, millboards, gaskets & ropes etc.	Scores	2		
Condition	Medium Damage		2		
Surface Treatment	Partially Unsealed		2		
Asbestos Type	<b>Amosite, Chrysotile</b>		2		
Material Assessment	Medium		8		
Substrate	Nailed to timber above.	Accessibility	High		
Main Photo		Close Up Photo

Recommendation	<b>Remove - Licensed Material Removal by a licensed asbestos contractor. This material is licensed therefore is subject to a 14 notification to the HSE prior to removal works taking place. All works must conform to the Control of Asbestos Regulations 2012.</b>				
Comments	Internal door and frame made of timber. Internal window frames made of timber. Nailed to timber above.

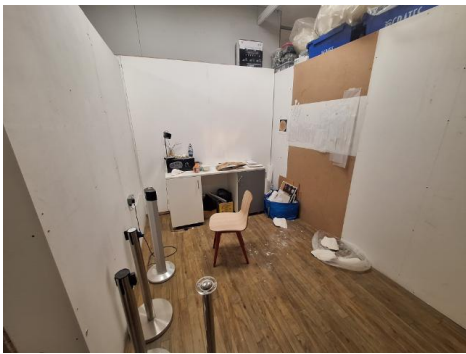
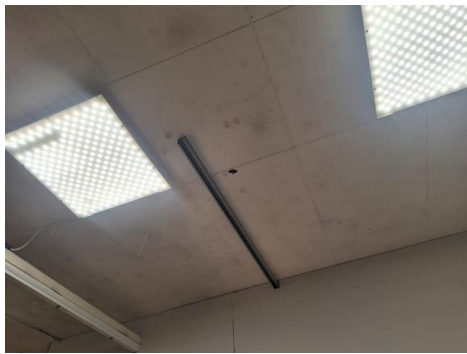
Building:	The Margate School	Floor	Ground Floor		
Location ID	057	Location	Workspace		
Sample Number	X002	Extent	9 m <sup>2</sup>		
Item / Position	Ceiling Tiles	Material	Insulating Board		
Product Type	Asbestos insulating board, millboards, gaskets & ropes etc.	Scores	2		
Condition	Medium Damage		2		
Surface Treatment	Partially Unsealed		2		
Asbestos Type	<b>Amosite, Chrysotile</b>		2		
Material Assessment	Medium		8		
Substrate	Nailed to timber above.	Accessibility	High		
Main Photo		Close Up Photo

Recommendation	<b>Remove - Licensed Material Removal by a licensed asbestos contractor. This material is licensed therefore is subject to a 14 notification to the HSE prior to removal works taking place. All works must conform to the Control of Asbestos Regulations 2012.</b>				
Comments	Internal door and frame made of timber. Nailed to timber above.

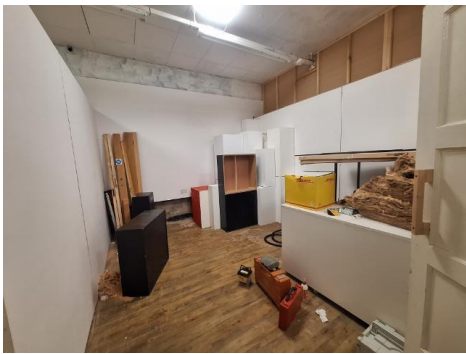
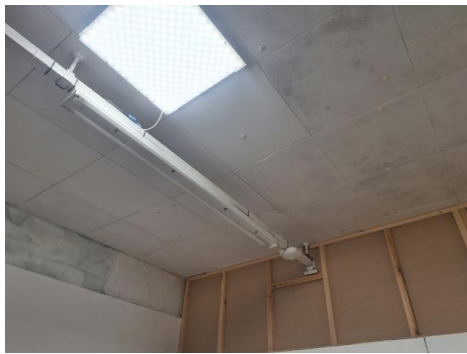
Building:	The Margate School	Floor	Ground Floor		
Location ID	058	Location	Workspace		
Sample Number	X002	Extent	9 m <sup>2</sup>		
Item / Position	Ceiling Tiles	Material	Insulating Board		
Product Type	Asbestos insulating board, millboards, gaskets & ropes etc.	Scores	2		
Condition	Medium Damage		2		
Surface Treatment	Partially Unsealed		2		
Asbestos Type	<b>Amosite, Chrysotile</b>		2		
Material Assessment	Medium		8		
Substrate	Nailed to timber above.	Accessibility	High		
Main Photo		Close Up Photo

Recommendation	<b>Remove - Licensed Material Removal by a licensed asbestos contractor. This material is licensed therefore is subject to a 14 notification to the HSE prior to removal works taking place. All works must conform to the Control of Asbestos Regulations 2012.</b>				
Comments	Internal door and frame made of timber. Nailed to timber above.

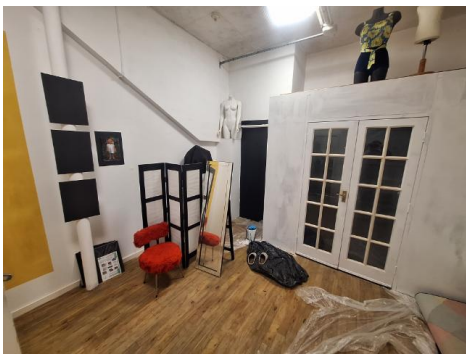
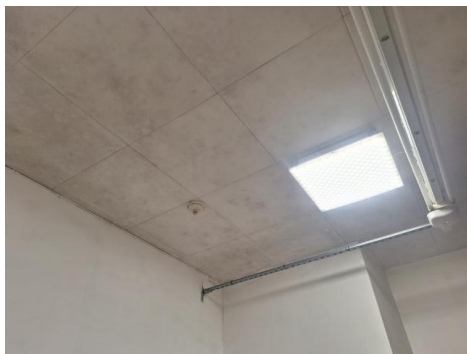
Building:	The Margate School	Floor	Ground Floor		
Location ID	059	Location	Office		
Sample Number	X002	Extent	16 m <sup>2</sup>		
Item / Position	Ceiling Tiles	Material	Insulating Board		
Product Type	Asbestos insulating board, millboards, gaskets & ropes etc.	Scores	2		
Condition	Medium Damage		2		
Surface Treatment	Partially Unsealed		2		
Asbestos Type	<b>Amosite, Chrysotile</b>		2		
Material Assessment	Medium		8		
Substrate	Nailed to timber above.	Accessibility	High		
Main Photo		Close Up Photo

Recommendation	<b>Remove - Licensed Material Removal by a licensed asbestos contractor. This material is licensed therefore is subject to a 14 notification to the HSE prior to removal works taking place. All works must conform to the Control of Asbestos Regulations 2012.</b>				
Comments	Internal door and frame made of timber. Internal window frames made of timber Ventilation ductwork penetrating wall made of metal . Panel to side of stairwell made of plasterboard. Nailed to timber above.

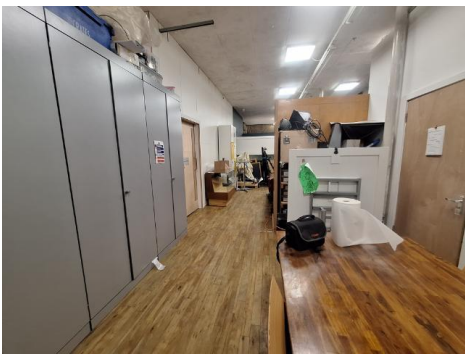
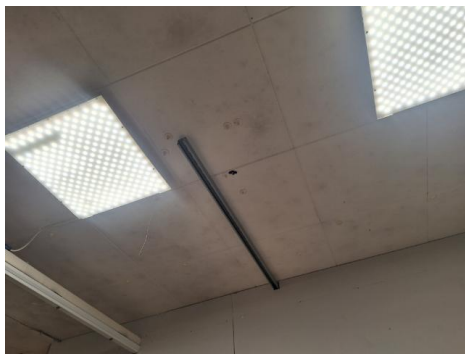
Building:	The Margate School	Floor	Ground Floor		
Location ID	061	Location	Circulation		
Sample Number	X002	Extent	100 m <sup>2</sup>		
Item / Position	Ceiling Tiles	Material	Insulating Board		
Product Type	Asbestos insulating board, millboards, gaskets & ropes etc.	Scores	2		
Condition	Medium Damage		2		
Surface Treatment	Partially Unsealed		2		
Asbestos Type	<b>Amosite, Chrysotile</b>		2		
Material Assessment	Medium		8		
Substrate	Nailed to timber above.	Accessibility	High		
Main Photo		Close Up Photo

Recommendation	<b>Remove - Licensed Material Removal by a licensed asbestos contractor. This material is licensed therefore is subject to a 14 notification to the HSE prior to removal works taking place. All works must conform to the Control of Asbestos Regulations 2012.</b>				
Comments	Internal door and frame made of timber. Understairs made of plastered concrete. Ventilation ductwork made of metal. Partition wall made of plasterboard. Nailed to timber above.

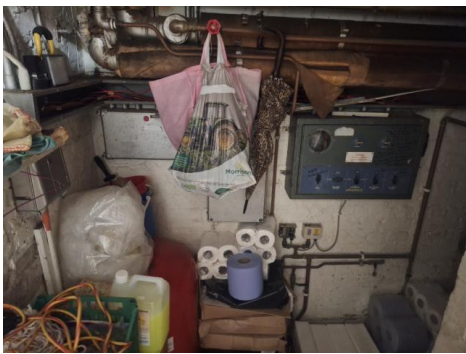
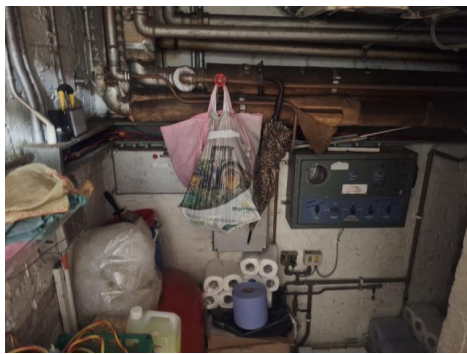
Building:	The Margate School	Floor	Ground Floor		
Location ID	062	Location	Understair store		
Sample Number	P	Extent	2 no		
Item / Position	Electrical units	Material	Woven Product		
Product Type	Asbestos insulating board, millboards, gaskets & ropes etc.	Scores	2		
Condition	Low Damage		1		
Surface Treatment	Sealed		1		
Asbestos Type	<b>Presumed Chrysotile</b>		1		
Material Assessment	Low		5		
Substrate	Unable to inspect due to live service supply	Accessibility	Low		
Main Photo		Close Up Photo

Recommendation	<b>Inaccessible Items / Strongly Presumed Inaccessible item. Isolation, access and sampling will be required prior to any works which may disturb the presumed item.</b>				
Comments	Unable to inspect due to live service supply

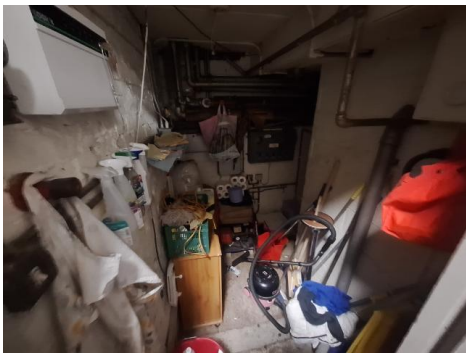
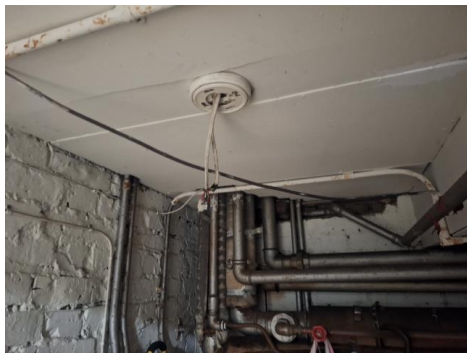
Building:	The Margate School	Floor	Ground Floor		
Location ID	062	Location	Understair store		
Sample Number	S012	Extent	3 m <sup>2</sup>		
Item / Position	Ceiling panel	Material	Insulating Board		
Product Type	Asbestos insulating board, millboards, gaskets & ropes etc.	Scores	2		
Condition	Low Damage		1		
Surface Treatment	Partially Unsealed		2		
Asbestos Type	<b>Amosite</b>		2		
Material Assessment	Medium		7		
Substrate	Screwed to timber	Accessibility	High		
Main Photo		Close Up Photo

Recommendation	<b>Remove - Licensed Material Removal by a licensed asbestos contractor. This material is licensed therefore is subject to a 14 notification to the HSE prior to removal works taking place. All works must conform to the Control of Asbestos Regulations 2012.</b>				
Comments	Internal door and frame made of timber. Pipework metal with cloth wrapped man made mineral fibre insulation. Screwed to timber

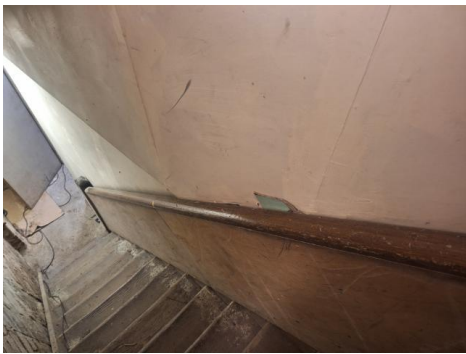
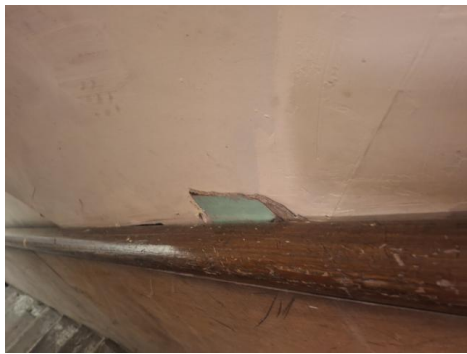
Building:	The Margate School	Floor	Ground Floor		
Location ID	063	Location	Basement Stairwell		
Sample Number	S015	Extent	1 m <sup>2</sup>		
Item / Position	Loose cement Debris sandwich between banister and wall	Material	Cement Product		
Product Type	Asbestos reinforced composites etc.	Scores	1		
Condition	Low Damage		1		
Surface Treatment	Sealed		1		
Asbestos Type	<b>Chrysotile</b>		1		
Material Assessment	Very Low		4		
Substrate	Loose debris piece	Accessibility	High		
Main Photo		Close Up Photo

Recommendation	<b>Remove - NON-Licensed Material Removal by an asbestos contractor. This material is not licensed however may still be notifiable to the HSE prior to removal works taking place. All works must conform to the Control of Asbestos Regulations 2012.</b>				
Comments	Internal door and frame made of timber. Loose debris piece

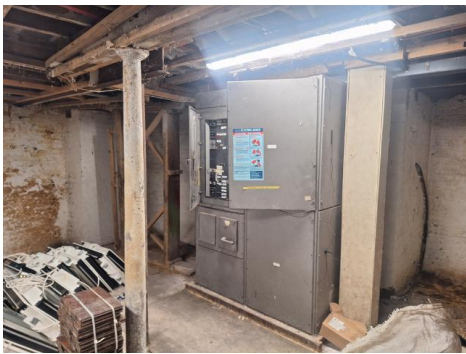
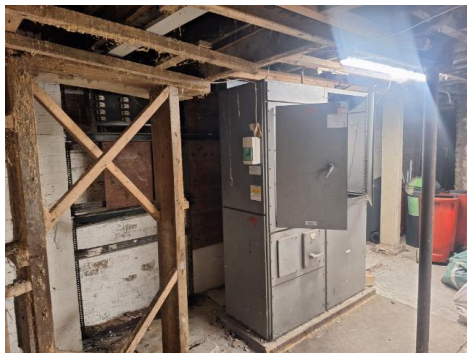
Building:	The Margate School	Floor	Basement		
Location ID	072	Location	Basement Intake Room		
Sample Number	P	Extent	3 no		
Item / Position	Electrical units	Material	Woven Product		
Product Type	Asbestos insulating board, millboards, gaskets & ropes etc.	Scores	2		
Condition	Low Damage		1		
Surface Treatment	Sealed		1		
Asbestos Type	<b>Presumed Chrysotile</b>		1		
Material Assessment	Low		5		
Substrate	Unable to open due to live service supply	Accessibility	Low		
Main Photo		Close Up Photo

Recommendation	<b>Inaccessible Items / Strongly Presumed Inaccessible item. Isolation, access and sampling will be required prior to any works which may disturb the presumed item.</b>				
Comments	Unable to open due to live service supply
