**External Repairs and  
Redecoration Works**

**The Margate School  
31-33 High Street  
Margate  
CT9 1DX**

**The Margate  
School**

Our Ref: 2324/102434  
April 2024

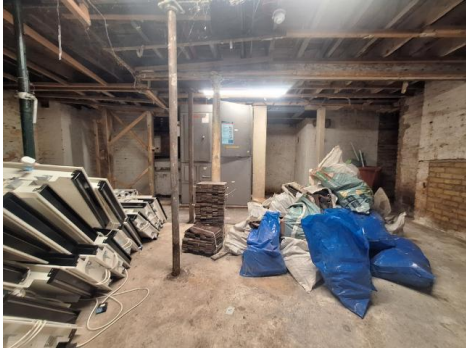
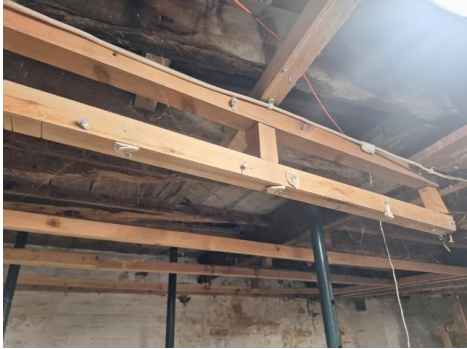
Building:	The Margate School	Floor	Basement		
Location ID	072	Location	Basement Intake Room		
Sample Number	S013	Extent	4 m <sup>2</sup>		
Item / Position	Panel debris to nailheads on timber frame.	Material	Insulating Board		
Product Type		Scores	-		
Condition			-		
Surface Treatment			-		
Asbestos Type	No asbestos detected		-		
Material Assessment	N/A				
Substrate	Nailed to timber	Accessibility	-		
Main Photo		Close Up Photo

Recommendation	No action required				
Comments	Boxing to column made of plasterboard. Nailed to timber

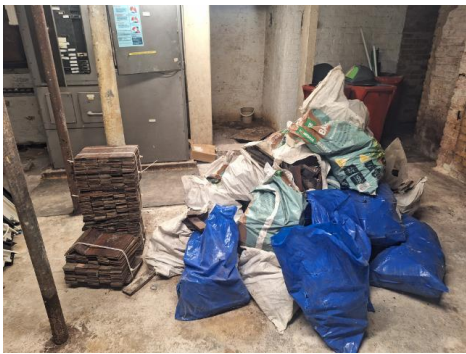
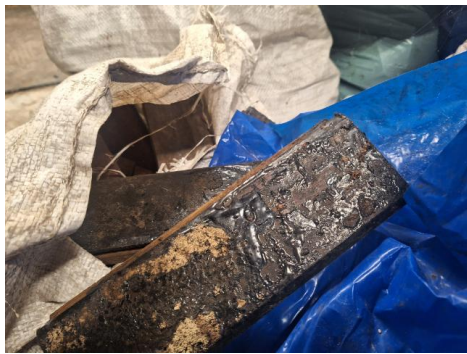
Building:	The Margate School	Floor	Basement		
Location ID	072	Location	Basement Intake Room		
Sample Number	S014	Extent	3 m <sup>3</sup>		
Item / Position	Bitumen to underside of redundant parquet flooring	Material	Bituminous Product		
Product Type		Scores	-		
Condition			-		
Surface Treatment			-		
Asbestos Type	No asbestos detected		-		
Material Assessment	N/A				
Substrate	Attached to timber	Accessibility	-		
Main Photo		Close Up Photo

Recommendation	No action required				
Comments	Attached to timber
