Client:	Corby Borough Council	Lead Surveyor:	Dan Stokes
	10 Fleming Road	Assistant Surveyor(s):	Stuart Guyatt
	Earlstreet Industrial Estate	Date of Survey:	18 March 2014
	Corby	Report Reference:	SY.14.03.207
	Northamptonshire	Date of Report:	30 April 2014
	NN17 4SW	Purpose of Survey:	Management
			Refurbishment
			Demolition
			Re-inspection
			Restricted Access
			Throughout
			Not Requested
			Not Requested
			Not Requested
			Refer to Section 1.2.2

**Report on Survey of Asbestos Materials
at**

**Kingswood Community Centre, Alberta Close
Corby, Northamptonshire
NN18 9HU**

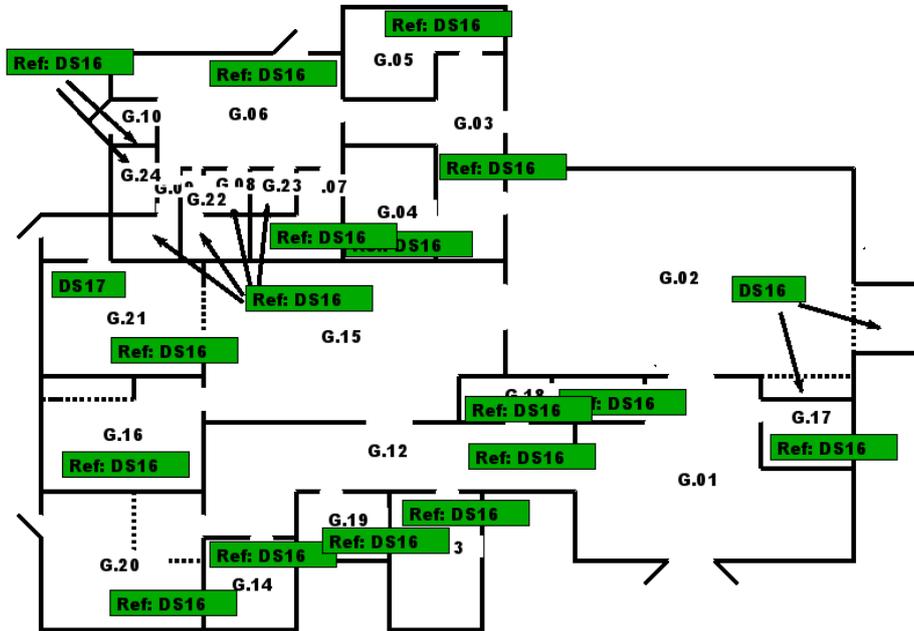
7.2 Plans (Not to Scale)

No visible suspect asbestos containing materials were identified during survey on this occasion.
