Request for Quotation

Stoney Stanton Village Hall Floor & Ventilation Requirements

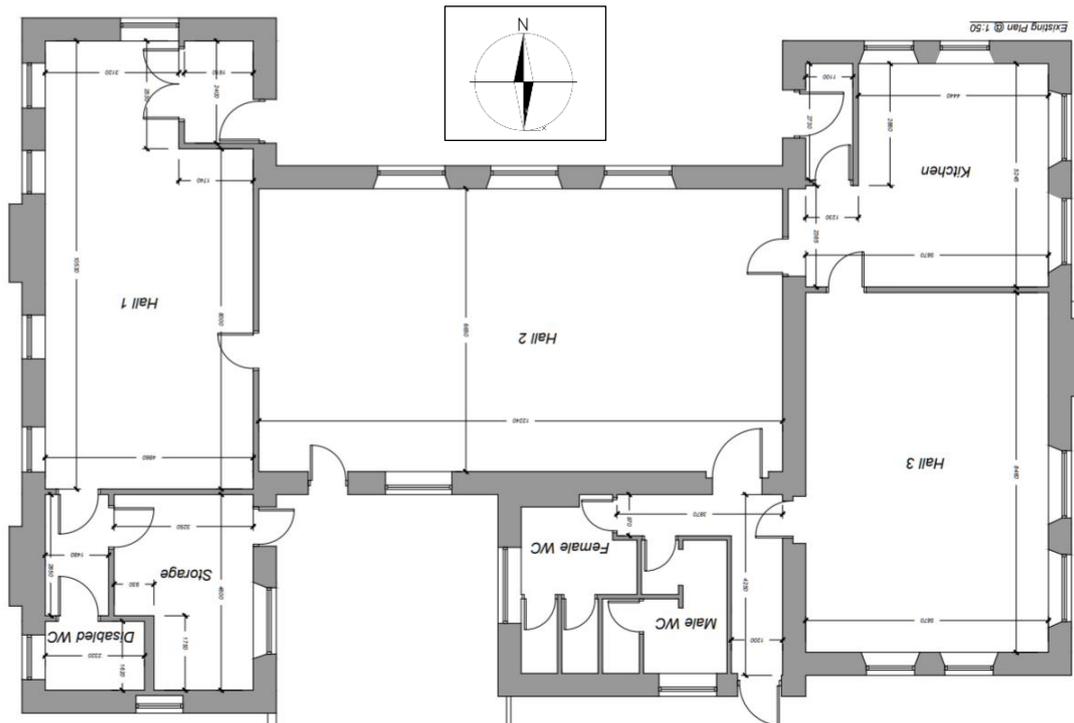
The building is laid out as per the drawing below into different areas described post the drawing:

Fig 1. Stoney Stanton Village Hall Layout 1:50 scale

There are key areas of the existing floor structure that have completely failed and need immediate repair to ensure the longevity of the hall as an asset for the village to use going forwards. The floors are split into the 3 areas that are identified on the drawing above as hall 1, 2 & 3 as well as a small lobby leading to the disabled WC.
