LOCATION:  
M5 J25-24 NB MP 201.7-196.6  
DRAWING No:  
583 Defect Treatment Plan Sheet 1 of 6  
DRAWN: FS DATE: 22/06/2020  
DESIGN: FS DATE: 22/06/2020  
CHECKED: CC DATE: 25/06/2020

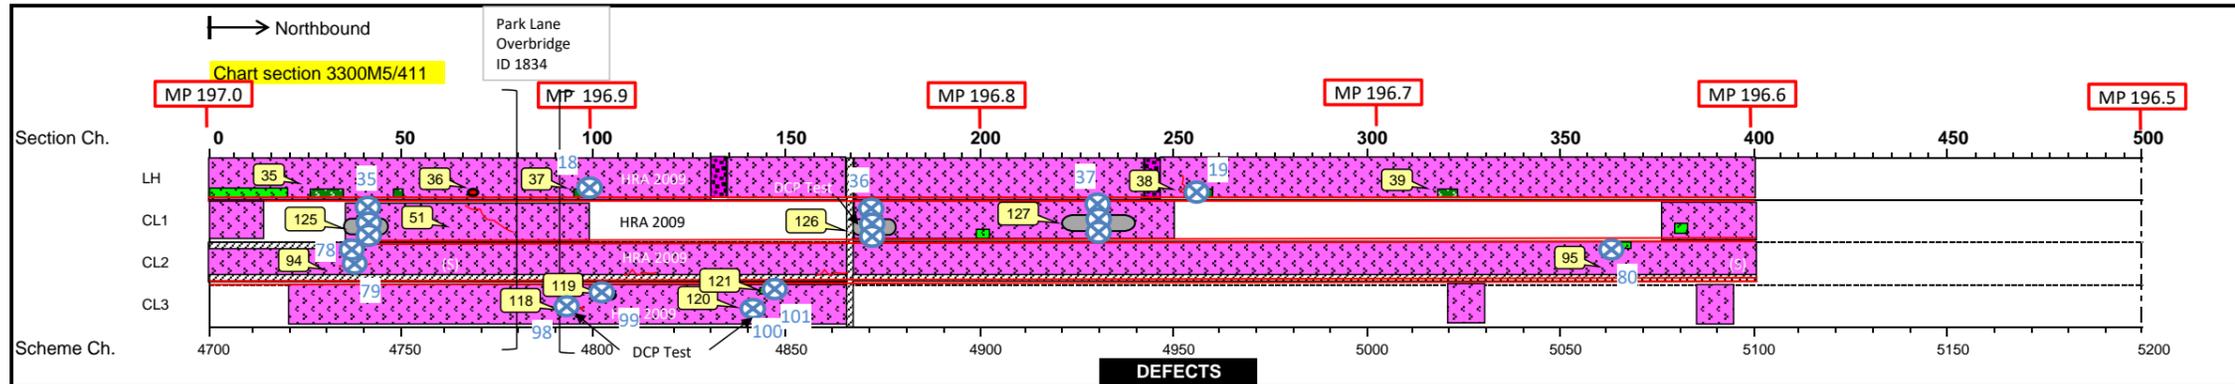
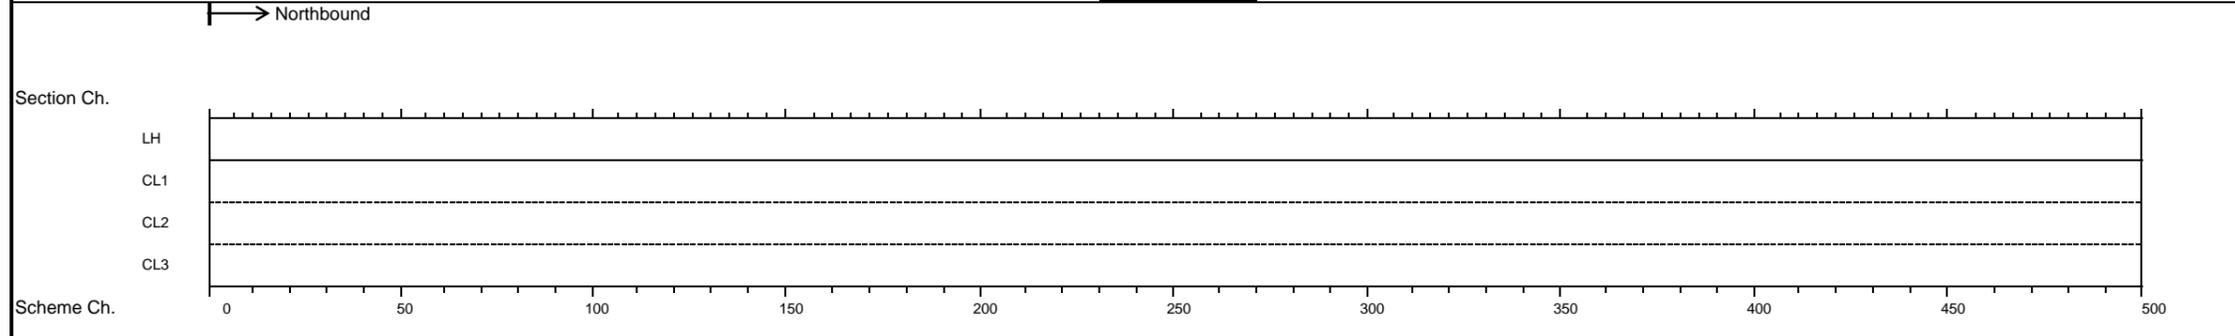
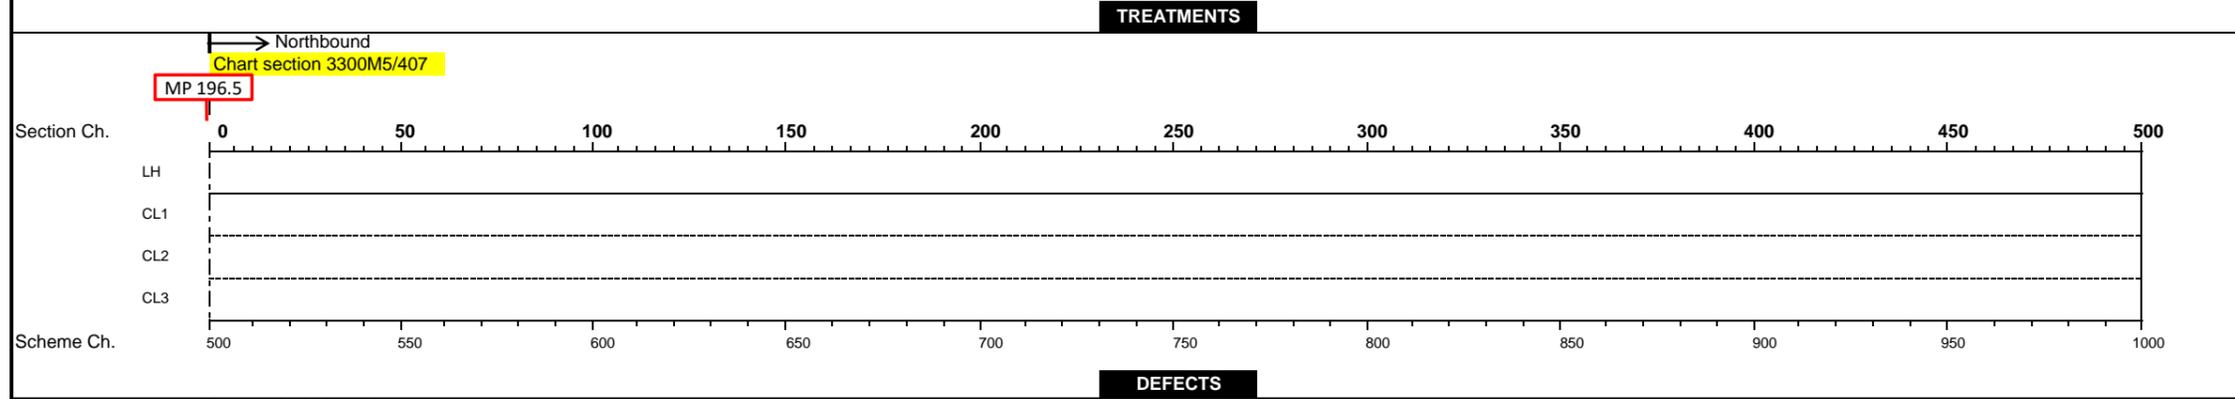
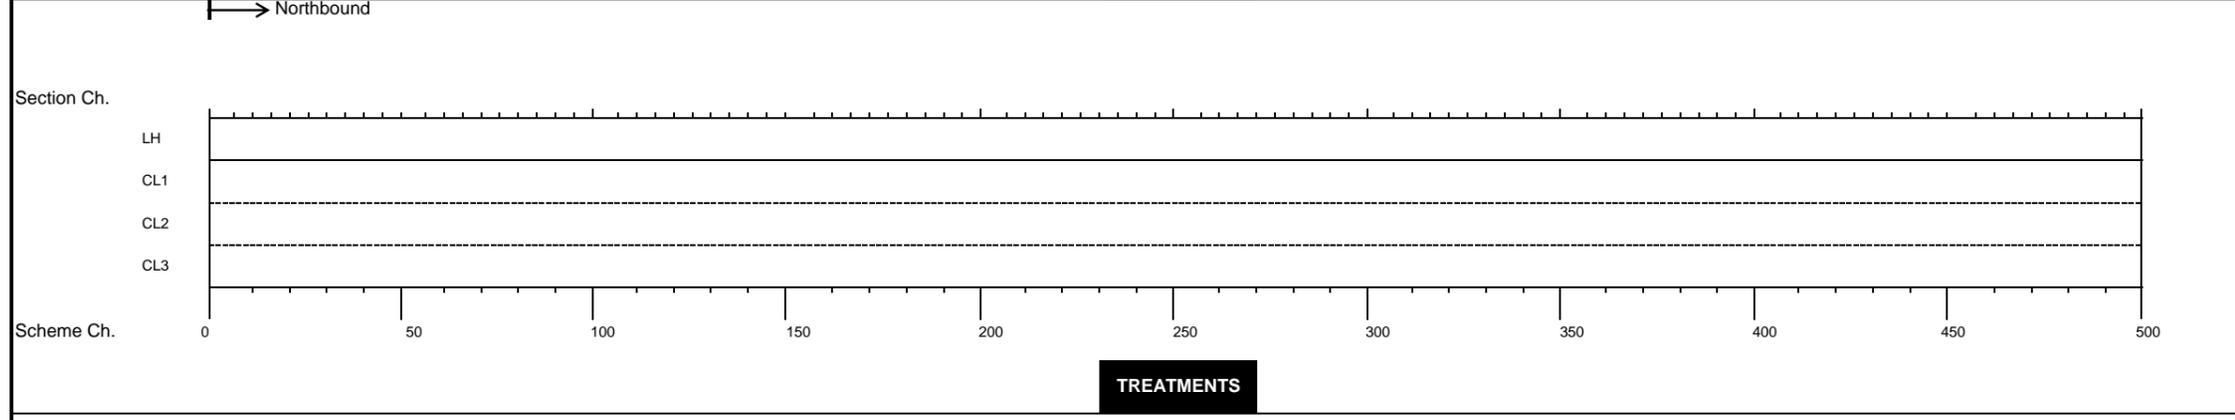
- 50mm inlay TSCS (Do Min)
- Fill and overbanding repair system for crack exceeding 5mm but not exceeding 10mm wide (Do Min)
- Deep repair/ inlay (Do Something)
