Management Asbestos Survey

Survey Reference Number: X-02177

1 Branksea Close
Isles of Scilly
TR21 0ND

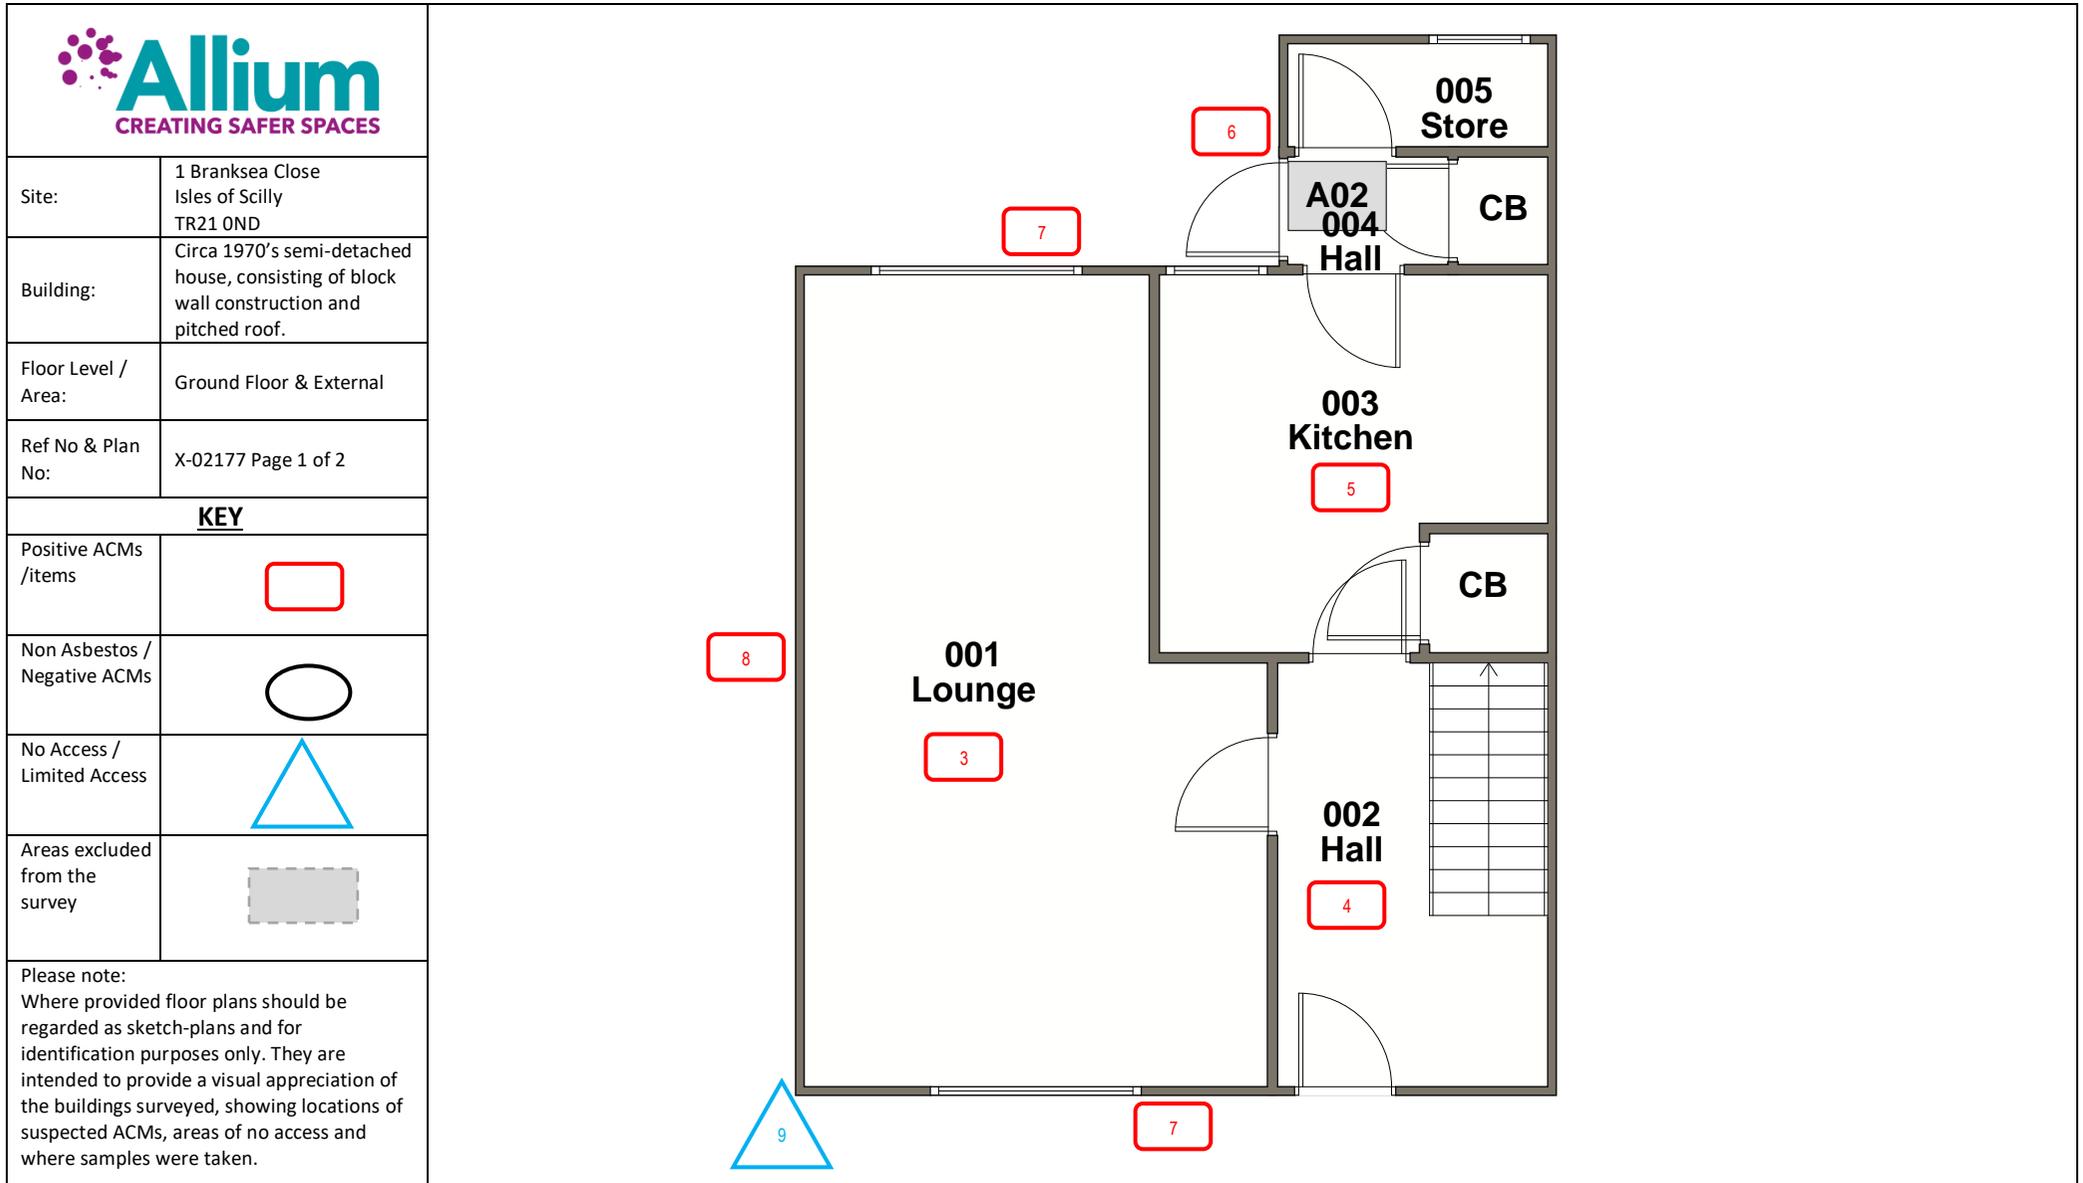
• THIS PLAN SHOULD BE READ IN CONJUNCTION WITH THE MAIN BODY OF THE REPORT AND INDIVIDUAL ITEM RECORDS

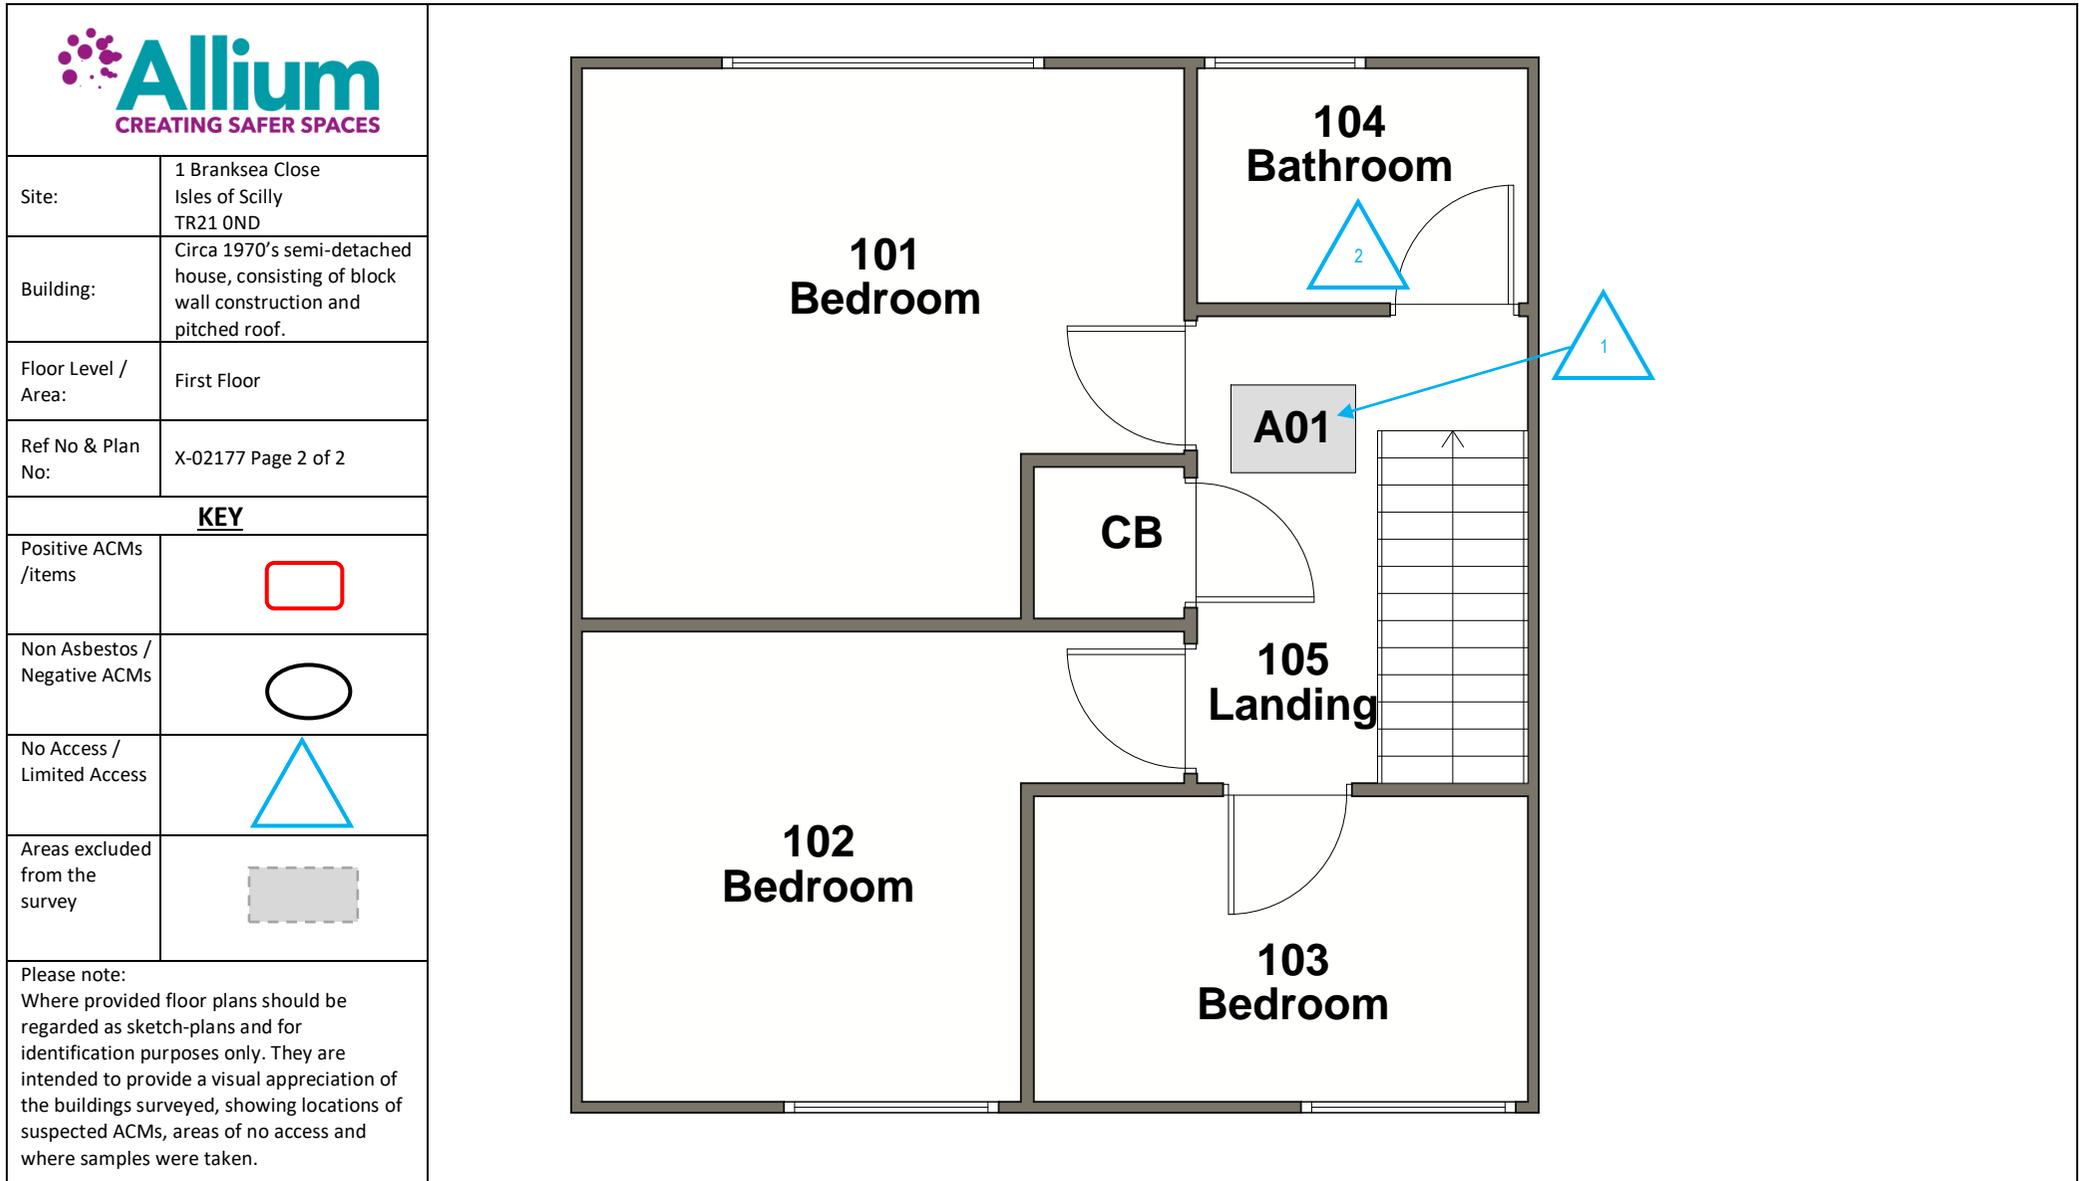
• THIS PLAN SHOULD BE READ IN CONJUNCTION WITH THE MAIN BODY OF THE REPORT AND INDIVIDUAL ITEM RECORDS
