BRITTEN PEARS ARTS

**Concert Hall Works
RIBA 3 Report
Capital Works Program
February 2025**

**de
matos
ryan**

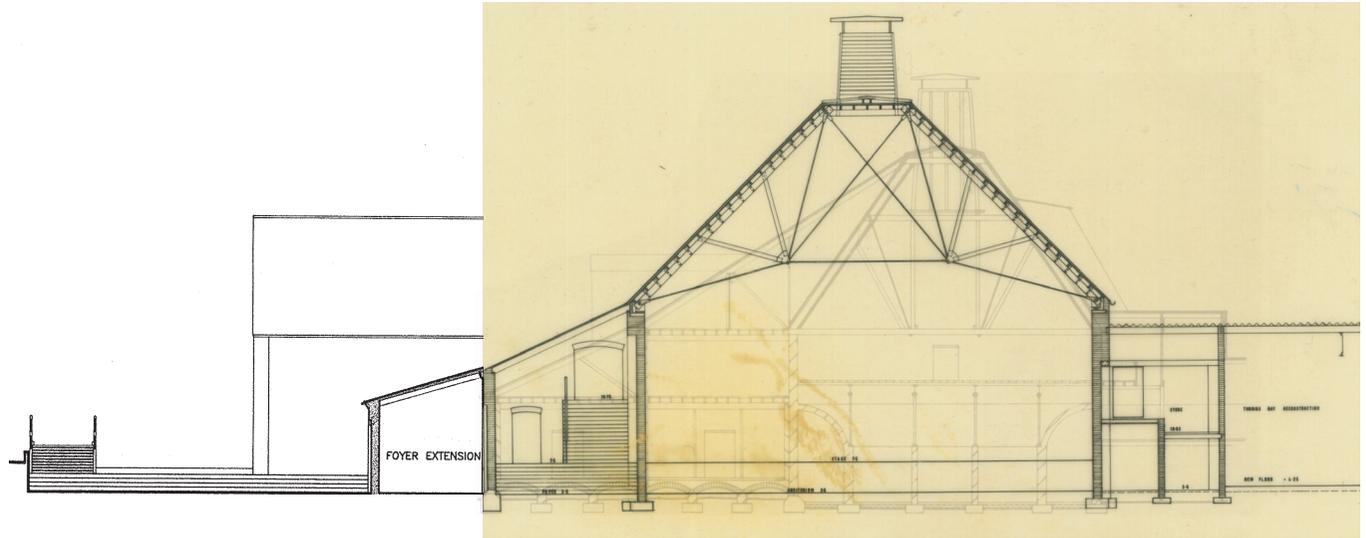
1997-1999 Works (left hand area)
Extension to the Foyer, River View cafe, and redevelopment of the Southern back of house areas. New rigging to the hall

1967/69 Concert Hall (main drawing)
The works demolished the internal walls, retaining outer walls, which were raised to found the new taller roof structure onto.

Pre 1967 (ghosted overlay)
The original malting building was lower and its roof landed on walls that were removed to deliver the width of the Concert Hall

The Concert Hall buildings have changed significantly since their original design as a maltings function. The most notable change in external form when the Concert Hall works were undertaken by ARUP in the mid 1960s was to demolish key internal walls, and to widen the span of the roof so the new roof structure and final hall width was wider. The roof therefore grew in height, along with the brickwork walls that supported it.

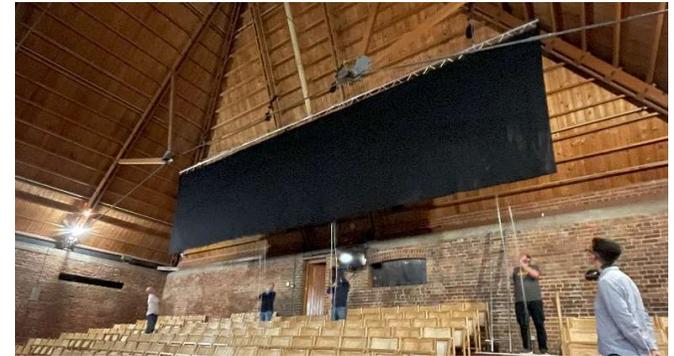
Existing rear drape hung from new truss to rear of the hall

The ability of hanging drapes on the stage side wall, which is an existing approach BPA already take, is also considered to be part of the overall approach, which helps to control the acoustic on stage during amplified music concerts.

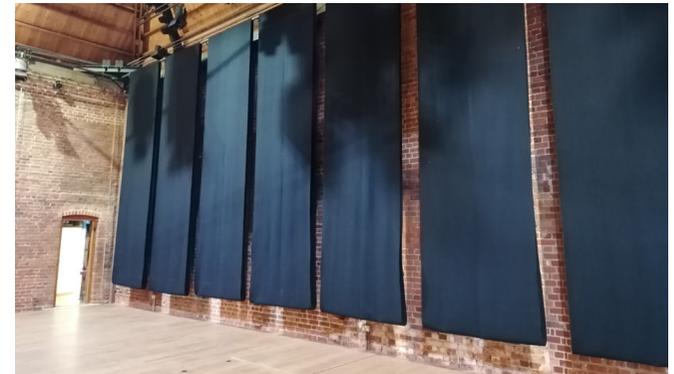
Typical looped material with velcro tabs hung over scaffold bar to stage area to manage local volume and reflections

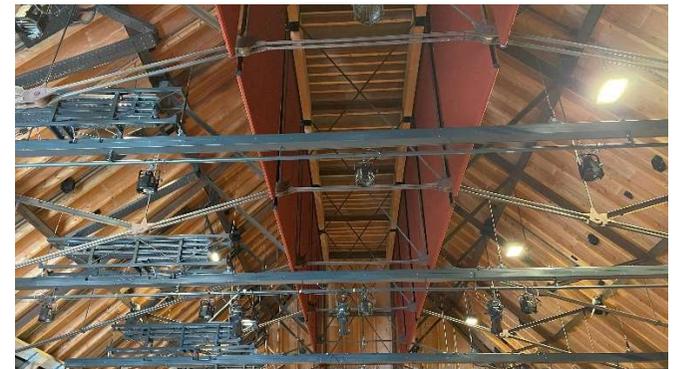
Hoffmann Building banner boxes with banners deployed, which is a similar approach suggested to the bluffs in the Concert Hall

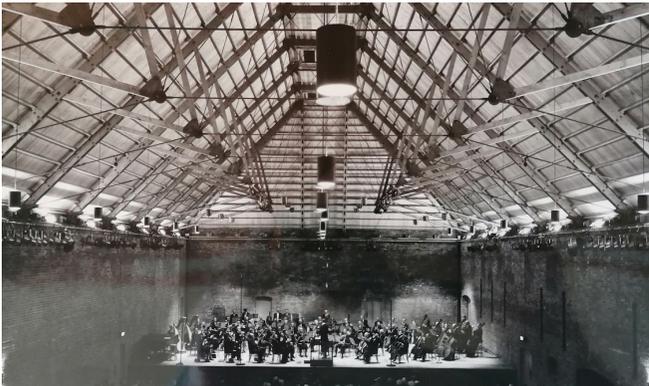
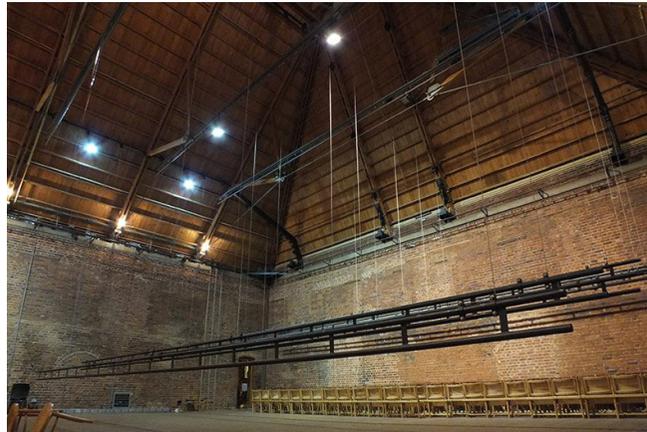
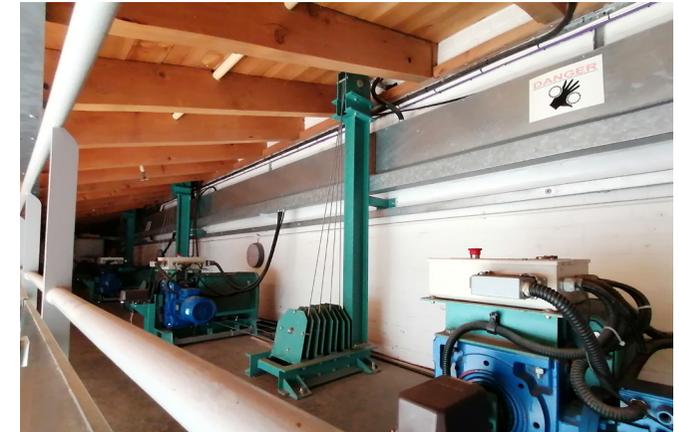
Clockwise from top left : Ladder bars dropped to stage level via winches. Winch gallery stage left. Over stage arrangement of flip flops and intermediate bars

The roof structure in this area is already at capacity with the level of rigging that has been installed over the stage. Load monitors can be added to the rigging at each connection point, but they are loose pieces of equipment and do not form part of the scope at present. Instead BPA will maintain their system of closely monitoring the loads being installed to the rig by touring companies and manually calculating the weights for each bar.

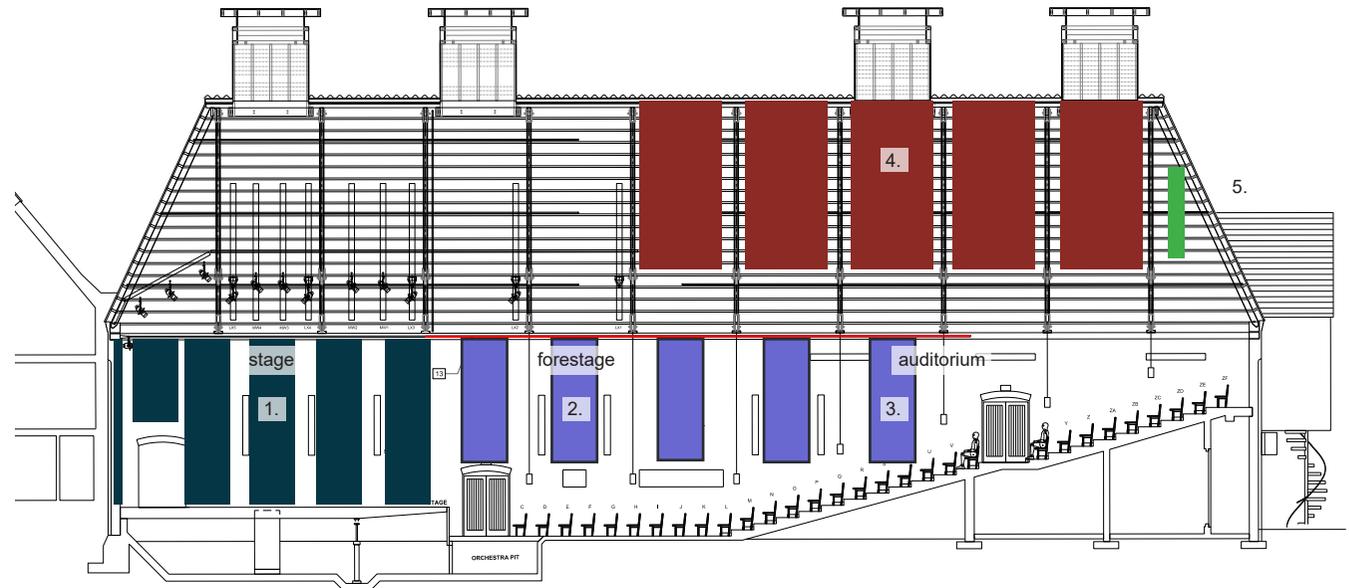
Section showing potential areas for acoustic treatments being considered, and setting out to ensure clearance to the venting air slots in brickwork.

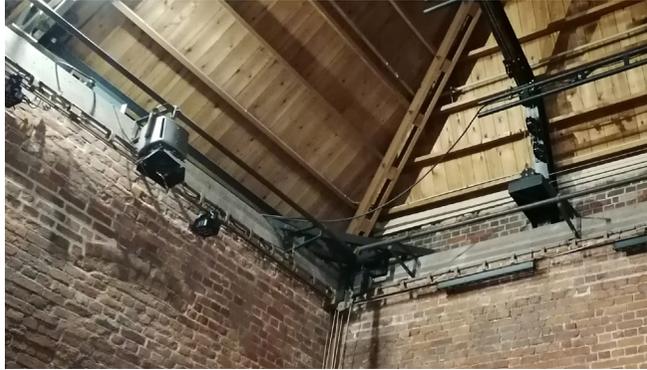
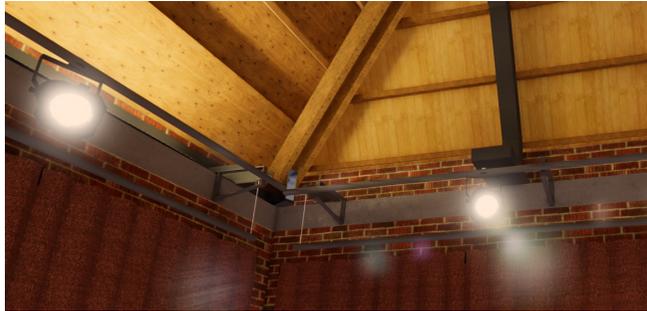
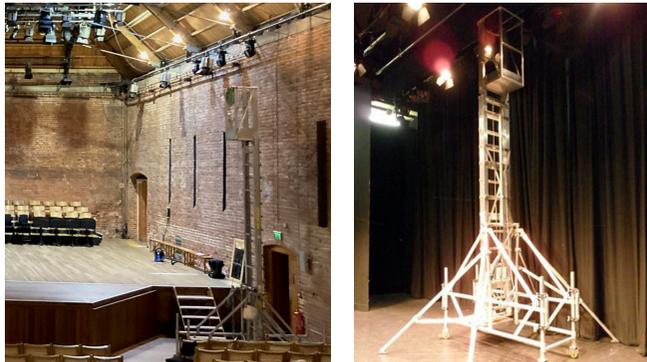
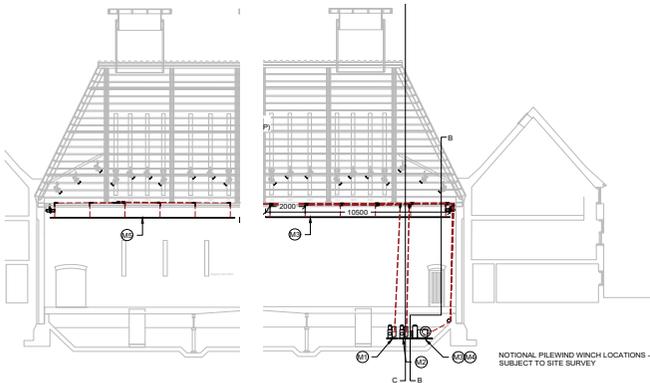
Charcoal Blue technical sections showing the arrangement on stage left and right for the winched bars. Stage right will run to the sub stage via exposed wireways, as per the existing rigging arrangement

Top; Photo of existing tab track and scaff bar at stage right and rear stage
Middle : Visual of new proposal with fixed scaff bar retained, but new winched bars added.
Bottom : photos of tallescope

Around the stage, there is a fixed perimeter rigging bar (which is original). Rigging drapes or lighting equipment on this bar requires access at high level (usually by tallescope) and for the equipment to be manually hauled up to high level. This is a time-consuming operation and can only be undertaken when the stage is clear: access is impossible when scenery is built onstage or an orchestra is set up.

This operation would be much more efficient if the fixed bars could be lowered to the stage for rigging. Access at high level would still be needed for focus of non-automated lighting fixtures, but manual handling at high level would be eliminated. Rather than a single bar like the existing one, ladder bars are proposed: these allow a greater distance between suspension points (reducing the overall quantity of steel wire ropes which must be diverted to the winches - locations tbc) and also allow for drapes and lighting equipment to be rigged in the same area.

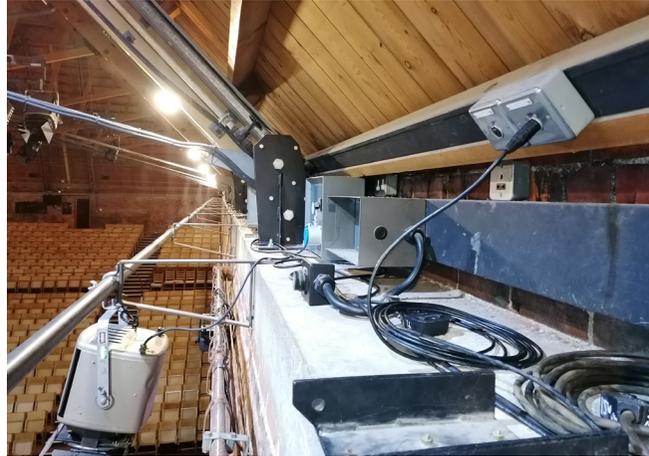
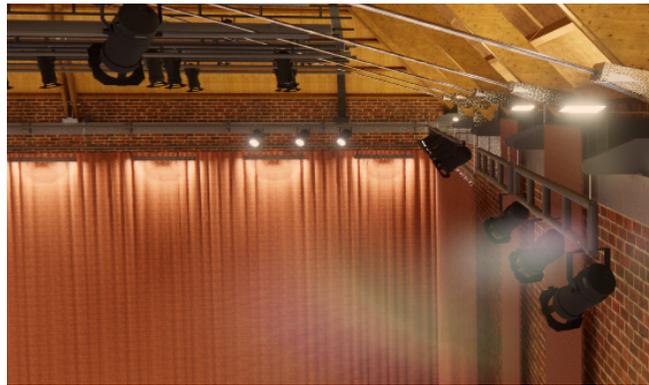
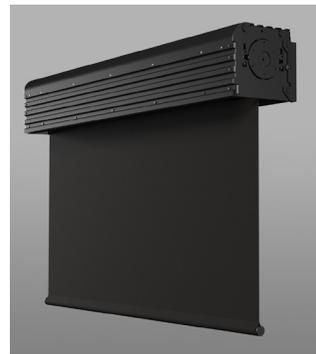
Top: Photo of existing ring beam arrangement with electrical containment run to the wall at the back, and data containment on the purlin above.
 Middle : Visual of new proposal with fixed scaff bar removed and new winched ladder bars and banner boxes.
 Bottom : example of standard banner box system.

Winched ladder bars are also proposed either side of the forestage. Here we propose to investigate the provision of motorised acoustic banners: when not in use, this would appear as a box mounted to the top of the concrete ring beam; when in use, a wide fabric banner would be deployed from the box (possibly around a divert runner) and sit approx 150mm away from the side walls of the Hall, lowered as far as necessary to achieve the required level of absorption. The ladder bars would sit further into the room than the banners, such that the back end of lighting fixtures are clear of the fabric.

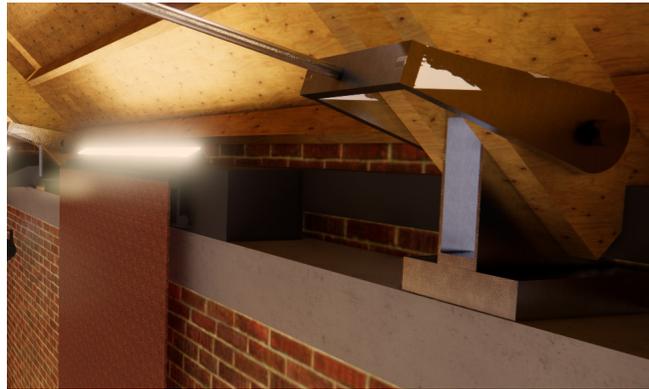
Top: Photo of existing ring beam arrangement, same as forestage.
 Middle: Visual of new proposal with fixed scaffold bar removed and new banner boxes.
 Bottom: example of standard banner box system.

Further back around the auditorium there is less need to rig technical equipment (the lighting angles are unsuitable to light the stage, for example) but deploying acoustic banners against these walls is expected to be highly effective in reducing the reverberation time. So we propose to introduce an acoustic banner in each bay between roof trusses

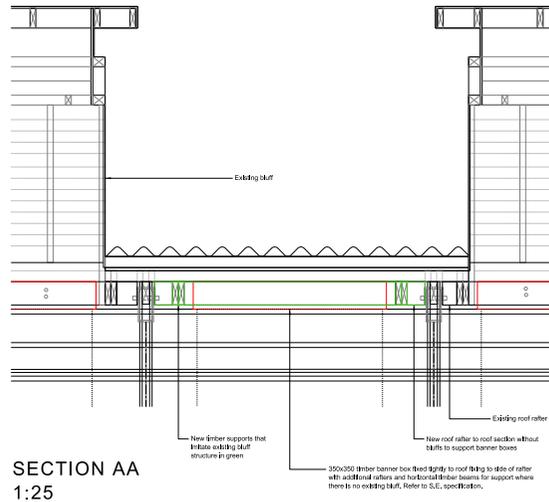
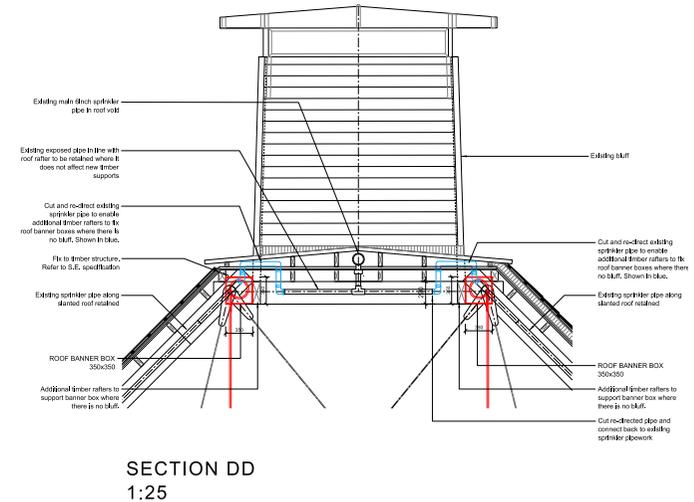
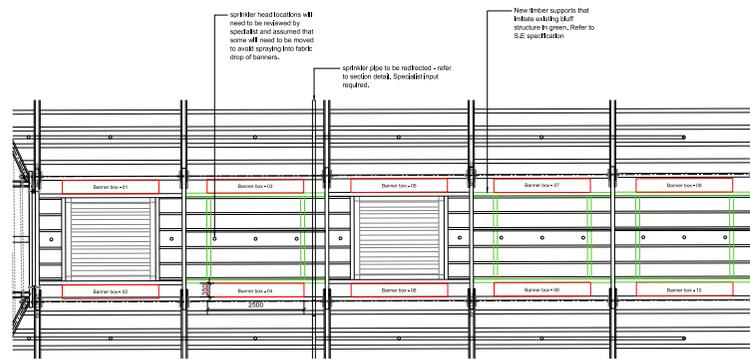
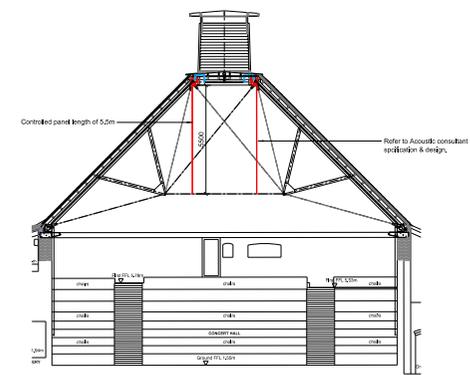
Image of existing Banner boxes mounted to the roof of the Britten Studio in the Hoffmann Building, with timber finish box enclosure to blend in with the roof soffit. A similar approach is intended for the Concert Hall installation.

Further to this, in bay no 2, the sprinkler system drops into the room from its high level primary feed route and branches down the pitch of the roof to feed the rear of the room. This pipe will clash with the new timber which supports the banner box, and so we intend to re-route this pipe up into the roof structure zone above, and then back down into the room to reconnect to the existing pipe run down the pitched roof soffit. This avoids the need to drop the new structural timbers down below the existing structural zone.

It is suggested that the banner boxes are linked to the fire alarm system so they will retract on a fire event detection to avoid the sprinkler heads in this location firing onto the banner material instead of down onto the concert hall floor area below.

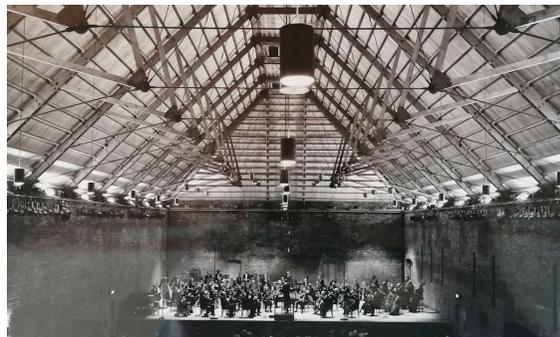
Original wall fixtures are still in place throughout the Foyers and Hall. The 1kw flood uplights are also visible here, located on top of the concrete ring beam

The wall fixtures can be retained and fitted with LED lamps, specifically designed for use in performing arts venues where smooth dimming to zero intensity is essential.

The 1kW floodlights uplighting the ceiling can be replaced with a linear LED fixture, capable of producing variable colour to suit the performance.

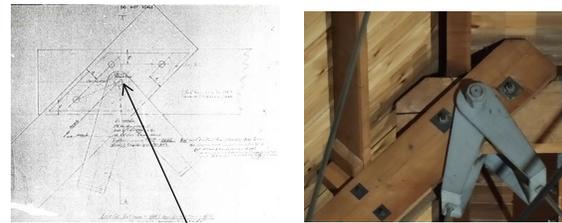
DETAIL A

Connection between steel rod and top chord member currently very highly utilised

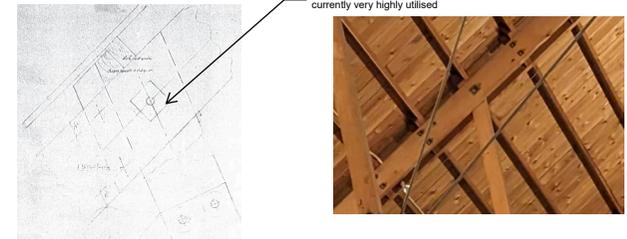
DETAIL B

Timber to timber connection currently very highly utilised

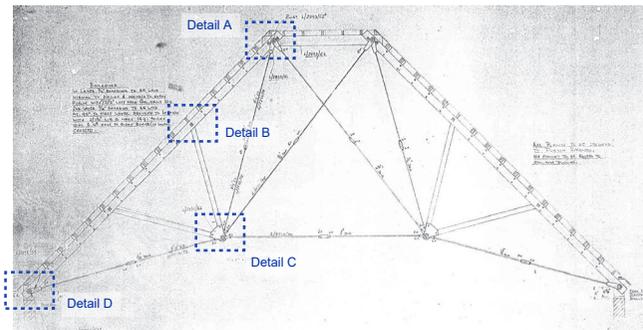
OVERALL SECTION

Site photos shown with extracts from Arup and William Brown (timber subcontractor) record drawings.

CONCERT HALL - EXISTING TRUSS CONNECTIONS

The roof structure is at a 45 deg pitch, which ARUP opted for as a compromise between the two existing maltings roof angles. The flat central spine was included to receive the bluffs, which provide natural ventilation to the space, and replicate the original smoke hoods. A simple roof truss with 60 ft spans was designed to each side, and the central zone with cross ties was used to take up the variance in the side brick walls of the hall, which varied by as much as 18 inches along their length

The primary timber elements are all Douglas fir, with all steel ties in 1 inch diameter. The purlins are German Whitewood. The original inner foyer roof was built as a simple lean to against the concert hall, and was formed using Columbian pine joists.

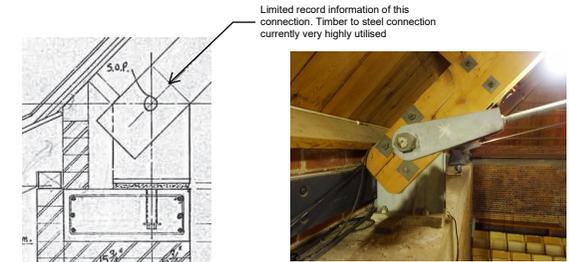
DETAIL D

Limited record information of this connection. Timber to steel connection currently very highly utilised

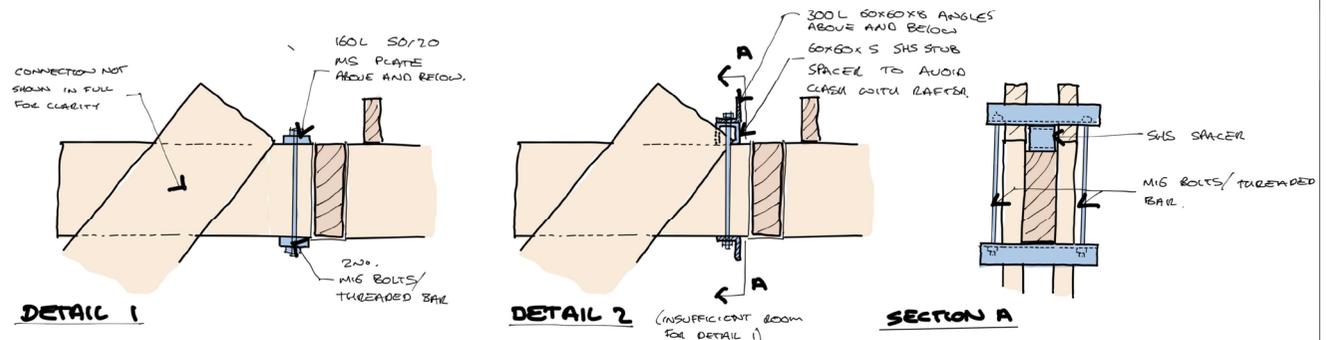
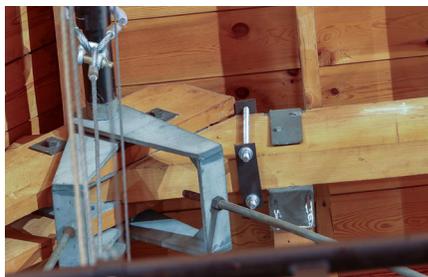
Details from Structural Engineer Report showing the remedial clamping plate to be installed to the ridge connections, where not already installed. Photo shows bay where this was already installed in circa 2017

Due to the net increase in loading in the roof in general, remedial strap repairs are proposed to the trusses not previously strengthened. This will help limit future crack propagation and reduction in connection capacity.

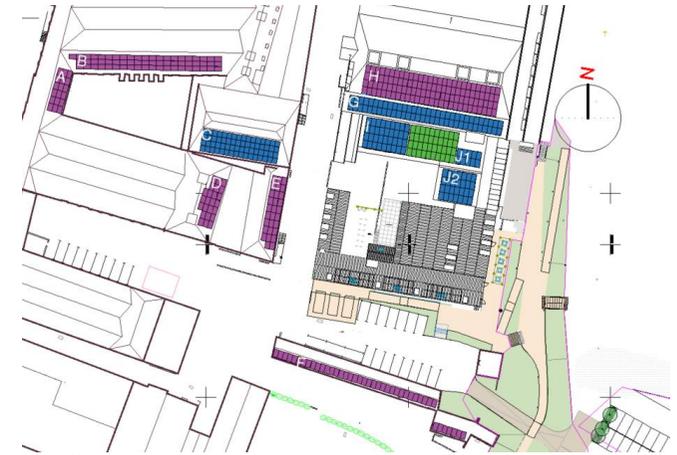
Figure 2. Map of all proposed PV

The table and diagram adjacent is from the feasibility report which identified all the rooftops available, and the selected areas are noted in blue.

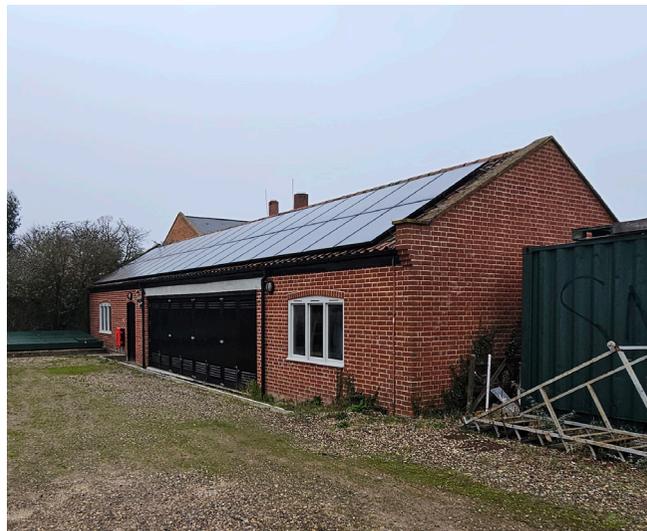
Energy Centre with a surface mounted array on Clay Pantile Roof

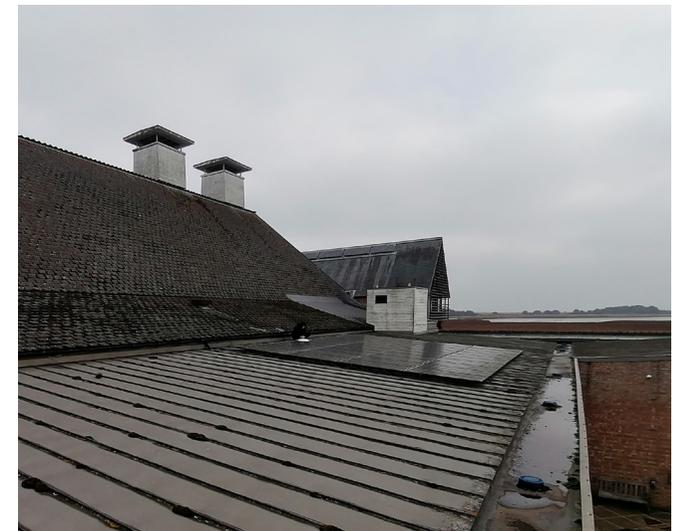
Concert Hall winch gallery standing seam roof with a surface mounted array

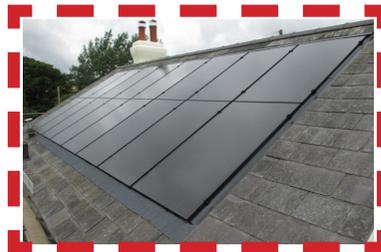
Inline Panels to slate roofs

The timber frame of the roof is a minimal design and has limited capacity for further load to be exerted onto it. Therefore, the only PV cells that it can accommodate from a structural point of view are in-line panels, which replace the slate tiles as the primary waterproofing element. BPA would like to consider a PV array on the southern side of the Concert Hall roof, as it is a large area and could offset the electrical demand of the building.

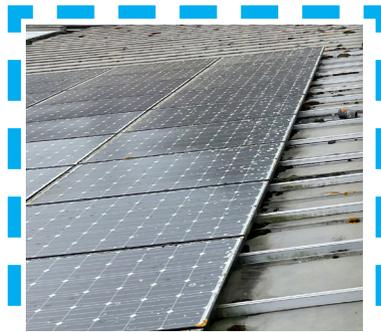
Surface mounted to flat roofs

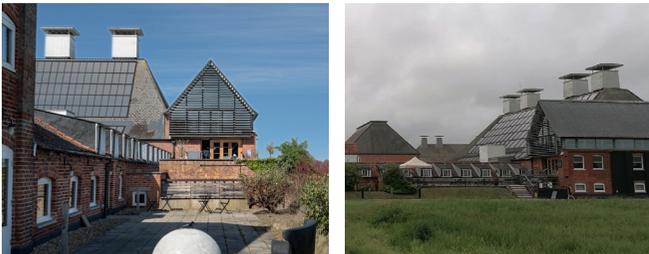
Visualisations of Inline PV array to main pitch of the roof

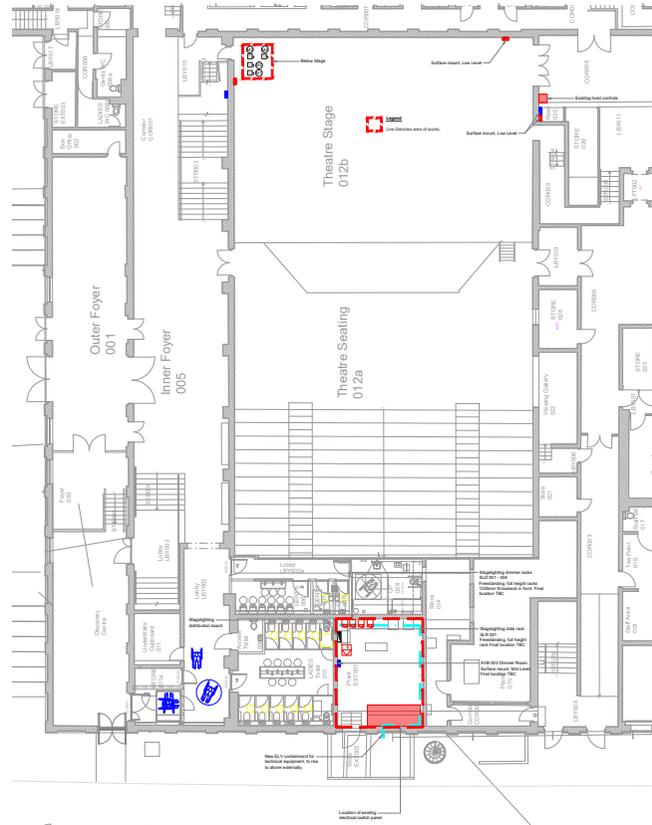
Ground level Electrical Proposals to Concert Hall

The new house lighting pendants will require new containment for LV & ELV supplies. New conduits will be required fixed to the roof trusses to serve the pendants. It would be recommended for the new house lights to also function as emergency lighting, this could be achieved by adding to the existing central emergency lighting battery system, if there is spare capacity, or by installing a new UPS system.

For the new replacement up-lights, the existing LV supplies shall remain, new ELV data shall be installed for controls.

To improve venue to venue interfaces, there is a proposed new fibre link between the Concert Hall / Britten Pears Building and the Hoffmann Building. New containment systems will be required to facilitate the installation of the new cabling including new below ground cable ducting and surface containment systems.

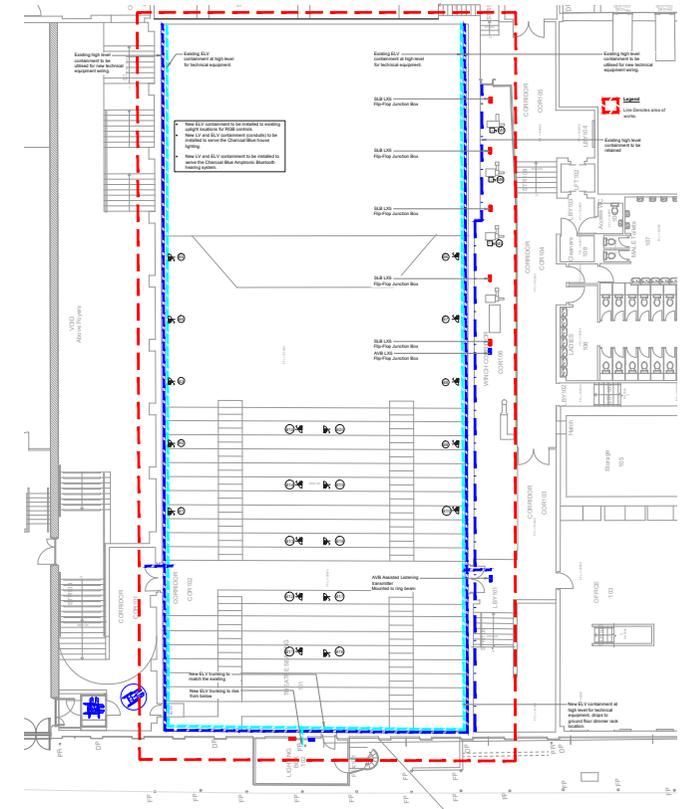
First Floor Electrical Proposals to Concert Hall

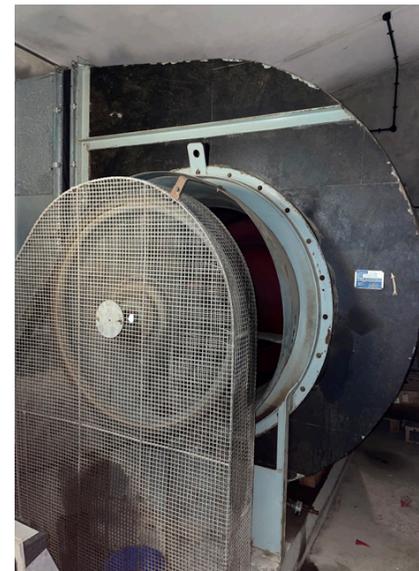
It is understood that the existing fan and supply system cannot be run at a fan motor inverter frequency of 21Hz or greater as regenerated (noise resulting from air movement through the ventilation system ductwork, grilles etc) noise becomes too intrusive in the theatre. This appears to be a limitation of the existing distribution ductwork and grilles. Supply air velocity is also understood to be too high for occupants seated near to the supply grilles, limiting the supply air capabilities. The supply air velocity in particular causes movement of papers etc being used in a performance.

Review of existing O&M information indicates that the existing supply system was commissioned for a flow rate of 5m³/s, however, for acoustic and high supply air velocity reasons, the fan speed has to be turned down on the inverter speed control, from 50Hz down to around 21Hz. The anticipated supply air volume is approximately 42-45% of the original and estimated to be around 2.1 to 2.25m³/s. This is only 23% of the required supply air volume for the occupancy. Current regulations would provide 10litres/second per person, totalling 9m³/s for the space.

The supply air fan is a basic, antiquated floor standing belt driven centrifugal fan. This is understood to have been installed around 1969, and has been retrofitted with a variable frequency inverter speed control drive.

It would appear that the fan has been built into the plantroom, and will most likely require some careful dismantling of the masonry in order to facilitate access for replacement of the ventilation plant, or alternatively bespoke site assembly of the ventilation plant.

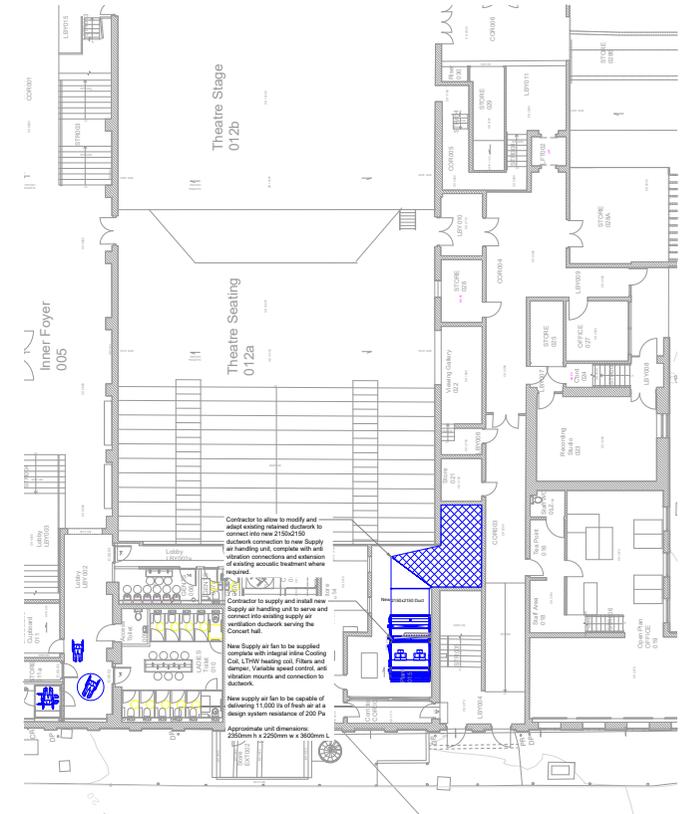
Proposed Ventilation system

Within the concert hall space, it is proposed that a new replacement supply air handling unit is to be provided within the existing fan plant room, this new supply fan is sized to provide 10 l/s per person based on a peak occupancy of 900 people within the concert hall. The new supply fan is to be provided with integral heating and cooling coils to temper the incoming air to either reduce occupant discomfort from cold draughts during the winter periods or to trim down the incoming air so reduce the perception of overheating. The existing ductwork shall be retained and maintained as its current installation except for localized modifications within the plantroom to suit the installation of the new air handling unit.

The plant will need to be site assembled to allow transport into the plantroom. In reality, due to the size of the plant, it may be necessary to carefully dismantle the external hit and miss brickwork and reinstat.

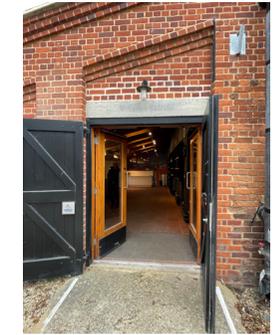
View of the opening made in 1999, viewed from the outer foyer, looking at the black painted wall which was once the external facade of the building in 1967.

Dotted line shows intent for new opening within same wall, to create similar door and a half installation to access the new platform lift in the inner foyer.

The new opening in the original external wall is intended to be similar in style to the opening that was made in the late 1990s when the Outer Foyer was first built. The image adjacent shows this doorway as it appears now on site.

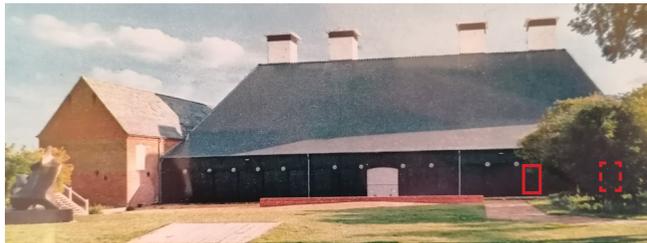
Dotted red lines show our proposal for new doorway, relative to the converted 1967 building. The solid red line denotes the similar opening made in 1999

The images beyond are of the Hall prior to the Outer Foyer construction. Here you can see the original black painted elevation with arched reveals and central doorway. We have dotted the new opening location we wish to form. The solid red line represents the location of the doorway formed in the 1990s.

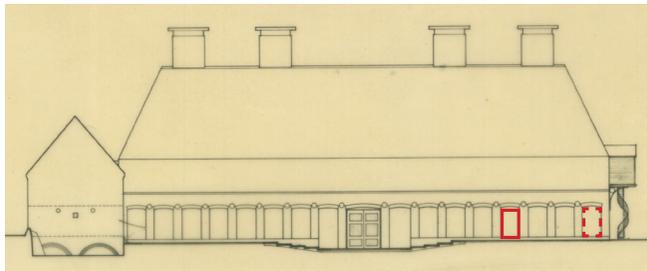
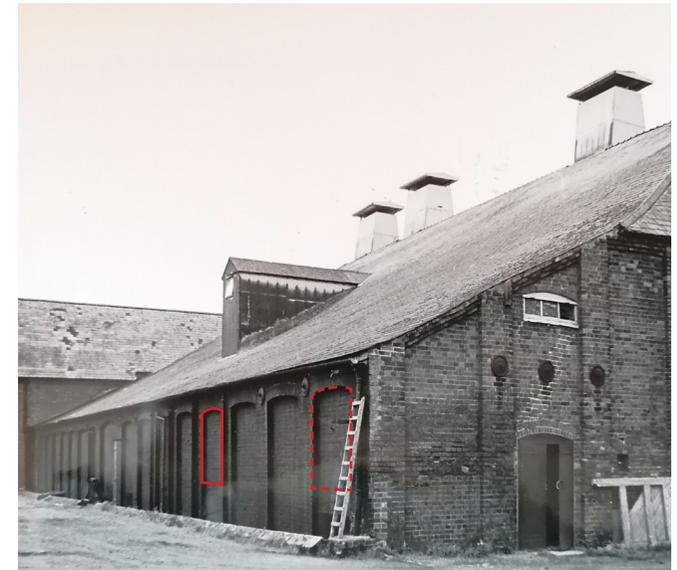
Image of the original Maltings building pre conversion in 1967 into the Concert Hall, showing the same original black painted wall, with red lines as above

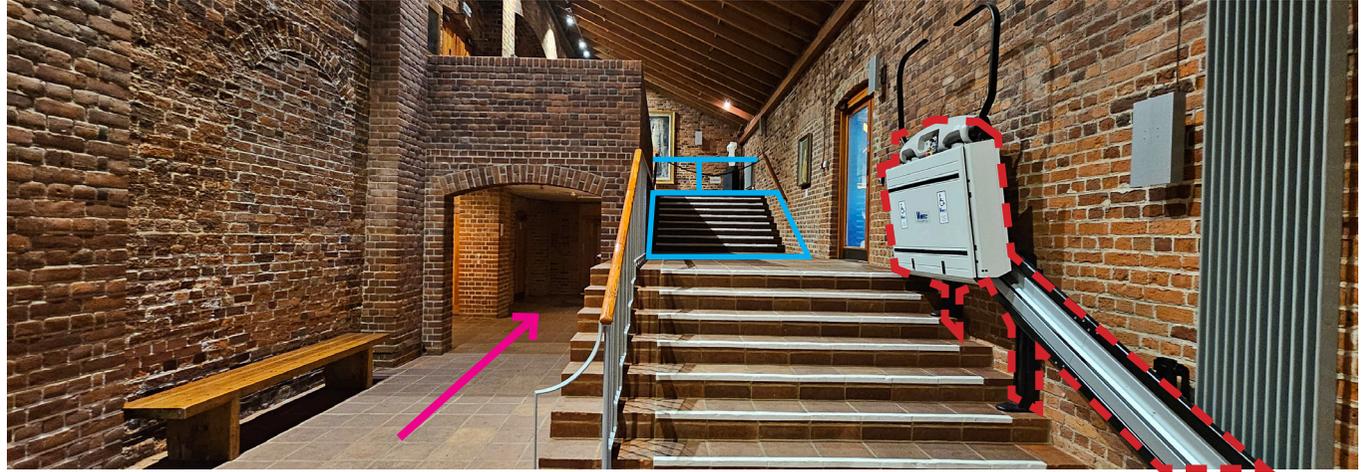
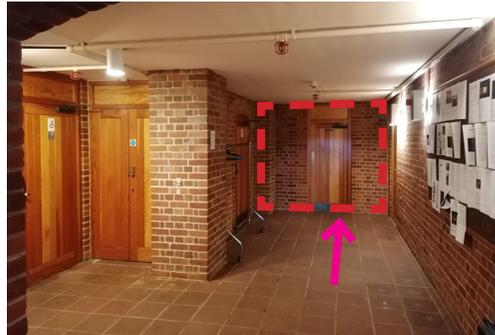
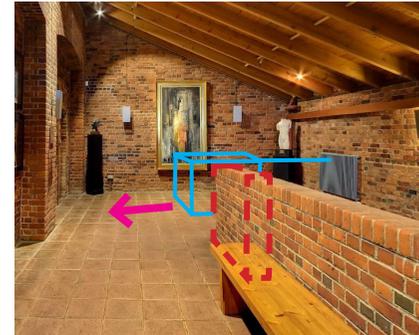
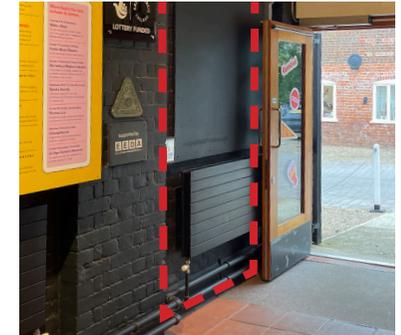
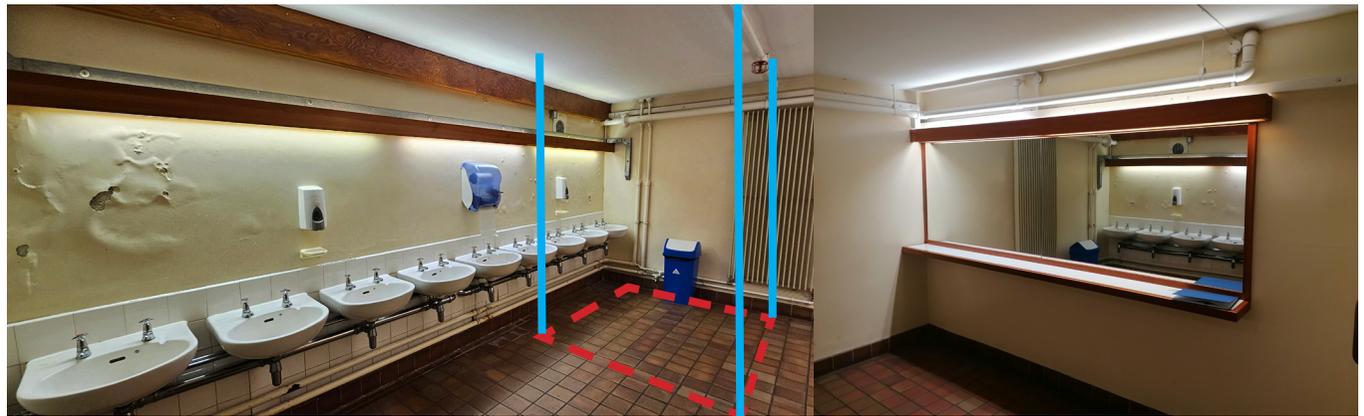
Photos of the existing areas with strip out / demolition areas denoted in red dotted lines, new access routes with pink arrows, and additional items in blue lines. Detailed drawings are in following pages

The new lift will be accessed from the lower level by the same route as the Female WC is currently. It is proposed to take down the brickwork partition wall separating the WC from the corridor area to ensure a suitably wide access approach to the lift entrance at this level. The quarry tiles in this existing WC zone will be removed and replaced with pammets to match the rest of the foyer area.

The existing upper flight of stairs will be left intact, but built over with a new concrete stair and new pammets laid to match existing. Nosings will be painted white to contrast as per existing condition. The existing handrail will be moved along the wall to suit new flight location.

The brickwork balustrade wall will be cut back at the upper landing, to ensure a clear opening sweep is maintained with the new lift installation in place. Flooring will be made good with replacement pammets where needed.

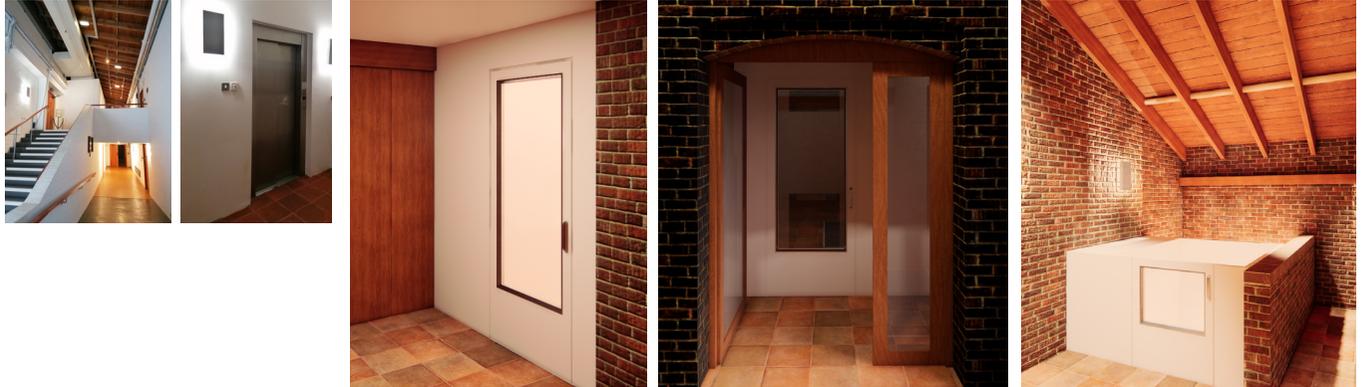
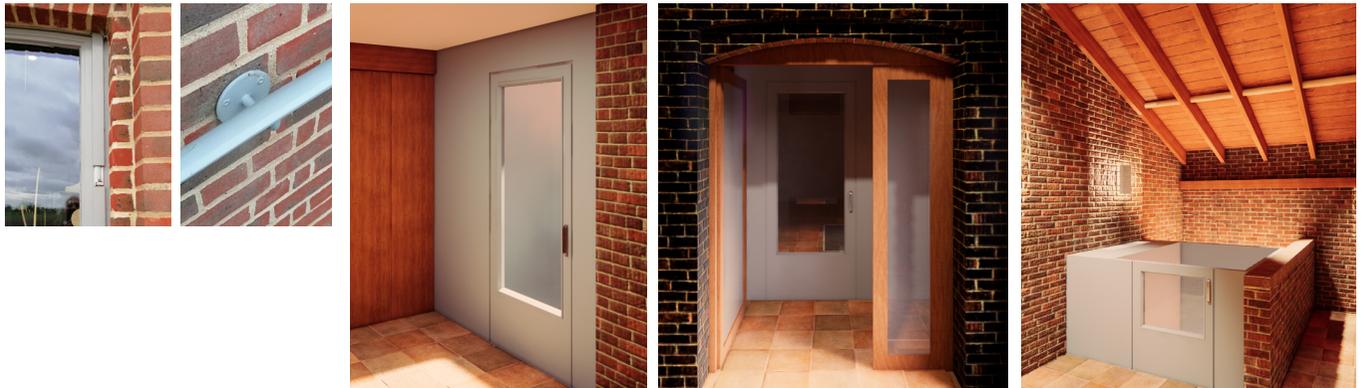
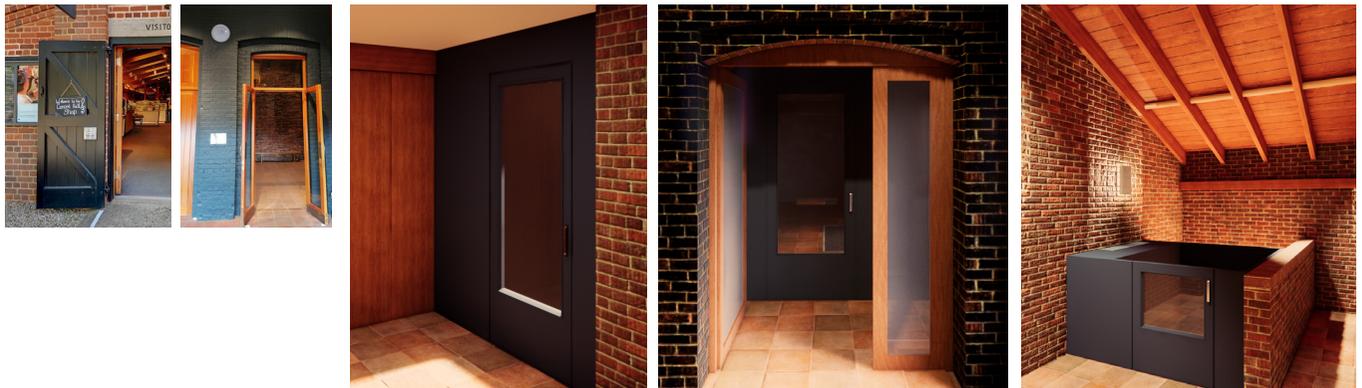
Standing in the centre of the Inner Foyer looking to the West up the stairway to the upper landing, and beginning your approach to the WC block on the lower level.

Here you can see the new brickwork wall that screens the new lift at the top of the staircase. You can also see the new staircase flight with matching clay paviours, built to provide the landing access space at the upper level in front of the new lift.

On the view into the WC area and access to the lift, we can see the new timber panelling proposed to clad the existing FWC basin area where there is failing plasterwork in the below ground wall zone. The lift is just out of view to the right of this end lobby area, set slightly back from the existing brickwork wall line.

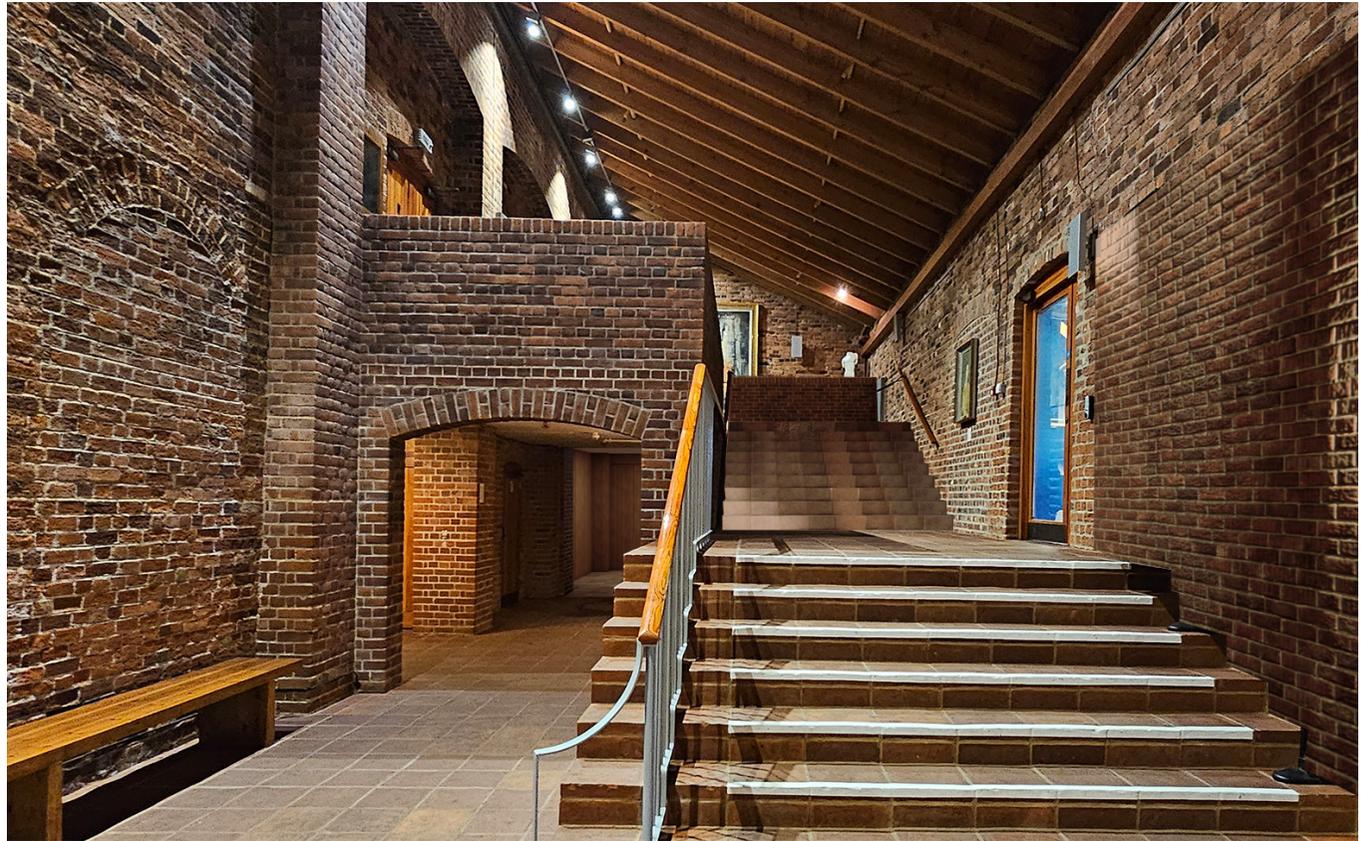
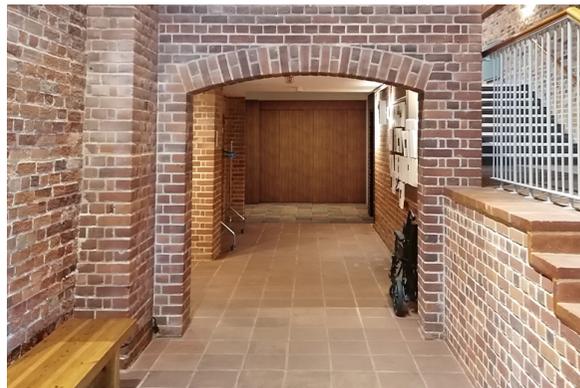
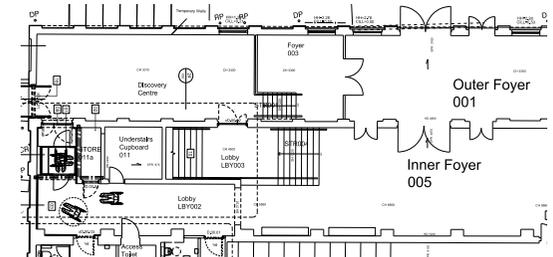
Travelling further into the WC lobby and towards the lift, we can see the existing concrete soffit of the floor slab above. A new store has been constructed next to the existing below stair store, which will provide an area for storing Concert Hall chairs that need to be removed due to wheelchair provision.

The quarry tiles within the FWC basin area will be lifted and replaced with new clay pammments to match the existing, so the extension of this foyer areas feels like a unified space.

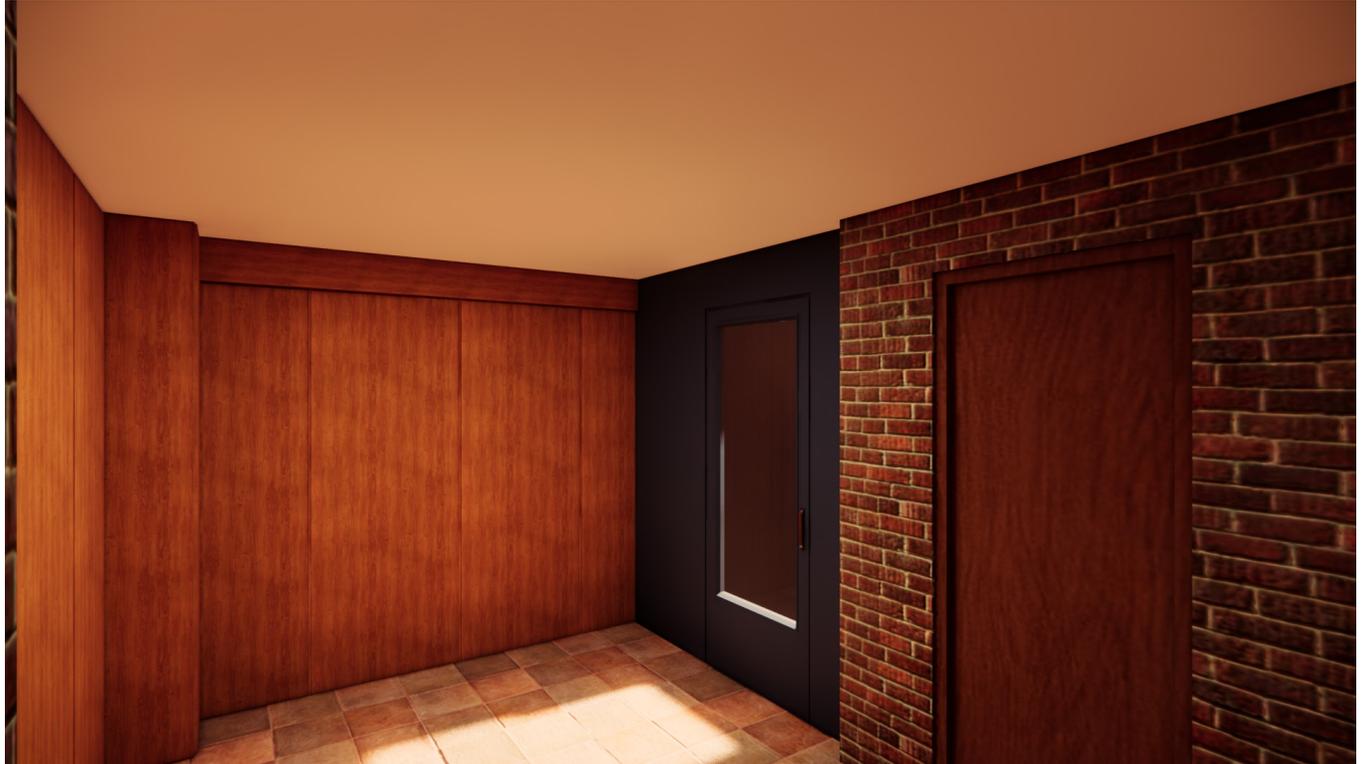
At the upper level of the Inner Foyer, the new lift is screened by a new brickwork wall matching the details of the existing balustrade wall of this level, with soldier course to top. The lift is set back from the edge of this brickwork wall.

The existing brickwork balustrade wall element needs to be cut back to suit the new staircase location, and brickwork will be made good at the cut line with retained bricks pieced in to the end face.
