BRITTEN PEARS ARTS

**Concert Hall Works
RIBA 3 Report
Capital Works Program
February 2025**

**de
matos
ryan**

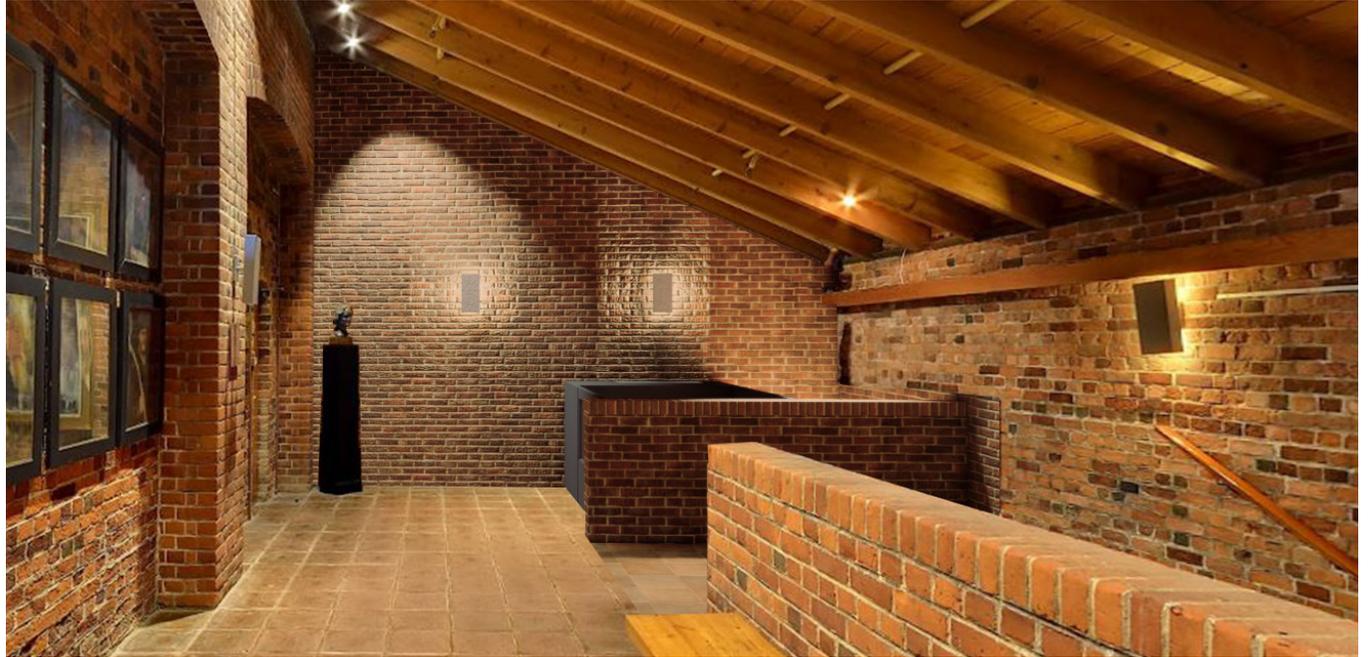
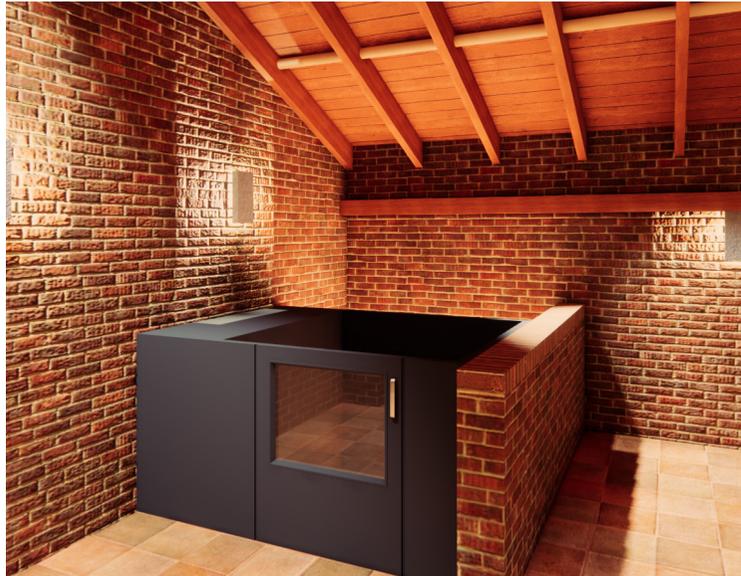
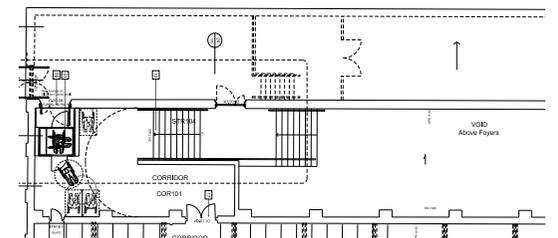
Looking over this new brickwork screening wall you will be able to see down into the new floor level constructed at the Outer Foyer level to provide access to the lift at this side of the car. The wall zone will be clad with the timber panelling used for the FWC basin area up to the datum of the floor level of the Inner Foyer.

A new doorway will be formed in the existing arched bay of the Outer Foyer to access the lift from this space. This doorway will be detailed to match the existing doorway adjacent, installed in 1999.

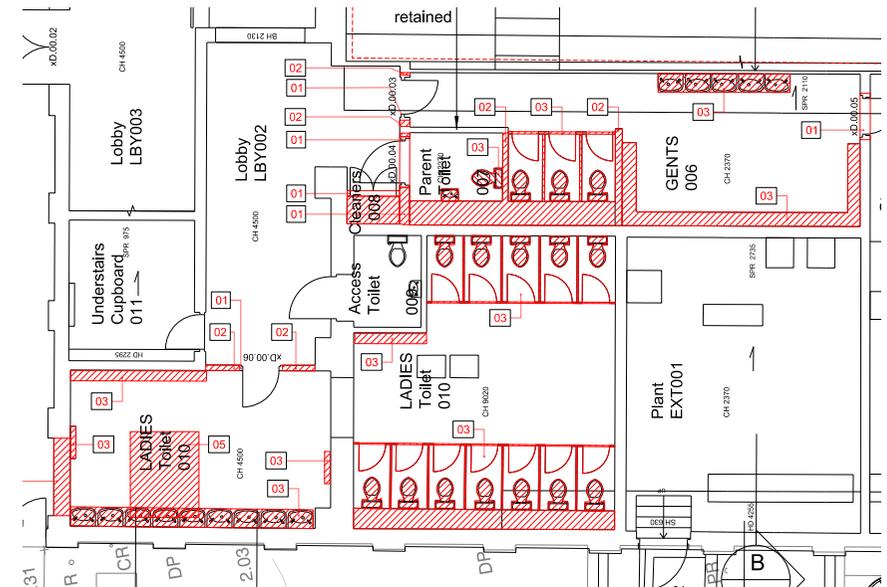
Existing layout.

The existing provision of quantity of Male and Female WCs and basins is in excess of the recommendations of BS6465 for a venue of this type. However, the existing provision is seen as a good baseline to aim to maintain with the new layout design.

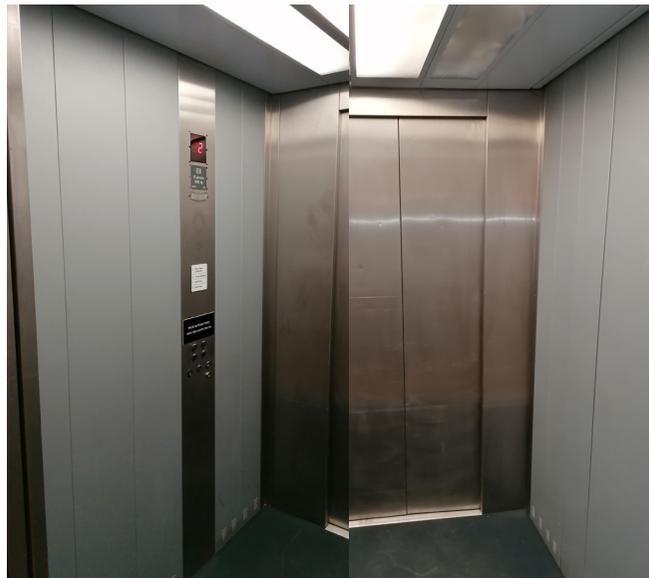
03 LIFT 002 - EXISTING DETAIL PLAN
24_500 / 1:50 @ A1

The lift is of through car construction and is as installed in 1999 with no visible upgrades or modifications. The lift and its controls do not conform to the latest DDA requirements. The lift landing buttons are in a poor state with no spares now available due to their age and the inconsistency in operation as well as temporary repairs having to be made.

The lift is a poor condition and not to the current standards including shaft items such as full lift shaft lighting and power in the lift shaft.

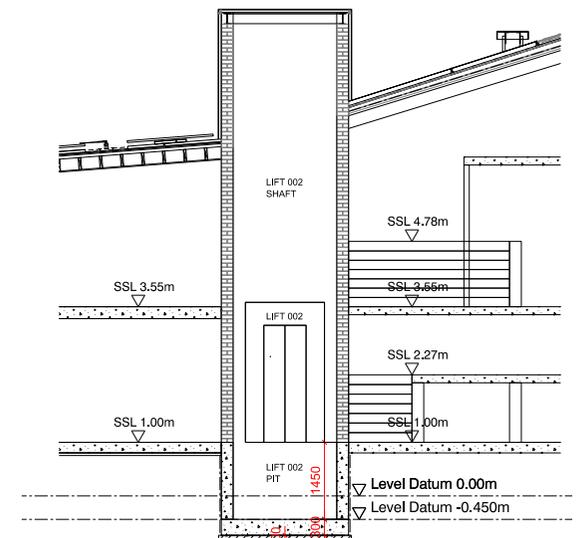
LIFT #2

Lift no.2 is a Kone, hydraulic lift with a separate motor room at ground floor level. As with Lift no. 1, it is in an "as installed" condition and is at its end of life. The lift has two entrances at 90° to each other to allow access to the required floors. The first floor is also on a restricted access, as it is not for general use only staff.

The lift landing call buttons are in a poor condition and need replacing, but spares are not available now due to age. The lift, like Lift no. 1, does not comply with the latest DDA requirements.

The lift is in a poor condition and not to the current standards including shaft items such as full lift shaft lighting and power in the lift shaft.

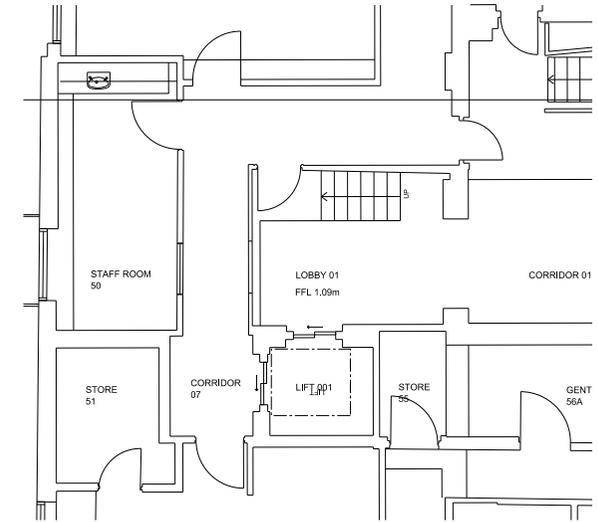
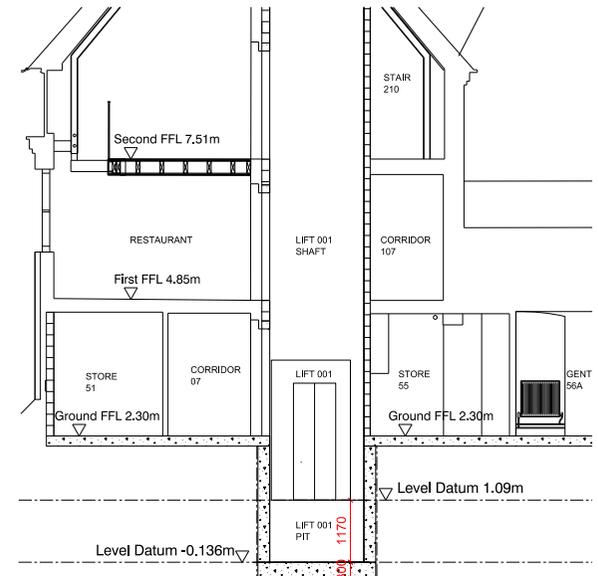
01 LIFT 001 - EXISTING DETAIL PLAN
24_500 1:50 @A1

The hydraulic pump unit is also original and would benefit from replacement with a new unit that is compliant with the latest lift regulations on un-requested movement in either direction compliance.

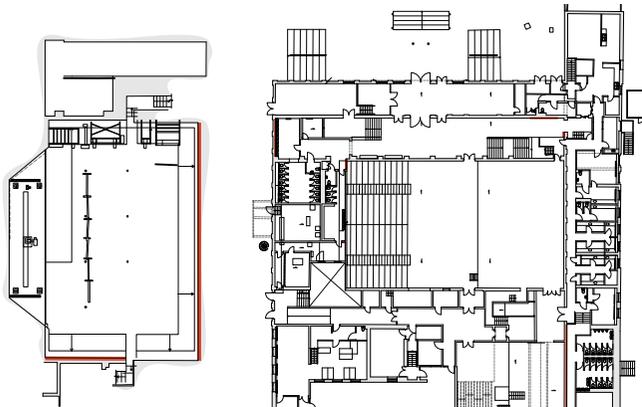
Locations identified to the under-stage basement (left), Ladies WCs and Lobby at ground floor level (right) requiring repointing, brickwork replacement, and/or replastering

The brackish water in the estuary has resulted in frequent salt movement in bricks and the deterioration of low level brickwork. This is particularly evident in areas where air movement is low, such as dead end corridor areas. Cementitious mortar in repointing and modern plasters have exacerbated decay.

Repointing and brick replacement is needed and some replastering. It is not intended to attempt to tank or fully waterproof the building, but to carry out pragmatic repairs.

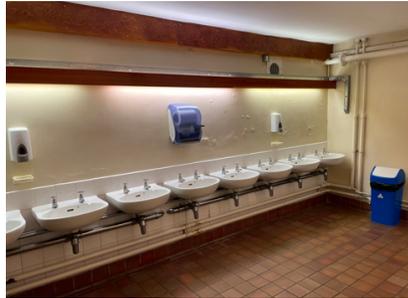
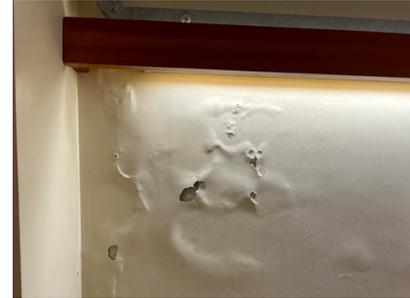
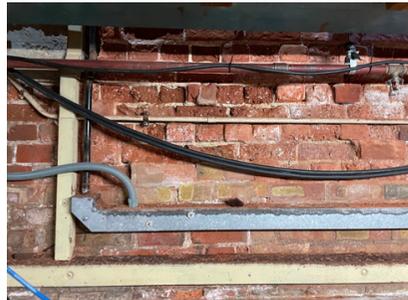
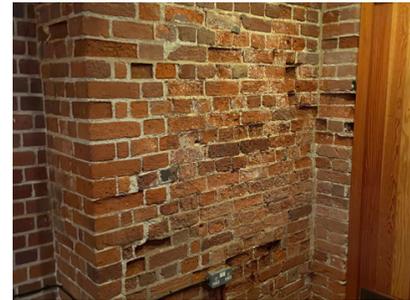
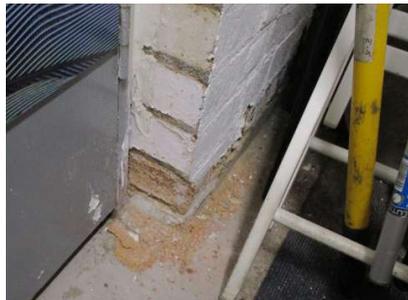
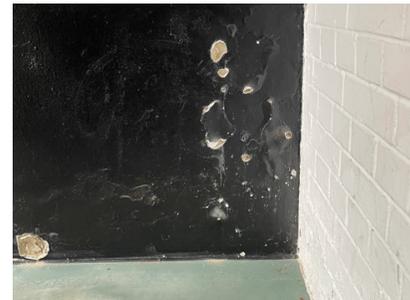
Photographs showing salt damage to brickwork and plaster

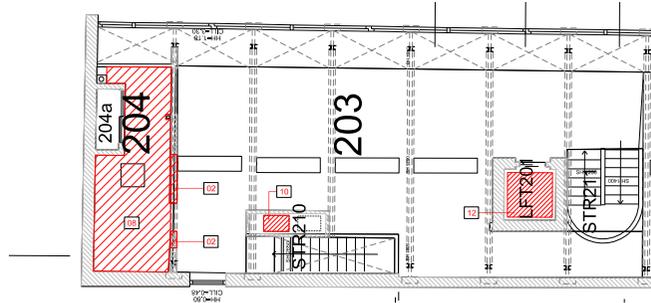
Existing arrangement

The events room above the Conert Hall cafe is currently served by an ad hoc servery and small finishing kitchen. The space can seat circa 110 guests, but the food is all produced in the lower ground level kitchen which also serves the Malt Cafe to the front of the site.

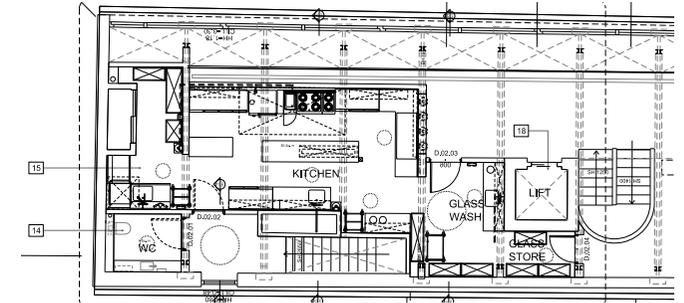
Proposed arrangement

An extended prep and reheat kitchen area on this upper floor level, close to the event area, would benefit the existing kitchen operations.

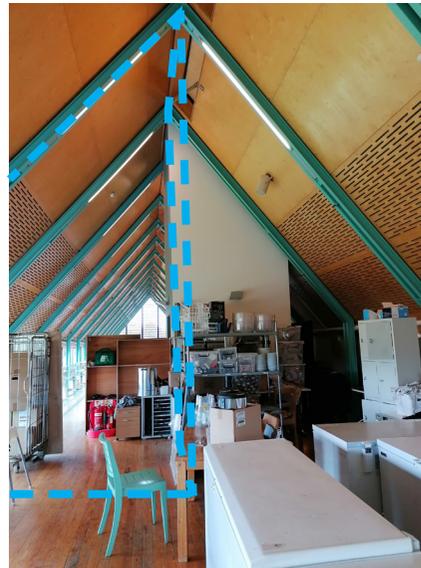
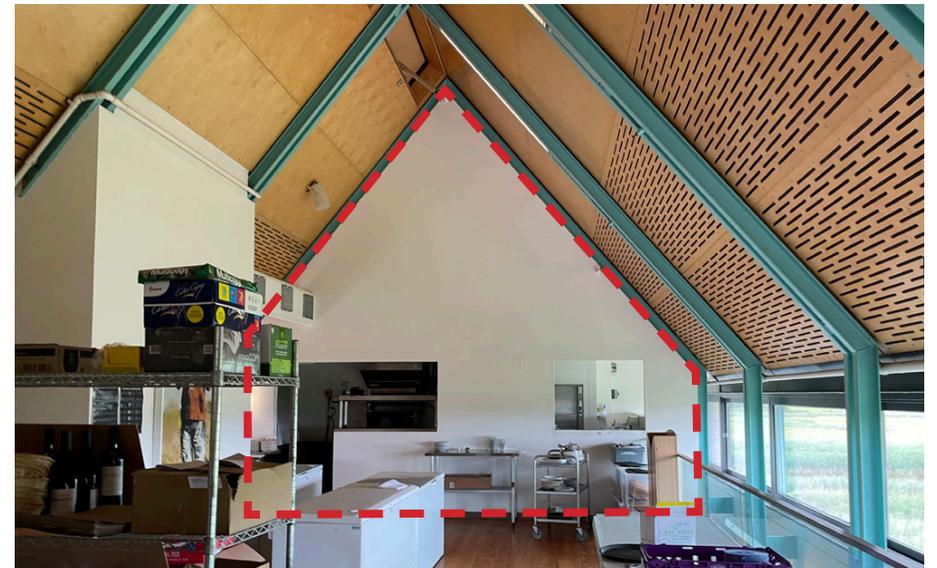
Overall views of the existing space where the finishing kitchen will be located. The light blue lines show the proposed new wall lines, and the red lines show the areas of demolition to remove the existing partition.

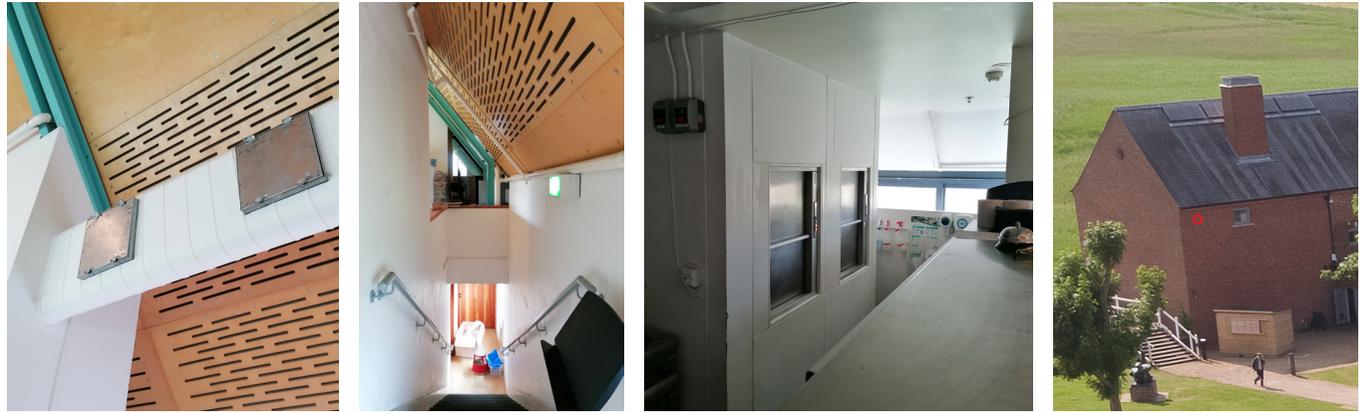
Left to right. Existing extract duct with inspection hatches that run into the existing brickwork chimney breast which terminates above roof ridge line externally. Capacity for fitting enlarged extract ductwork into this brickwork construction needs to be confirmed via further exploration, but it is anticipated to be suitable. View looking down the staircase to the cafe on the lower level. Space on upper level behind the lift shaft is planned to be used as new plant space for water cylinders to serve the new kitchen basins. View of the existing servery dumbwaiters, to be retained. External view of this part of the building, showing the brick chimney and window to the top of the staircase. It is anticipated that a new SVP external terminal will be needed next to this window on the western facade, as per the red circle.

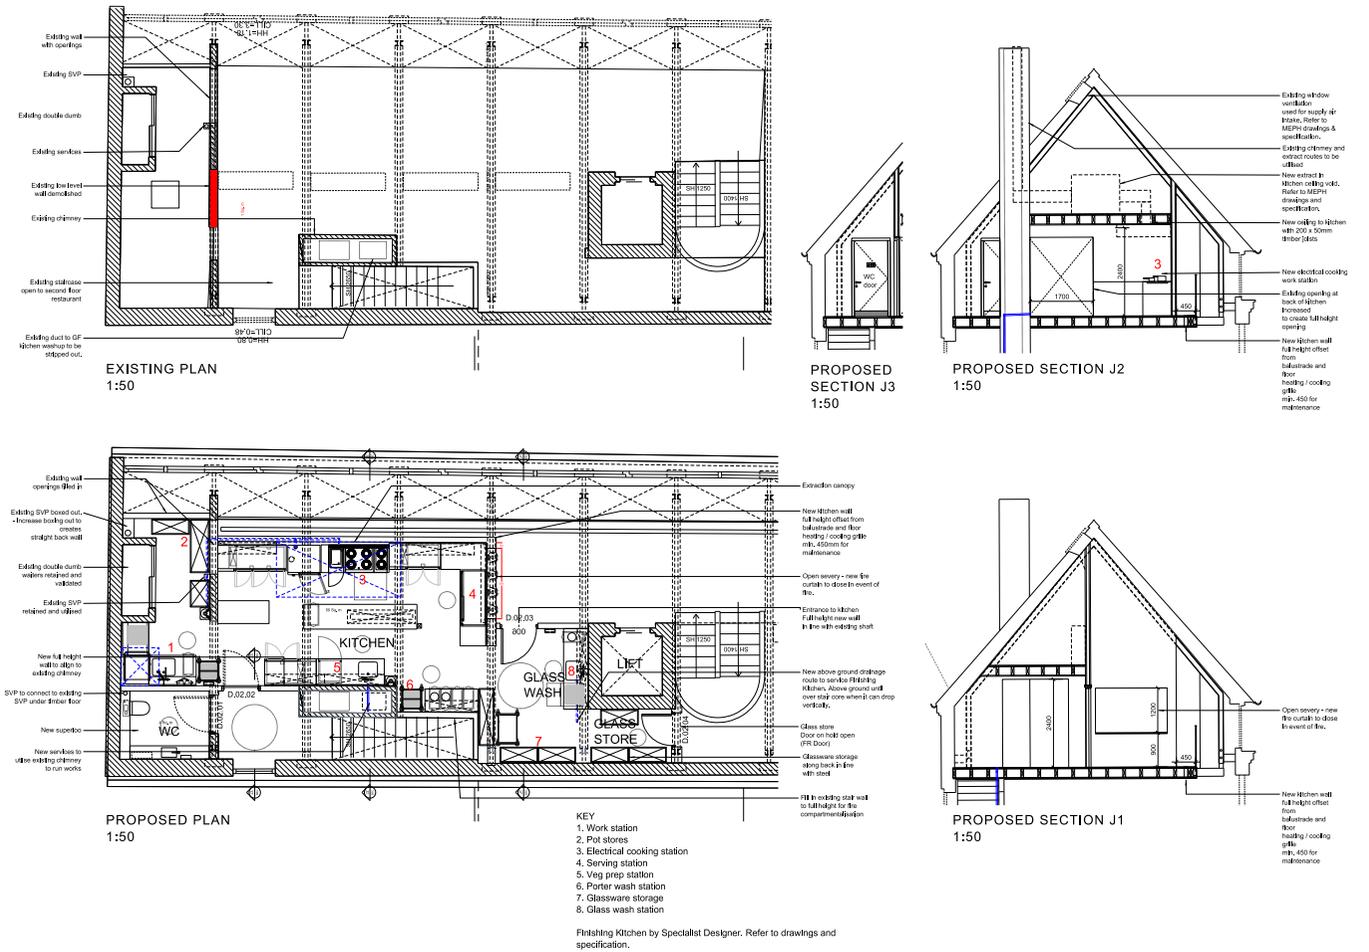
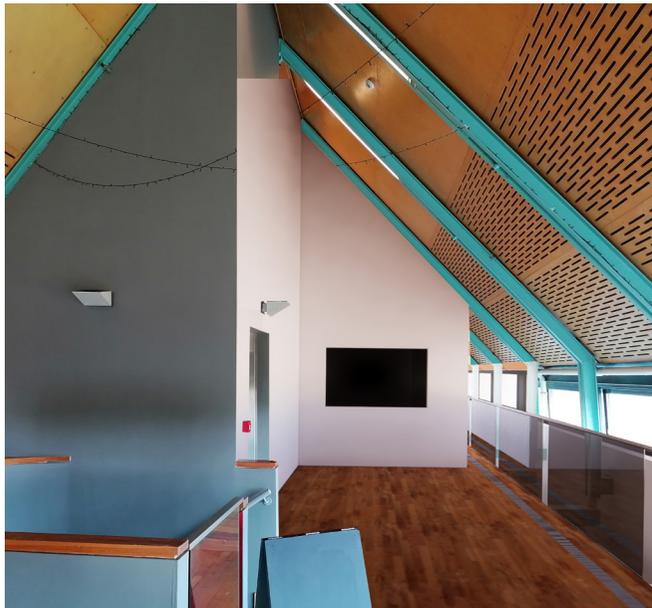
The proposals seek to demolish the small existing servery area, but retain the two dumbwaiters, serviced by Stannah. The new enclosure to the extended kitchen area will take a similar approach to the existing partition, in that it will align with the green steel roof structure location to avoid an interface with the timber ceiling panelling. This also avoids complications with an interface with the roof vent boxes on the western side of the pitch. A suspended ceiling will be installed to the kitchen area, so plant can be run at high level above the work area, and be isolated from grease and dirt build up.

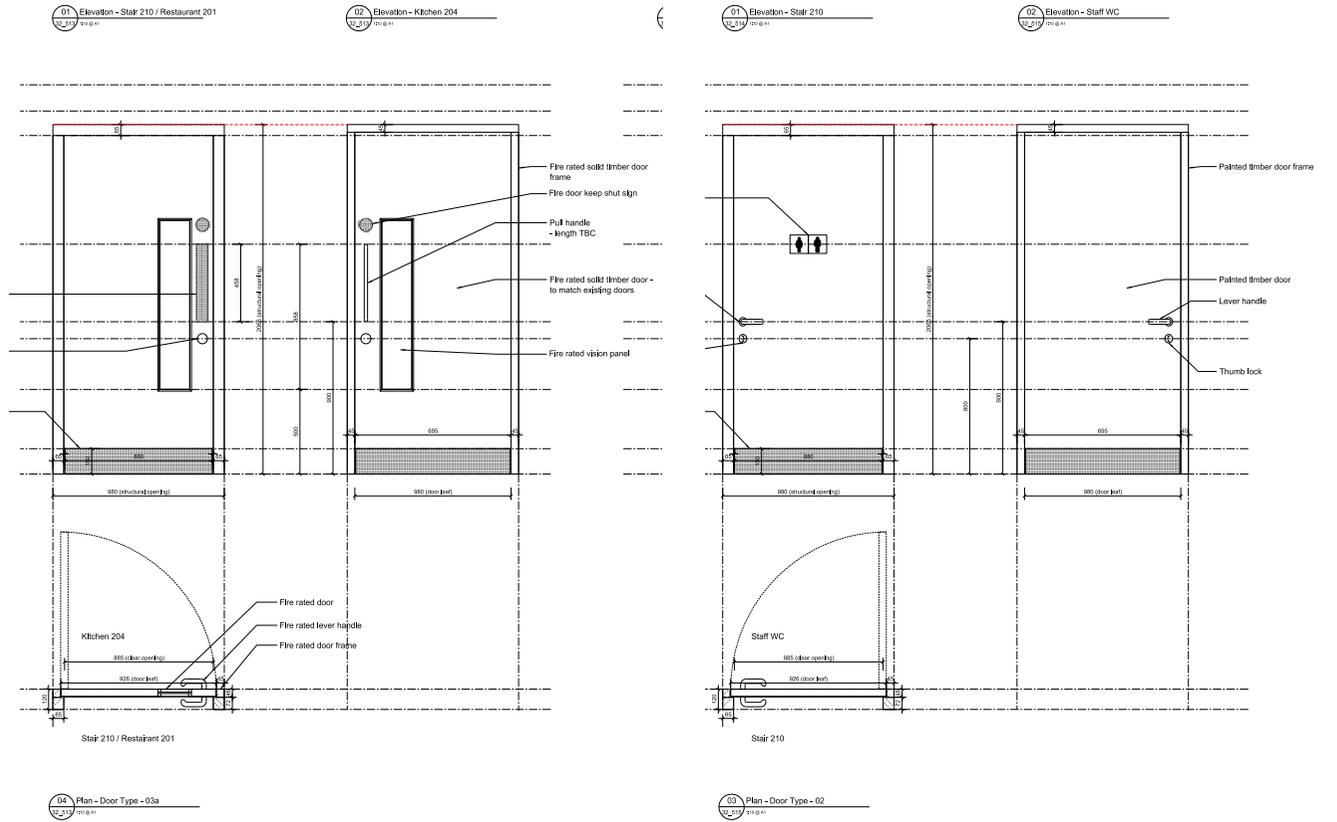
The new doors to enclose Kitchen area will be simple flat panelled solid core timber doors with painted faces, and flat painted timber architraves.

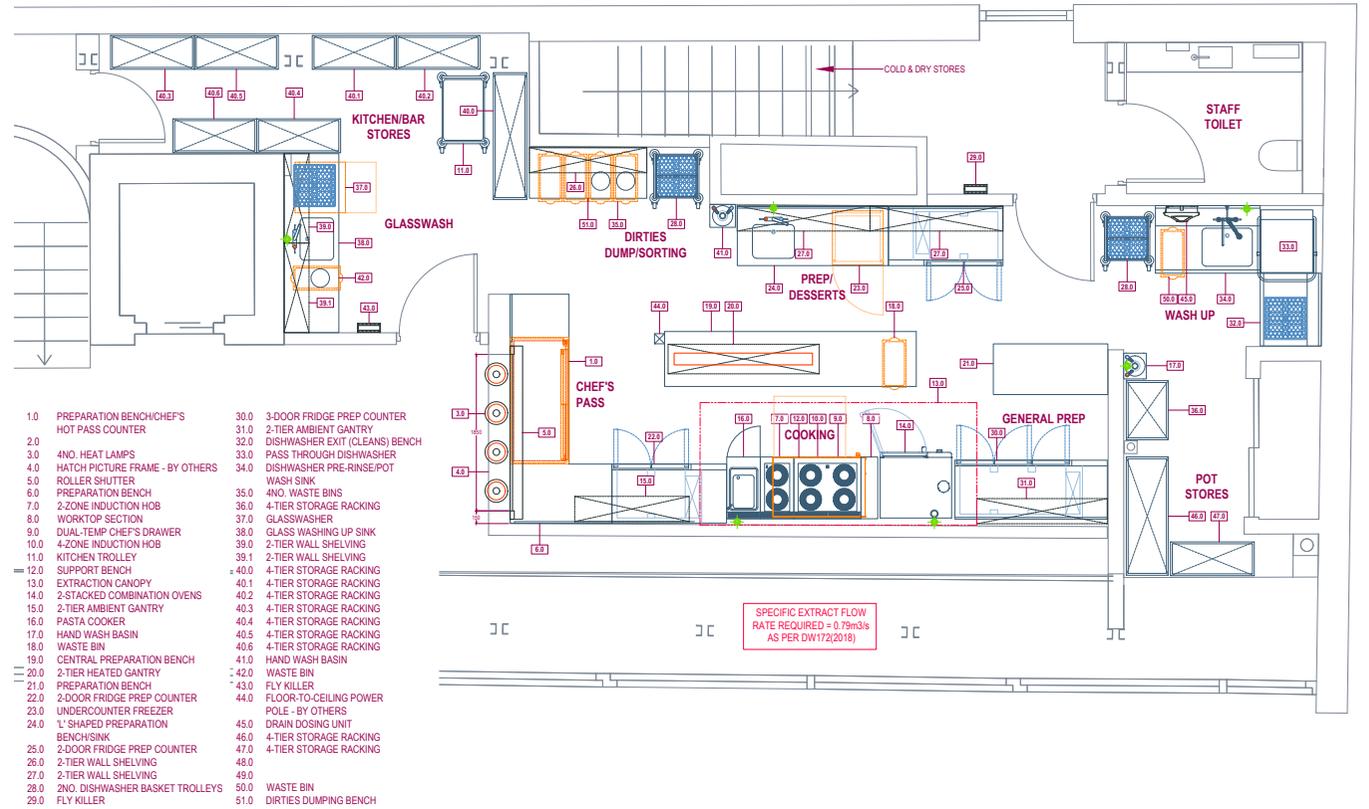
Adjacent is a drawing from the Kitchen Design Team to show the scale of equipment fit out intended to this new area.

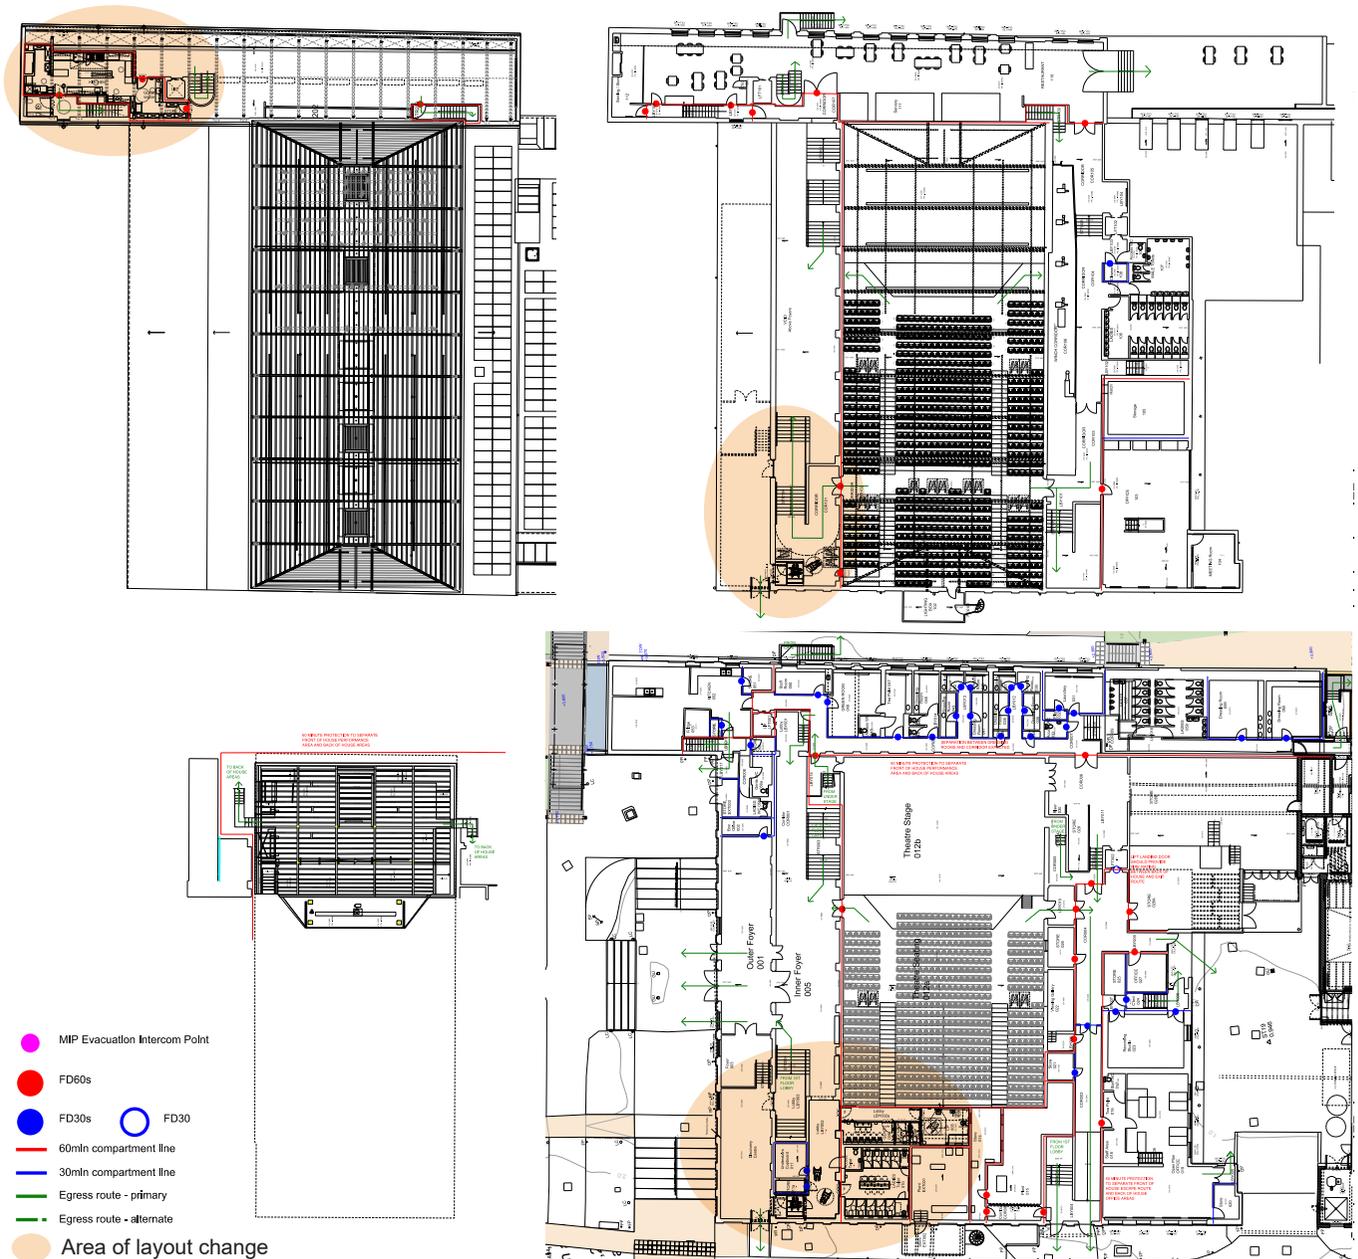
2.5.25. Concert Hall : Fire Strategy - Existing Layout

There is no existing fire strategy on record that we have located to date. The diagrams on this page are our assumptions on the existing strategy based on a visual inspection of doorsets and wall constructions alongside required egress routes.

The areas of layout change are noted on this mark up in the shaded areas. There are no other layout changes proposed. On the GF level, there is a new doorway planned between inner and outer foyer which we assume should perform as a fire door. The rest of the changes are to the WC spaces. There is an enlargement of the existing kitchen on the upper level of the restaurant.

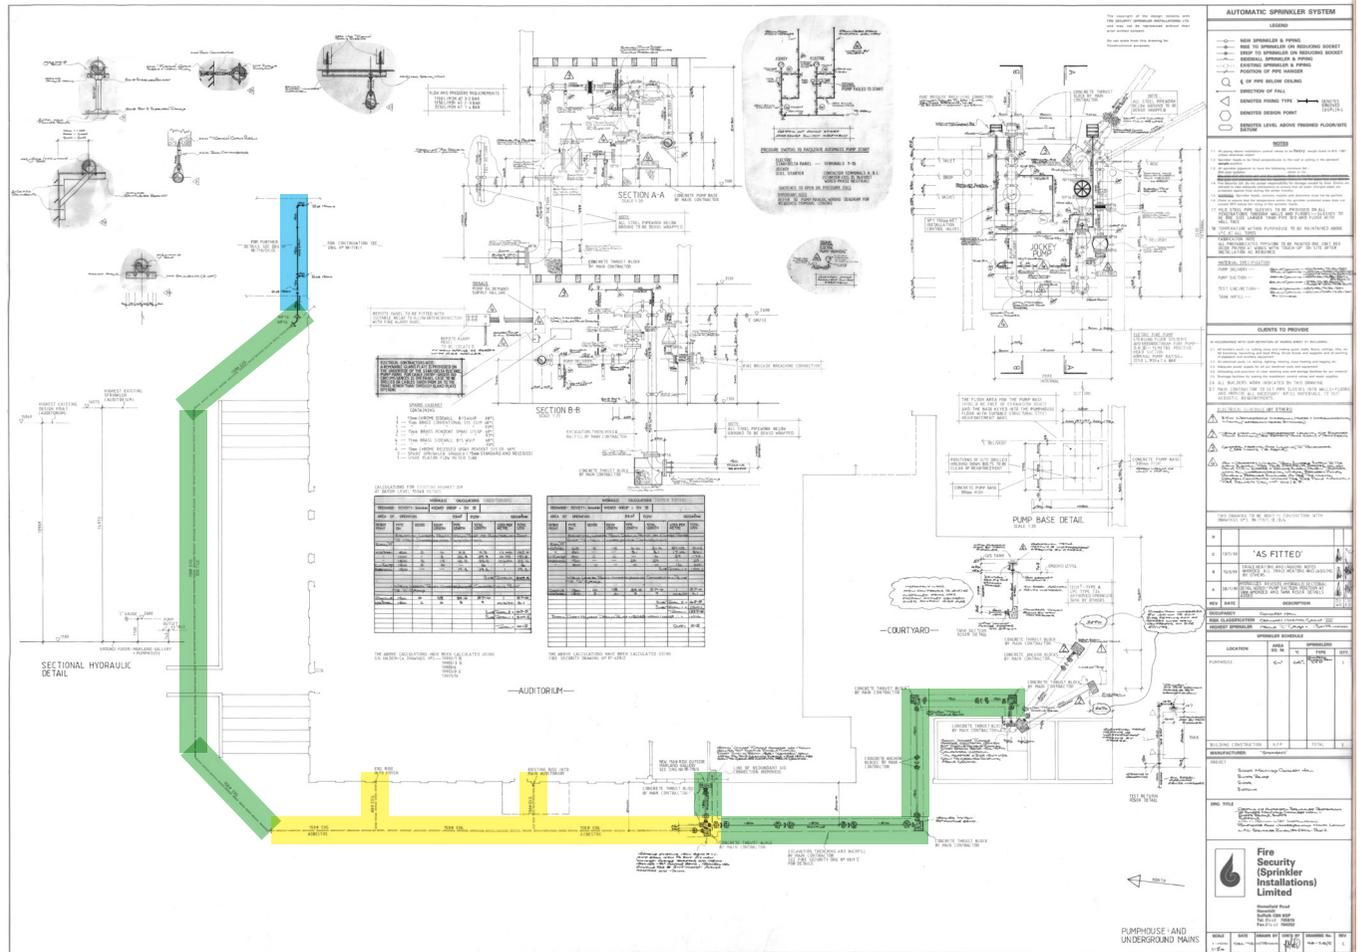
Concert Hall : Fire Strategy - 1990s Sprinkler Installation

The adjacent drawing is from the Record files from the installer. This records the works undertaken in the late 1990s which included the installation of new electric pump, new water tank, and new below ground routes. The colour coding on the plan adjacent indicates the following:

Green = 1990s installation to connect to the new electric pumpset and tank.
Ductile pipework

Blue = 1990s installation to connect Kitchen areas to system extension
HQ galv pipework

In 2024 BPA undertook a 25 year condition inspection of the system. The pipework report concluded that the pipework is in satisfactory condition. However the head testing has not yet concluded at this stage.

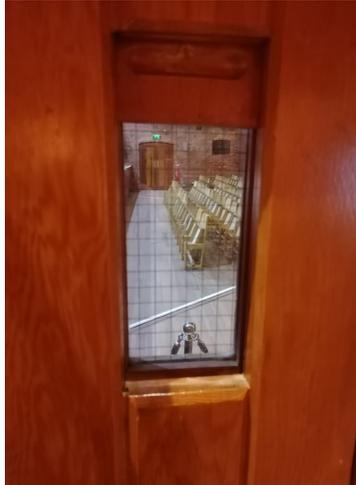
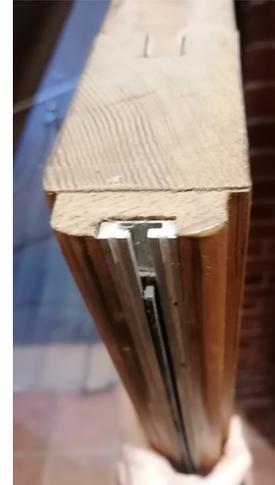
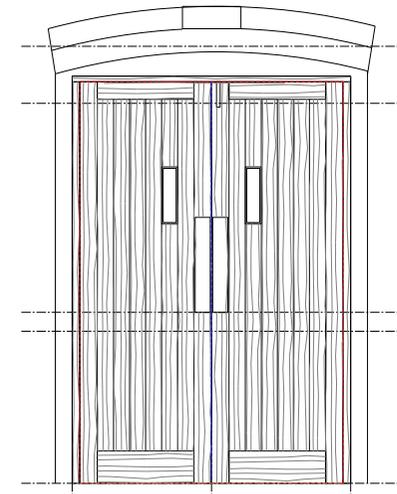
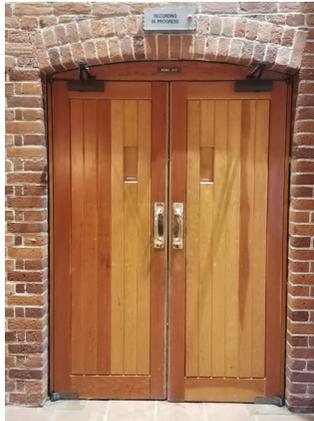
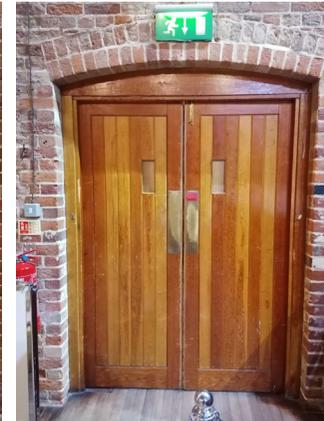
Therefore, to be able to deem these have the suitable performance to act within a compartment line, we need to take the 15mm panelling off one doorset and inspect the core construction. It may be required to rebuild the core of these doors with a solid fire rated panel, and then re-fix the panelling to replicate the existing appearance.

In addition, the end profile will be removed so a new metal smoke and acoustic seal can be added to the ends, and compression seals will be added to the door frames, and drop seals to the door base.

- - - New Fire seal - Perimeter seal
- - - New Fire seal Intumescent S
- - - New Fire seal - Floor Strip

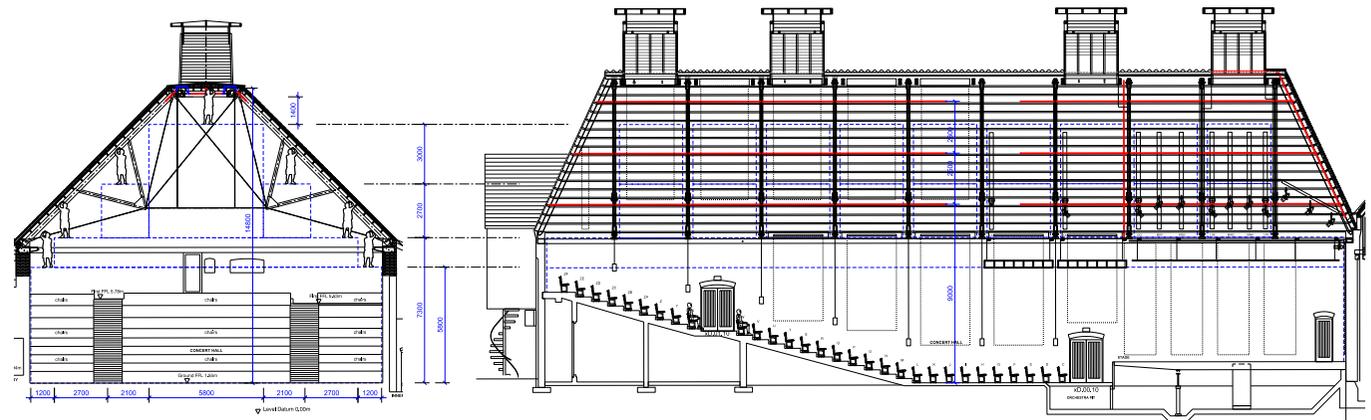
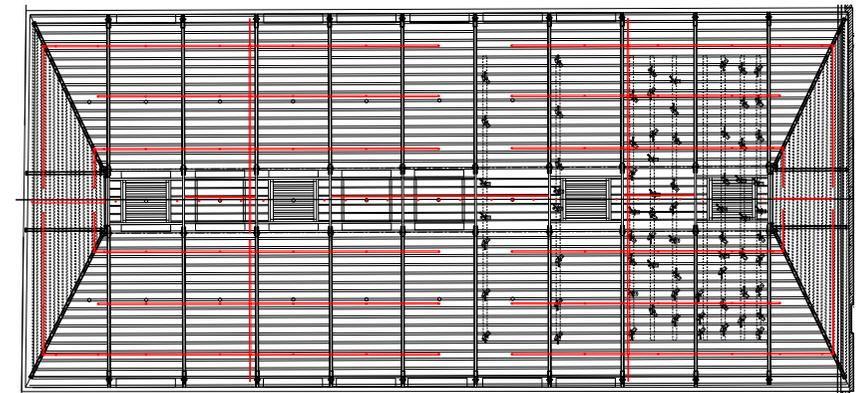
Access to the upper levels of the Hall soffit will require the erection of a bird cage scaffold inside the hall. The sketch attached shows the lifts of scaffold that would enable the most useful access zones to each area of works being undertaken.

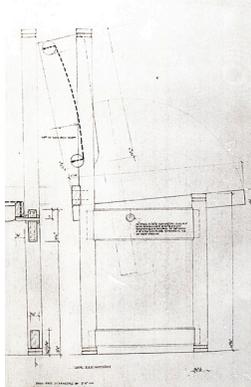
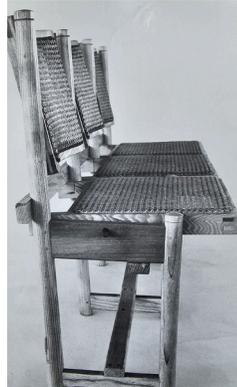
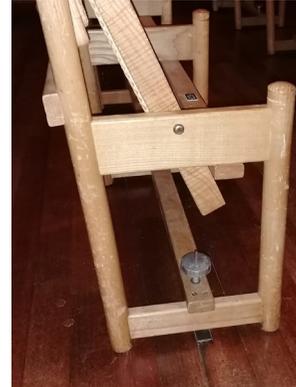
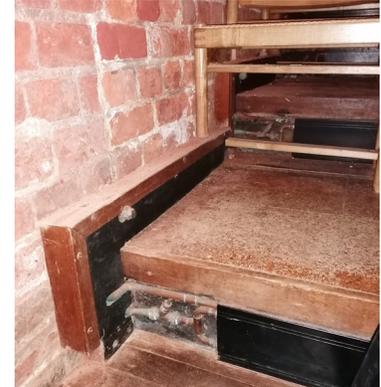
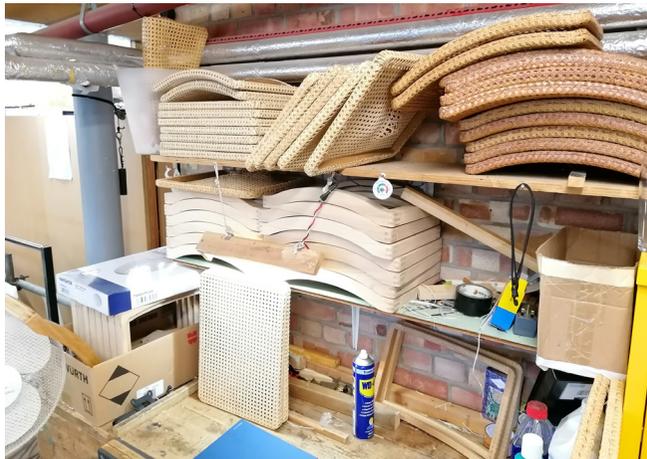
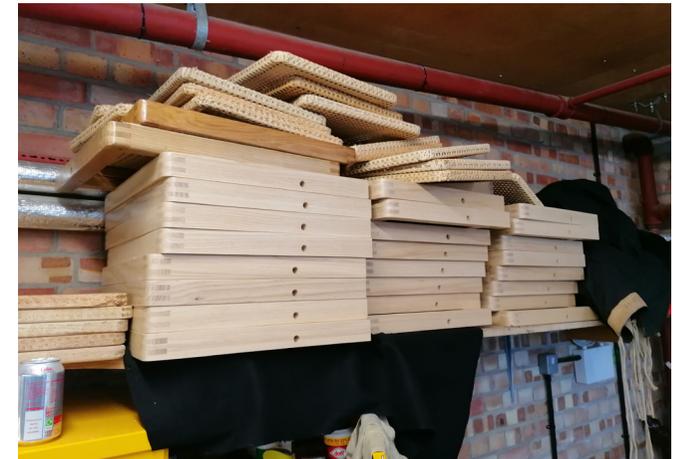
Above : Seat rattan fixing area in the Concert Hall. Below : range of fixings needed to the Ash frames to fix cracking

The design team has been asked to investigate potential solutions to the seating. Our understanding of the original Arup Associates design intent is that the chairs were not expected to contribute to the hall's acoustic, which was designed for the occupied condition only.

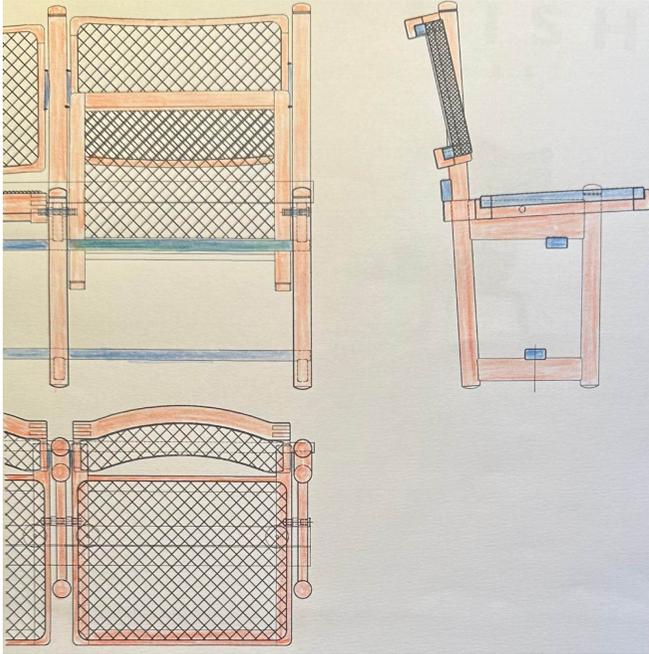
2.6.4. Proposed Changes to seats

what can probably be retained

what should certainly be replaced

- replace seat with an upholstered version, leaving the basket weave visual effect on the underside and viewable when the seats are up
 - replace seat and back with an upholstered version, and accept no basket weave on the front of the back

- replace seat and back with upholstered version and abandon the basket weave appearance altogether.
- There is also the option (discounted) of replacing the whole auditorium with modern alternatives.

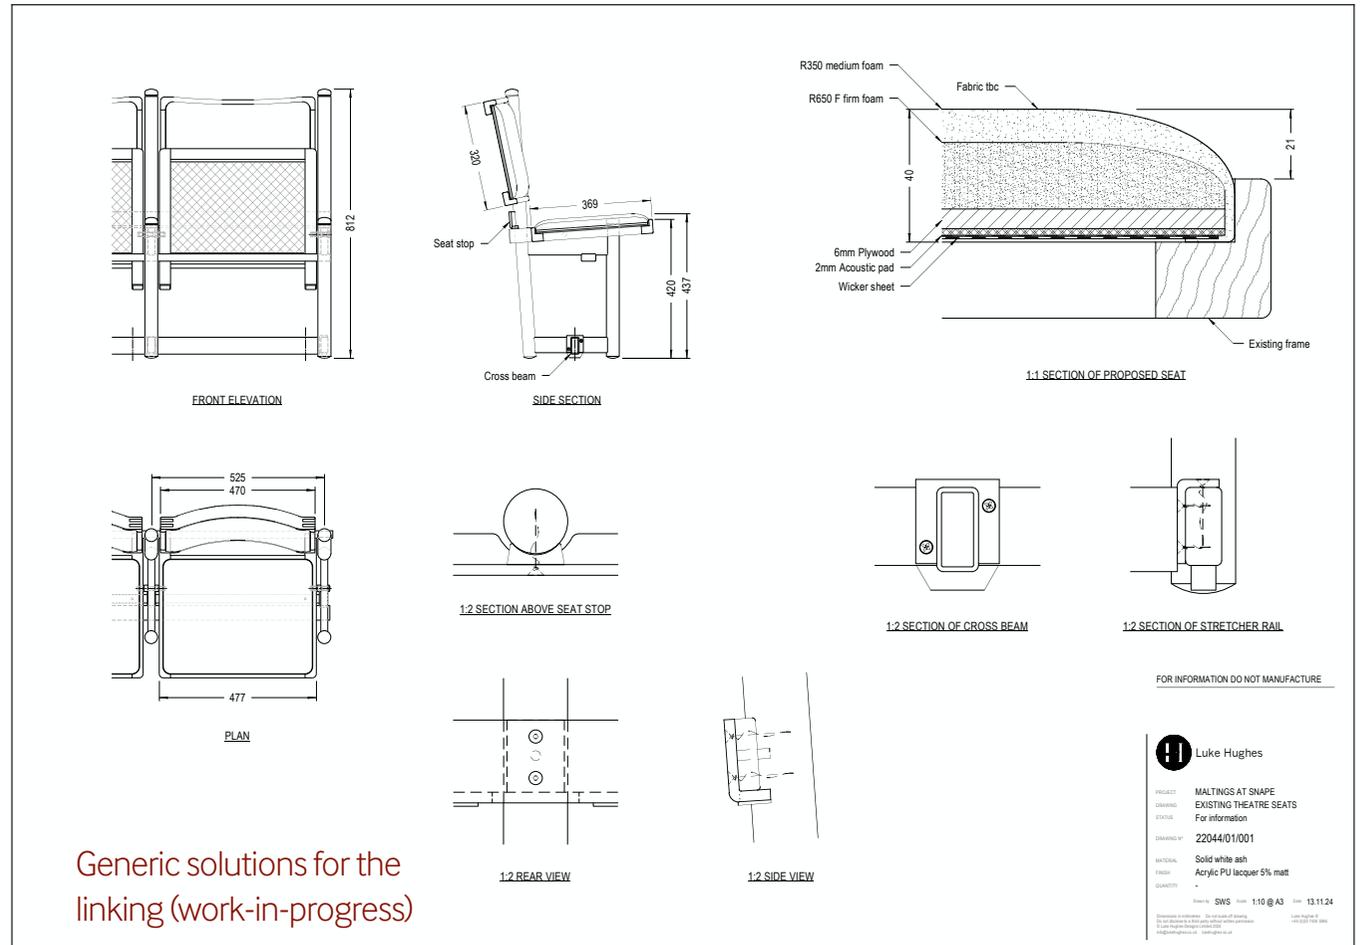
Generic solutions for the linking (work-in-progress)

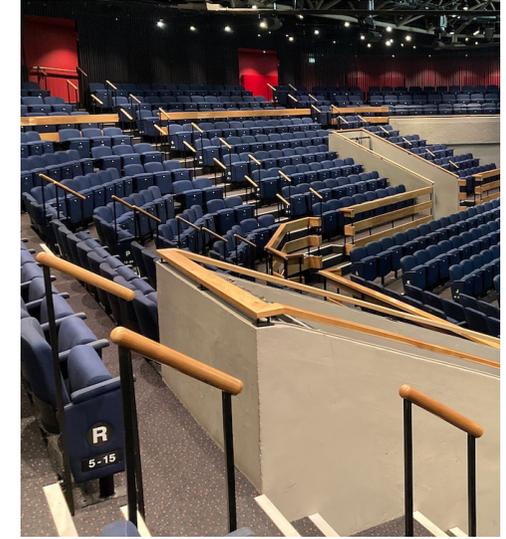
Grab rails along stepped aisles

Grab rails are proposed along the stepped aisles to assist less mobile members of the audience.
