SPECIFICATION DOCUMENT

**Penton Hook Lock House
147 Thames Side
Staines-upon-Thames
TW18 2JA**

Phase 1 - Internal Insulation Upgrades

PHASE 1 - INTERNAL WALL INSULATION UPGRADES

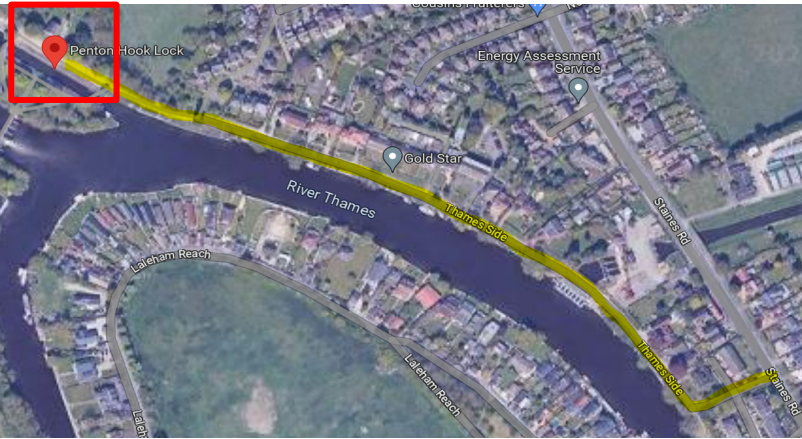
3.8.9	It should be noted that, due to the location of Penton Hook Lock House, there is limited vehicle access to the property, via the towpath - see yellow line on map below, (access via a Environment Agency key access gate). This may limit the type of plant and equipment etc. that can be carried to the property. The contractor is to visit site prior to works starting. Possible use of an Environment Agency barge boat may possibly be arranged following review (upon further clarity and confirmation from the Environment Agency).

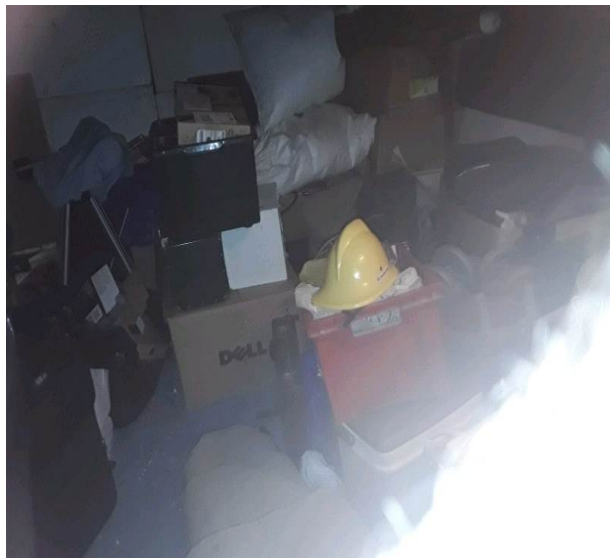
Item	Level	Building Name / Location / Room Number	Survey Type	Sample Reference	Quantity			
15	Basement	Main Cellar	Refurbishment	Visual Inspection	-

Material Description / Location		Material Risk			
			No suspect materials observed within surveyed area		Product Type	Extent of Damage	Surface Treatment	Asbestos Type
			Additional Information		-	-	-	-
			Non asbestos timber doors. Non asbestos fuseboard. Limited inspection due to stored Items, apply caution.		Score - Material Risk			
					-	-		
			Recommendations		Accessibility			
			-		-			
		Review Period						
		-						
Inspection Level		Analysis Result		Product Type		Licensed / Non-Licensed		
-		-		-		-

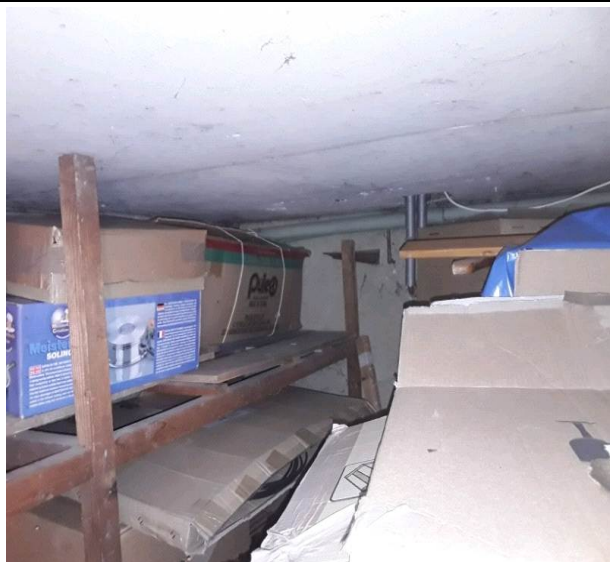
Item	Level	Building Name / Location / Room Number	Survey Type	Sample Reference	Quantity			
16	Basement	Cellar	Refurbishment	AH000065	24m²

Material Description / Location		Material Risk			
			Asbestos insulating board high level panels to ceiling		Product Type	Extent of Damage	Surface Treatment	Asbestos Type
			Additional Information		2	1	2	2
			High level unencapsulated ceiling panels. Non asbestos Vaillant boiler. Limited inspection due to stored items, apply caution.		Score - Material Risk			
					7		Medium	
			Recommendations		Accessibility			
Remove under asbestos controlled conditions if affected by works or encapsulate and manage in accordance with current asbestos legislation		High						
		Review Period						
		Annual						
Inspection Level		Analysis Result	Product Type		Licensed / Non-Licensed			
Identified		Chrysotile + Amosite	Asbestos Insulating Board		Licensable

Item	Level	Building / Location	Material Description / Product Type	Quantity	Condition (Damage)	Material Risk	Inspection	Recommendation
16	Basement	Cellar	Asbestos insulating board high level panels to ceiling	24m ²	Low Damage	Medium	Identified	Remove under asbestos controlled conditions if affected by works or encapsulate and manage in accordance with current asbestos legislation

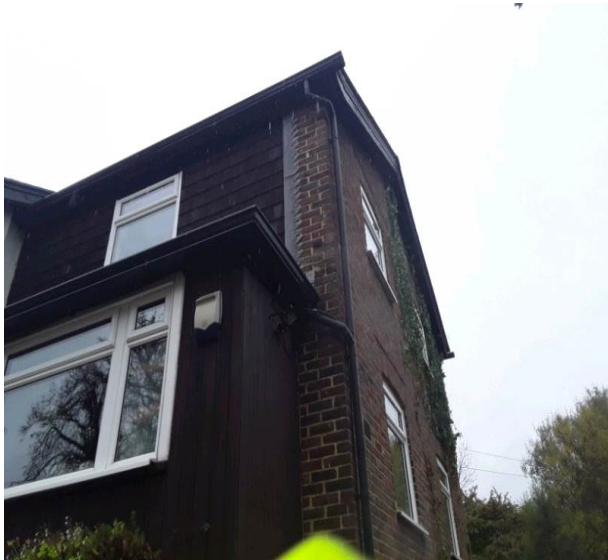
Item	Level	Building Name / Location / Room Number	Survey Type	Sample Reference	Quantity			
17	External	External Elevations	Refurbishment	Visual Inspection	-

Material Description / Location		Material Risk			
			No suspect materials observed within surveyed area		Product Type	Extent of Damage	Surface Treatment	Asbestos Type
			Additional Information		-	-	-	-
			Cast soil pipe. Plastic rainwater goods. Limited inspection above 4m, apply caution.		Score - Material Risk			
					-		-	
			Recommendations		Accessibility			
-		-						
		Review Period						
		-						
Inspection Level		Analysis Result	Product Type		Licensed / Non-Licensed			
-		-	-		-
