LOCATION:
M5 J25-24 NB MP 201.7-196.6
DRAWING No.
583 Defect Treatment Plan Sheet 1 of 6
DRAWN: FS DATE: 22/06/2020
DESIGN: FS DATE: 22/06/2020
CHECKED: CC DATE: 25/06/2020

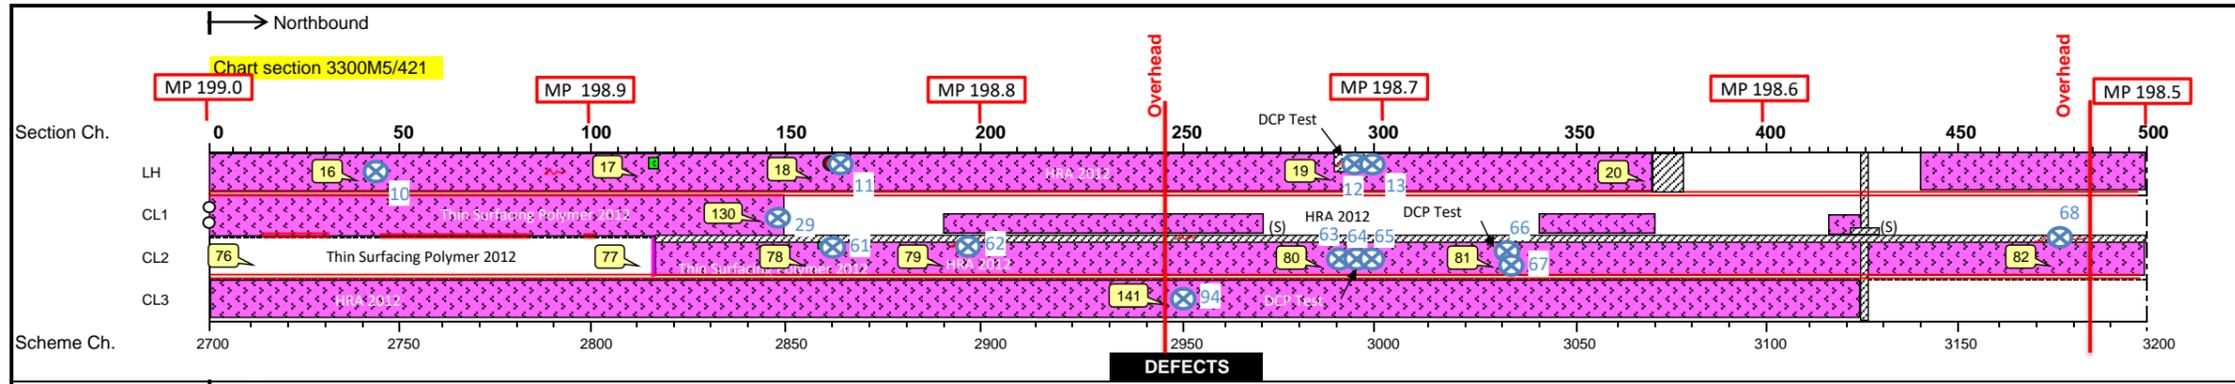
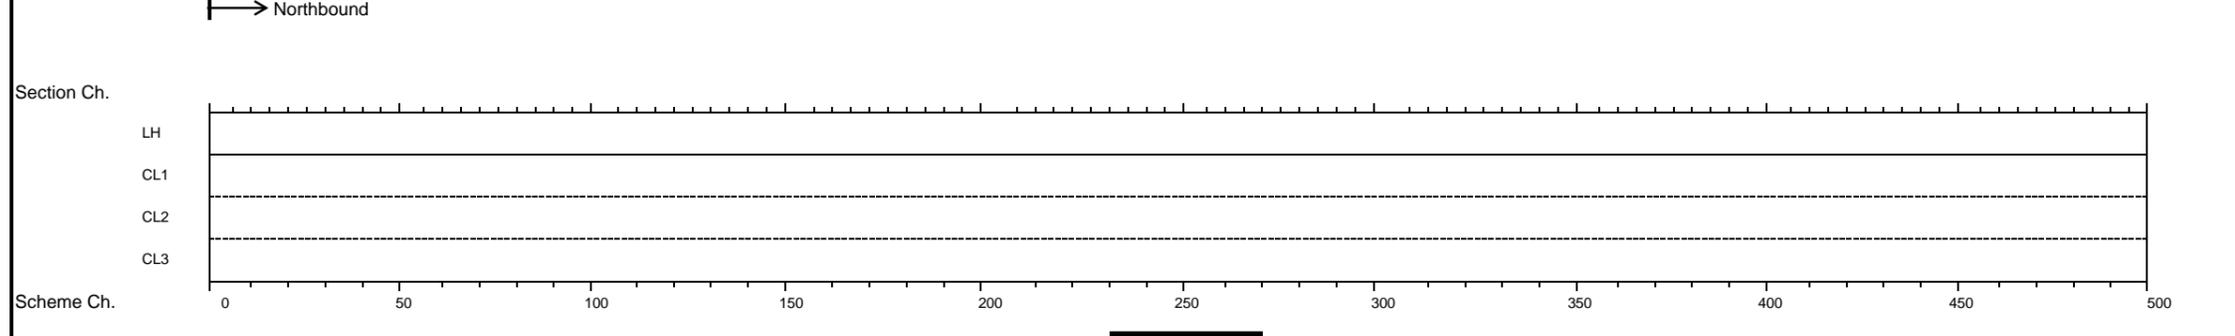
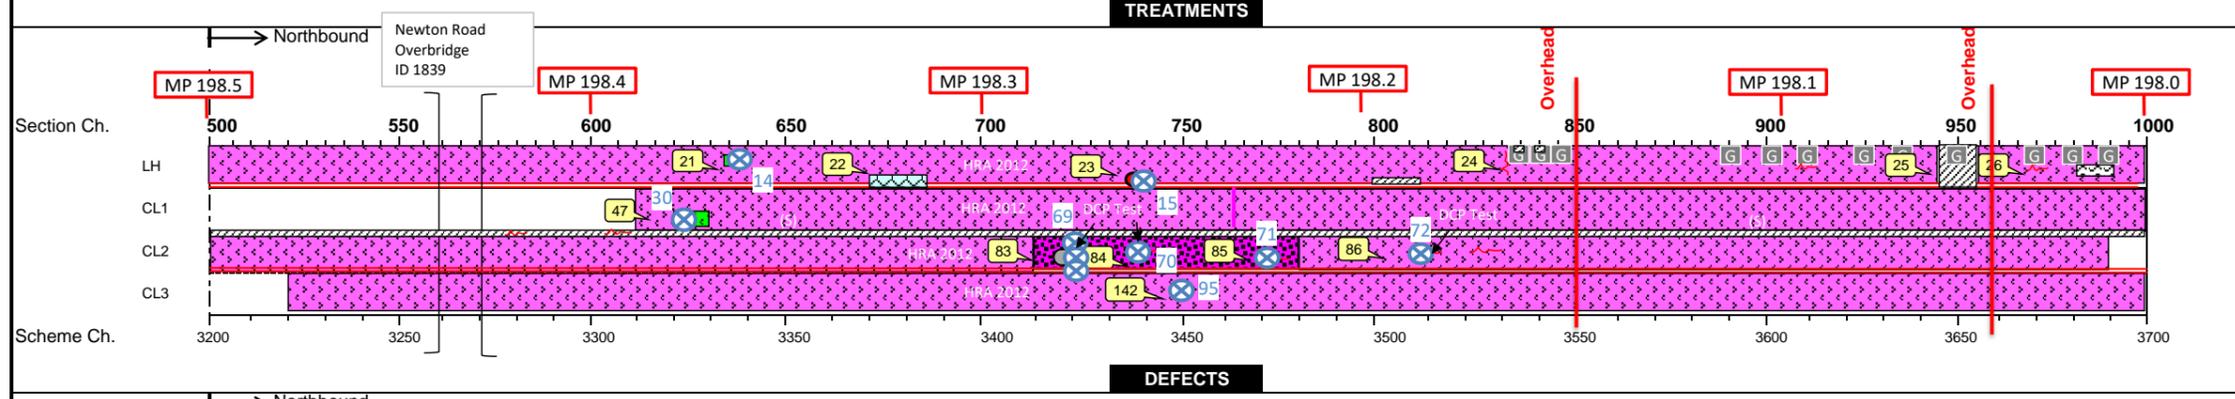
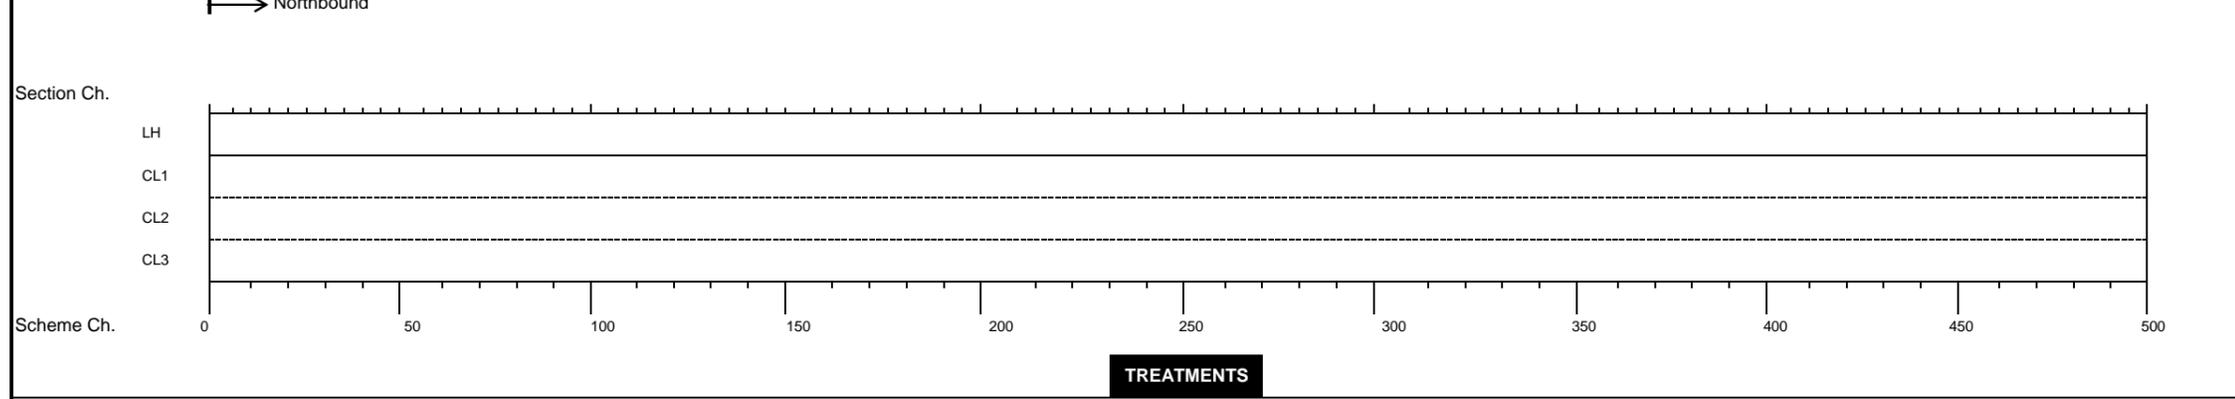
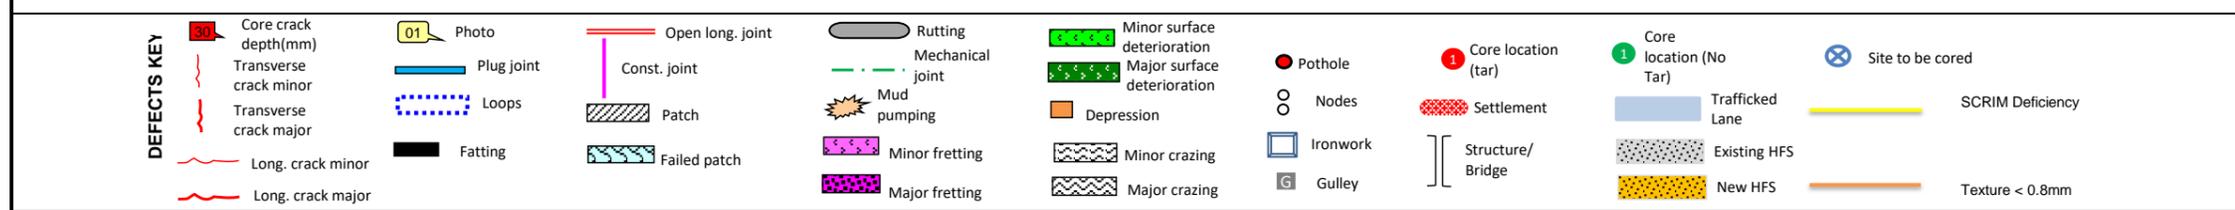
- TREATMENT KEY:**
- 50mm inlay TSCS (Do Min)
 - Fill and overbanding repair system for crack exceeding 5mm but not exceeding 10mm wide (Do Min)
 - Deep repair/ inlay (Do Something)

- 1) Dimensions are approximate and have been based on the most up-to-date AVIS video data
- 2) Only overhead power lines shown on the treatment plans. For other utilities please refer to the C2 plans for the area
- 3) Due to the potential inaccuracy of AVIS data regarding exact chainages, where Core locations are within the vicinity of a Gully, coring Contractor to adjust the location to avoid potential coring into/through carrier pipes
