## CDM – Pre-Construction Information

Nature of project		Comments/response
Name of client		Ruan Minor Village Hall Committee
Location of project		Village Hall, Ruan Minor, Helston, TR12 7JN
Nature of construction work to be carried out (e.g. scope of works)		Thermal improvements to main hall, installation of air conditioning unit and air flow improvements to roof void.
Timescale for completion of construction work		November 2023 – 2 months.
Contact names and addresses of the project team (if appointed)		RTP Surveyors – Principal Designer and Contract Administrator (Liam Mainstone BSc (Hons) PGDip Surv AssocRICS contact point)  JHA Consulting - Structural Engineer – John Harding BSc CEng MStructE
The existing environment		Comments/response
Surrounding land uses and related restrictions adjacent to proposed construction site (e.g. premises, schools, shops or factories)		Vehicular access to the property is accessed via Glebe Terrace, with private parking available for several vehicles.  Additional parking is available to the rear of the Village hall in Long Reach Car Park.  We recommend that the use of site radios is prohibited. The use of noise reduction screens should be considered

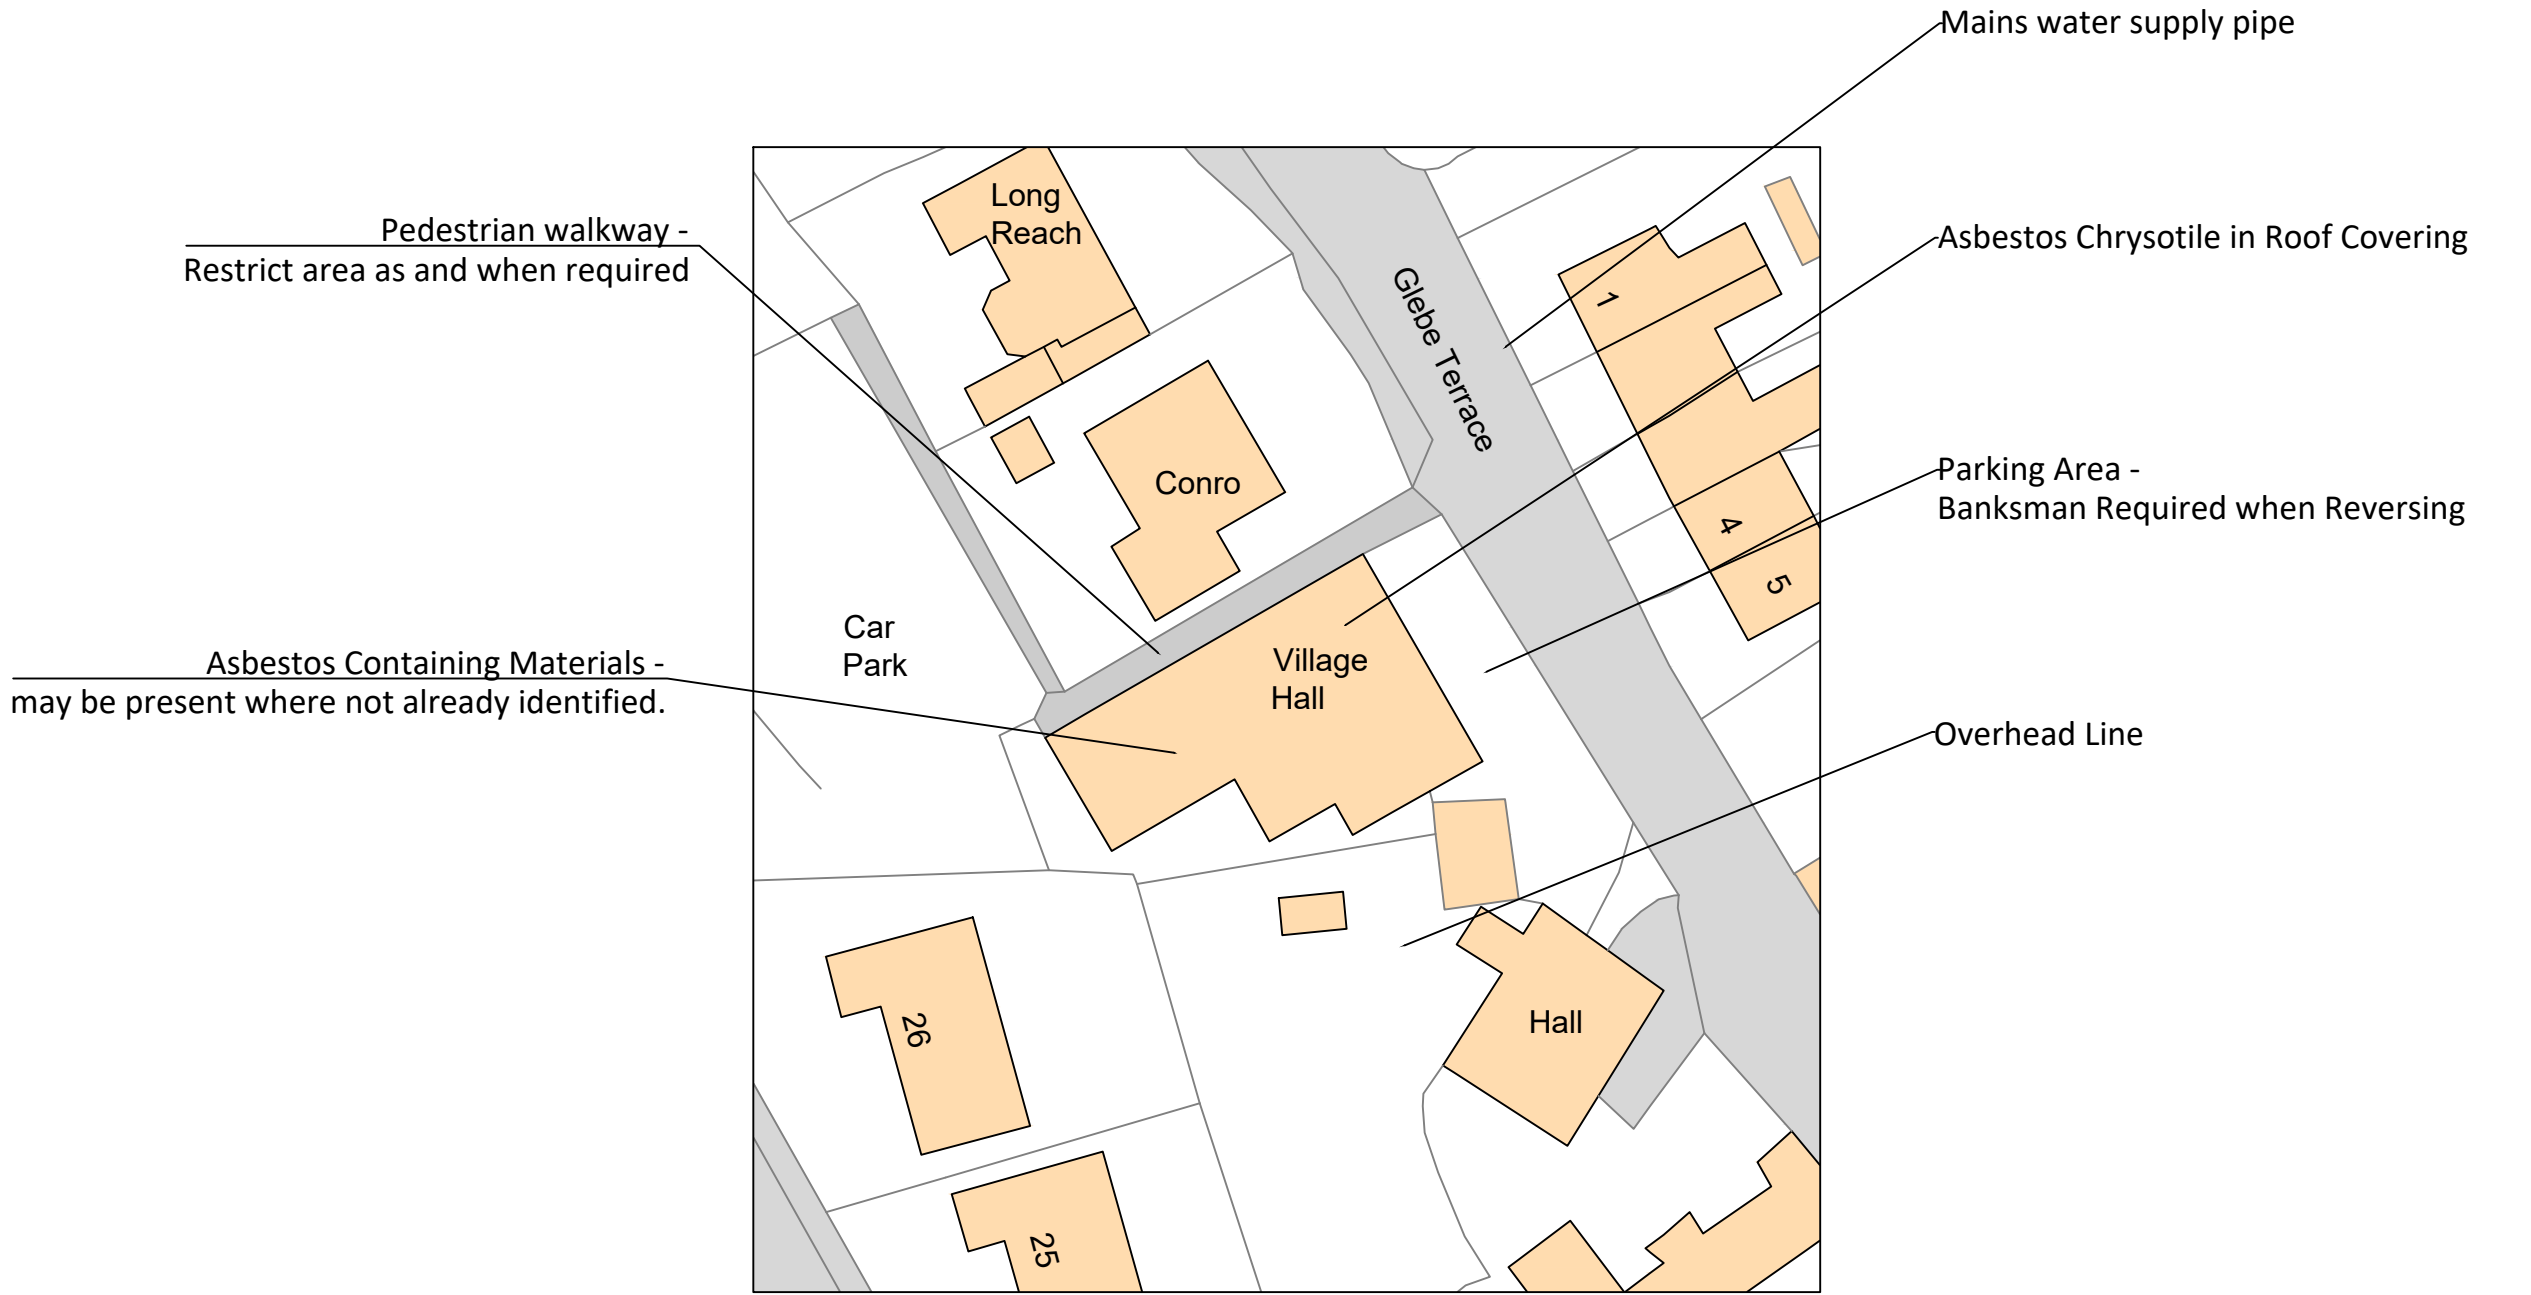
CONSTRUCTION HAZARD PLAN  
1:500

DRAWING TITLE  
Construction Hazard Plan

4) Work near high voltage power lines; **risks to be controlled by Principal Contractor (refer to WPD/National Grid information and attached CDM hazard plan).**
