LOCATION:  
M5 J25-24 NB MP 201.7-196.6

DRAWING No:  
583 Defect Treatment Plan Sheet 1 of 6

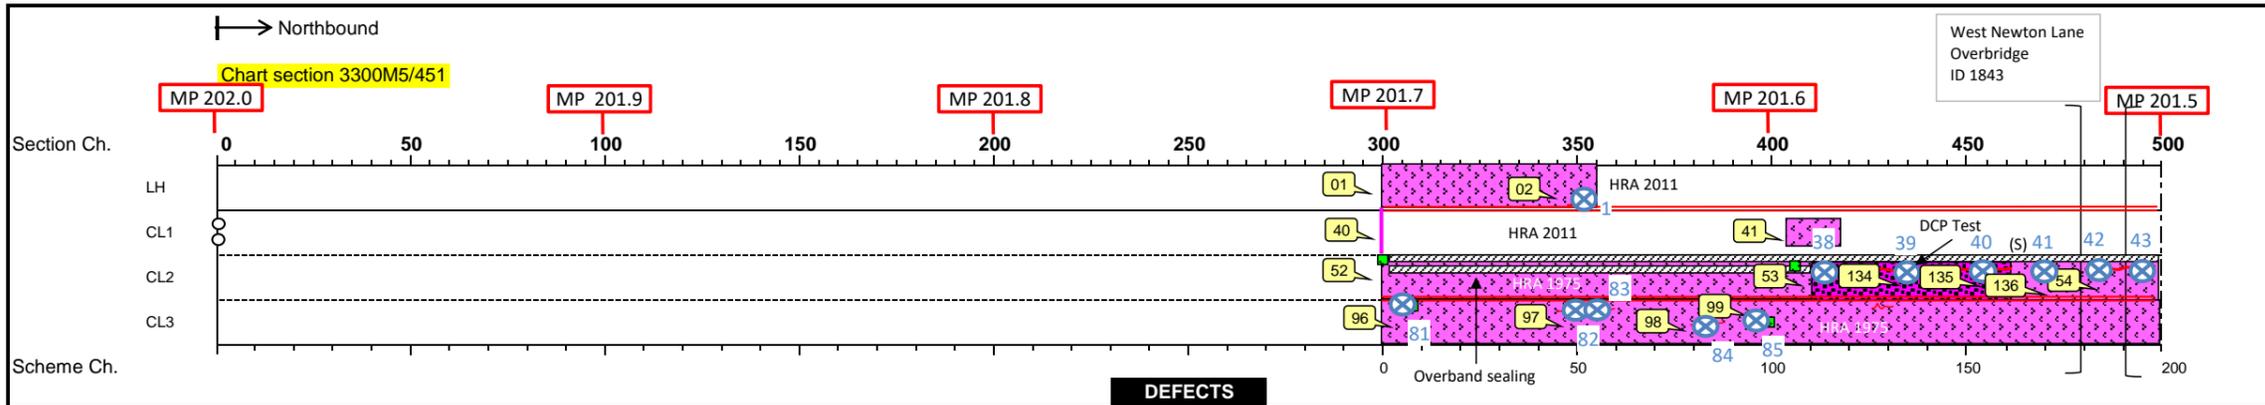
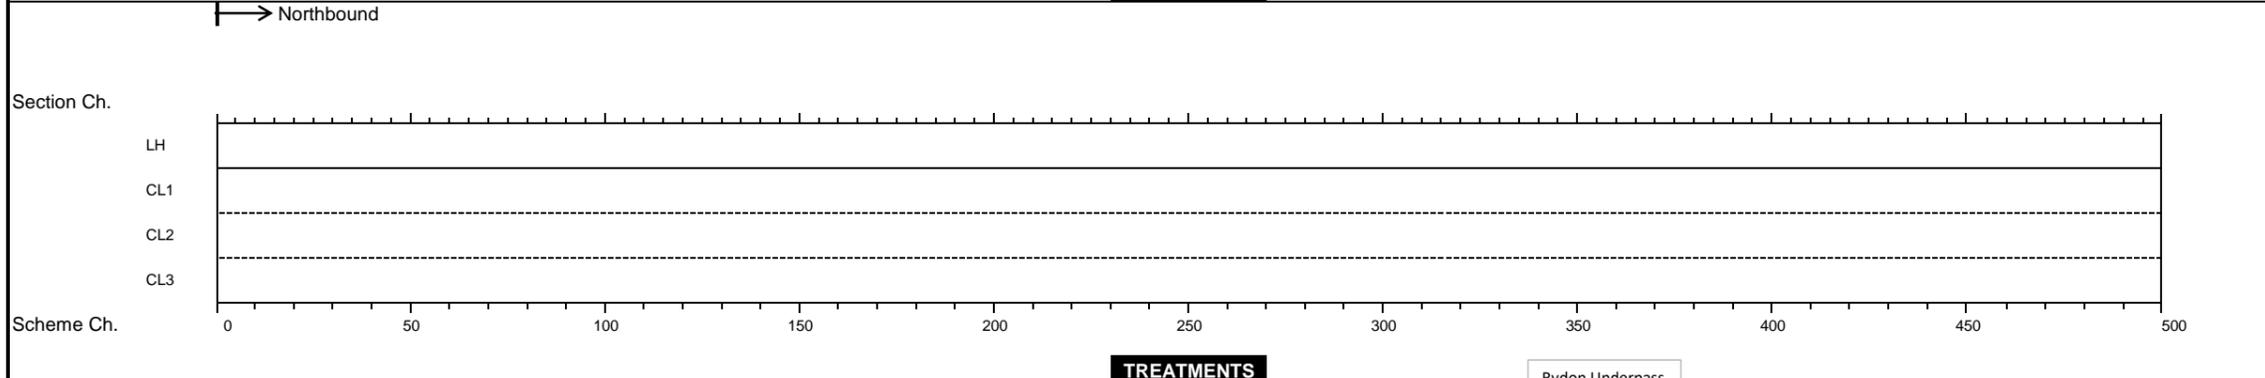
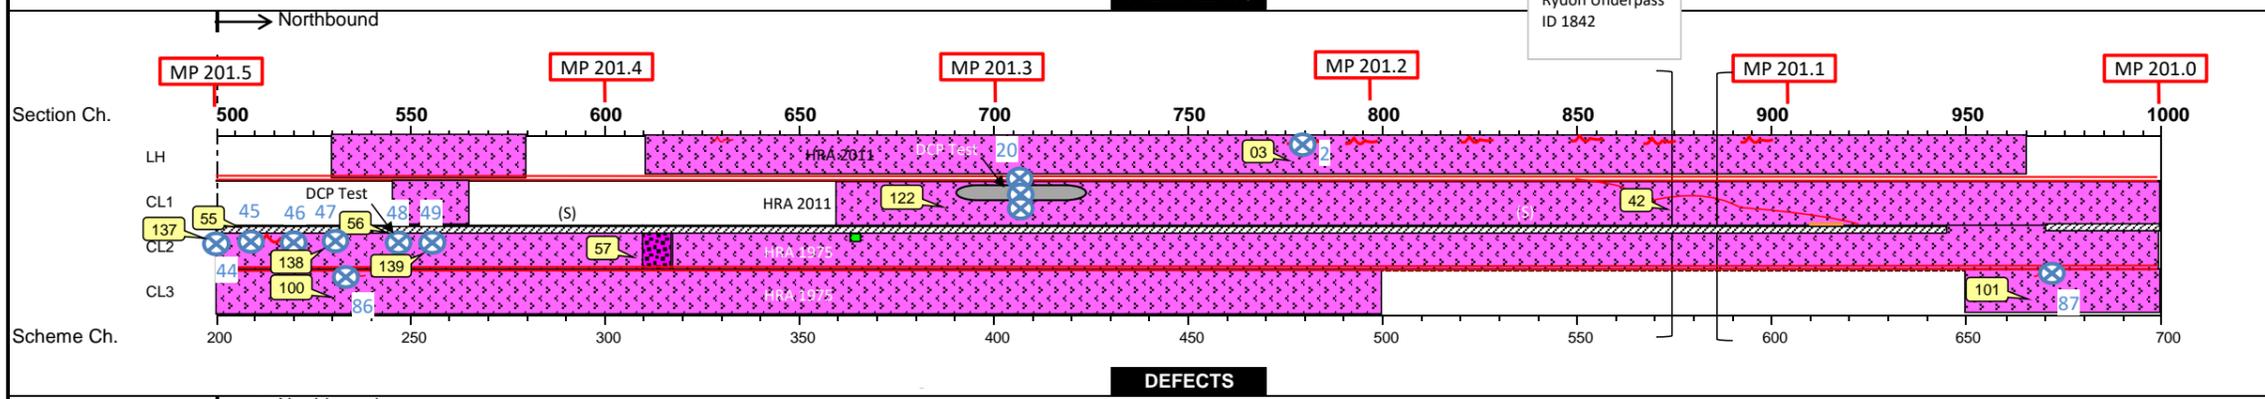
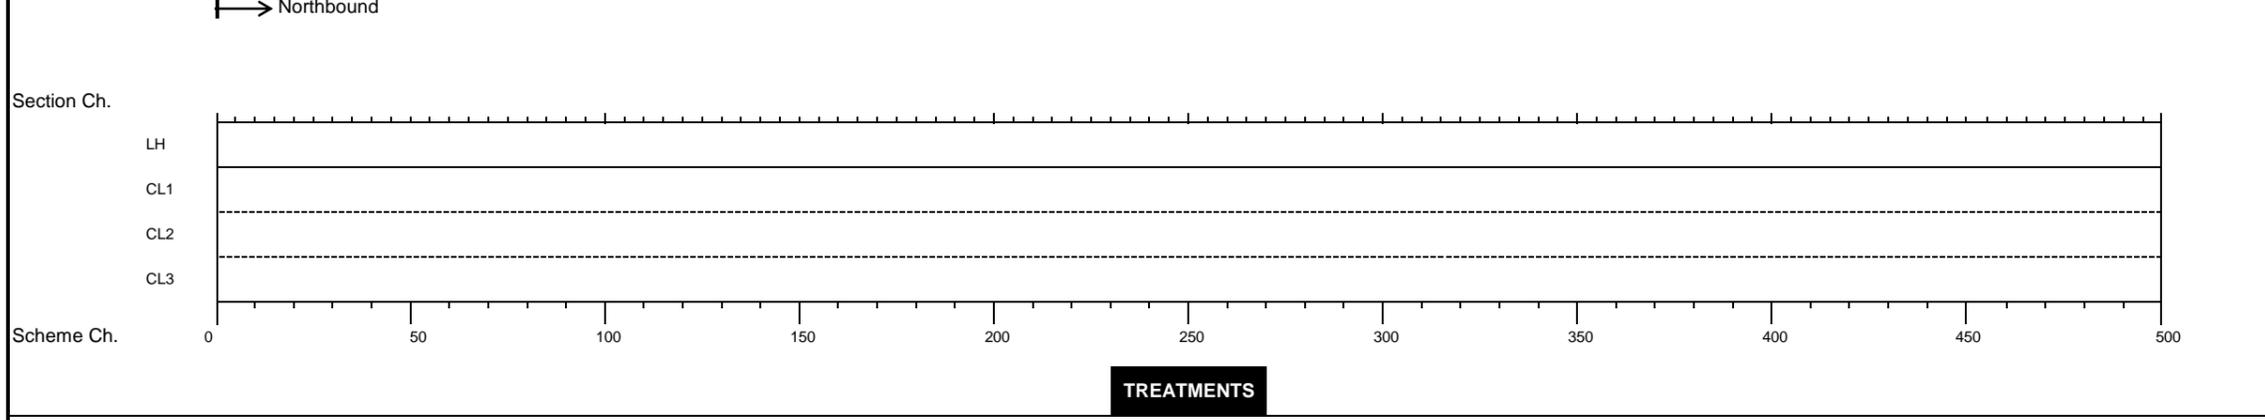
- 50mm inlay TSCS (Do Min)
- Fill and overbanding repair system for crack exceeding 5mm but not exceeding 10mm wide (Do Min)
- Deep repair/ inlay (Do Something)
