Scheme Title: A36 Serrington NB & SB MP 51.6 - 52.8 RS

Drawing Title: Defect Treatment Plan 1

Drawing No: VCS Plan 1 **Rev:** A

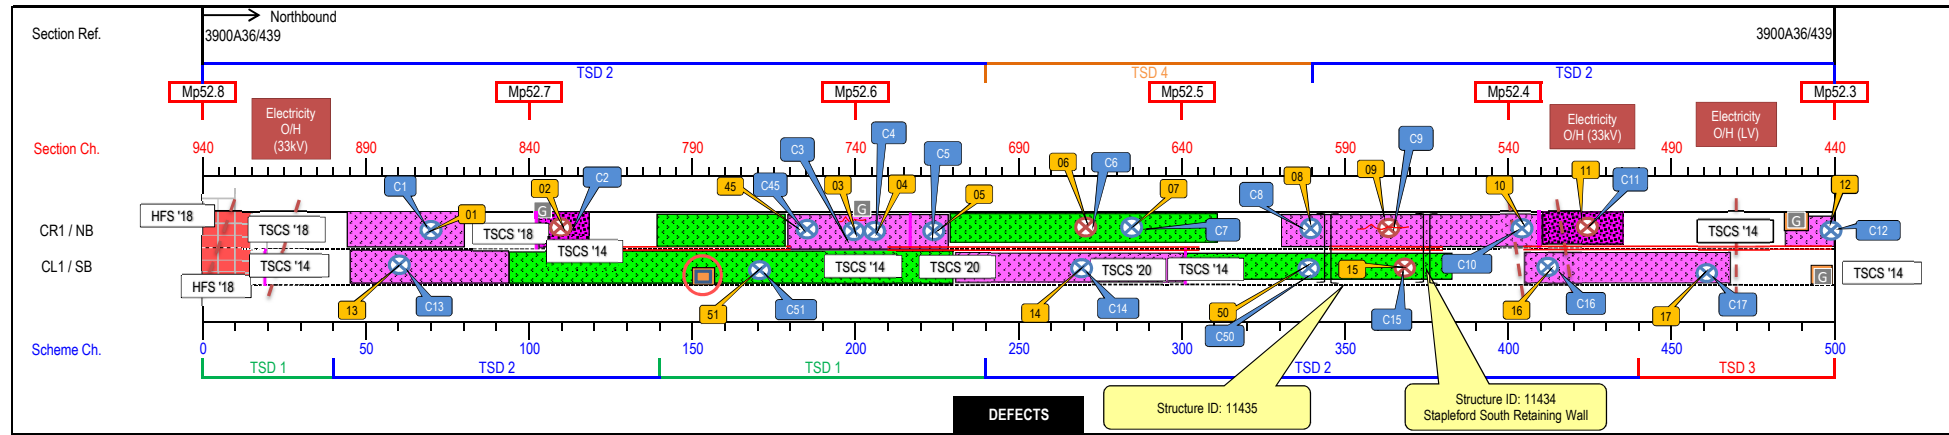
- 50mm inlay TSCS (Do Min)
- Fill and overbanding repair system for crack exceeding 5mm but not exceeding 10mm wide (Do Min)
- Deep repair/ inlay (Do Something)
