LOCATION:  
 M5 J14-15 SB MP 125 - 129.5  
 DRAWING No:  
 572 Defect Treatment Plan Sheet 4 of 5  
 DRAWN: MT DATE: 19/06/2020  
 DESIGN: MT DATE: 19/06/2020  
 CHECKED: CC DATE: 17/06/2020

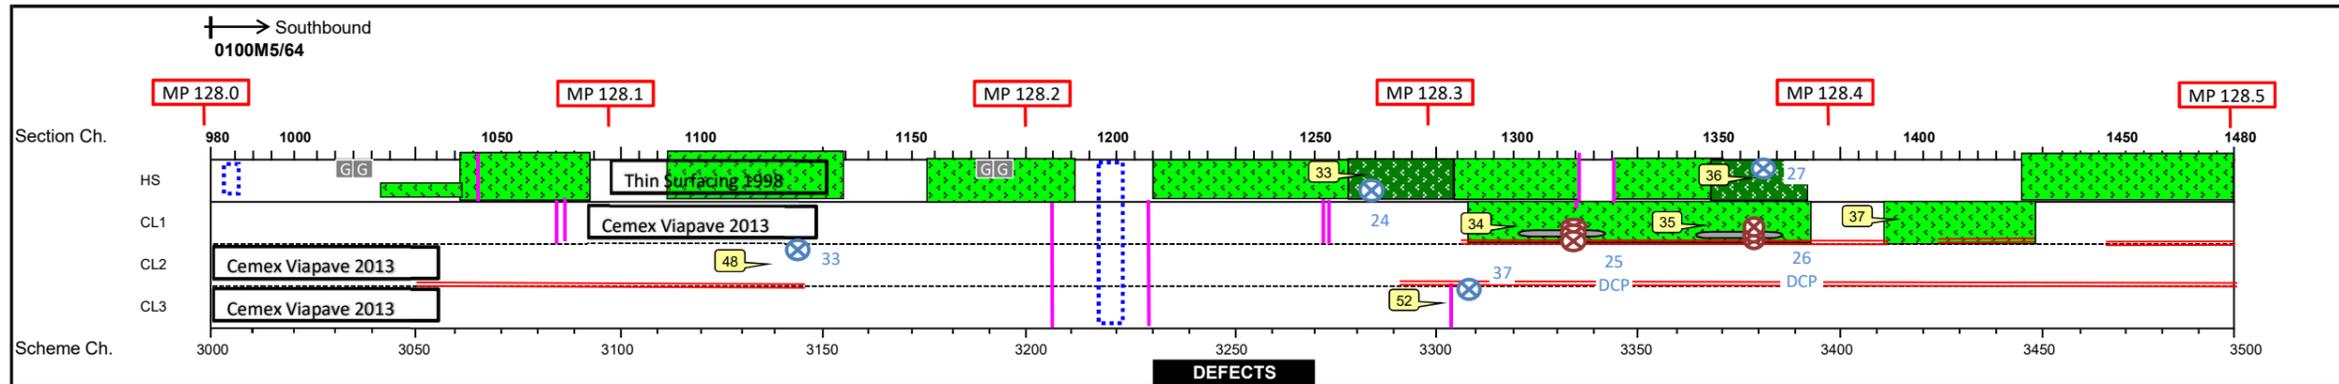
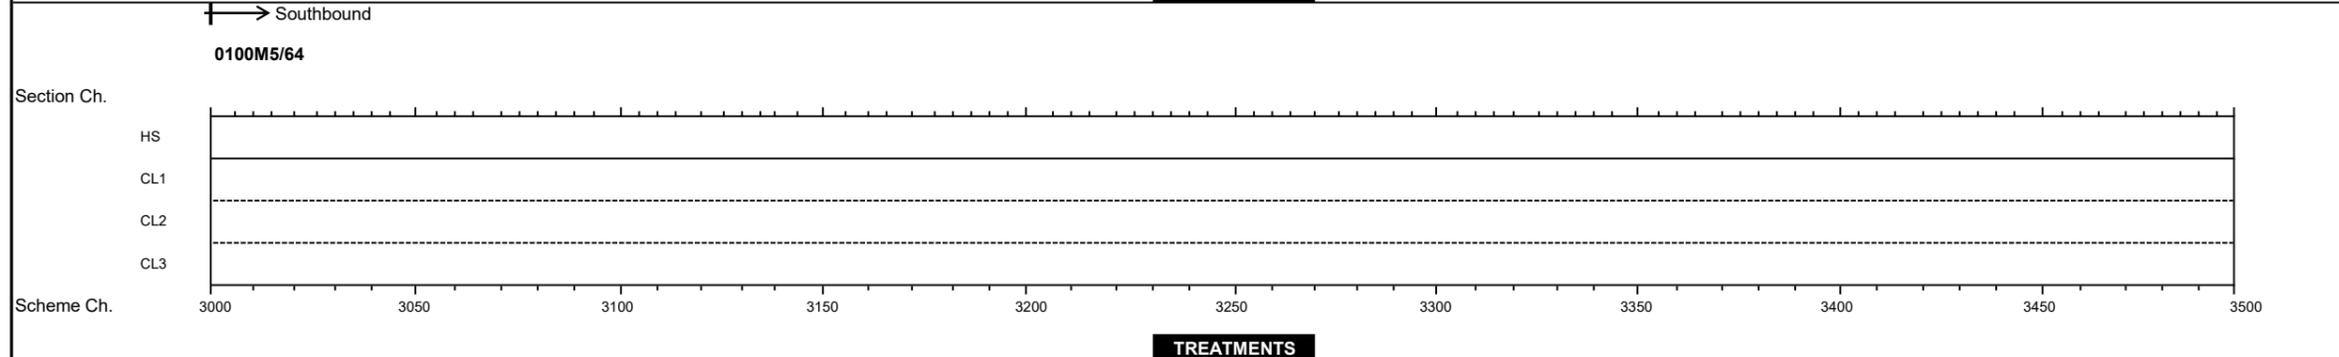
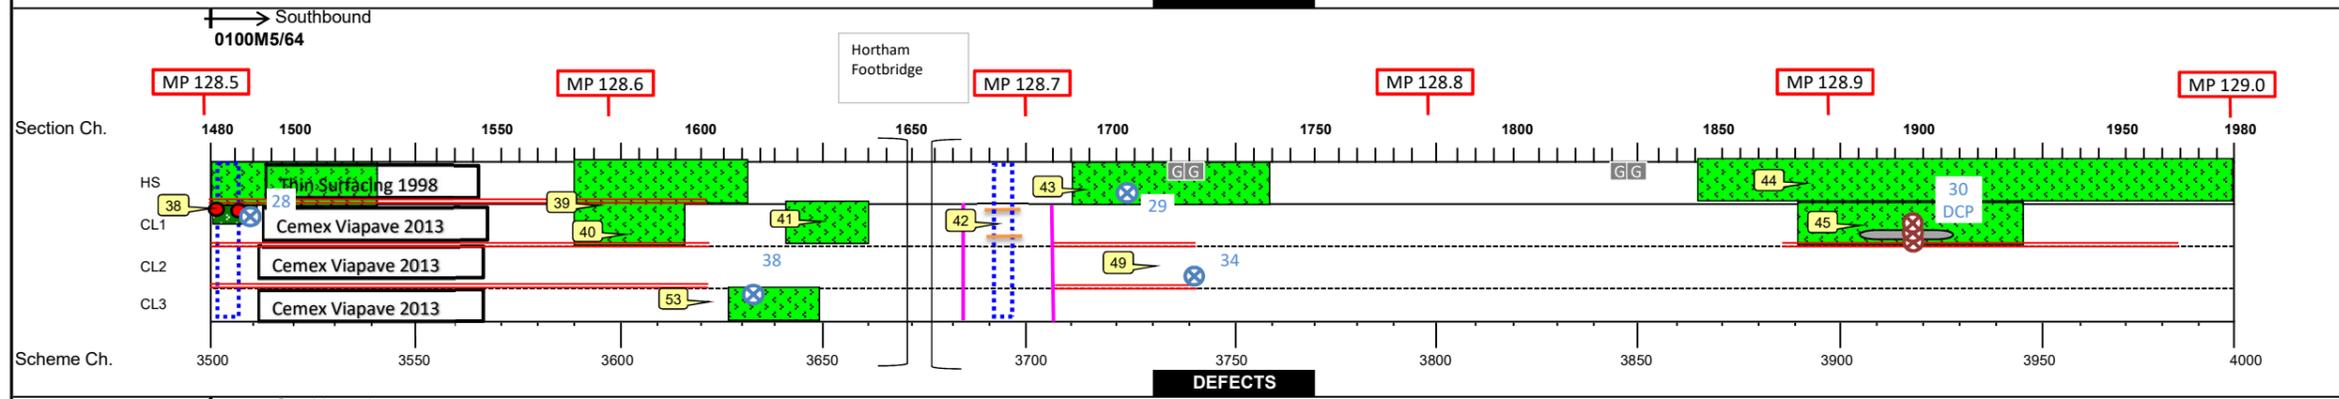
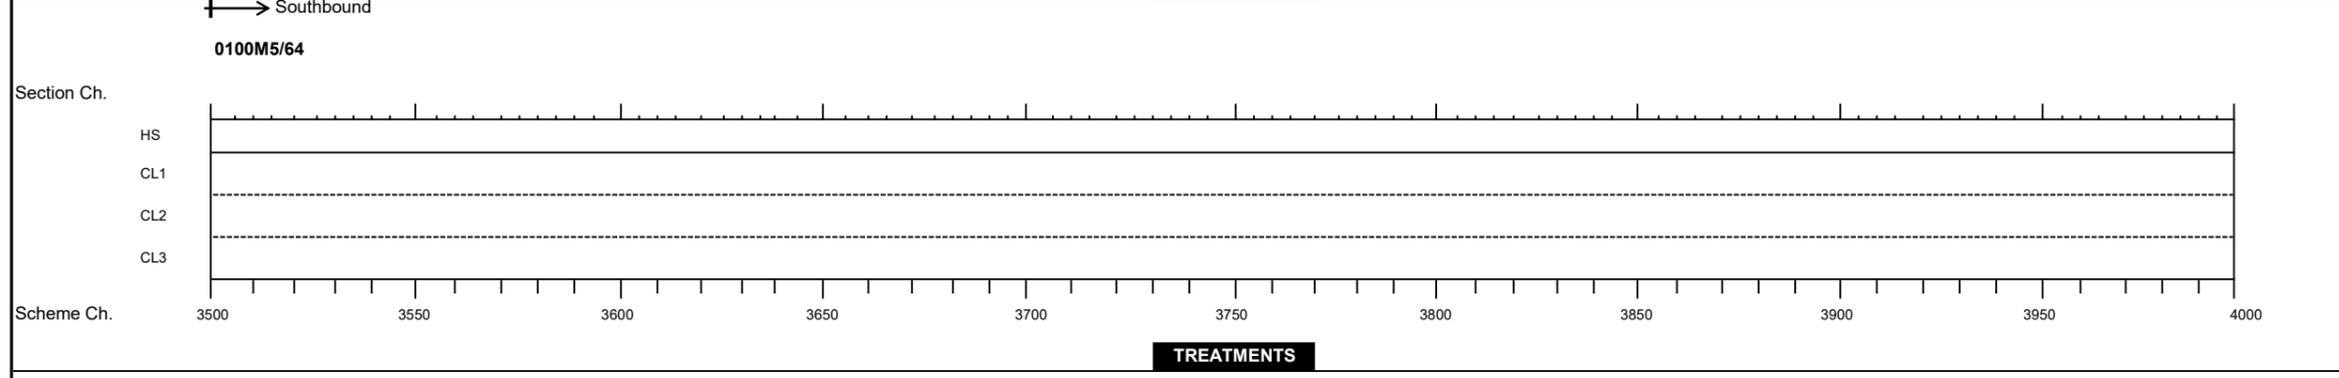
Not to scale - for illustrative purposes only

- TREATMENT KEY:**
- 50mm inlay TSCS (Do Min)
  - Fill and overbanding repair system for crack exceeding 5mm but not exceeding 10mm wide (Do Min)
  - Deep repair/ inlay (Do Something)
