SPECIFICATION DOCUMENT

**Penton Hook Lock House
147 Thames Side
Staines-upon-Thames
TW18 2JA**

Phase 1 - Internal Insulation Upgrades

PHASE 1 - INTERNAL INSULATION UPGRADES

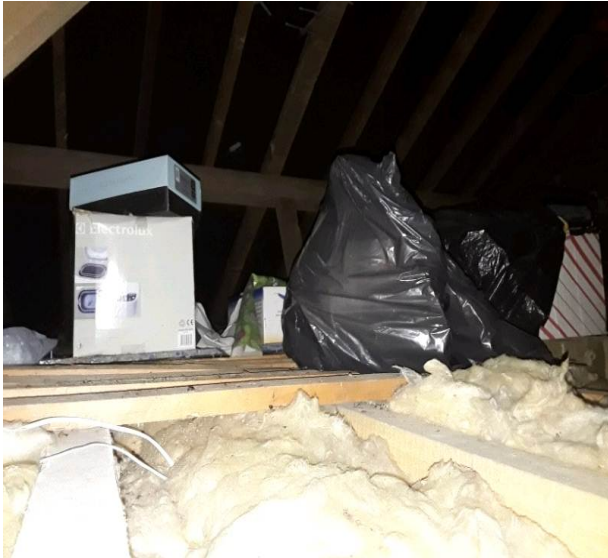
Item	Level	Building Name / Location / Room Number	Survey Type	Sample Reference	Quantity			
1	Roof Void	Loft Space 1	Refurbishment	Visual Inspection	-

Material Description / Location		Material Risk			
			No suspect materials observed within surveyed area		Product Type	Extent of Damage	Surface Treatment	Asbestos Type
			Additional Information		-	-	-	-
			Limited inspection due to volume of insulation.		Score - Material Risk			
					-		-	
			Recommendations		Accessibility			
			-		-			
Review Period								
-								
Inspection Level		Analysis Result		Product Type		Licensed / Non-Licensed		
-		-		-		-

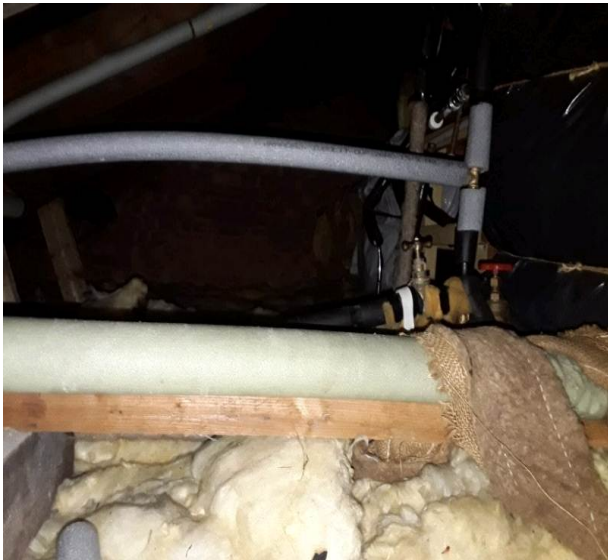
Item	Level	Building Name / Location / Room Number	Survey Type	Sample Reference	Quantity			
2	Roof Void	Loft Space 2	Refurbishment	Visual Inspection	-

Material Description / Location		Material Risk			
			No suspect materials observed within surveyed area		Product Type	Extent of Damage	Surface Treatment	Asbestos Type
			Additional Information		-	-	-	-
			Limited inspection due to volume of insulation and accessibility, apply caution. Plastic water tanks. Foam wrapped pipework.		Score - Material Risk			
					-		-	
			Recommendations		Accessibility			
			-		-			
Review Period								
-								
Inspection Level		Analysis Result		Product Type		Licensed / Non-Licensed		
-		-		-		-

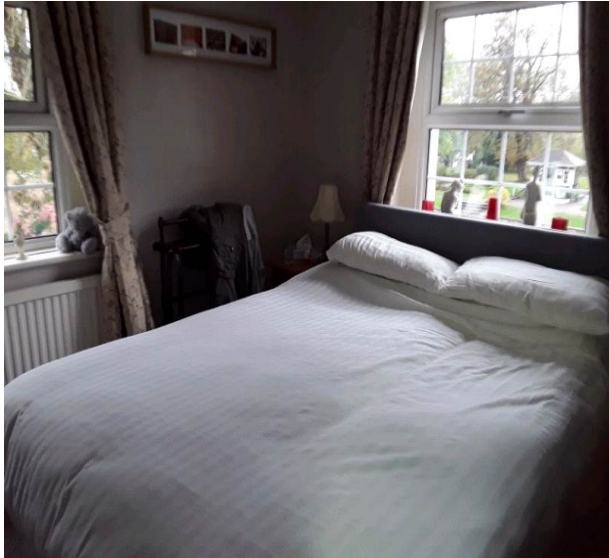
Item	Level	Building Name / Location / Room Number	Survey Type	Sample Reference	Quantity			
3	First Floor	Bedroom 1	Refurbishment	Visual Inspection	-

Material Description / Location		Material Risk			
			No suspect materials observed within surveyed area		Product Type	Extent of Damage	Surface Treatment	Asbestos Type
					-	-	-	-
			Additional Information		-	-	-	-
			UPVC windows. Non asbestos timber doors.		Score - Material Risk			
					-		-	
			Recommendations		Accessibility			
			-		-			
Review Period								
-								
Inspection Level		Analysis Result		Product Type		Licensed / Non-Licensed		
-		-		-		-

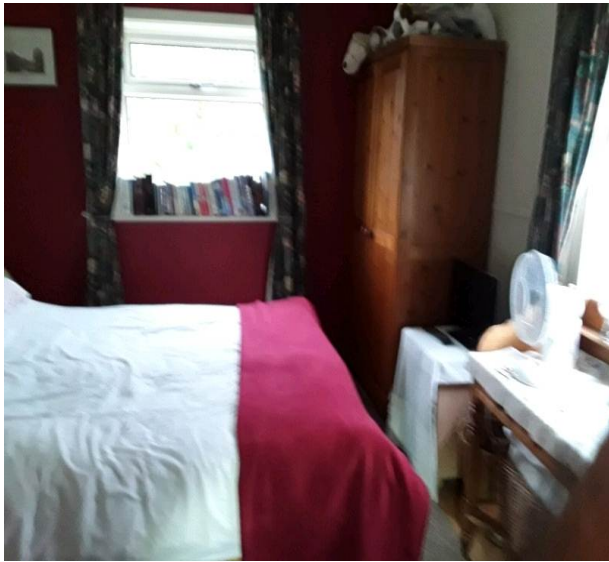
Item	Level	Building Name / Location / Room Number	Survey Type	Sample Reference	Quantity			
4	First Floor	Bedroom 2	Refurbishment	Visual Inspection	-

Material Description / Location		Material Risk			
			No suspect materials observed within surveyed area		Product Type	Extent of Damage	Surface Treatment	Asbestos Type
			Additional Information		-	-	-	-
			UPVC windows. Non asbestos timber doors.		Score - Material Risk			
					-		-	
			Recommendations		Accessibility			
			-		-			
Review Period								
-								
Inspection Level		Analysis Result		Product Type		Licensed / Non-Licensed		
-		-		-		-

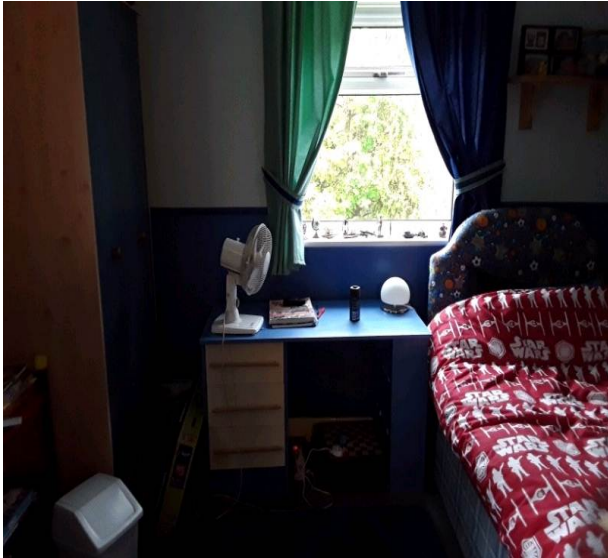
Item	Level	Building Name / Location / Room Number	Survey Type	Sample Reference	Quantity			
5	First Floor	Bedroom 3	Refurbishment	Visual Inspection	-

Material Description / Location		Material Risk			
			No suspect materials observed within surveyed area		Product Type	Extent of Damage	Surface Treatment	Asbestos Type
			Additional Information		-	-	-	-
			UPVC windows. Non asbestos timber doors.		Score - Material Risk			
					-		-	
			Recommendations		Accessibility			
			-		-			
Review Period								
-								
Inspection Level		Analysis Result		Product Type		Licensed / Non-Licensed		
-		-		-		-

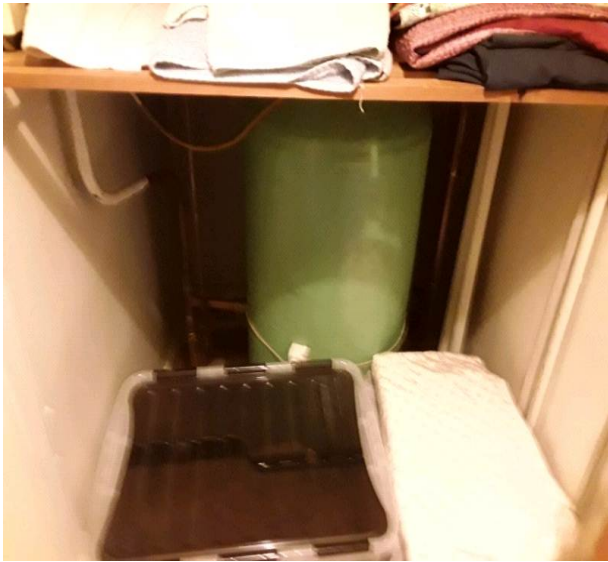
Item	Level	Building Name / Location / Room Number	Survey Type	Sample Reference	Quantity				
6	First Floor	Airing Cupboard	Refurbishment	Visual Inspection	-

Material Description / Location		Material Risk				
			No suspect materials observed within surveyed area		Product Type	Extent of Damage	Surface Treatment	Asbestos Type	
			Additional Information		-	-	-	-	
			Copper tank with foam jacket. Non asbestos timber doors.		Score - Material Risk				
					-		-		
			Recommendations		Accessibility				
			-		-				
Review Period									
		-							
Inspection Level		Analysis Result		Product Type		Licensed / Non-Licensed			
-		-		-		-

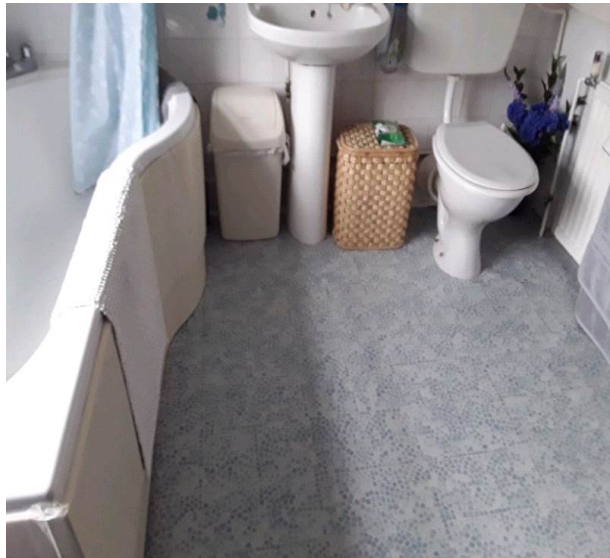
Item	Level	Building Name / Location / Room Number	Survey Type	Sample Reference	Quantity			
7	First Floor	Bathroom	Refurbishment	Visual Inspection	-

Material Description / Location		Material Risk			
			No suspect materials observed within surveyed area		Product Type	Extent of Damage	Surface Treatment	Asbestos Type
			Additional Information		-	-	-	-
			UPVC windows. Plastic bath panel. Ceramic toilet cistern. Non asbestos vinyl flooring. Limited inspection below fixed glue fixed vinyl flooring without causing irreparable damage, apply caution.		Score - Material Risk			
					-		-	
			Recommendations		Accessibility			
-		-						
		Review Period						
		-						
Inspection Level		Analysis Result		Product Type		Licensed / Non-Licensed		
-		-		-		-

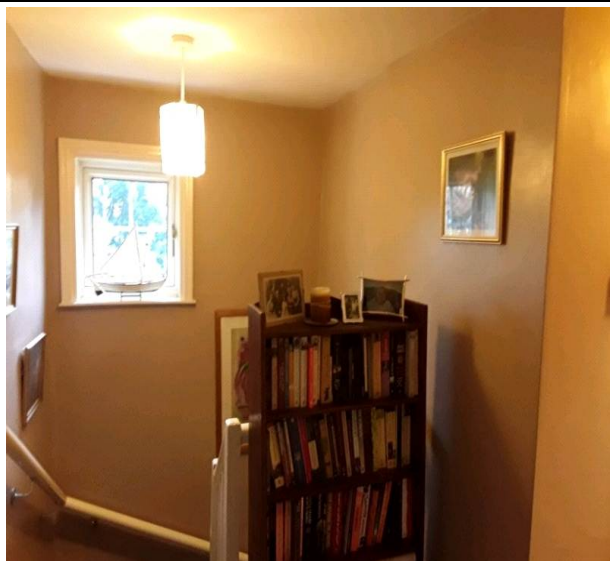
Item	Level	Building Name / Location / Room Number	Survey Type	Sample Reference	Quantity			
8	First Floor	Stairs/ Landing and Cupboard	Refurbishment	Visual Inspection	-

Material Description / Location		Material Risk			
			No suspect materials observed within surveyed area		Product Type	Extent of Damage	Surface Treatment	Asbestos Type
			Additional Information		-	-	-	-
			UPVC windows. Non asbestos timber doors. Timber trap hatch.		Score - Material Risk			
					-		-	
			Recommendations		Accessibility			
			-		-			
Review Period								
-								
Inspection Level		Analysis Result		Product Type		Licensed / Non-Licensed		
-		-		-		-

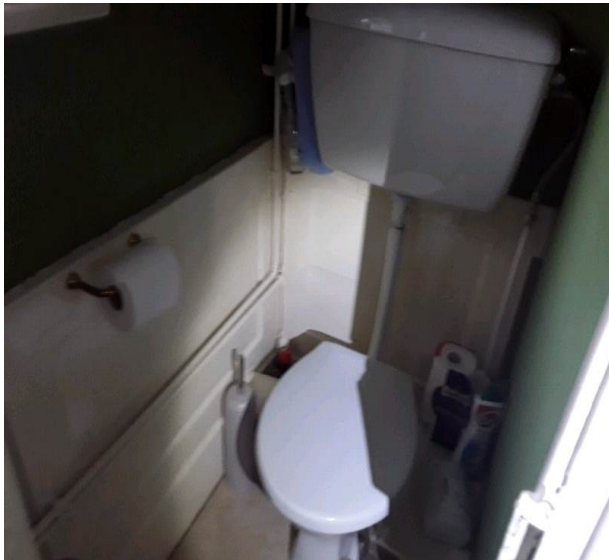
Item	Level	Building Name / Location / Room Number	Survey Type	Sample Reference	Quantity			
10	Ground Floor	Toilet	Refurbishment	Visual Inspection	-

Material Description / Location		Material Risk			
			No suspect materials observed within surveyed area		Product Type	Extent of Damage	Surface Treatment	Asbestos Type
			Additional Information		-	-	-	-
			UPVC windows. Ceramic toilet cistern. Non asbestos vinyl flooring. Limited inspection below fixed glue fixed vinyl flooring without causing irreparable damage, apply caution.		Score - Material Risk			
					-		-	
			Recommendations		Accessibility			
			-		-			
Review Period								
-								
Inspection Level		Analysis Result		Product Type		Licensed / Non-Licensed		
-		-		-		-

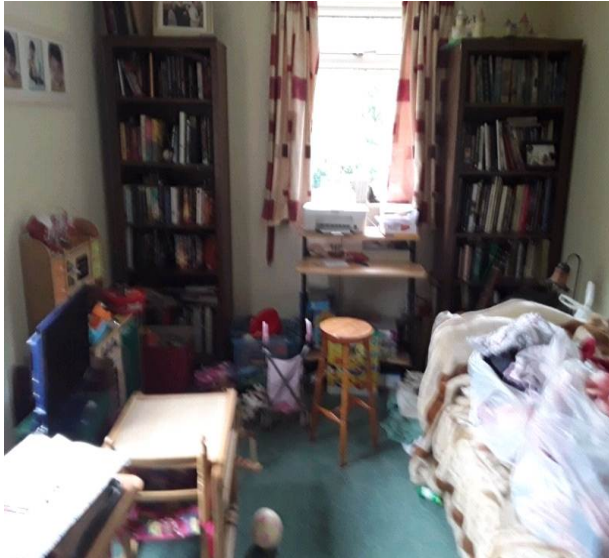
Item	Level	Building Name / Location / Room Number	Survey Type	Sample Reference	Quantity			
11	Ground Floor	Parlour	Refurbishment	Visual Inspection	-

Material Description / Location		Material Risk			
			No suspect materials observed within surveyed area		Product Type	Extent of Damage	Surface Treatment	Asbestos Type
			Additional Information		-	-	-	-
			UPVC windows. Non asbestos timber doors. Timber infill panel to fireplace. No access within fireplace, apply caution.		Score - Material Risk			
					-		-	
			Recommendations		Accessibility			
-		-						
		Review Period						
		-						
Inspection Level		Analysis Result		Product Type		Licensed / Non-Licensed		
-		-		-		-

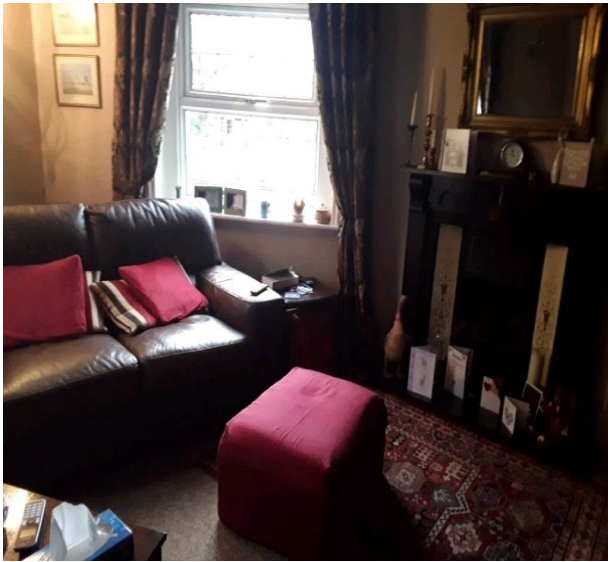
Item	Level	Building Name / Location / Room Number	Survey Type	Sample Reference	Quantity			
12	Ground Floor	Lounge	Refurbishment	Visual Inspection	-

Material Description / Location		Material Risk			
			No suspect materials observed within surveyed area		Product Type	Extent of Damage	Surface Treatment	Asbestos Type
			Additional Information		-	-	-	-
			UPVC windows. Non asbestos timber doors. No access within fireplace, apply caution.		Score - Material Risk			
					-		-	
			Recommendations		Accessibility			
			-		-			
Review Period								
-								
Inspection Level		Analysis Result		Product Type		Licensed / Non-Licensed		
-		-		-		-

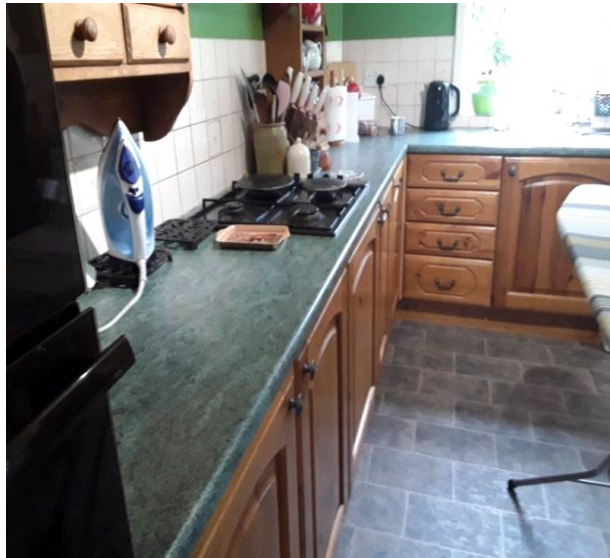
Item	Level	Building Name / Location / Room Number	Survey Type	Sample Reference	Quantity			
13	Ground Floor	Kitchen	Refurbishment	Visual Inspection	-

Material Description / Location		Material Risk			
			No suspect materials observed within surveyed area		Product Type	Extent of Damage	Surface Treatment	Asbestos Type
					-	-	-	-
			Additional Information		Score - Material Risk			
			UPVC windows. Non asbestos timber doors. Non asbestos vinyl flooring. Timber boxing. Non asbestos damper pad to sink. Limited inspection below glue fixed vinyl flooring without causing irreparable damage, apply caution.		-			
					-			
			Recommendations		Accessibility			
-		-						
		Review Period						
		-						
Inspection Level		Analysis Result		Product Type		Licensed / Non-Licensed		
-		-		-		-

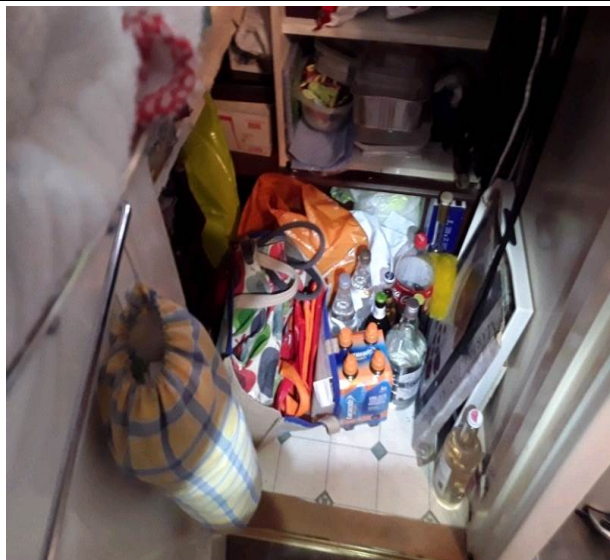
Item	Level	Building Name / Location / Room Number	Survey Type	Sample Reference	Quantity			
14	Ground Floor	Kitchen Store	Refurbishment	Visual Inspection	-

Material Description / Location		Material Risk			
			No suspect materials observed within surveyed area		Product Type	Extent of Damage	Surface Treatment	Asbestos Type
			Additional Information		-	-	-	-
			UPVC windows. Non asbestos timber doors. Non asbestos vinyl flooring.		Score - Material Risk			
					-		-	
			Recommendations		Accessibility			
-		-						
		Review Period						
		-						
Inspection Level		Analysis Result		Product Type		Licensed / Non-Licensed		
-		-		-		-

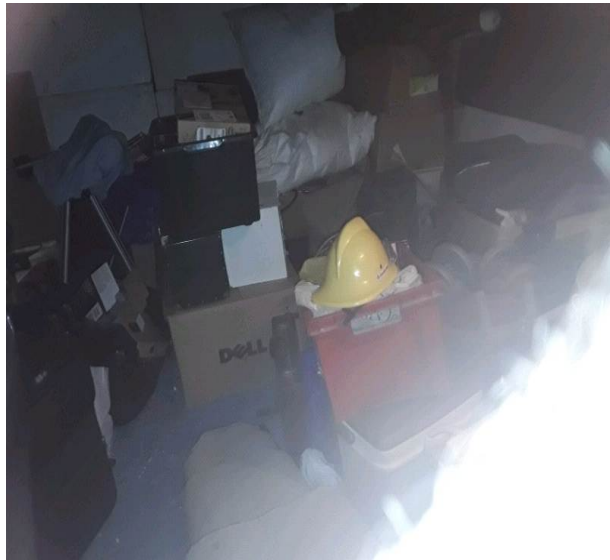
Item	Level	Building Name / Location / Room Number	Survey Type	Sample Reference	Quantity			
15	Basement	Main Cellar	Refurbishment	Visual Inspection	-

Material Description / Location		Material Risk			
			No suspect materials observed within surveyed area		Product Type	Extent of Damage	Surface Treatment	Asbestos Type
			Additional Information		-	-	-	-
			Non asbestos timber doors. Non asbestos fuseboard. Limited inspection due to stored Items, apply caution.		Score - Material Risk			
					-	-		
			Recommendations		Accessibility			
			-		-			
		Review Period						
		-						
Inspection Level		Analysis Result	Product Type		Licensed / Non-Licensed			
-		-	-		-

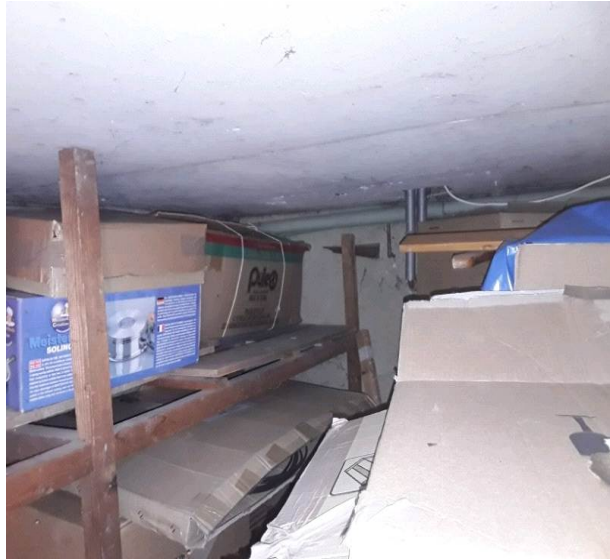
Item	Level	Building Name / Location / Room Number	Survey Type	Sample Reference	Quantity			
16	Basement	Cellar	Refurbishment	AH000065	24m²

Material Description / Location		Material Risk			
			Asbestos insulating board high level panels to ceiling		Product Type	Extent of Damage	Surface Treatment	Asbestos Type
			Additional Information		2	1	2	2
			High level unencapsulated ceiling panels. Non asbestos Vaillant boiler. Limited inspection due to stored items, apply caution.		Score - Material Risk			
					7		Medium	
			Recommendations		Accessibility			
Remove under asbestos controlled conditions if affected by works or encapsulate and manage in accordance with current asbestos legislation		High						
		Review Period						
		Annual						
Inspection Level		Analysis Result	Product Type		Licensed / Non-Licensed			
Identified		Chrysotile + Amosite	Asbestos Insulating Board		Licensable

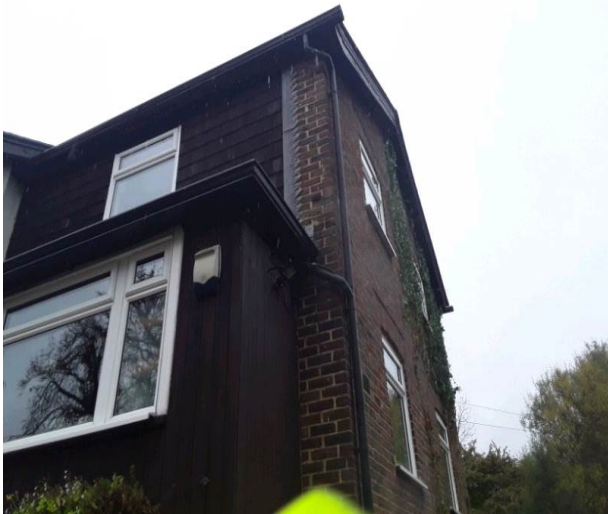
Item	Level	Building Name / Location / Room Number	Survey Type	Sample Reference	Quantity			
17	External	External Elevations	Refurbishment	Visual Inspection	-

Material Description / Location		Material Risk			
			No suspect materials observed within surveyed area		Product Type	Extent of Damage	Surface Treatment	Asbestos Type
			Additional Information		-	-	-	-
			Cast soil pipe. Plastic rainwater goods. Limited inspection above 4m, apply caution.		Score - Material Risk			
					-		-	
			Recommendations		Accessibility			
			-		-			
Review Period								
-								
Inspection Level		Analysis Result		Product Type		Licensed / Non-Licensed		
-		-		-		-
