LOCATION:
M5 J14-15 SB MP 125 - 129.5

DRAWING NO:
572 Defect Treatment Plan Sheet 1 of 5

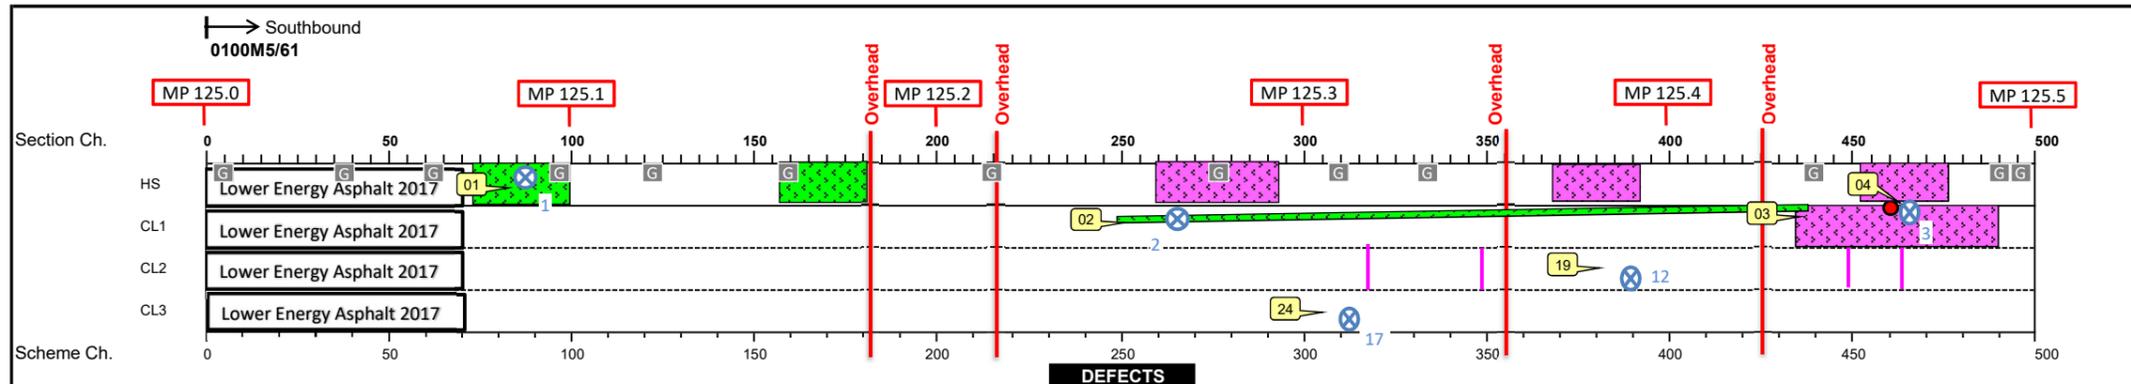
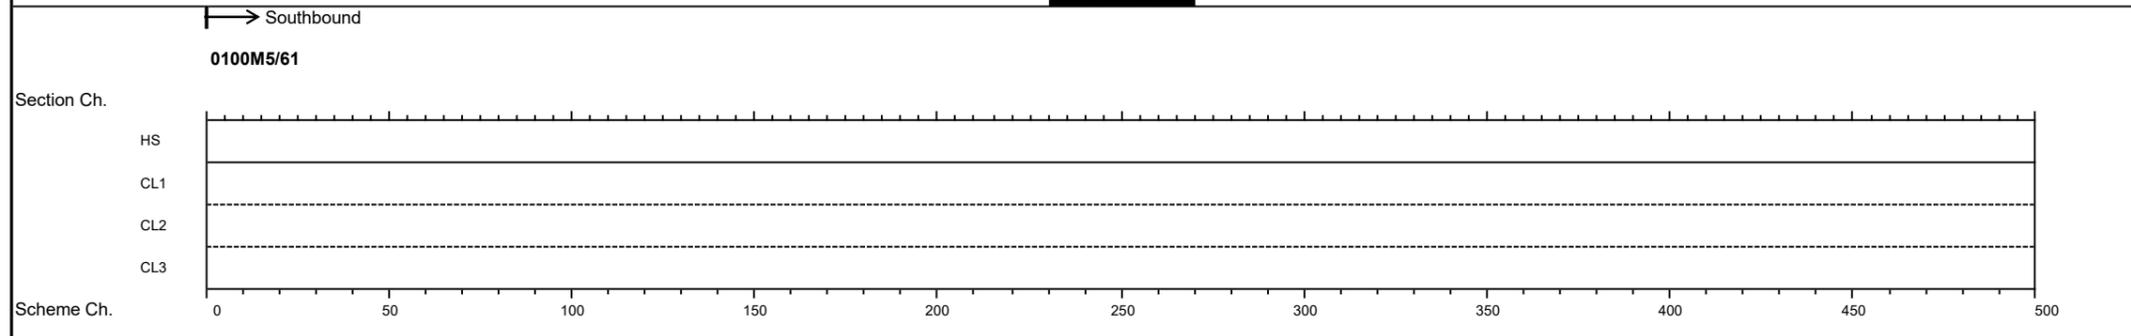
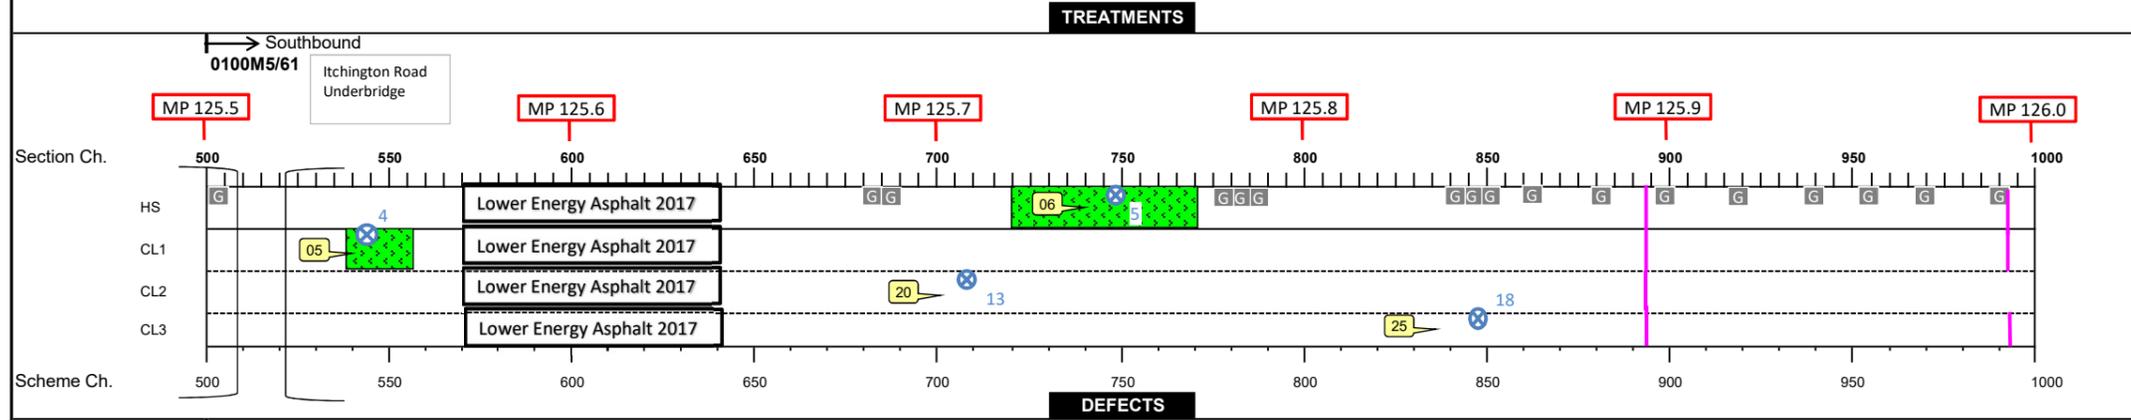
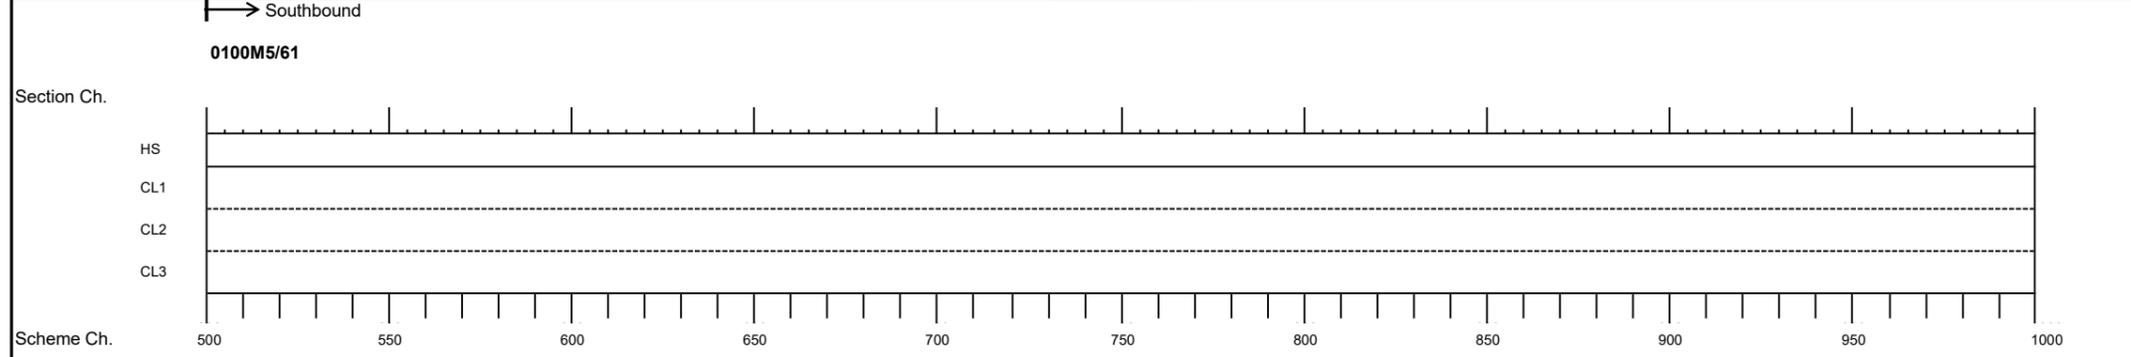
- 50mm inlay TSCS (Do Min)
- Fill and overbanding repair system for crack exceeding 5mm but not exceeding 10mm wide (Do Min)
- Deep repair/ inlay (Do Something)
