Management Asbestos Survey

Survey Reference Number: X-01242

4 Ennor House
Old Town
St Mary's
Isles of Scilly
TR21 0NN

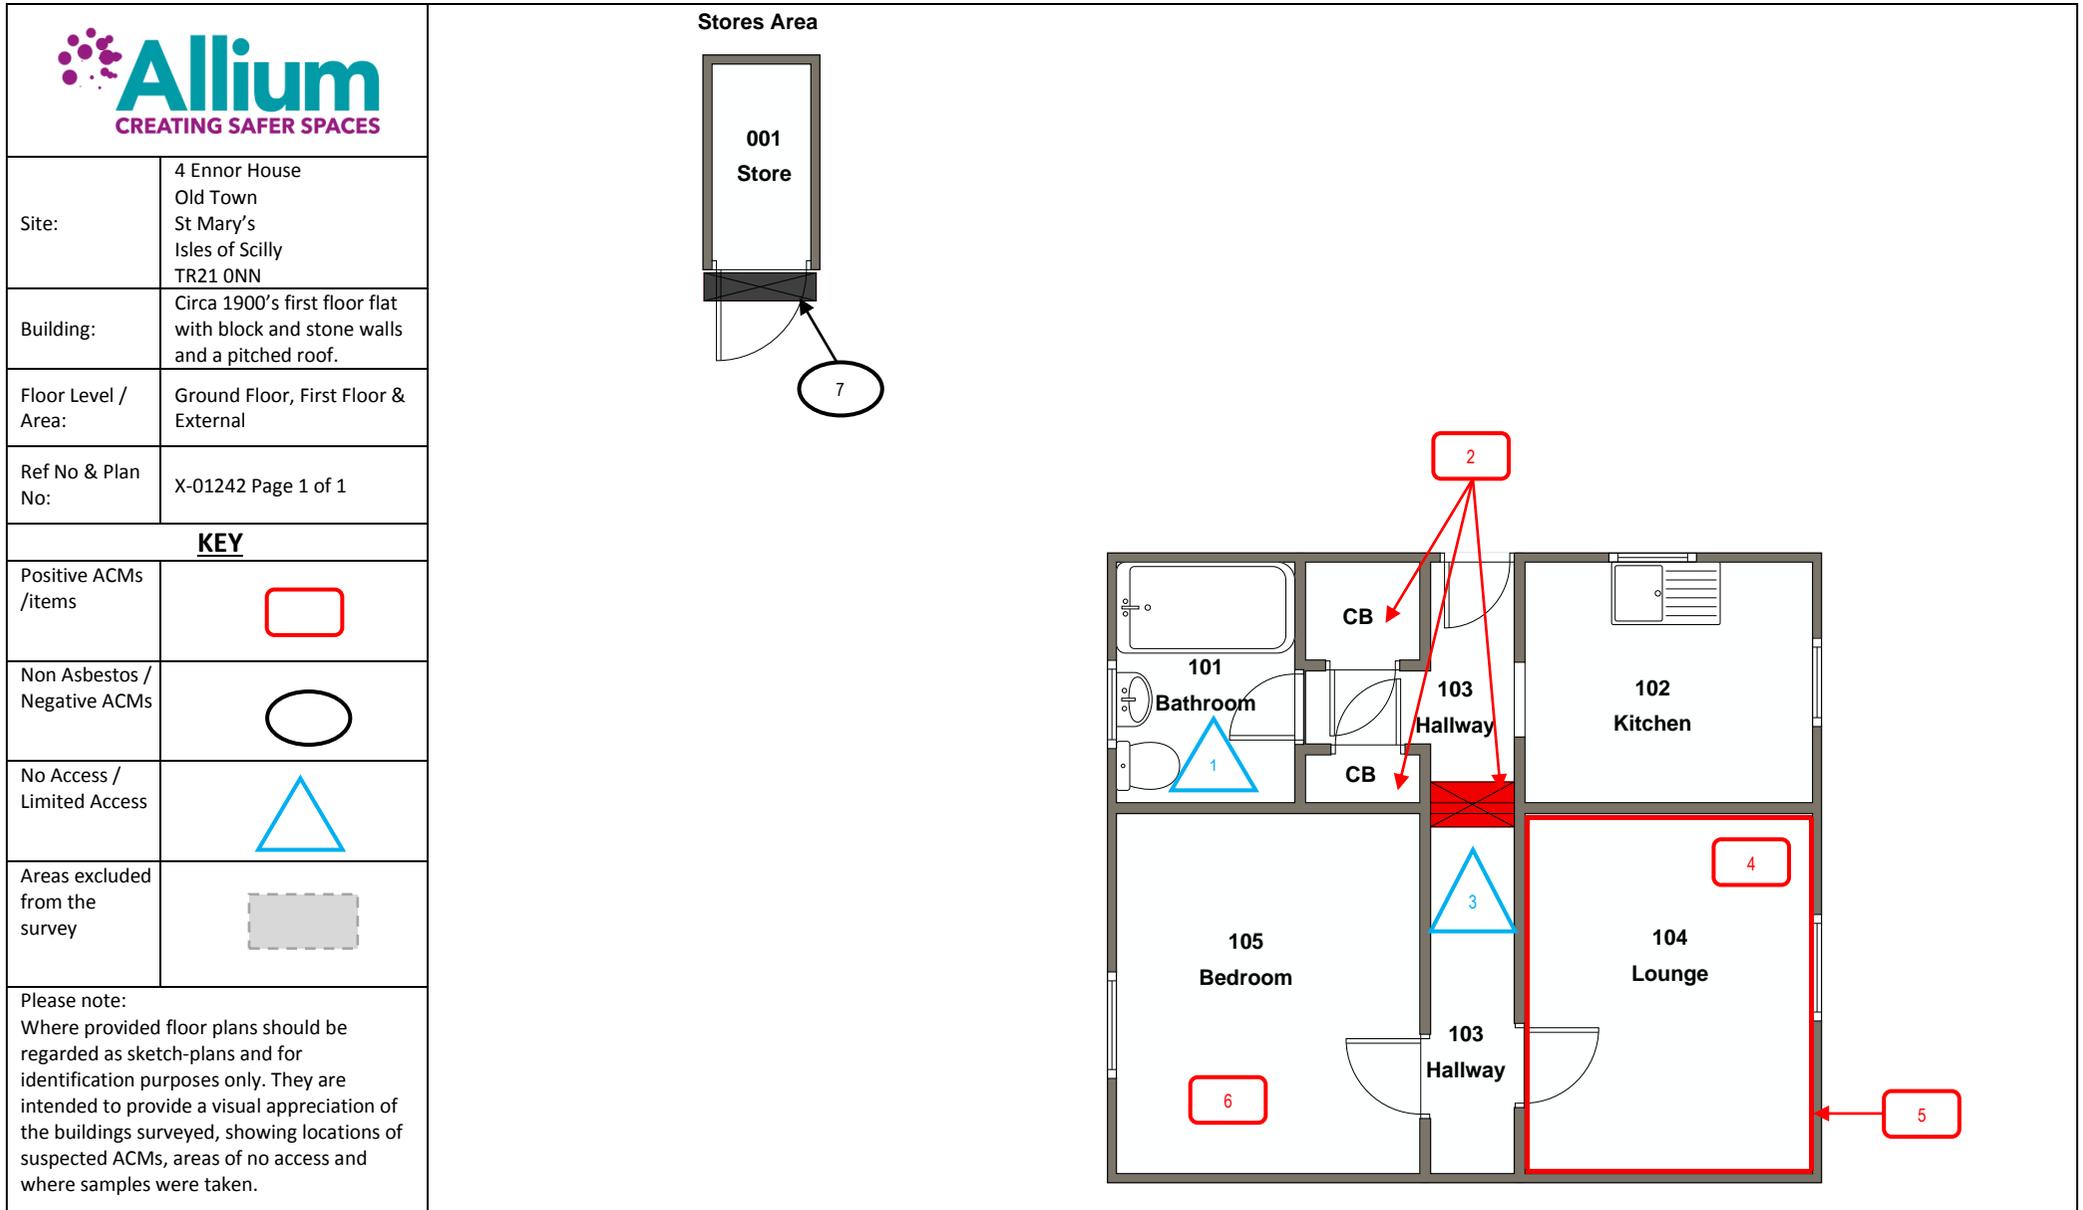
• THIS PLAN SHOULD BE READ IN CONJUNCTION WITH THE MAIN BODY OF THE REPORT AND INDIVIDUAL ITEM RECORDS
