MELTON BOROUGH COUNCIL
NEW PUBLIC TOILET FACILITIES

PRE-CONSTRUCTION INFORMATION

April 2017

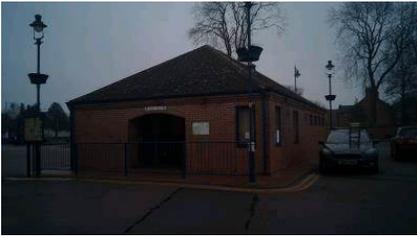
3.1 Description of buildings surveyed

<p>Building designation <i>St Mary's Way</i></p> <p>Age of Building <i>Unknown</i></p> <p>Internal notes <i>N/A</i></p>	<p>Building description <i>Public Toilets</i></p> <p>Construction type <i>Brick built with a tiled roof</i></p> <p>External notes <i>N/A</i></p>
---	--	---

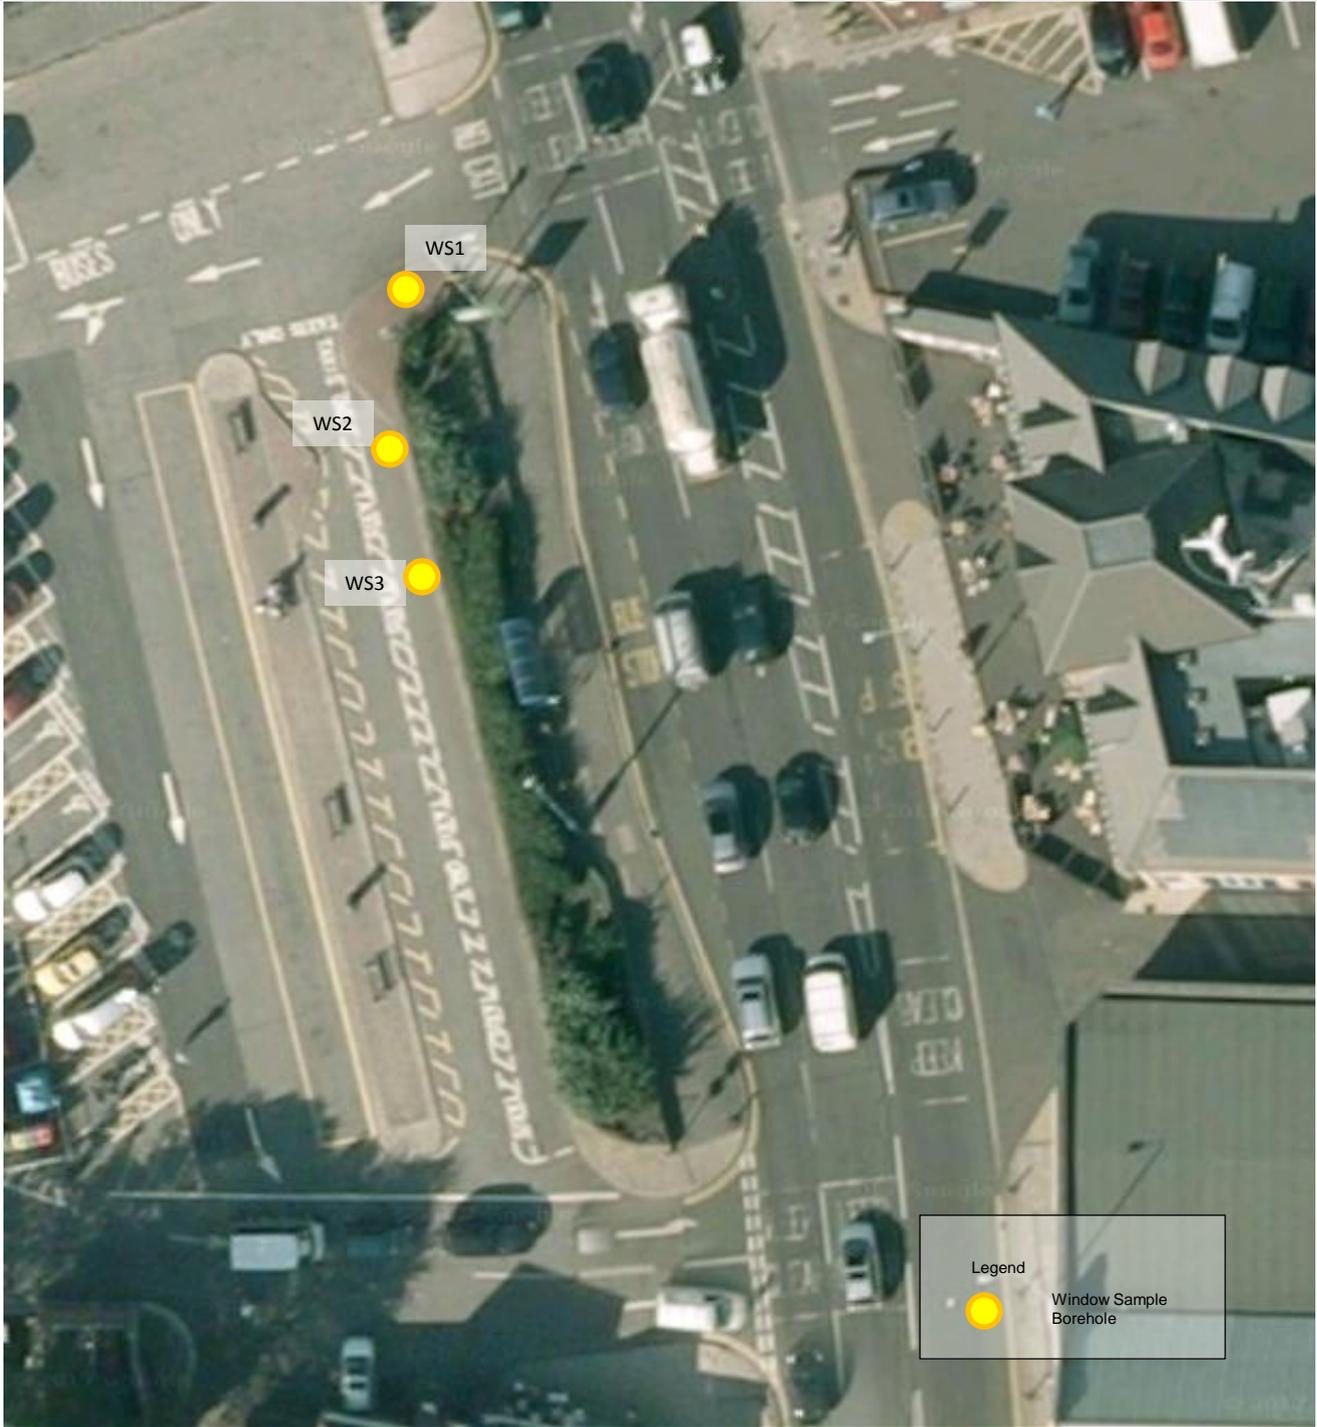
Lawrence House, Meadowbank Way, Eastwood, Nottingham, NG16 3SB Tel: 0870 600 6090 www.hspconsulting.com				
	Checked By LEB					
Title Site Investigation Layout Plan	HSP Drg. No.					Rev.
	C2521-SK3a

Client Gleeds Building Surveying Ltd	Scale NTS	Rev. By	Date	Details	Chkd	
	Date Mar 2017	Drawing Status		INFORMATION		
Project Wilton Road, Melton Mowbray	Drawn By LEB

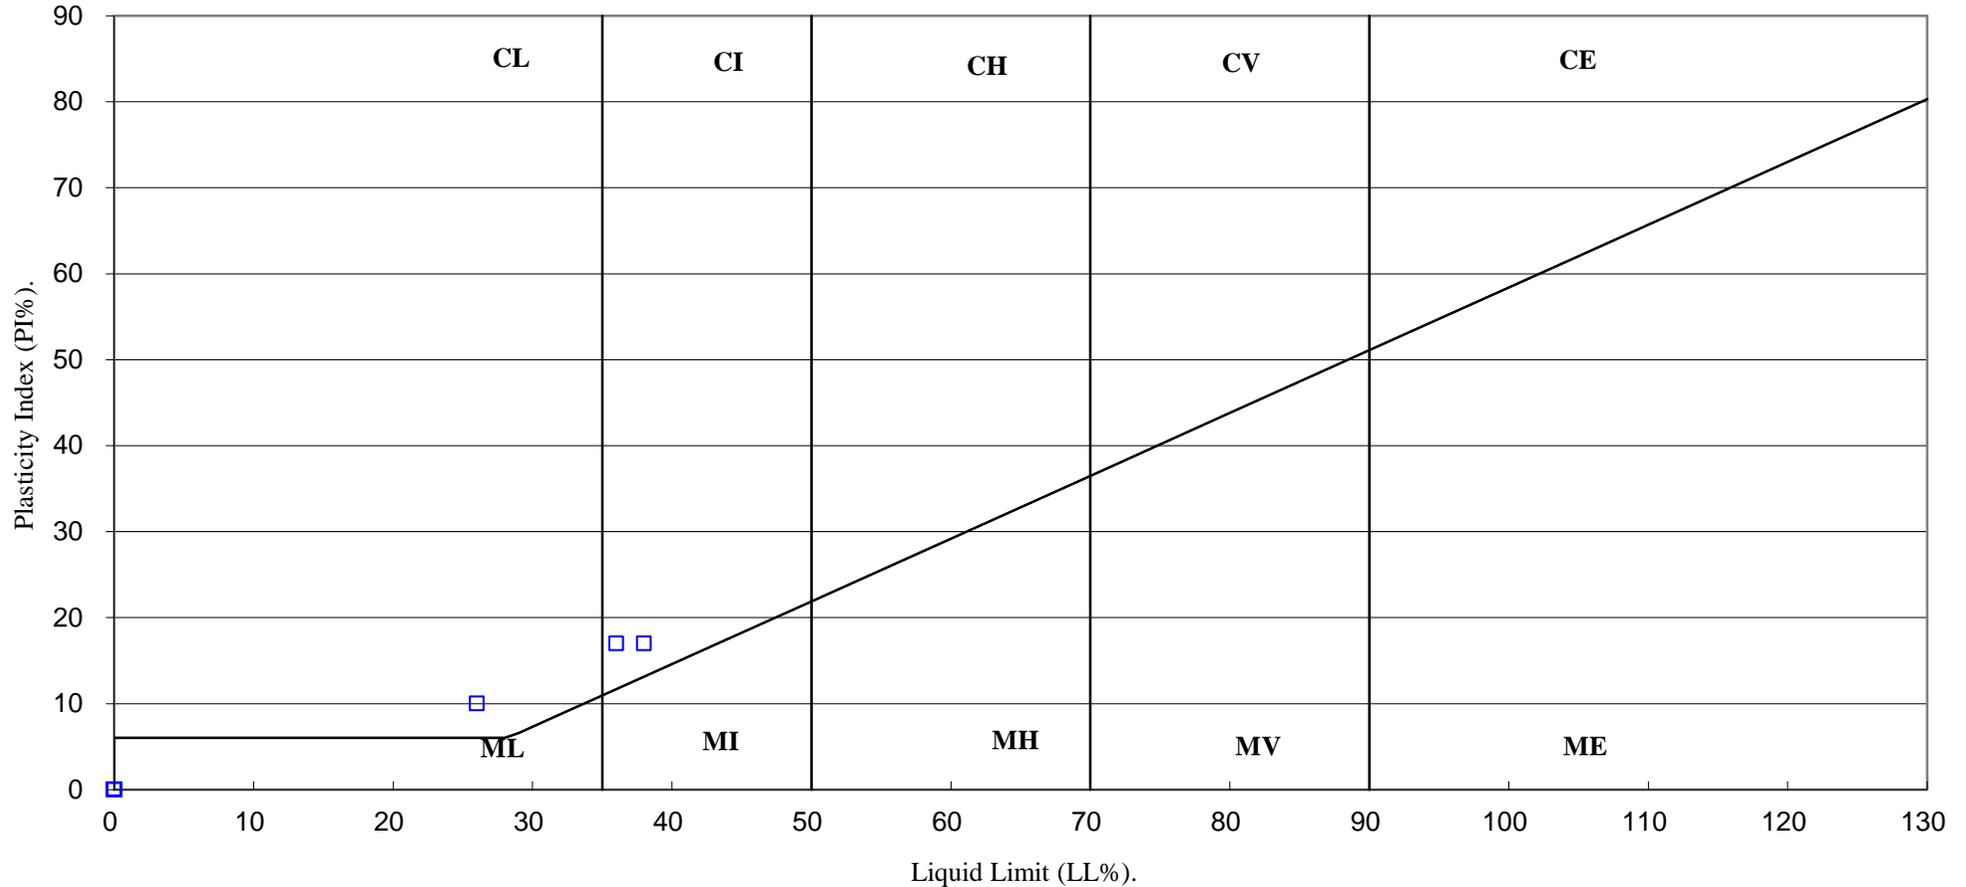
PLASTICITY CHART FOR CASAGRANDE CLASSIFICATION.

(BS5930 :2015)
