LOCATION:
M5 J25-24 NB MP 201.7-196.6
DRAWING No:
583 Defect Treatment Plan Sheet 1 of 6
DRAWN: FS DATE: 22/06/2020
DESIGN: FS DATE: 22/06/2020
CHECKED: CC DATE: 25/06/2020

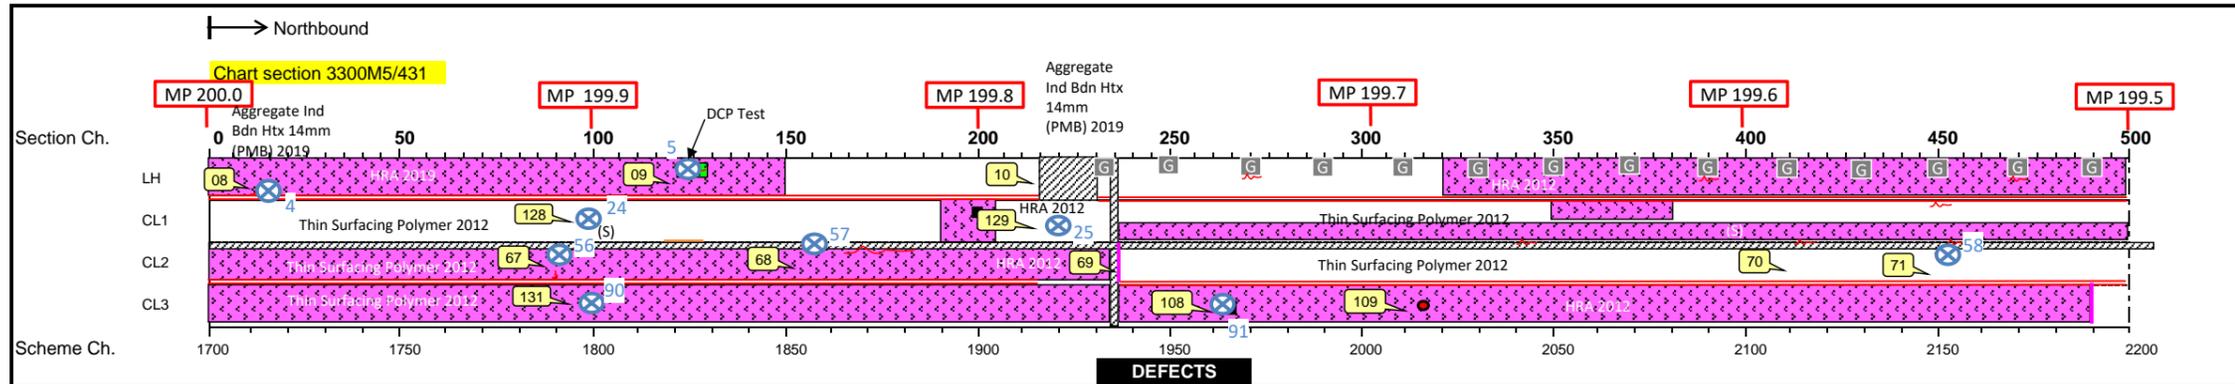
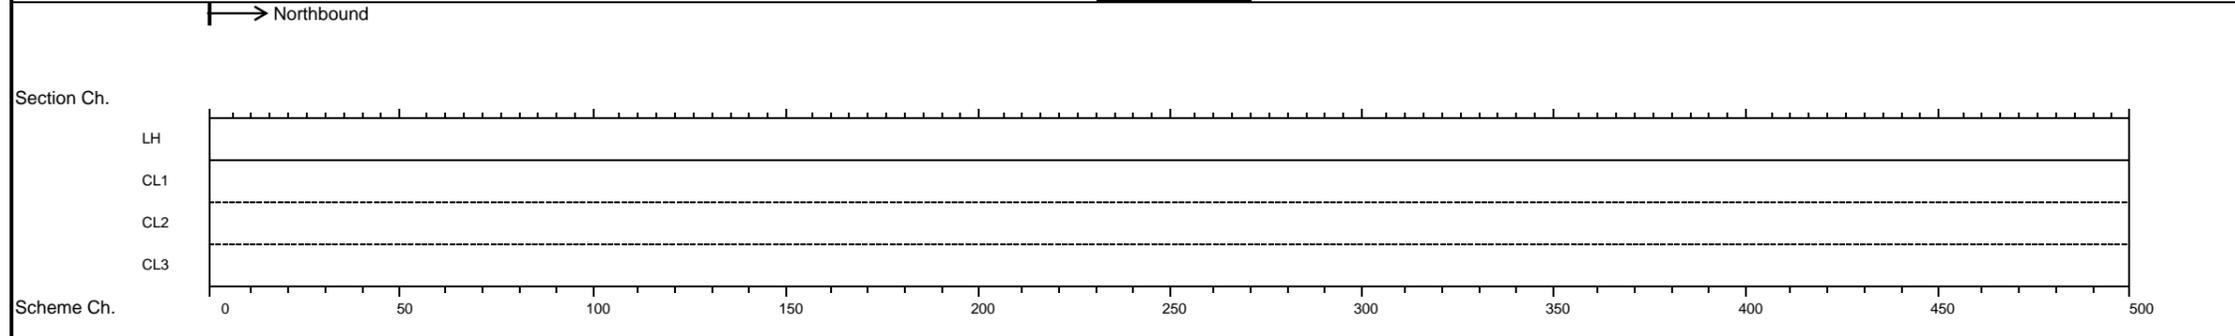
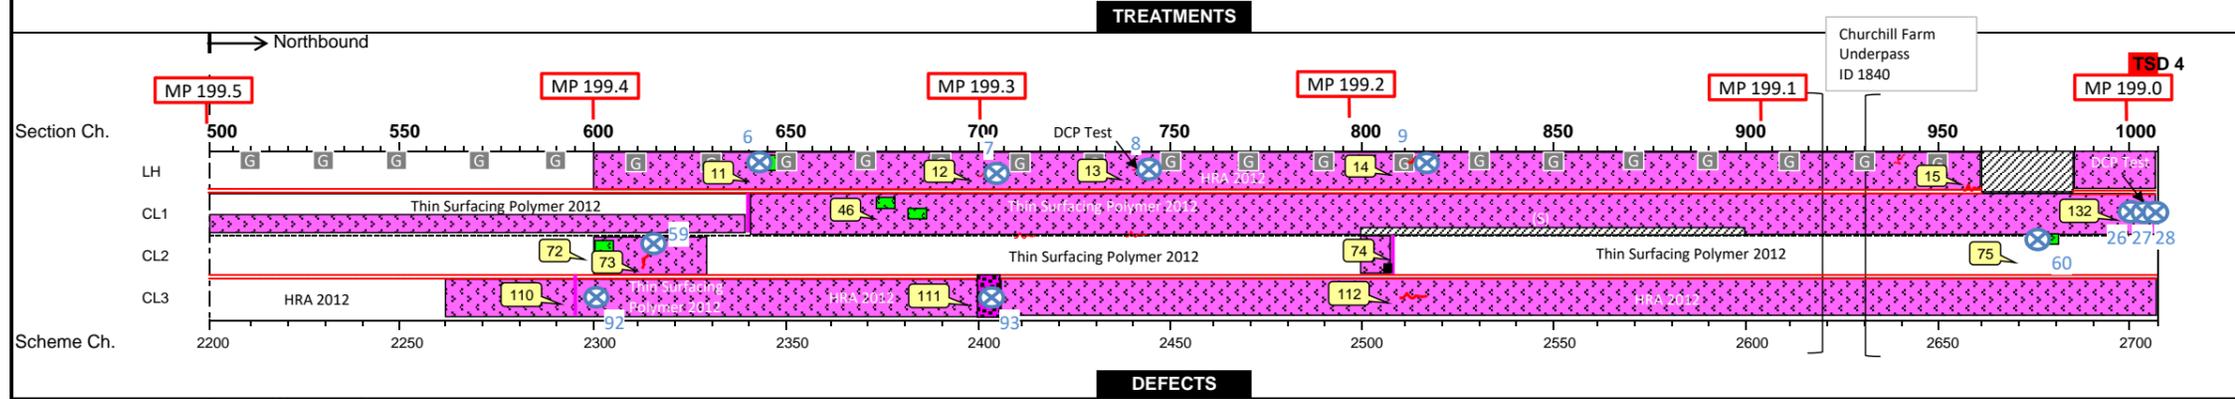
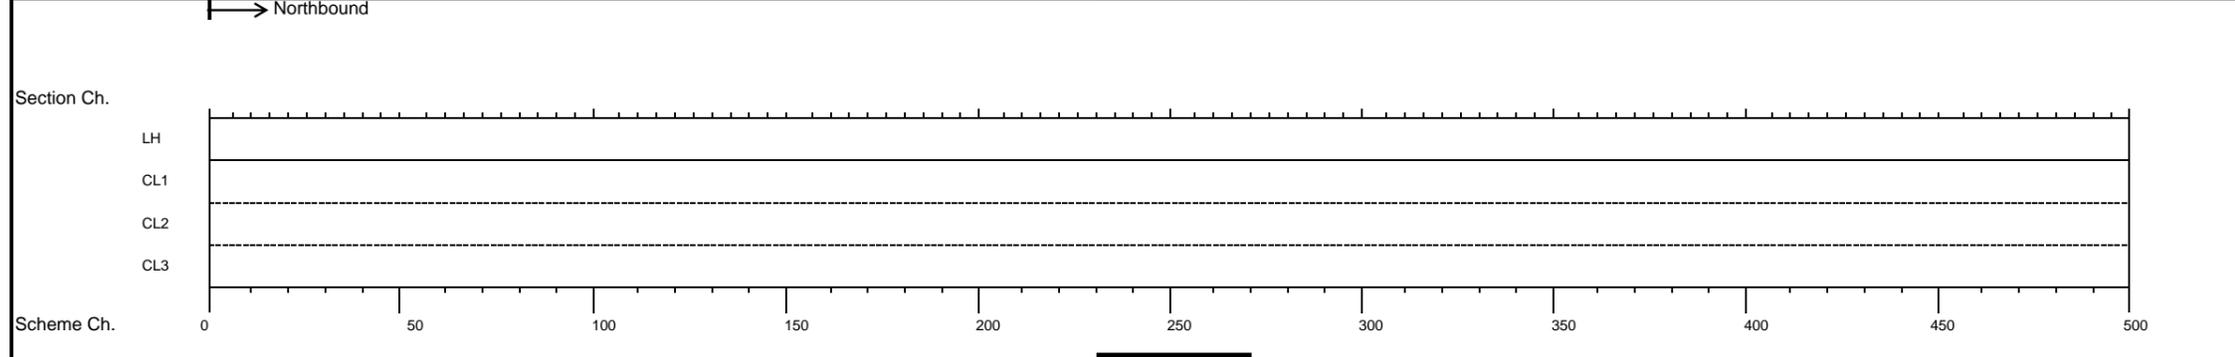
- 50mm inlay TSCS (Do Min)
- Fill and overbanding repair system for crack exceeding 5mm but not exceeding 10mm wide (Do Min)
- Deep repair/ inlay (Do Something)

- 1) Dimensions are approximate and have been based on the most up-to-date AVIS video data
- 2) Only overhead power lines shown on the treatment plans. For other utilities please refer to the C2 plans for the area
- 3) Due to the potential inaccuracy of AVIS data regarding exact chainages, where Core locations are within the vicinity of a Gully, coring Contractor to adjust the location to avoid potential coring into/through carrier pipes
