Requirements for repair of 3 x Delta 740X RHIBs

UNDA KEVLAR / STAINLESS STEEL KEEL GUARDS

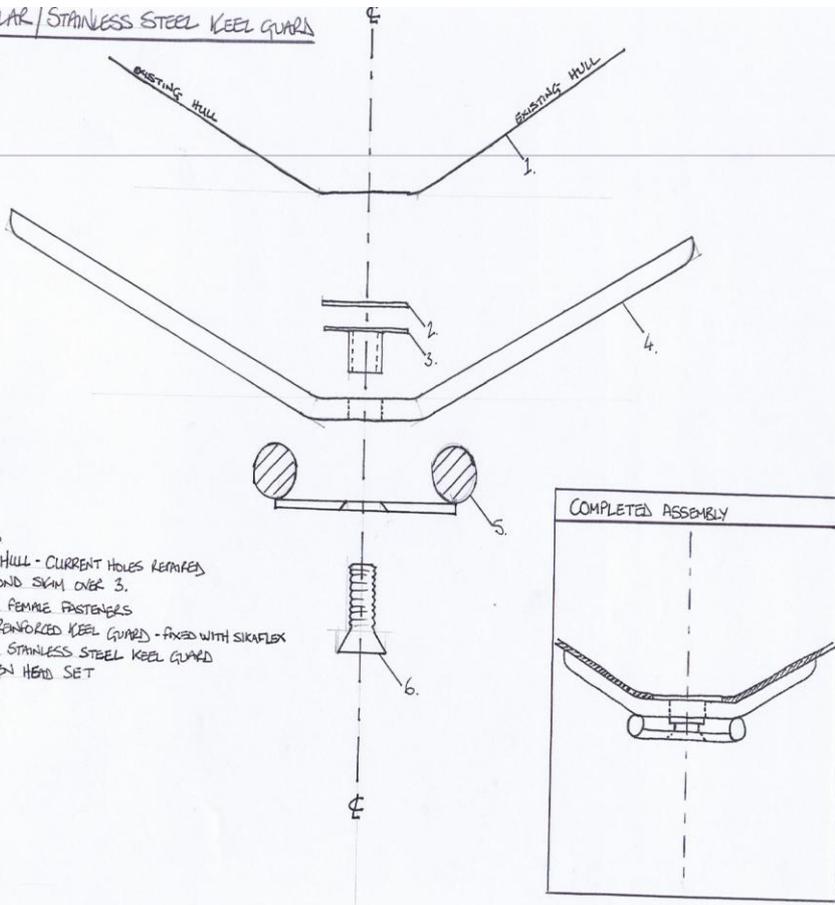
1. EXISTING HULL - CURRENT HOLES REMOVED
2. CRESTOBOND SKIM OVER 3.
3. BIG HEAD FEMALE FASTENERS
4. KEVLAR REINFORCED KEEL GUARDS - FIXED WITH SIKAFLEX
5. EXISTING STAINLESS STEEL KEEL GUARD
6. CSK ALLEN HEAD SET

- The existing stainless steel keel band is to be removed in its entirety
- A new Kevlar/Stainless keel band is to be installed in accordance with the drawing at Appendix A.
