Condition Survey Report

200004653397-Woodbridge Art Club

Woodbridge Art Club

15 Tidemill Way
Woodbridge
IP12 1BY

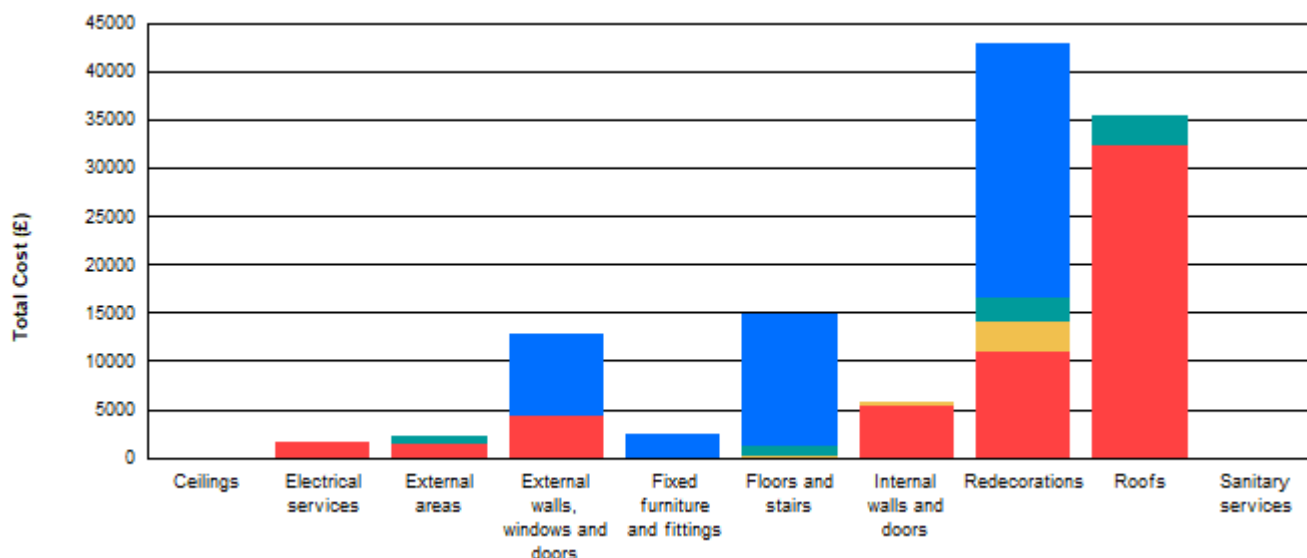
Cost Summary Chart

Element	Priority 1	Priority 2	Priority 3	Priority 4	Total
Ceilings	£0.00	£0.00	£0.00	£0.00	£0.00
Electrical services	£1,500.00	£0.00	£0.00	£0.00	£1,500.00
External areas	£1,400.00	£0.00	£750.00	£0.00	£2,150.00
External walls, windows and doors	£4,250.00	£0.00	£0.00	£8,500.00	£12,750.00
Fixed furniture and fittings	£0.00	£0.00	£0.00	£2,500.00	£2,500.00
Floors and stairs	£0.00	£200.00	£1,000.00	£13,743.44	£14,943.44
Internal walls and doors	£5,300.00	£500.00	£0.00	£0.00	£5,800.00
Redecorations	£11,000.00	£2,935.52	£2,641.03	£26,405.64	£42,982.18
Roofs	£32,341.46	£0.00	£3,000.00	£0.00	£35,341.46
Sanitary services	£0.00	£0.00	£0.00	£0.00	£0.00
Total costs	£55,791.46	£3,635.52	£7,391.03	£51,149.08	£117,967.08
