TREE PROTECTION PLAN

CLIENT	DATE	31.05.2024	PROJECT NUMBER	0266	REVISION
PENZANCE COUNCIL	SCALE	1:300	DRAWING TITLE	Tree Protection Plan	
	SIZE	A3	DRAWING NUMBER	103	A
	STATUS	CONCEPT	_

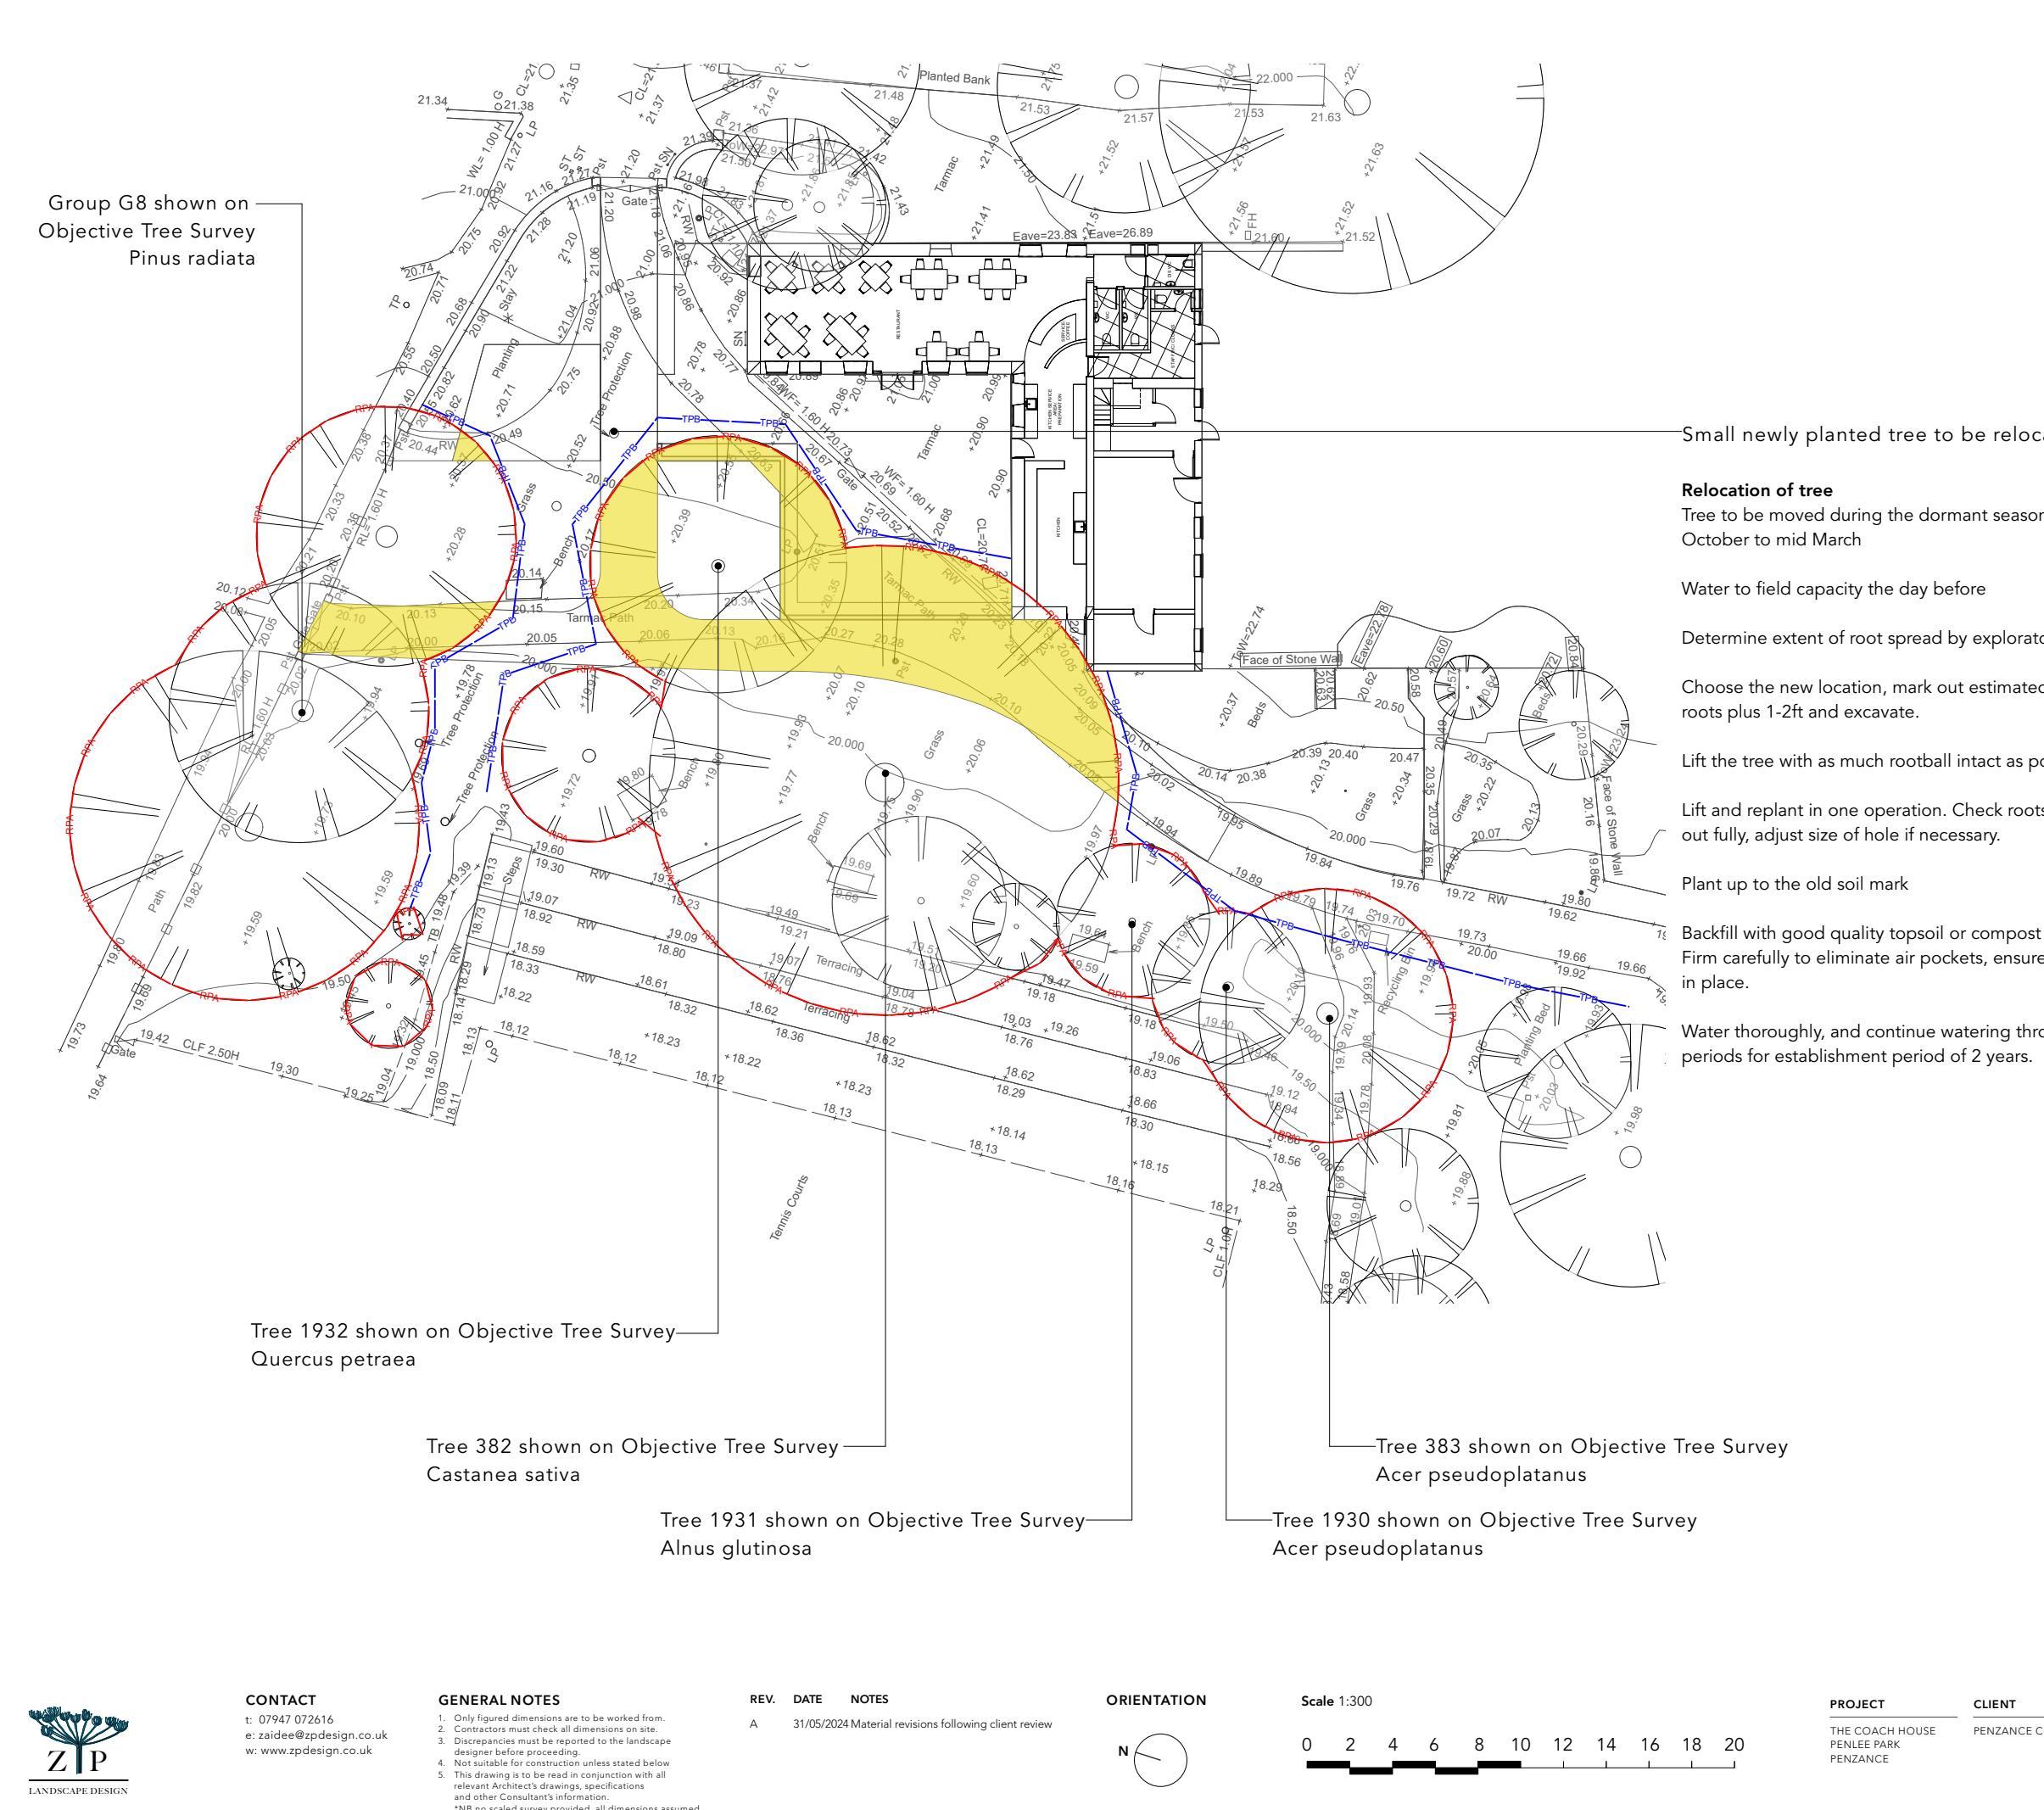
КЕҮ				
	TPB Tree Protection Barrier (TPB)				
	Compressed air tools / hand dig only				
	Read in conjunction with Objective Tree Consultancy Report 01.05.2023				
	Prior to any work commencing protective (heras or similar) fencing 2.5 metres in height will need to be installed as per this plan. Fencing to BS 5837:2012				
	Protective fencing must remain in place until all work is completed and all associated materials and equipment are removed from site.				
cated	Where incursion to the RPA is necessary a temporary surface may be required to prevent disturbance or compaction of soil.				
n from late ory digging	Any pedestrian traffic within the RPA requires suitable ground protection consisting of: porous geotextile material on which a compressible layer can be added such as sharp sand with scaffold boards or similar on top.				
d spread of	No storage of equipment, materials or chemical based solutions is permitted within the RPA.

ossible	No vehicular access within the RPA without prior agreement.				
ts can spread	No burning of materials or fires within 10 metres of the RPA.				
	No disturbance of soil including level changes or compaction within the RPA without prior consultation.				
t if required. e tree protection	No storage of temporary buildings, sheds or offices within the RPA.				
oughout dry	No changes will take place that will alter the amount of water infiltration surrounding or within the RPA.				
	Protection of tree roots In order to reduce any significant damage to tree roots within the RPA all soil stripping and excavation must be carried out by hand digging or compressed air tools only. Where construction is within the RPA the use of specialist engineering solutions may be required.				
	All tree roots uncovered must be wrapped immediately in dry sacking until backfilling takes place. Tree roots must not remain exposed.

Clumps of fibrous roots must not be severed and need to be retained as above.				
	Severance of structural roots 25mm or more in diameter is not permitted.				
	If roots are accidentally damaged the tree owner must be notified and given the opportunity to inspect the damage before it is covered over.
