Inspection Date: 3 April 2024.

The Play Inspection Company Ltd Unit 5 Glenmore Business Park Blackhill Road Poole Dorset **BH16 6NL** 01202 590675

ltem:	Multi Use Games Area - Multi Use Games Area (MUGA)	Risk Level:	L - Low Risk
Manufacturer:	Parkdale Play & Leisure Ltd	Surface:	Bitmac

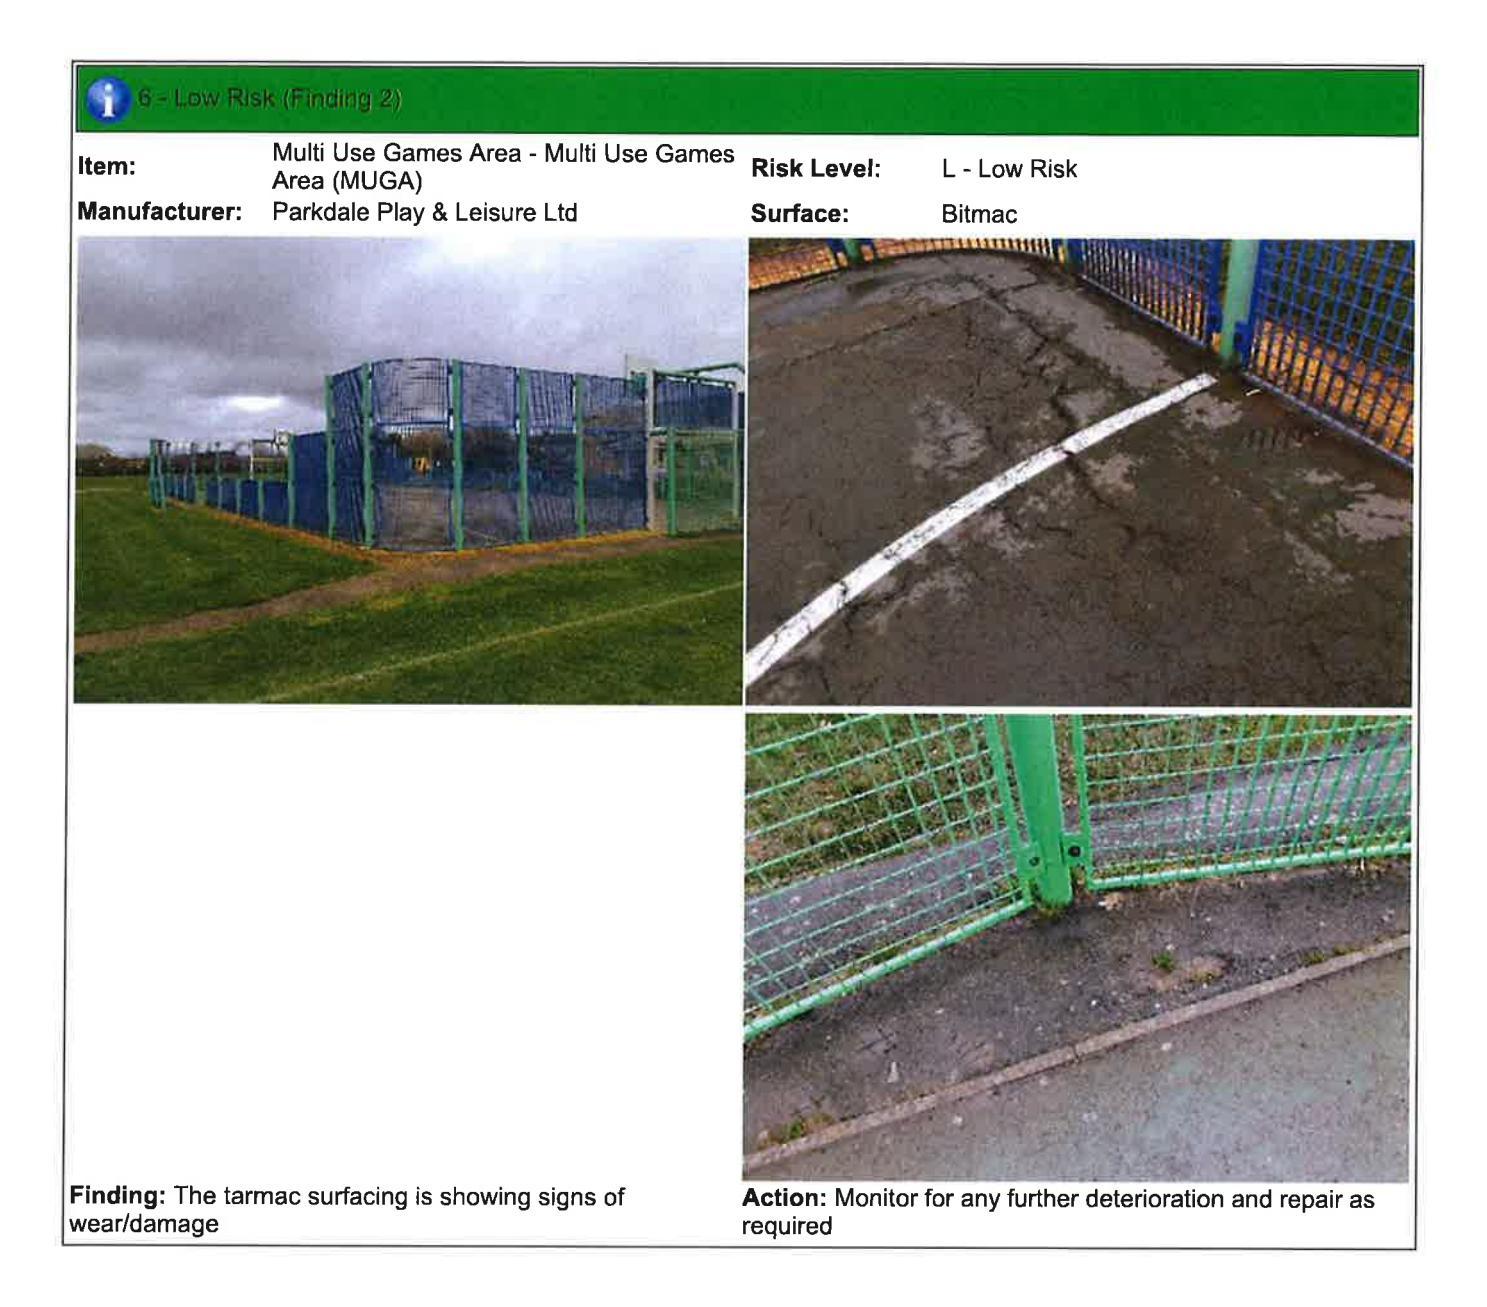
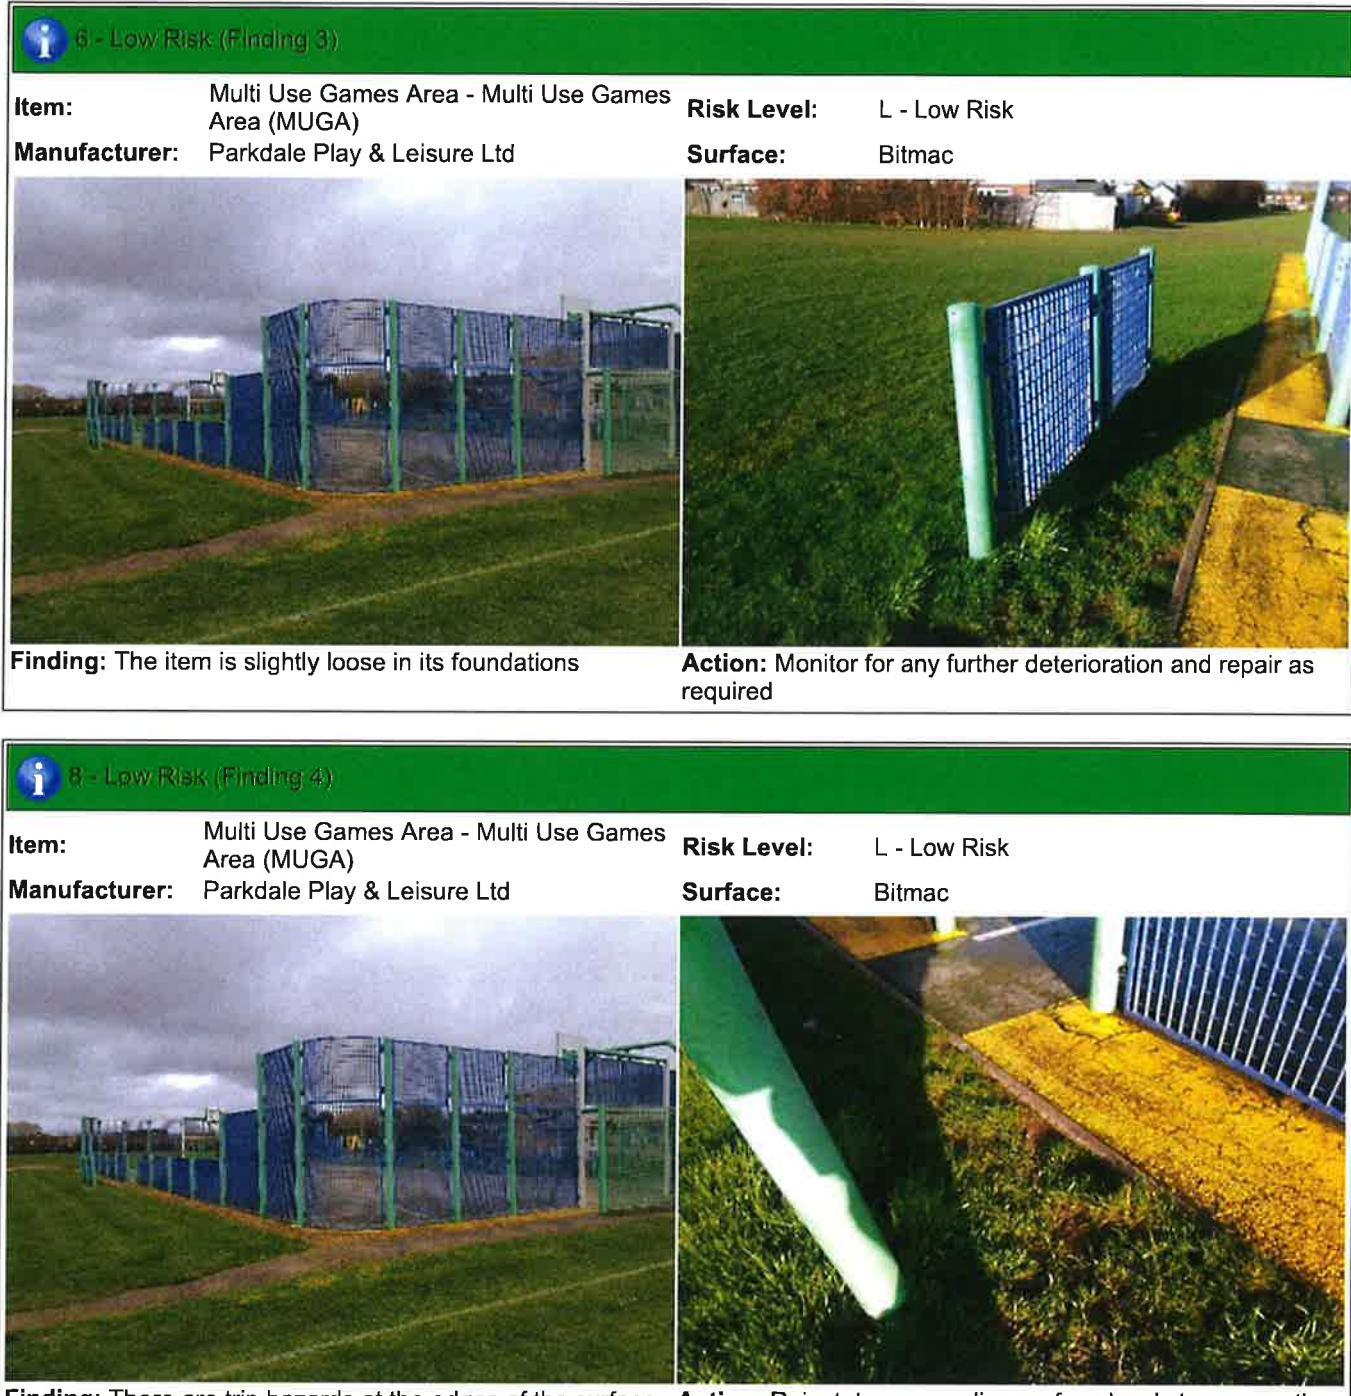
Finding: The paintwork on this item has been damaged or Action: Treat any rusting components and repaint worn exposing the metal underneath which is rusting

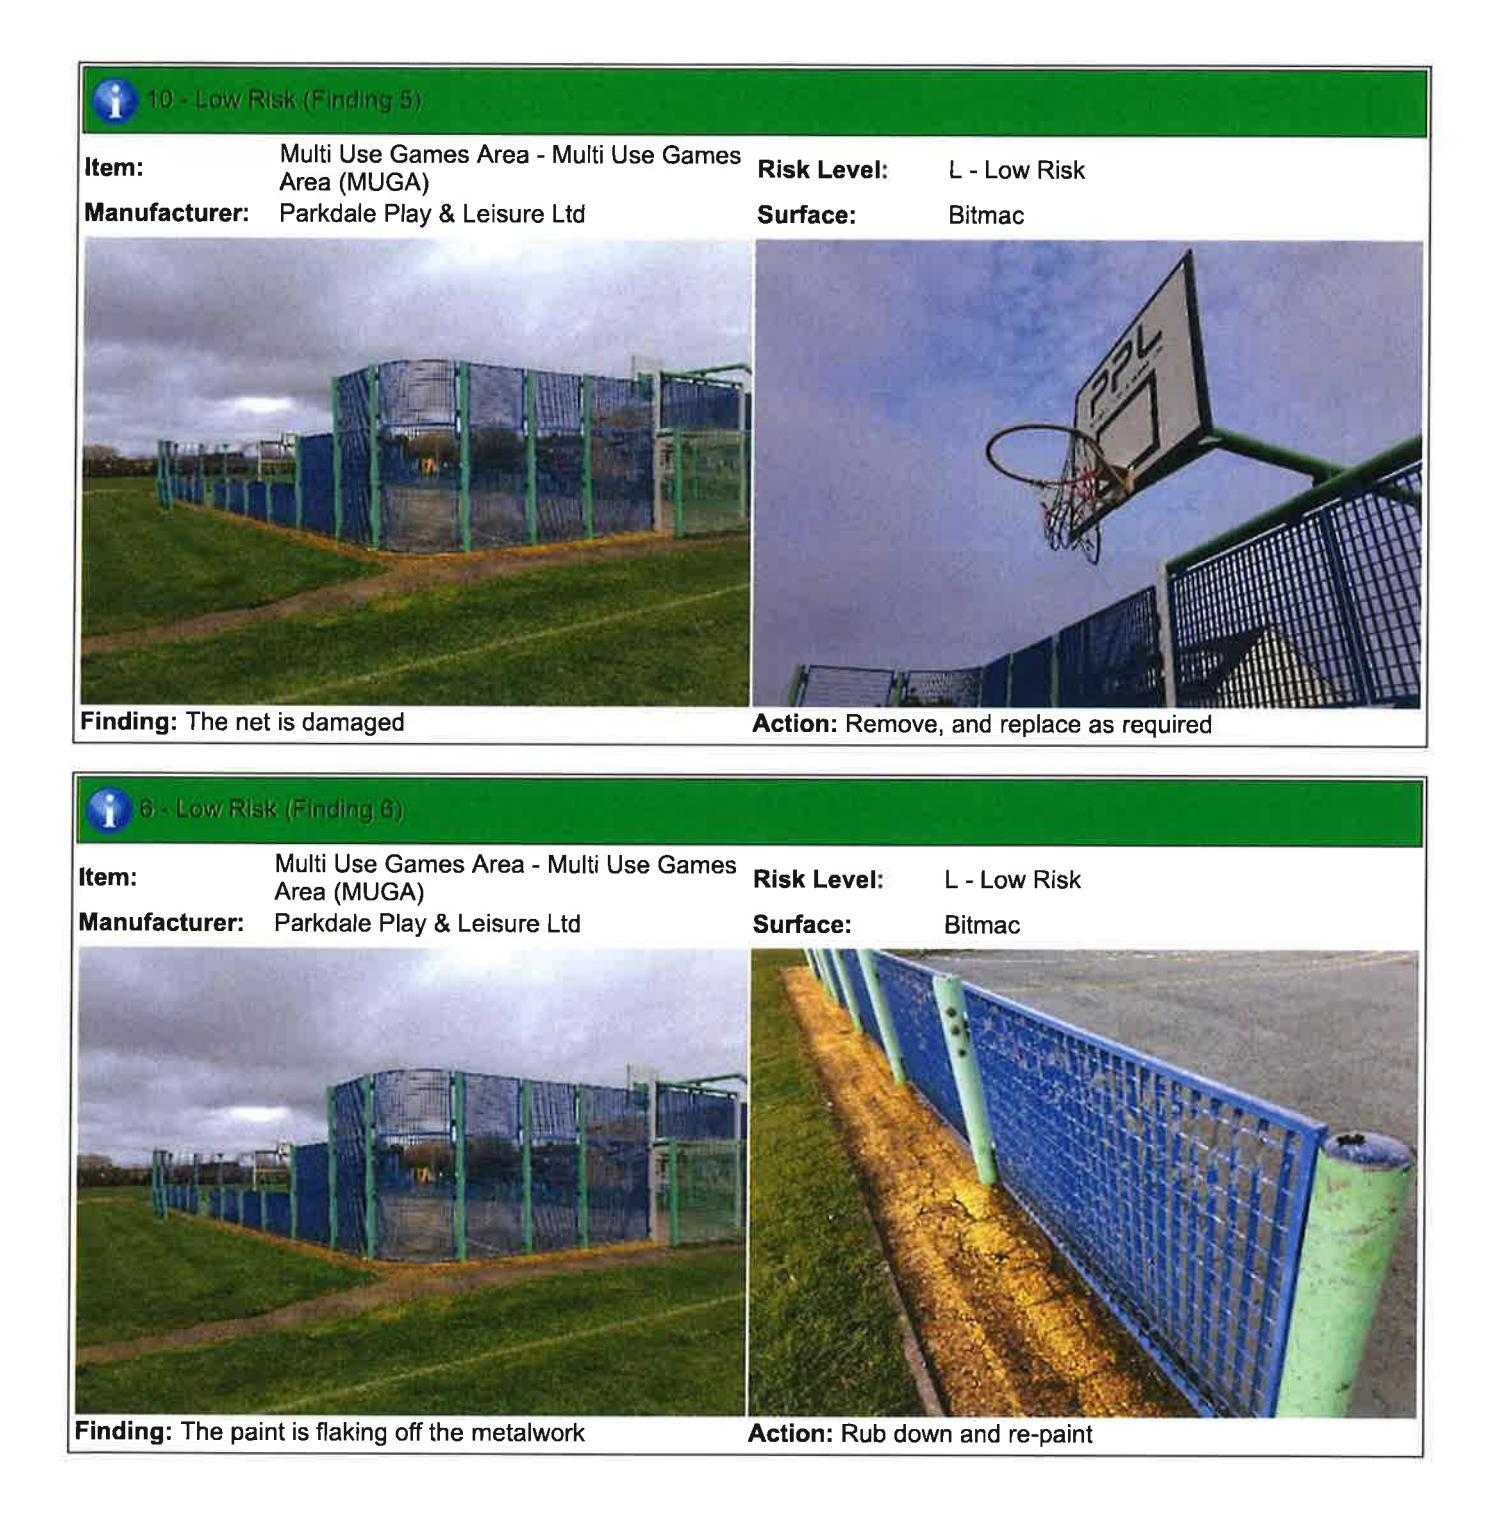
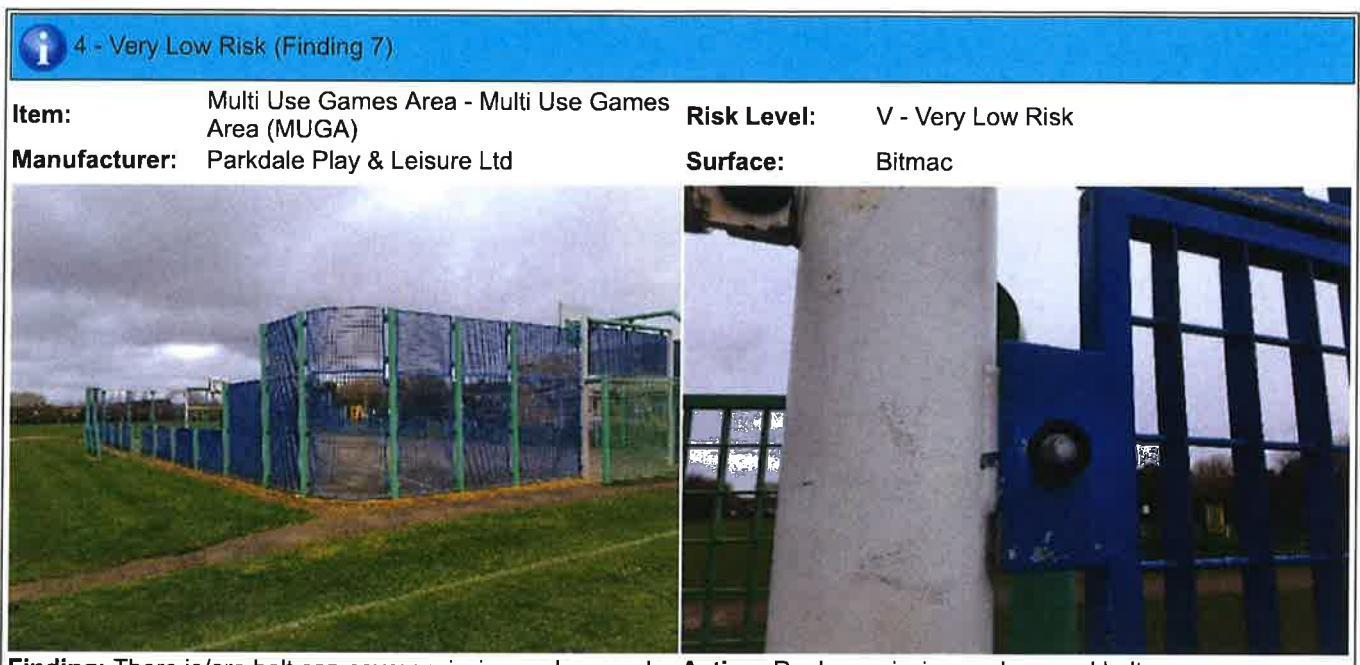
Finding: There are trip hazards at the edges of the surface trip points **Action:** Reinstate surrounding surface levels to remove the trip points
