976 / 203F

Trowbridge Museum Redevelopment The Shires, Court Street, Trowbridge Wilts. BA14 8AT for Trowbridge Town Council THIRD FLOOR PLAN PROPOSED

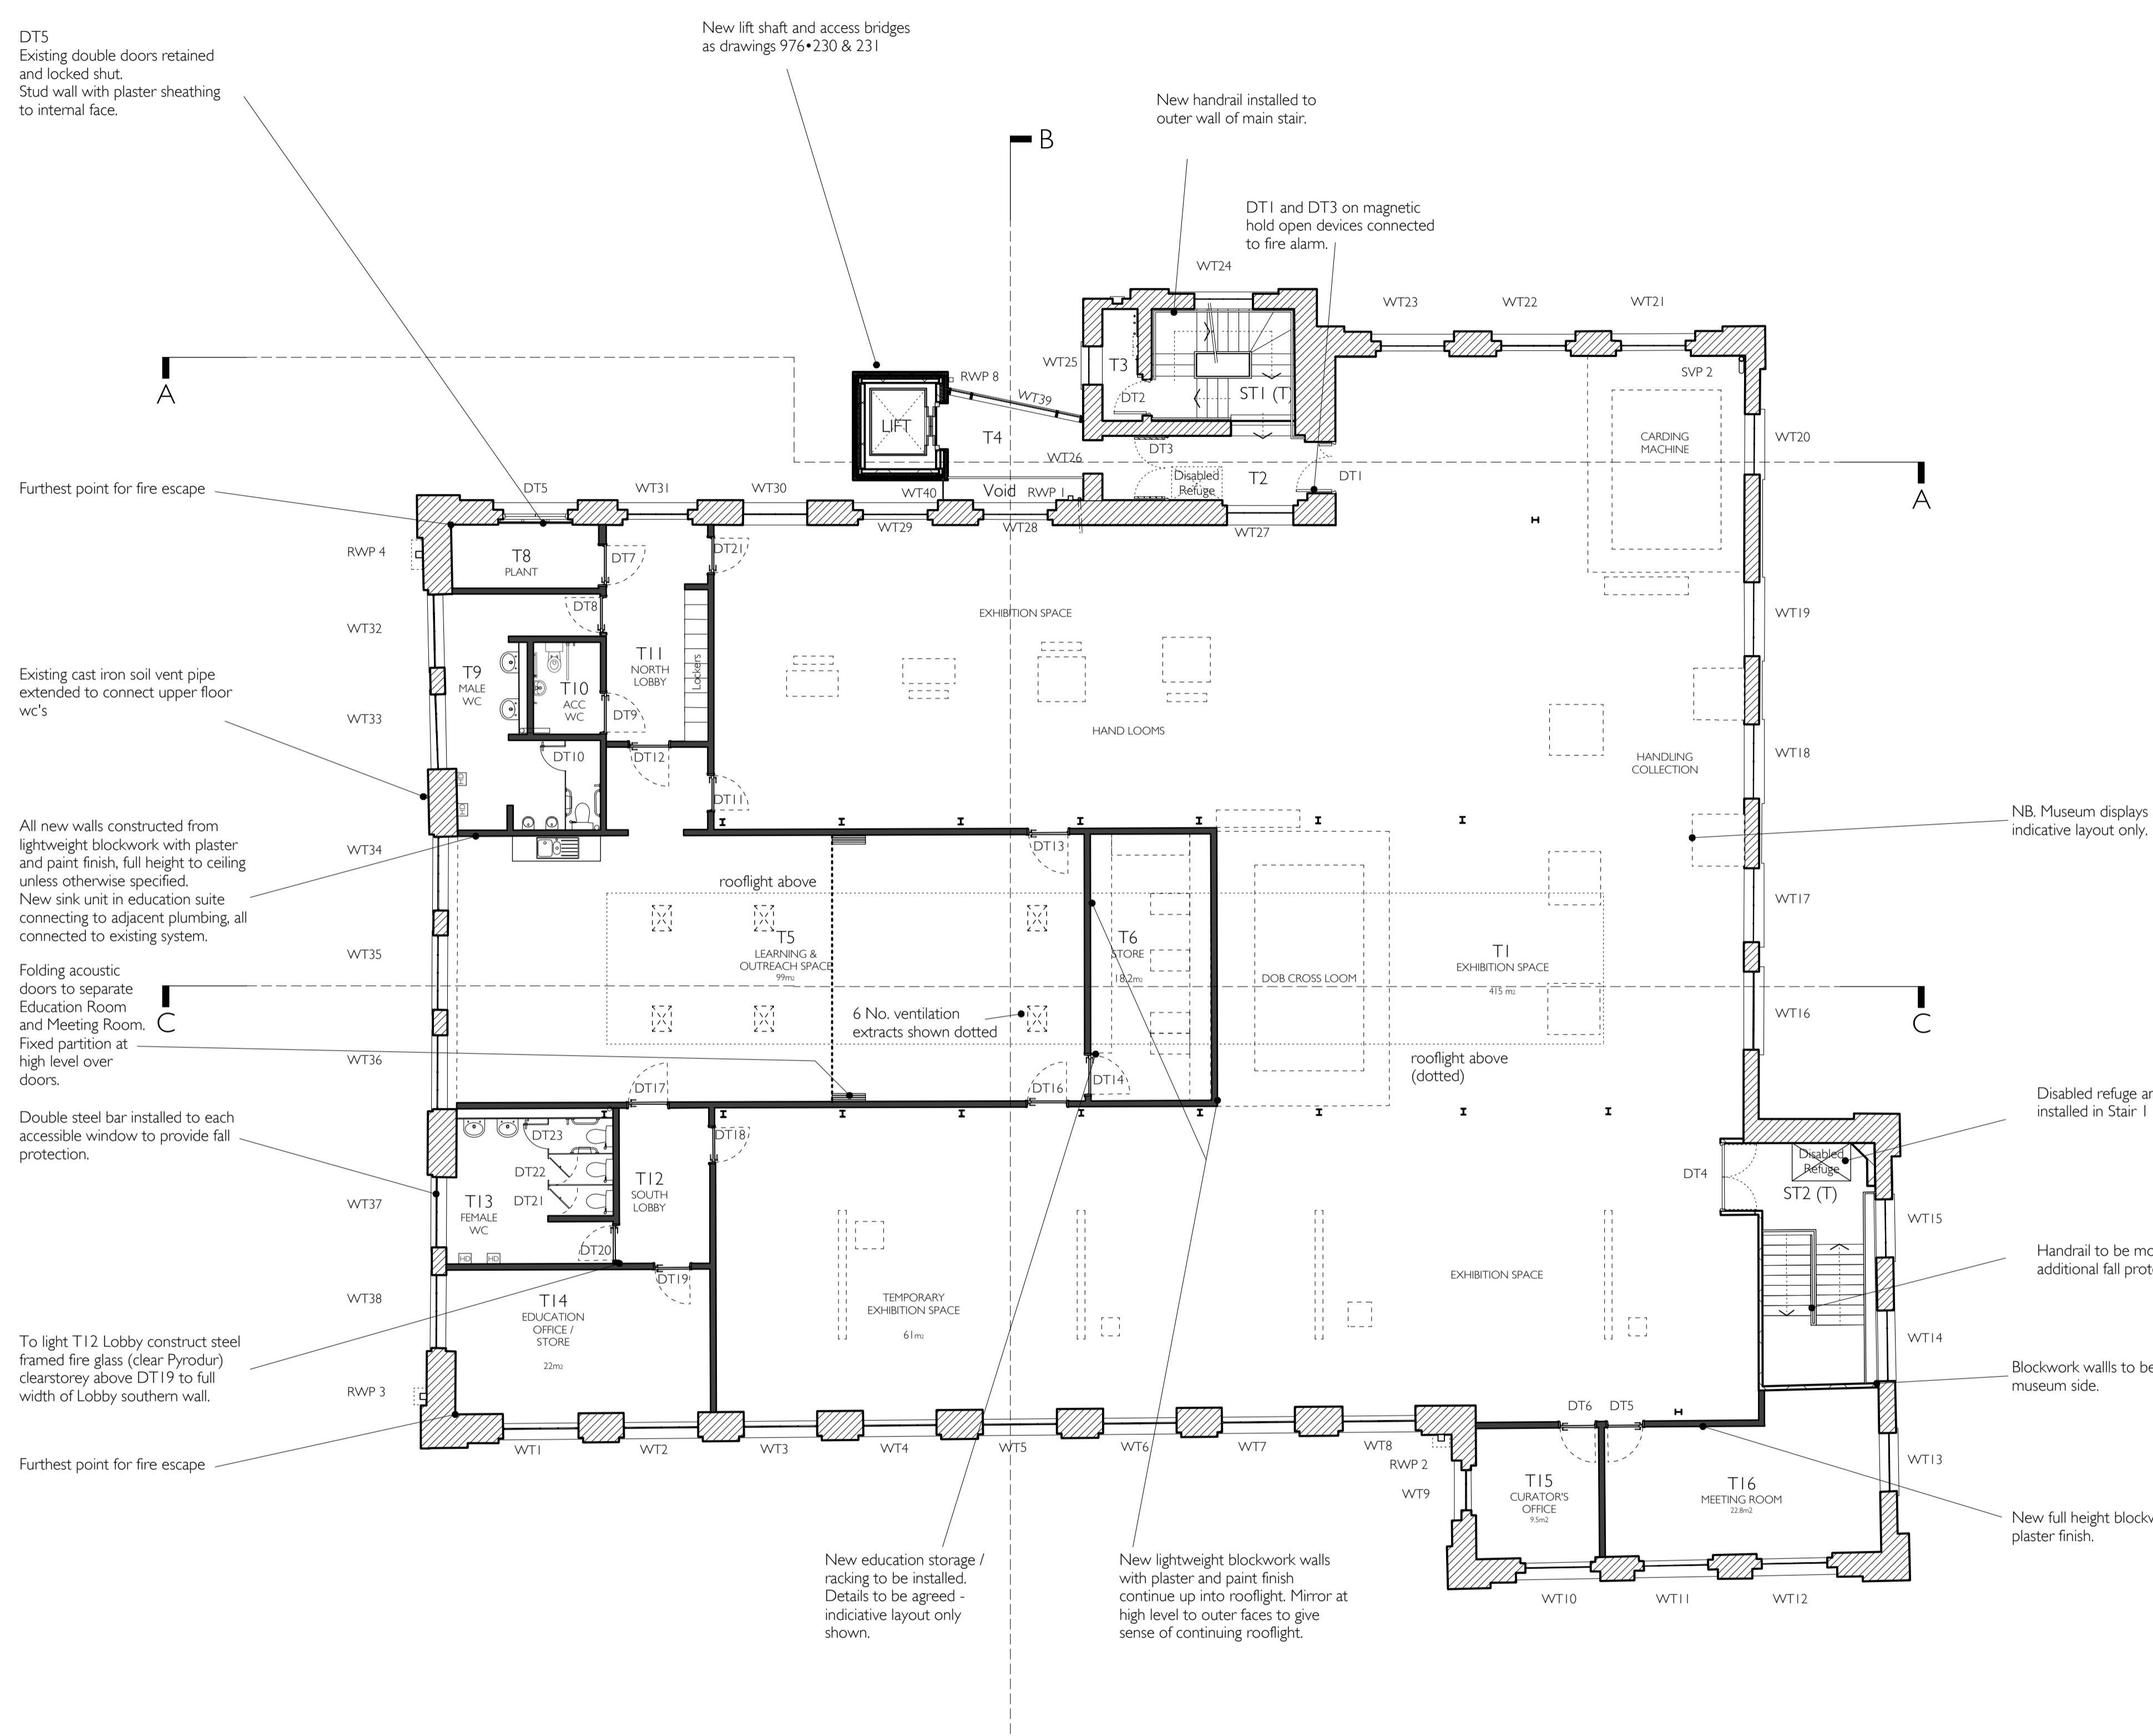
NB. Museum displays shown dashed,

Disabled refuge and call points installed in Stair 1 and Stair 2.

Handrail to be modified to provide

additional fall protection.

Blockwork wallIs to be plastered on

New full height blockwork wallls,
