The Royal Institution of Cornwall

Project Number 230794

Document Number 0200

Roof Repair Works (MEND) at the Royal Cornwall Museum Pre Construction Information

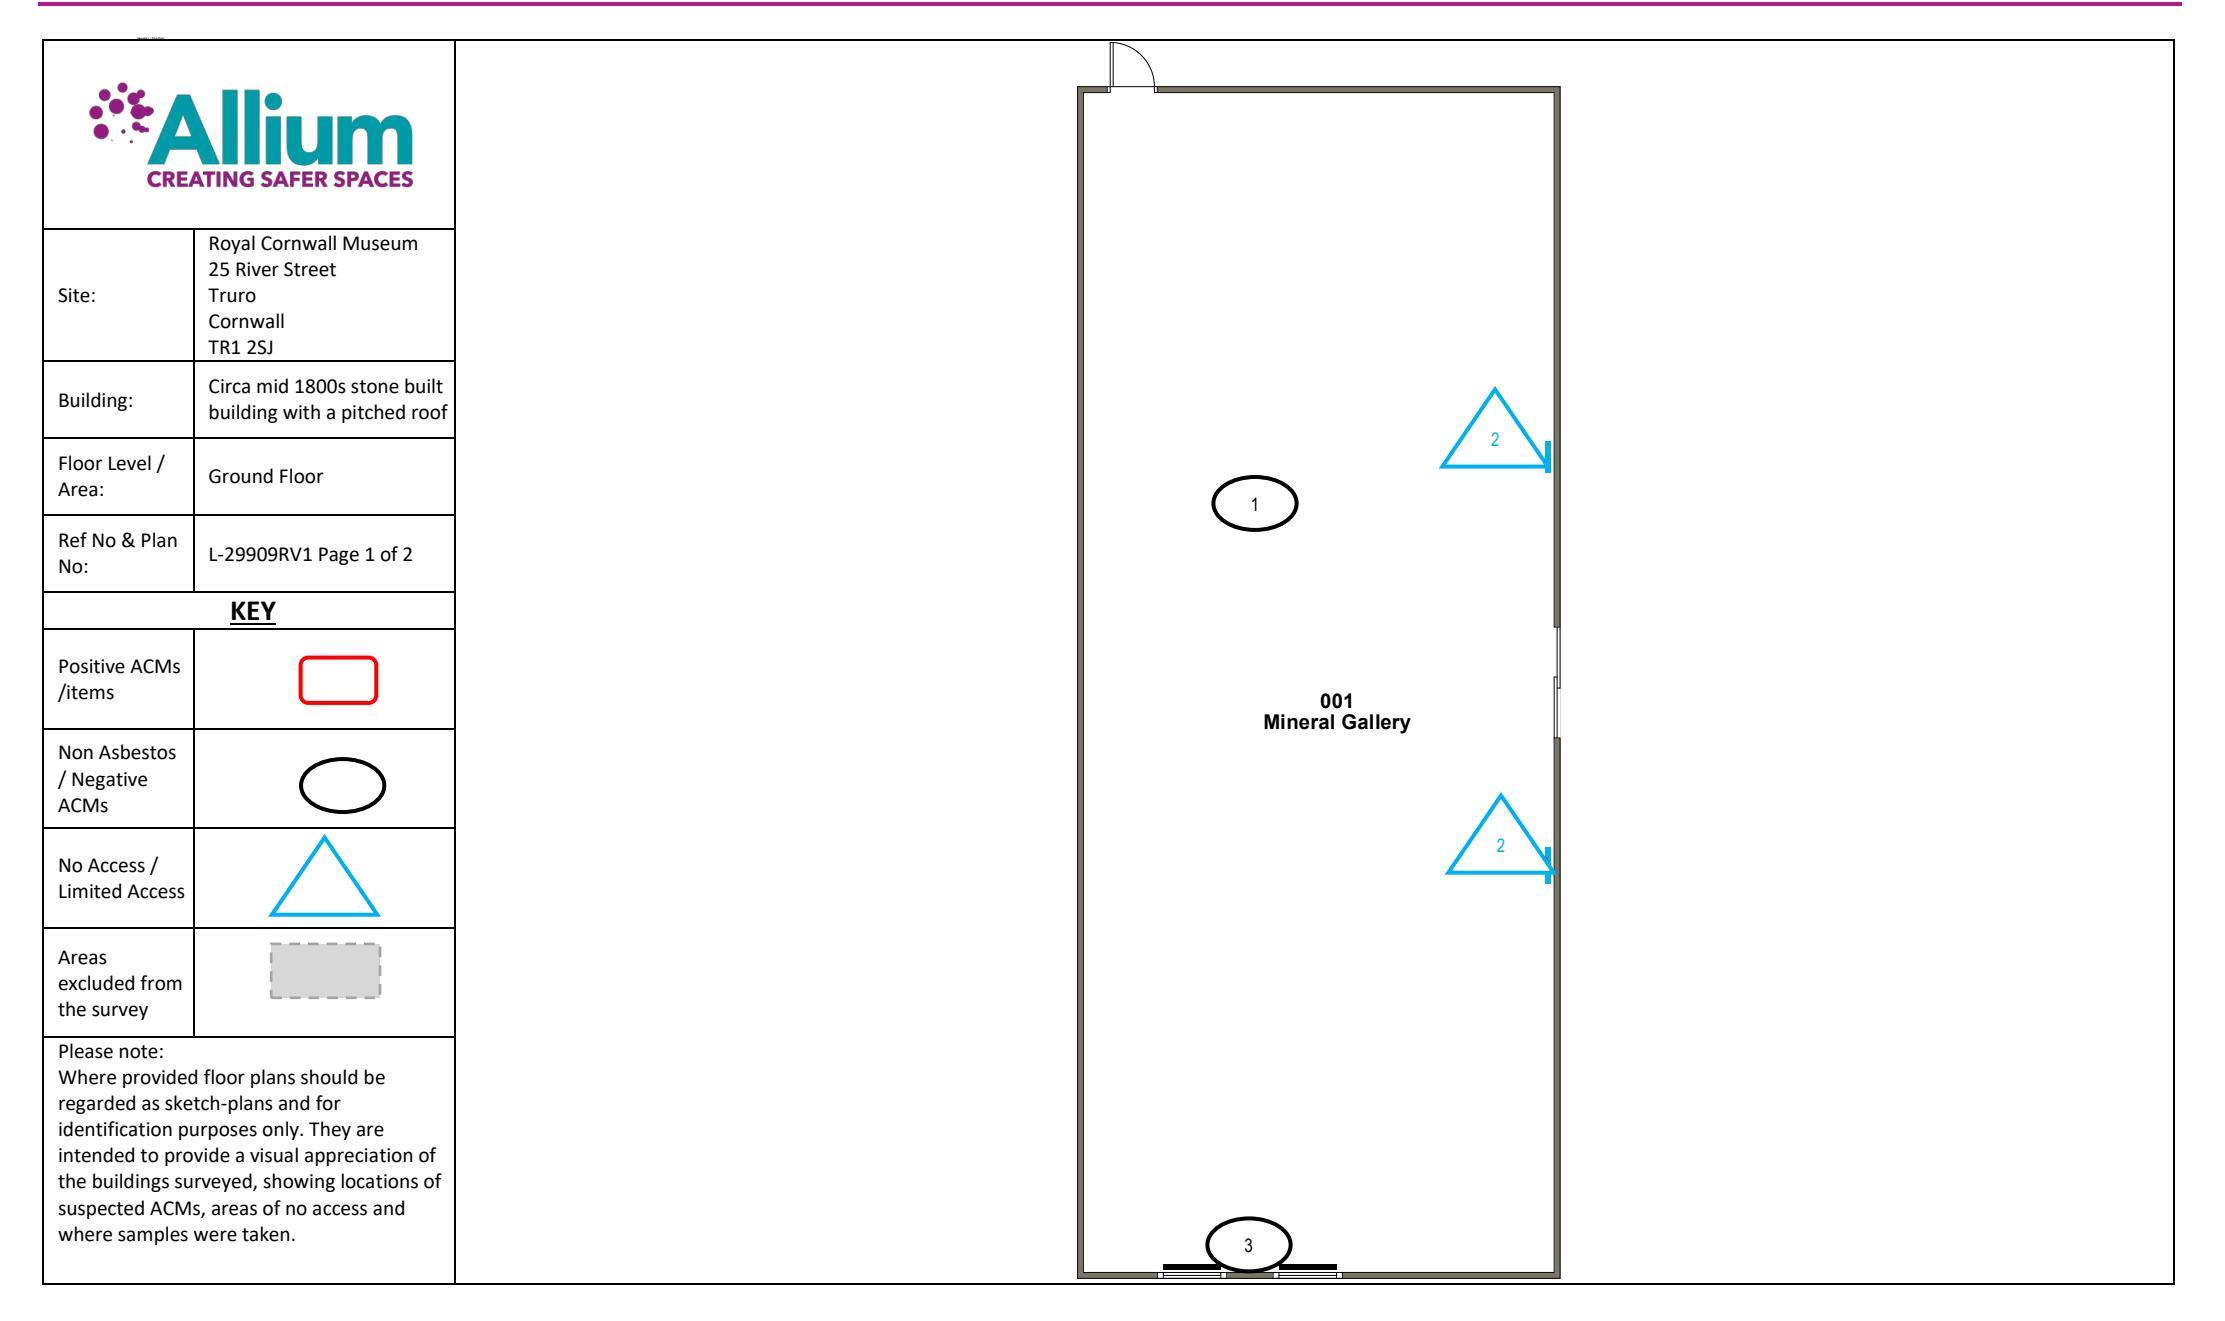
• THIS PLAN SHOULD BE READ IN CONJUNCTION WITH THE MAIN BODY OF THE REPORT AND INDIVIDUAL ITEM RECORDS

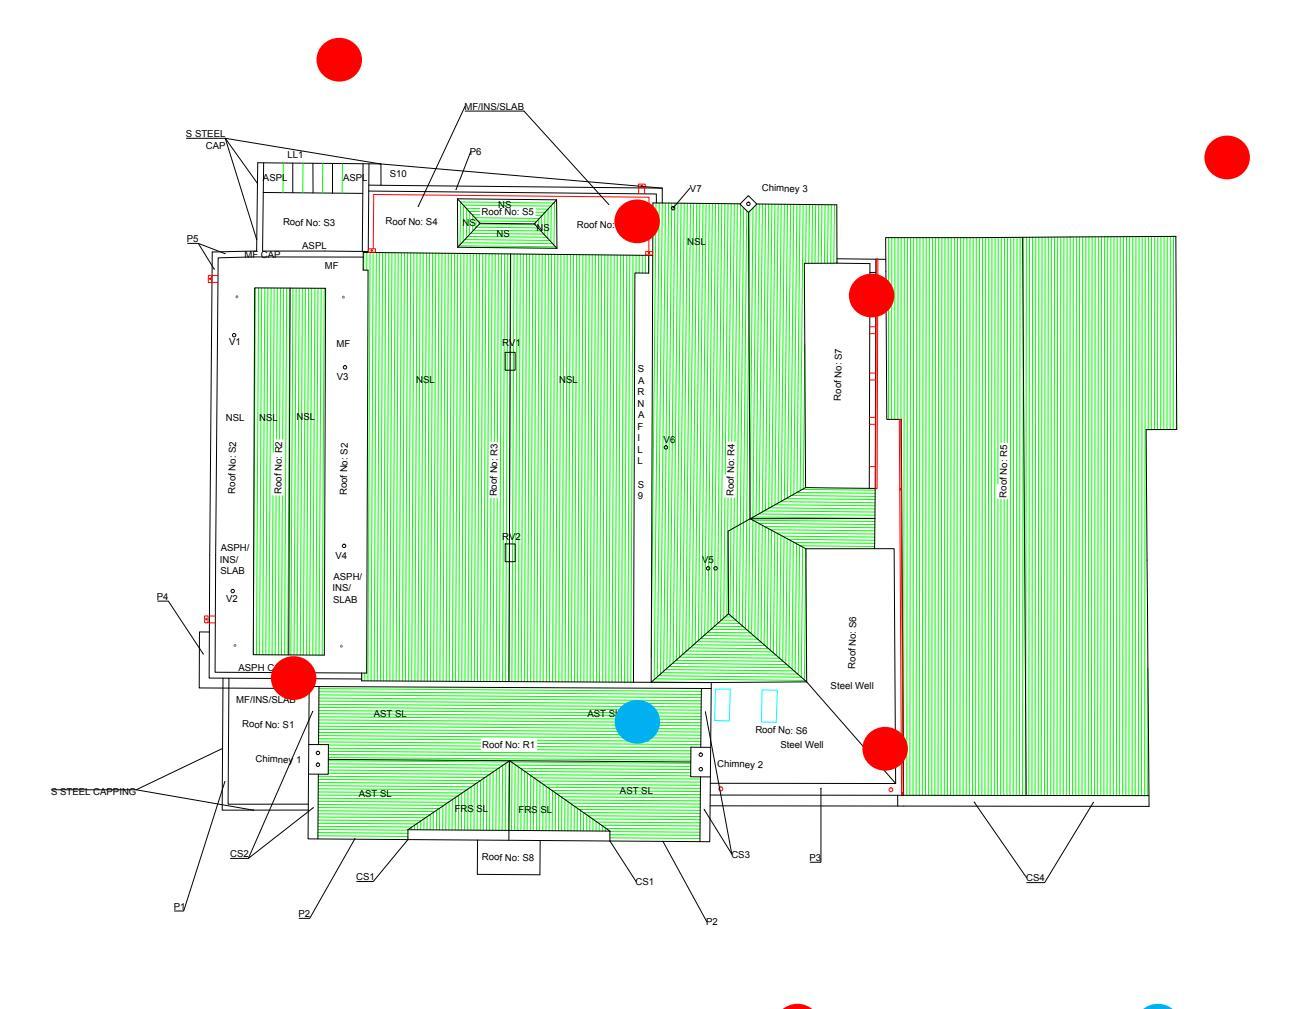
Figure 2. Roof plan showing proposed location of surveyors () and remote monitoring () for phase 2 ecology surveys.

Due to the presence of a hanging ceiling, it was not possible to carry out a visual search of R1. Remote monitoring (at least five consecutive nights between May and August) of R1 was recommended. This was carried out from 4th - 12th July 2022 (8 consecutive nights). A SongMeter (SM2+) detector was placed in the roof void and set to record bats from one hour before sunset to one hour after sunrise (see Figure 1 for location).

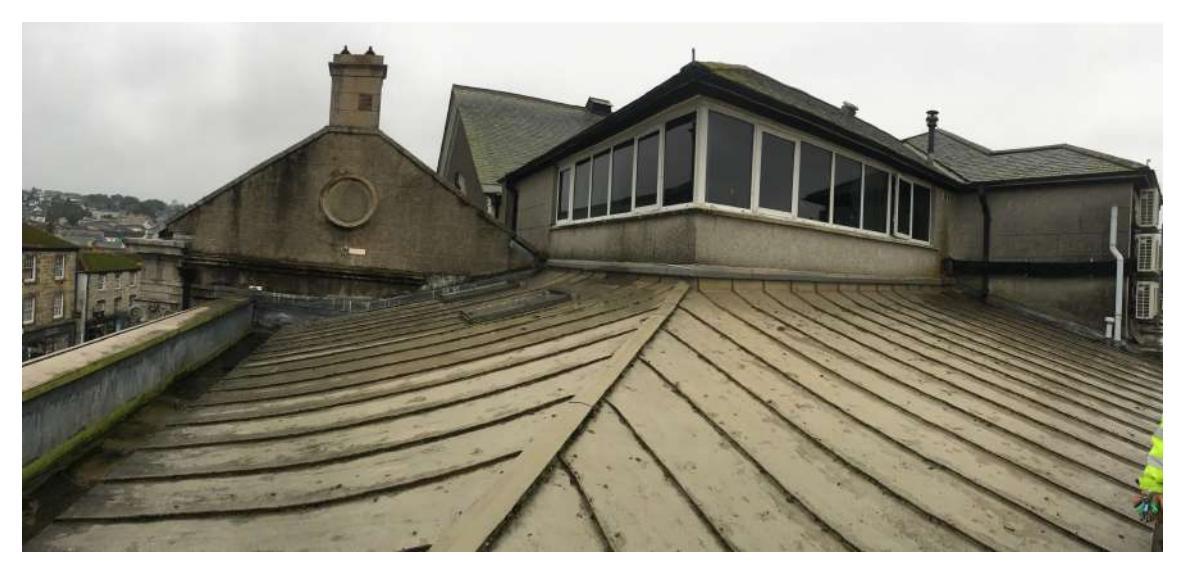
Photograph 3. Granite gable of Roof No R1 and southern parts of R4.

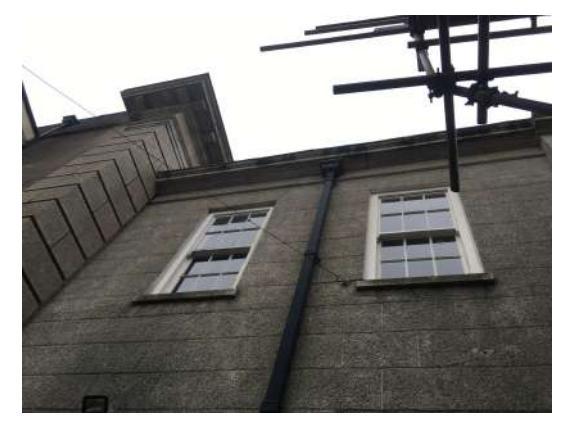
Photograph 4. Granite cornices of Roof No R1.

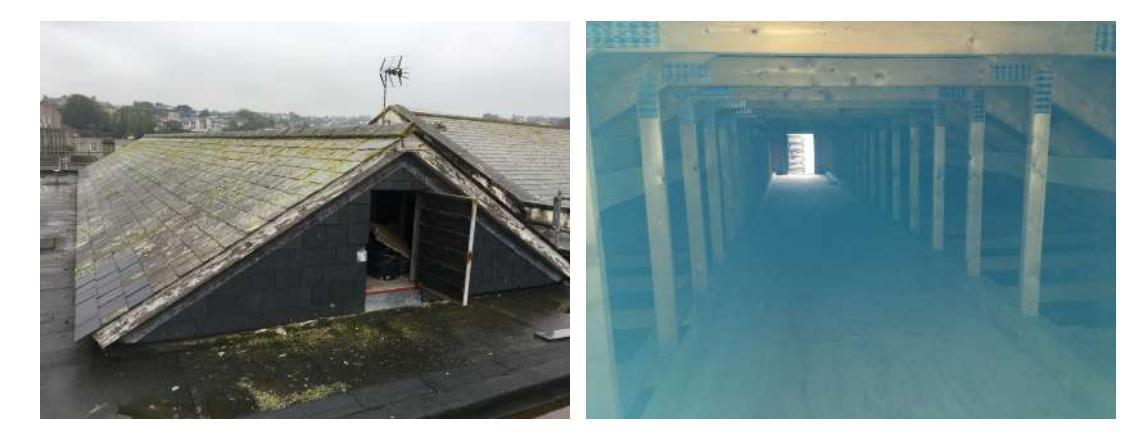
Photograph 5. Roof No R2 North and east elevations. Photograph 6. Roof No R2 internal.

Roof No R2 is pitched gable roof. It has flat roof sections at the eaves (Roof No S2). It is therefore possible to walk entirely around Roof No R2 at the flat roof height. The roof covering is natural slate with clay ridge tiles. There is a foil type membrane present. No potential bat access points were observed to allow bats to the voids between the membrane and slates nor under the ridge tiles. At each gable is a louvred metal door which could potentially allow bat access to the walk-in void within. However, a thorough search of this void was achieved and no evidence of roosting bats was found. The hanging slates on the gables do not have any potential bat access points. A through search or all areas accessible to roosting bats was carried out an no evidence was found. Roof No R2 has been assessed as having negligible potential as a bat roost and no further surveys of this roof were required.

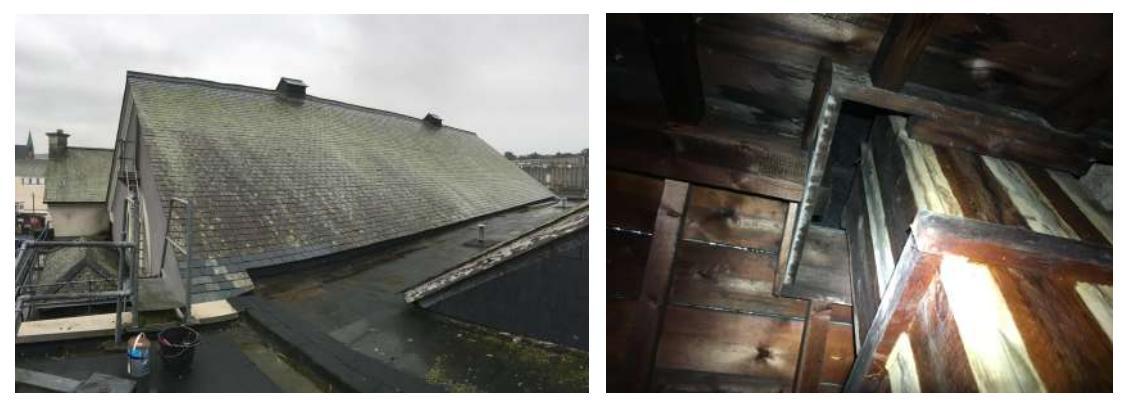
Photograph 7. Roof No R3 North and west elevations. Photograph 8. Roof vent in No R3.

The presence or absence of bats in R3 could not be determined via a visual survey alone. R3 was assessed as having low potential as a bat roost. Therefore, one emergence survey at dusk using two surveyors was recommended to prove absence of bats. Remote monitoring of the void was not required. R3 was surveyed at dusk from the flat roof sections.

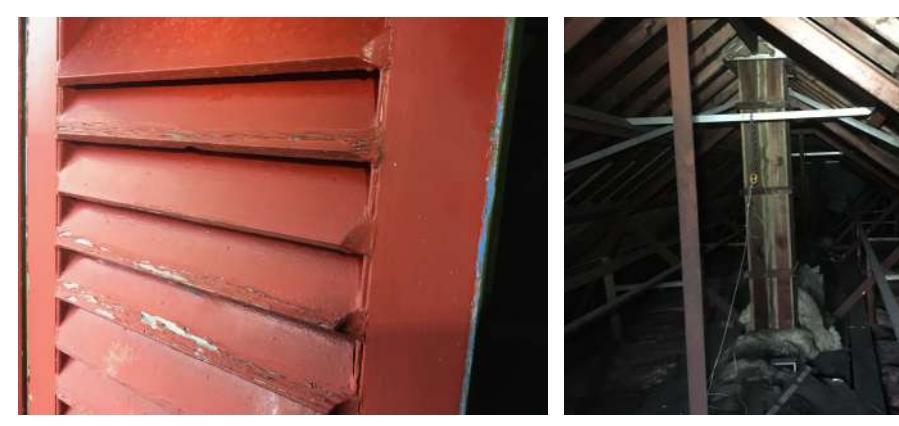
Photograph 9. Roof No R3 louvred door.

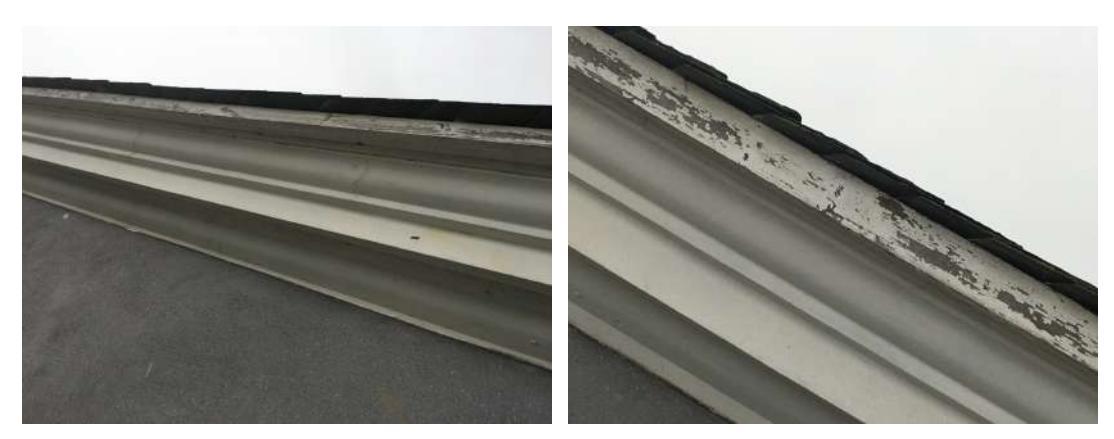
Photograph 11. Tightly fitted soffit of R3. Photograph 12.

Photograph 12. Gaps between soffit and slates on R3.

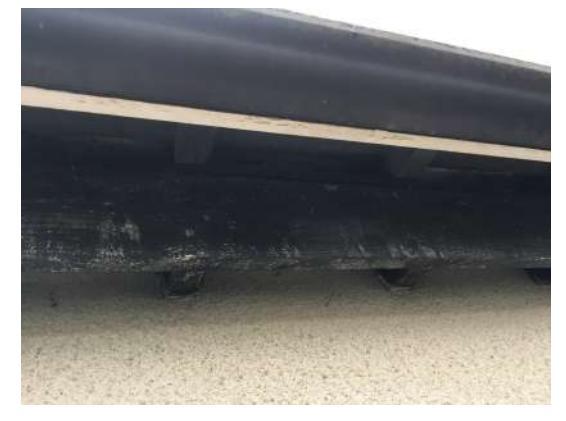
Photograph 13. Gaps between the rafters at the eaves of R4.

The presence or absence of bats in R4 could not be determined via a visual survey alone. R4 was assessed as having low potential as a bat roost. Therefore, one emergence survey at dusk using two surveyors (a third surveyor covering R3 also covered the west roof slope of R4) was recommended to prove absence of bats. Remote monitoring was not required. R4 was surveyed at dusk from the flat roof sections.

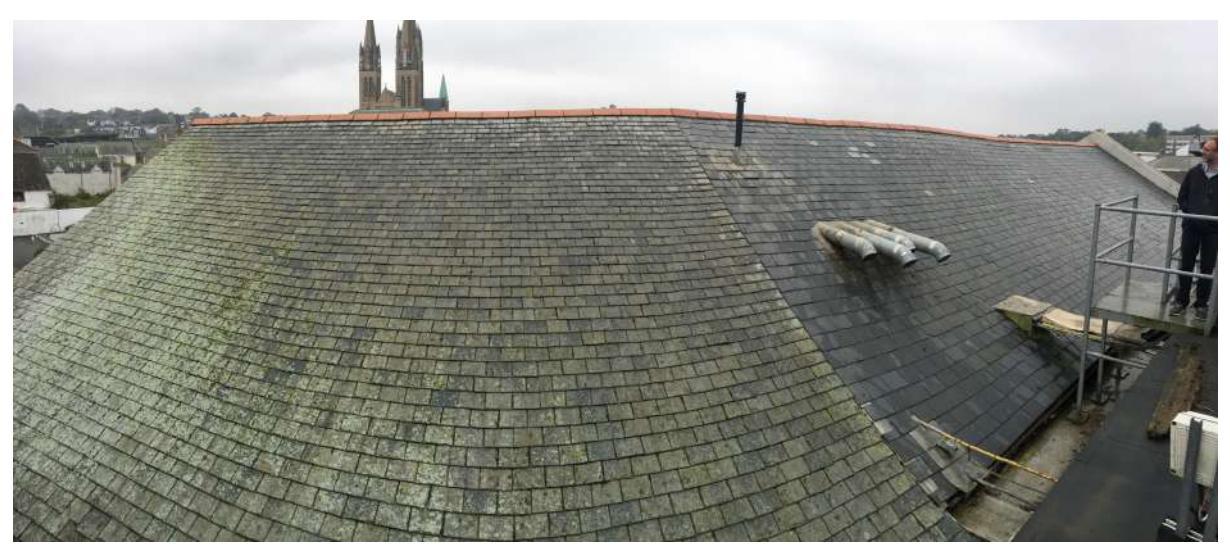
Photograph 14. West roof slope of R5.

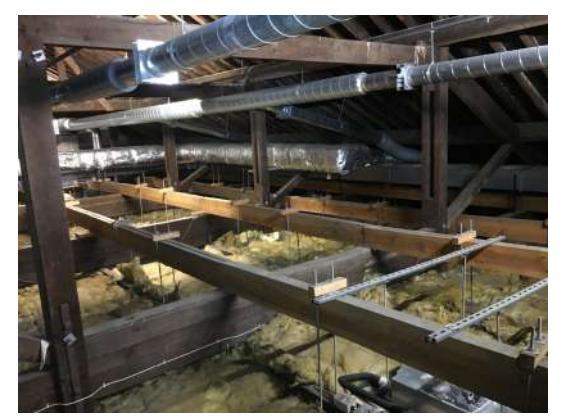
Photograph 15. Roof void of R5.

There is a small eaves void in the north east corner of R5. This has a concrete base. No evidence of bats was found within.

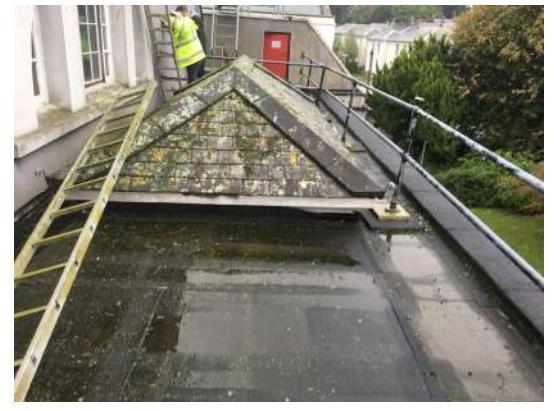
Photograph 16. Roof No S5.

There is a small hipped roof within the flat roof (S4) to the north of R3 (see Photograph 16). It is possible that this was a former light-well that has been slated. It does not have any potential for roosting bats and no further surveys of S5 were required.

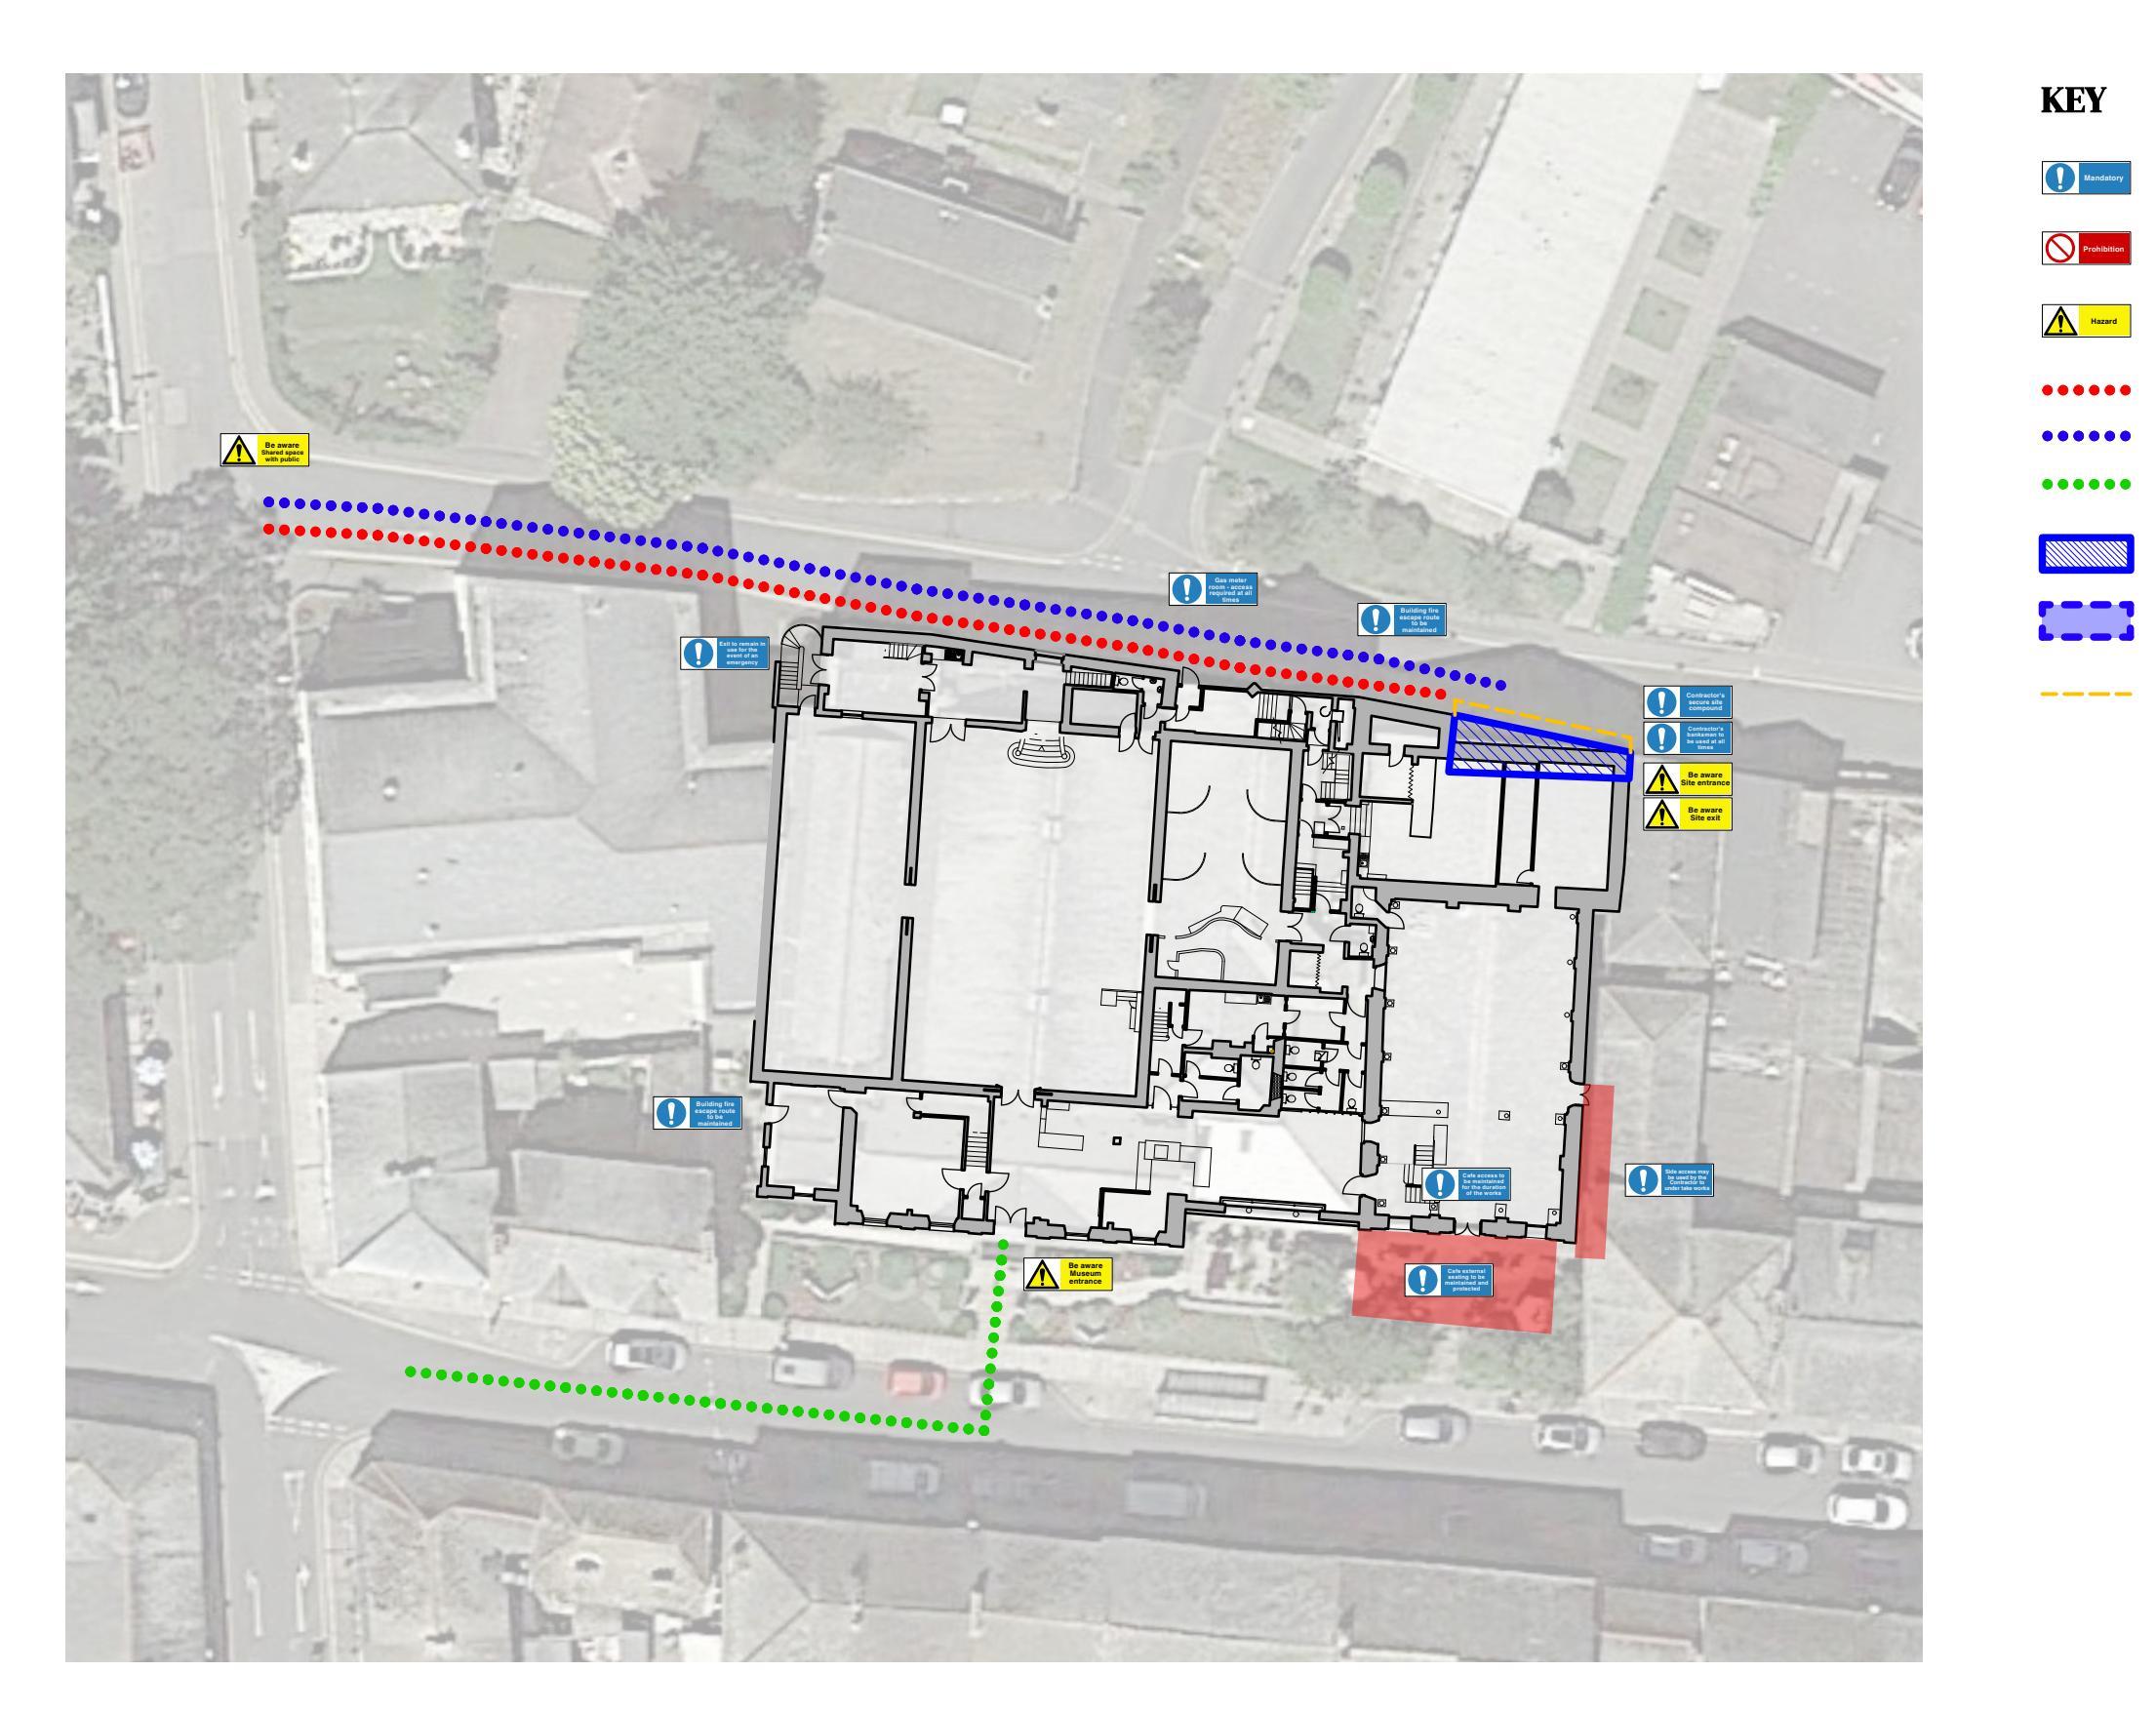
SITE LOGISTICS PLAN

The Museum and related areas will remain open to the public and staff for the duration of the project.
