PRE-CONSTRUCTION INFORMATION

(CDM) Regulations 2015

Proposed Extension and Refurbishment of Lemsford Village Hall

Current Revision: 00 Issue Date: 20th May 2019

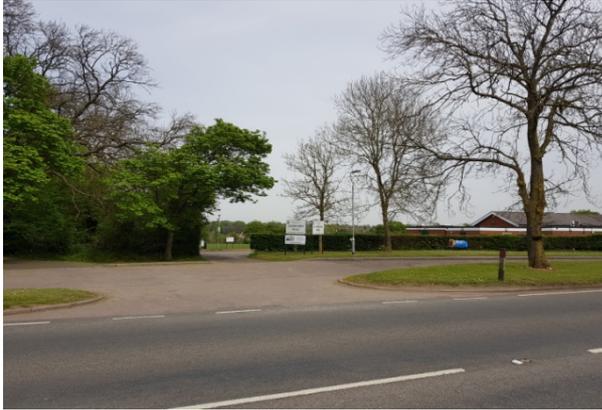
Site Access (From Brocket Road)

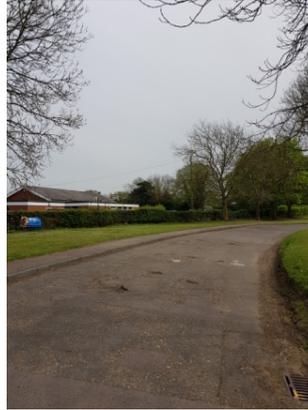
Lay-by running parallel to Brocket Road

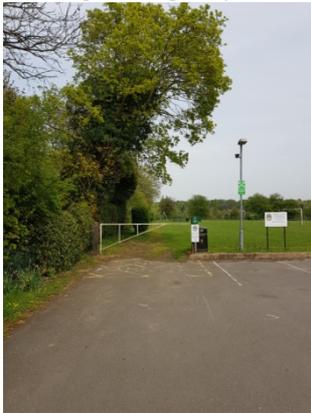
Existing Emergency access to pitch

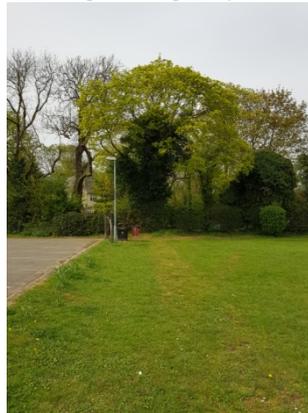
Existing Emergency access to pitch side

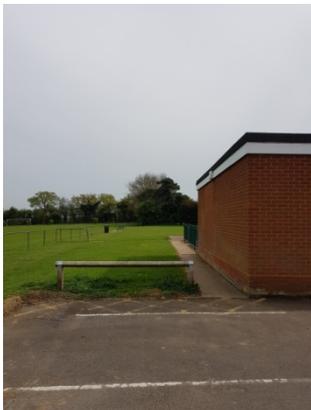
Knee rail fence on north east corner

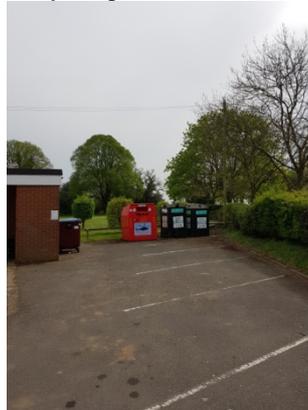
Recycling facilities on west elevation

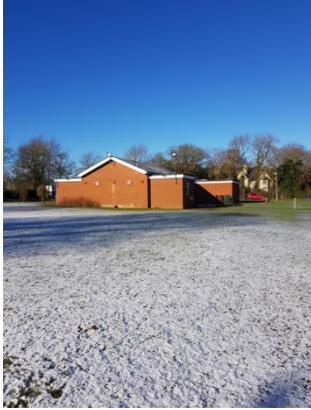
View of south elevation
(area of proposed extension)

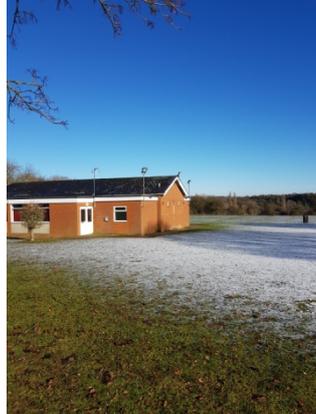
View of south west corner
(area of proposed extension)
