TASK NO.	TASK/DESCRIPTION	NOTES
H4.09	<p data-bbox="485 360 1150 383">H4 EXTERNAL DOORS, OPENINGS AND HATCHES</p> <p data-bbox="411 421 799 450">Door Locking Arrangements</p>

TASK NO.	TASK/DESCRIPTION	NOTES
H5.04	<p data-bbox="539 322 1070 349">H5 TOPSIDES AND SUPERSTRUCTURE</p> <p data-bbox="403 385 608 416">Draught Marks</p>

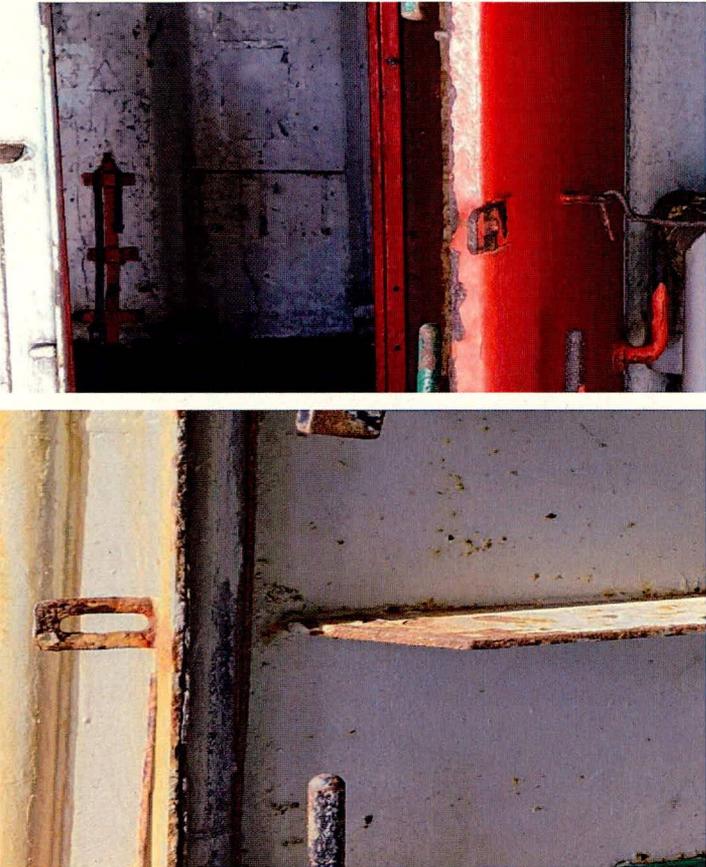
<p data-bbox="411 1442 1217 1570">Upper deck door locking arrangements are seized in numerous locations. Contractor is to free up /RENEW hasp and staple fittings on all associated doors as required. REPRESENTATION on completion. ALLOW for 7m² REPRESENTATION. ALLOW for 23 doors.</p>	<p data-bbox="1251 450 1450 613">Hotwork Required – Appropriate precautions to be taken iaw General 8.4.</p> <p data-bbox="1251 647 1450 757">IAW Paint scheme -General 12 and Annex B refer.</p>

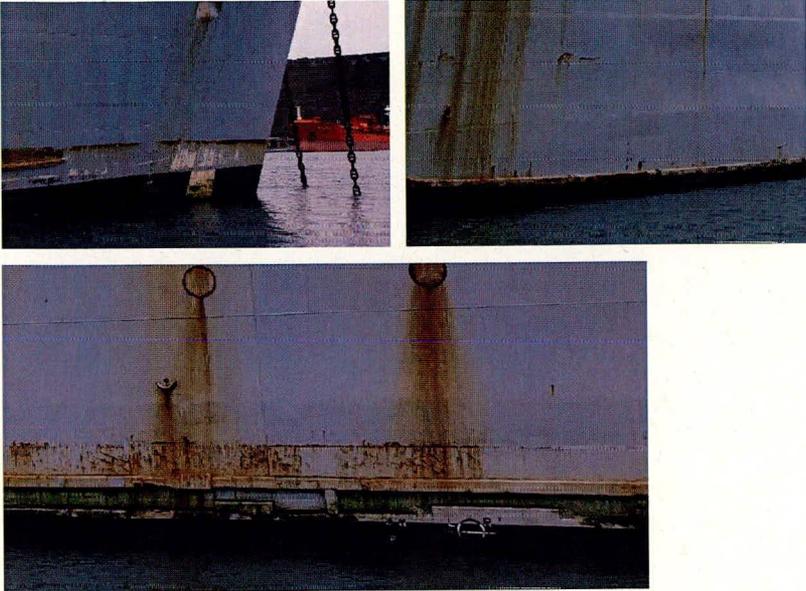
<p data-bbox="403 1037 1214 1155">Fwd, Midships and Aft draught marks port and stbd are obscured with marine growth and paint coverings are degraded. All relevant areas to be cleaned and REPRESENTED (Black on topsides, white on boot toppings).</p> <p data-bbox="403 1167 831 1193">ALLOW for 6m² REPRESENTATION.</p>	<p data-bbox="1249 385 1444 495">IAW Paint scheme -General 12 and Annex B refer.</p>

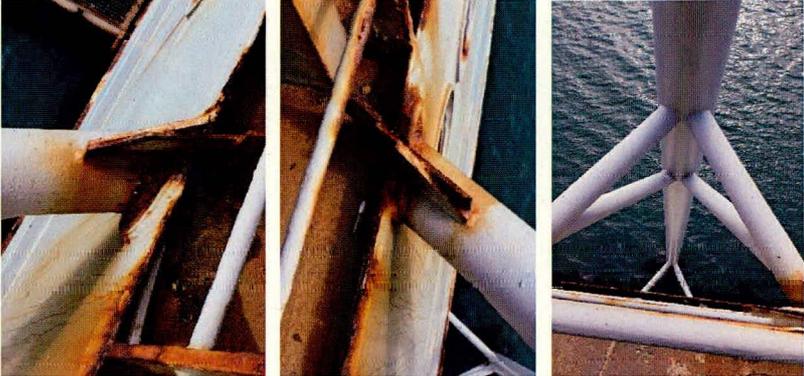
TASK NO.	TASK/DESCRIPTION	NOTES
	H5 TOPSIDES AND SUPERSTRUCTURE	
H5.03	<p data-bbox="405 383 863 416">Oil Rig Training Aid Fixing Points</p>

<p data-bbox="405 813 1214 954">The oil rig training aid affixed port side outboard has 4 welded fixing points. These have all had a total breakdown of paint coatings and are showing signs of active corrosion. Fixing points to be SURVEYED and remedial action taken as required. All areas to be REPRESENTED on completion.</p> <p data-bbox="405 967 834 996">ALLOW for 4m² REPRESENTATION.</p>	<p data-bbox="1249 387 1445 501">IAW Paint scheme -General 12 and Annex B refer.</p> <p data-bbox="1249 533 1445 613">To be completed in conjunction with H5.06.</p>

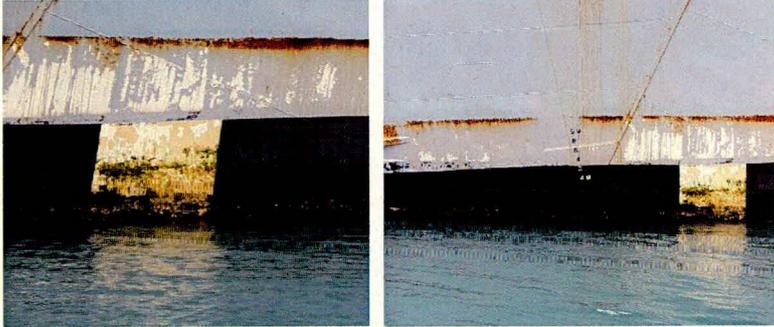
TASK NO.	TASK/DESCRIPTION	NOTES
H5.05	<p data-bbox="539 324 1070 353">H5 TOPSIDES AND SUPERSTRUCTURE</p> <p data-bbox="400 387 655 416">Draught Indicators</p> <div data-bbox="397 432 1171 759">

</div> <p data-bbox="400 775 1209 875">Port and stbd draught indicators are obscured, worn and difficult to identify. Indicators (2 x port, 2 x stbd) – REPRESENTATIVE coatings. ALLOW for 8m² REPRESENTATION.</p>	<p data-bbox="1249 387 1444 499">IAW Paint scheme -General 12 and Annex B refer.</p>
