First floor plan M&E

PROJECT: Alterations to Collection Store, Explosion Museum, Gosport

DRAWING NO: A1023 - 212

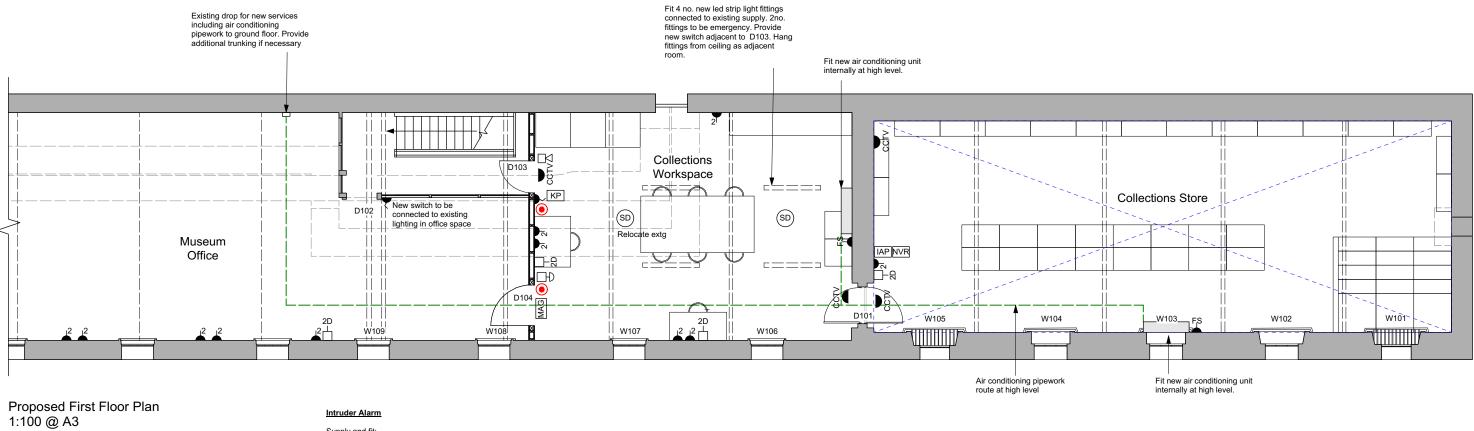
1 x Grade 3 Scantronic ION alarm panel to be located on the rear wall in the collections store. 1 x Grade 3 Scantronic ION keypad located adjacent to either door D103 or D104 depending in the choice of entry rout. 1 x Grade 3 Scantron ION10 Wired expander, Located on the rear wall in collections near the alarm panel.

Warning Devices: 1 x internal sounder location above D103

Alarm Monitoring: 1 X GRADE 3 Redcare secure to be located inside the main control panel

ZONE 1 - Supply and fit 1 x Grade 3 door contact on the top lock side of door D104. ZONE 2 - Supply and fit 1 x Grade 3 door contact on the top lock side of door D103.

- ZONE 3 Supply and fit 1 x Grade 3 door contact on the top lock side of door D104.
- ZONE 4 Supply and fit 1 x Grade 3 Dual tech motion detector above door D101 in collections store.

ZONE 5 - Supply and fit 1 x Grade 3 Dual tech motion detector adjacent to the alarm panel in collections store. ZONE 6 - Supply and fit 1 x Grade 3 Dual tech motion detector adjacent to the alarm panel in collections store.

ZONE 7 - Supply and fit 1 x Grade 3 Dual tech 360 motion detector on the cage celling above window W103 RIGHT walk way ZONE 8 - Supply and fit 1 x grade 3 Panic Alarm button in collections workspace.

- ZONE 9 Supply and fit 1 x grade 3 Panic Alarm button in collections store.

- Supply and fit: 1 x 8 channel Network Video Recorder (NVR) in the collections store located on a desk next to door D101. 1 x 21 inch flat screen LED monitor to be located on top of the NVR in the collections store.
- 1 x 3TB Surveillance Seagate hard drive.
- Cameras:
- Camera type A 4 MP IR Fixed Dome Network Camera 1/3" Progressive Scan CMOS
 2688 ×1520@30fps 2.8 fixed lens
 Color: 0.01 Lux @ (F1.2, AGC ON), 0.018 Lux @ (F1.6, AGC ON), 0 Lux with IR
 H.265+, H.265, H.264+, H.264 Three streams 120dB WDR • 2 Behavior analyses, and face detection • BLC/3D DNR/ROI/HLC • IP67

Camera 1 - Supply and fit camera type A above door D101 looking into collections workspace covering the doors and windows. Camera 2 - Supply and fit camera type A above door D103 looking into collections workspace covering the doors and windows. Camera 3 - Supply and fit camera type A above door D101 looking into collections store looking along the main windows down to the back wall. Camera 4 - Supply and fit camera type A in the collections store adjacent to the alarm panel looking down the back walkway.

All new cabling to run in existing conduit/ trunking or to be installed in new to match existing

Provide all power supplies/ data points as required for CCTV cameras, maglocks etc
