# TRINITY TIMBER PRESERVATION & DAMP CONTROL LIMITED

Re: 21 Market Place, Southwold, IP18 6ED.

## Damp report

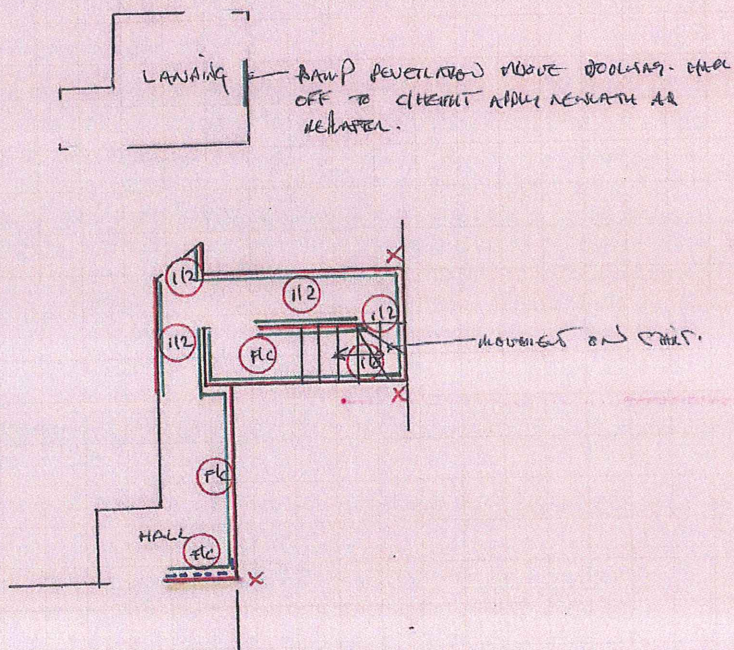
On the front wall there is dampness showing above the dado where in the past they have attempted to mask the damp. There are very high damp readings on this section above the dado together with visible staining of the decorations. Further we note the skirting is affected by fungal rot due to the high levels of moisture present. Moving to the right hand wall there is dampness especially on the front corner and this moves forward onto the party wall where the damp extends to a height of 1.9ms above floor level. Moisture readings were in the high range and consistent with rising dampness.

Moving to the left of the front entry there are dry linings and some stud walling. At the far end of the hall on the left hand wall there was dampness as far as the sealed off doorway, on the back wall and in the cupboard below the stairs moving on the stairwell. We also note some weakness to the bottom of the stairs. This would be a area for further investigation.

Going back to the ground floor based on the above findings and for the purpose of this report it would be necessary to hack off the areas of damp/contaminated plaster and depending on what we find to apply 'Newton 805' membrane. The membrane will provide an effective separation between the masonry and the finished plaster as residual dampness and ongoing salt contamination is likely without a suitable physical barrier between the brick and the finishing plaster.

We would also inject a new damp proof course including a degree of tanking as detailed on the enclosed sketch plan which will be carried out by means of the following method and in accordance with BS6576 and agreement board certificate no. 86/1766.

Drill brickwork or mortar in the first available course at least 150mm above existing or proposed external ground level. The drilling will be composed of holes bored to an approximate depth of 75mm per 112mm of brickwork thickness and approximately 125mm apart. The bricks or mortar will then be injected under pressure using an approved chemical until a new damp proof course is formed. All abutting or adjoining walls will be isolated by a vertical damp proof course. The new damp proof course will be installed below joist level where practicable subject to site conditions. The new damp proof course will be installed by means of multiple injection from the exterior or interior or both as detailed on the enclosed drawing.
