LEGIONELLA RISK ASSESSMENT

CUSTOMER : NATURAL ENVIRONMENTAL
RESEARCH COUNCIL

SITE : BRITISH GEOLOGICAL SURVEY,
KEYWORTH

DATE : 13 JULY 2016

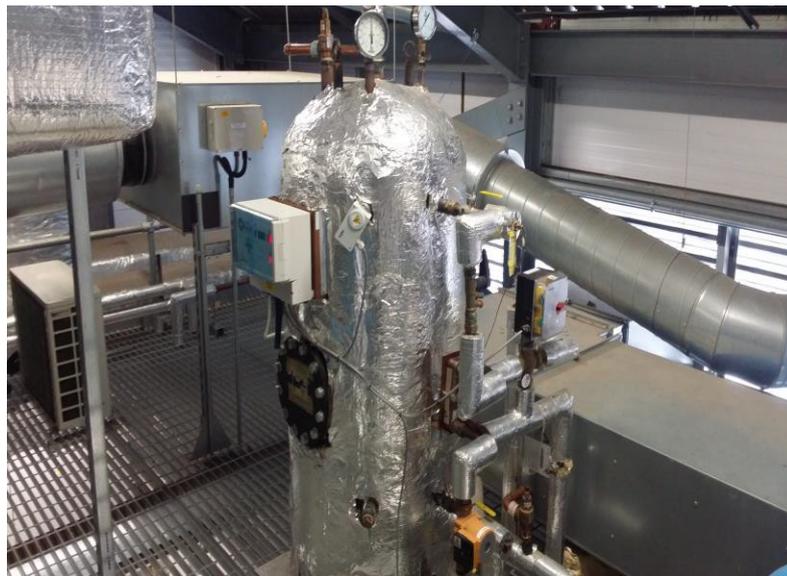
CAL 1

CAL	Gauges Fitted	Temperatures (°C)			Return Type	Access Hatch	Drain Operable	Blowdown Appearance	Is Shunt Pump Required?	Are Recs Required?
		Stored	Flow	Return						
1	yes	62.0	-	56.0	single	yes	yes	clear	no	no
Comments:

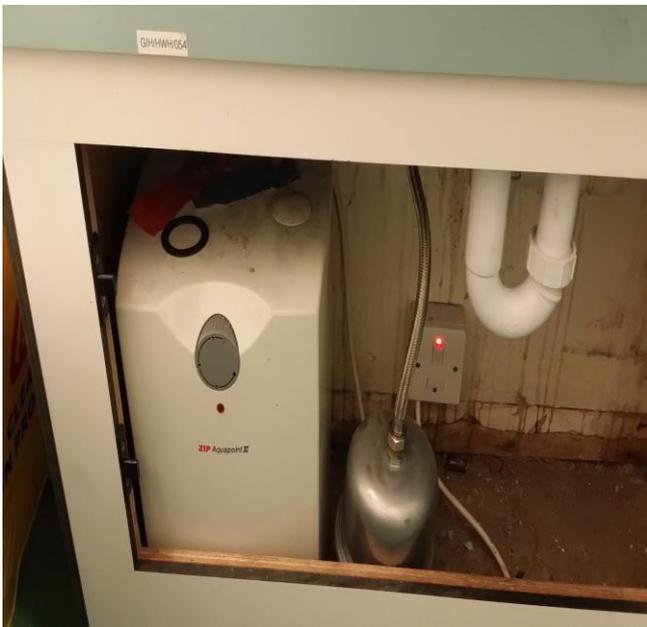
Asset Referenc	System Usage	Outlet Temps > 50°C ?	Recommendations Required?
POU 1	Daily	Yes	No
POU 2	Daily	Yes	No

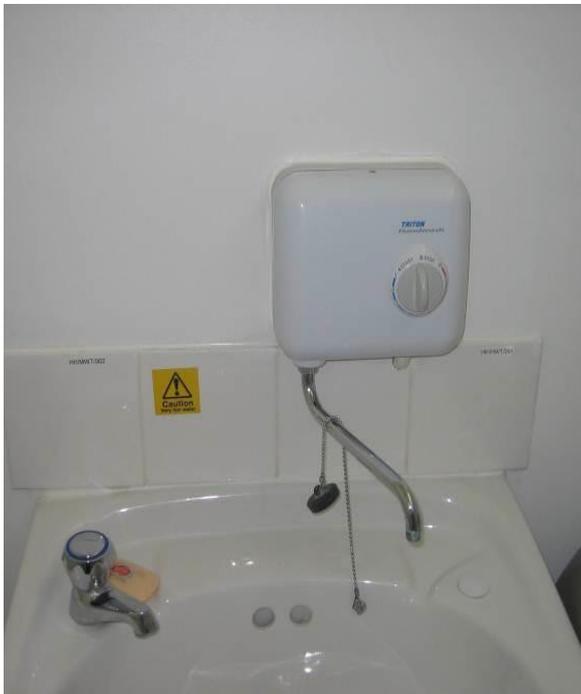
POU 1 (HH/HWT/001)

Asset Reference	System Usage	Outlet Temps > 50°C ?	Recommendations Required?
POU 1	At least weekly	50.3	No
POU 2	At least weekly	54.1	No

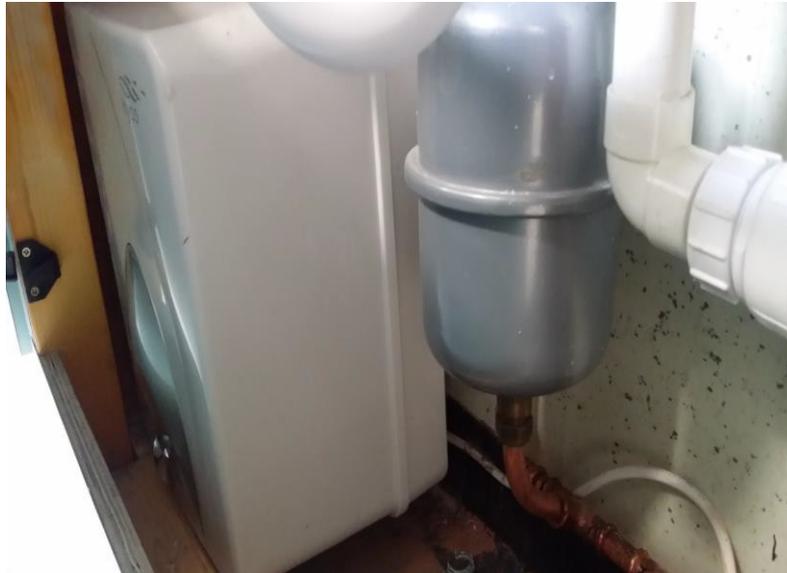
Asset Reference	System Usage	Outlet Temps > 50°C ?	Recommendations Required?
POU 1	At least weekly	Yes	No
POU 2	At least weekly	Yes	No

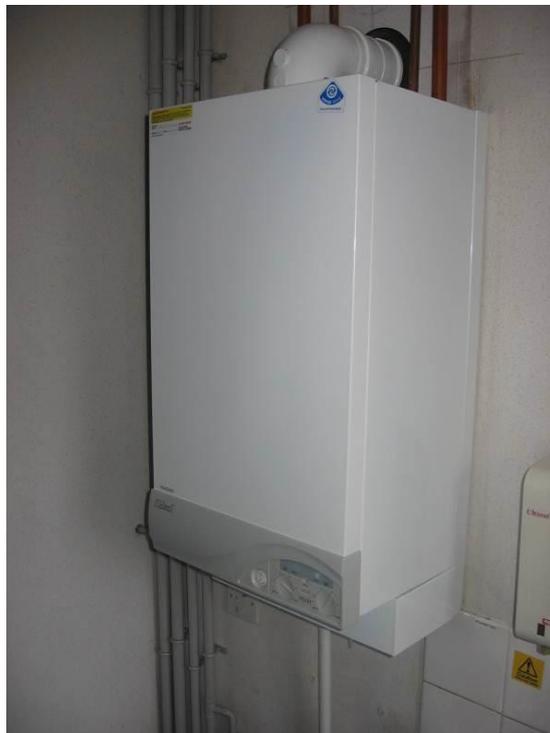
Asset Reference	System Usage	Outlet Temps > 50°C ?	Recommendation s Required?
IWH 1	Daily	Yes	No

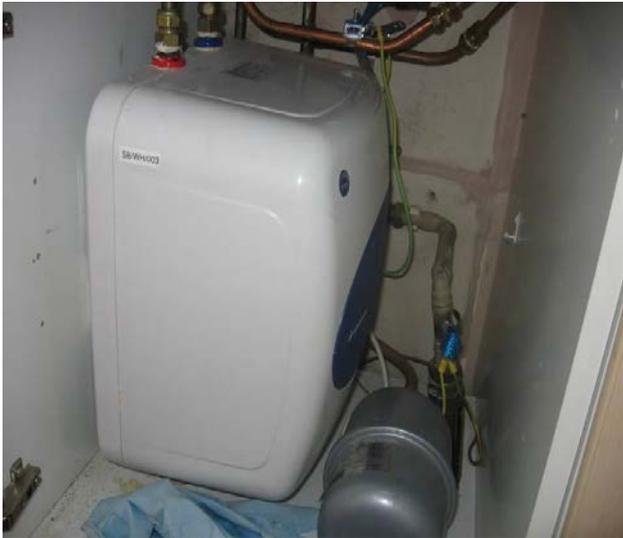
Asset Reference	System Usage	Outlet Temps > 50°C ?	Recommendations Required?
POU 1	Daily	52.3	No
POU 2	Daily	50.4	No

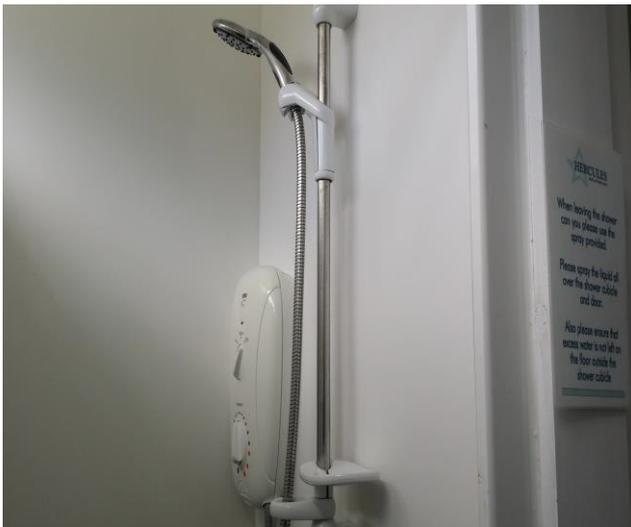
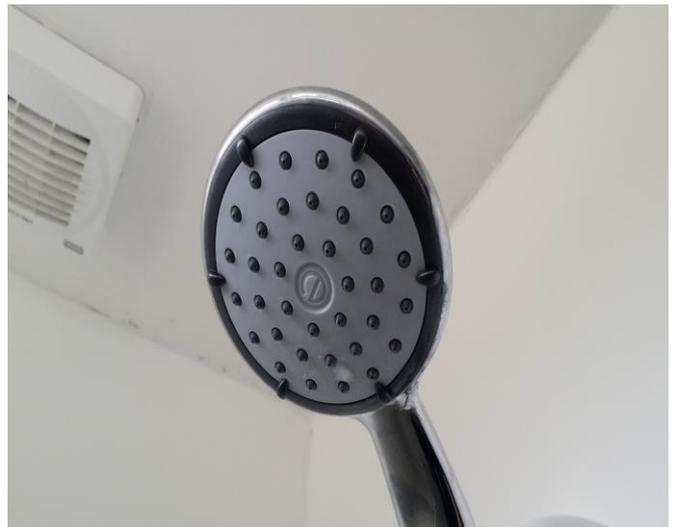
Shower	Location	Contamination	Usage	Hot > 50°C	Cold < 20°C	Type
S 1 – 2	First Floor Ladies Changing	Clean	At least weekly	Yes	Yes	Mains electric showers
S 3 – 4	First Floor Gents Changing	Clean	At least weekly	Yes	Yes	Mains electric showers
Comments:

TYPICAL SHOWER

TYPICAL SHOWERHEAD

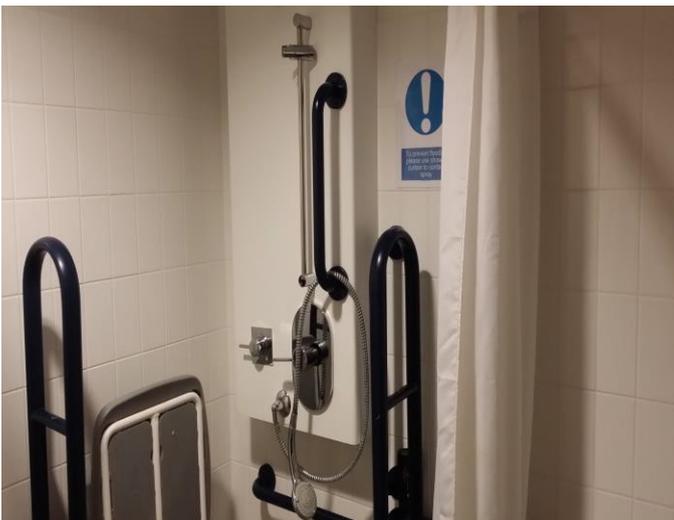
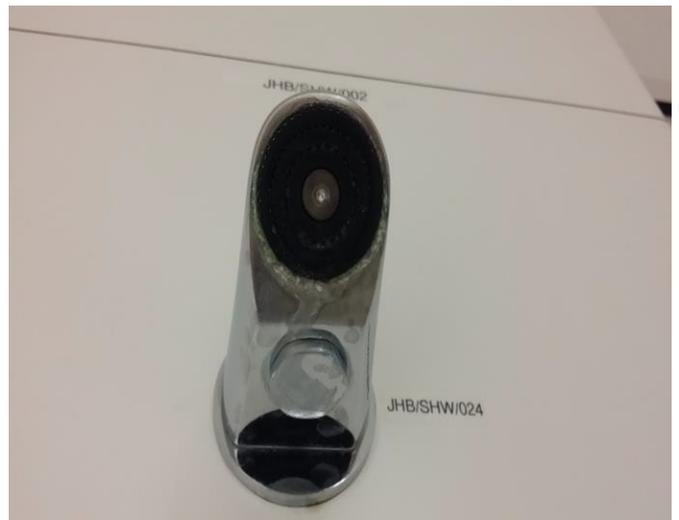
Shower	Location	Contamination	Usage	Hot > 50°C	Cold < 20°C	Type
S 1	Ground Floor Shower Room	Slight scale	At least weekly	Yes	No	Domestic mixer shower
Comments The shower is of the accessible type with two heads: one fixed and one on a hose.

S 1 SHOWERHEAD

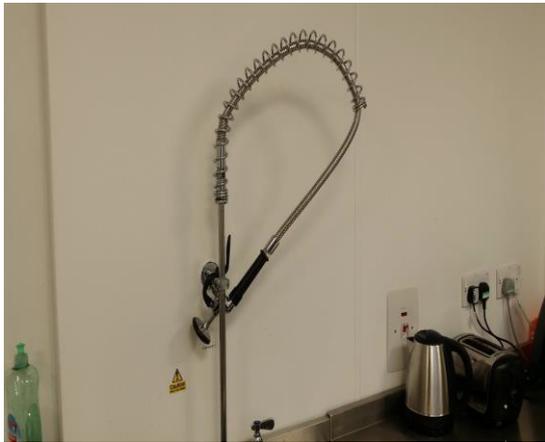
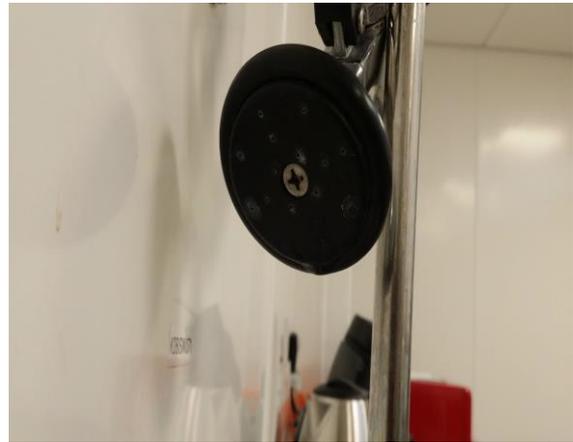
Shower	Location	Contamination	Usage	Hot > 50°C	Cold < 20°C	Type
RS 1	First floor staff kitchen	Slight scale	At least weekly	Yes	Yes	Mixer
Comments

RS 1 SPRAY HEAD

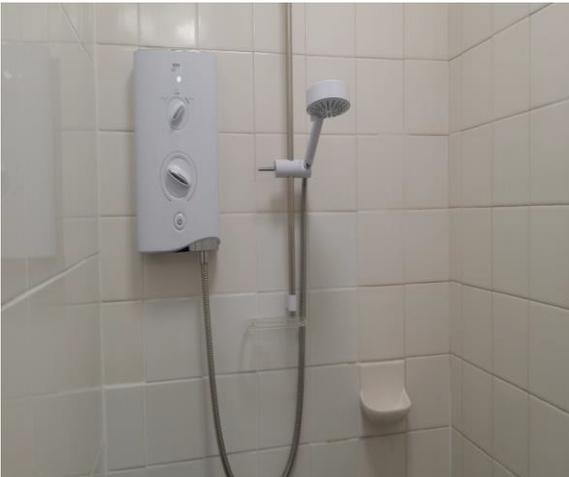
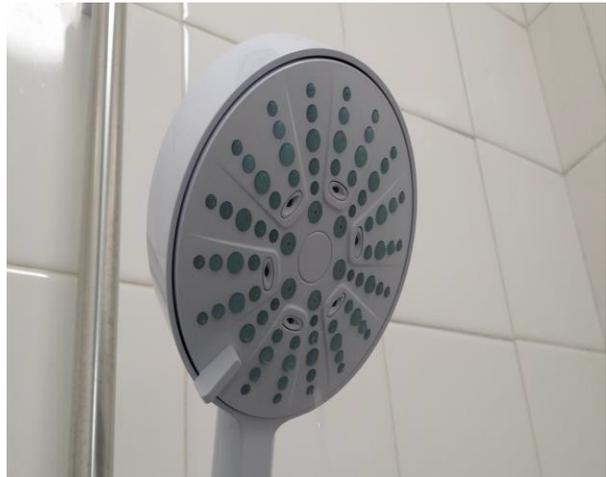
Shower	Location	Contamination	Usage	Hot > 50°C	Cold < 20°C	Type
S 1 – 2	Ground Floor Ladies Changing Area	Clean	At least weekly	-	No	Electric
S 3 – 5	First Floor Gents Changing Area	Clean	At least weekly	-	No	Electric
Comments

TYPICAL SHOWER

TYPICAL SHOWERHEAD

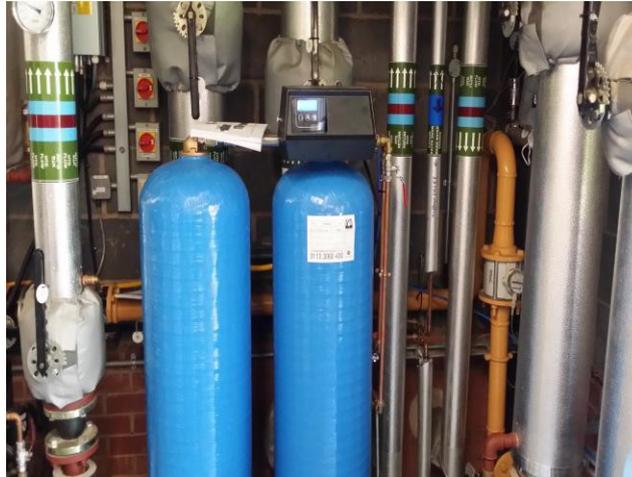
WS 1

LOCATION	Location of outlet	GIH plantroom
TYPE	Type of System	Water Softener
IDENTIFICATION	Designation	WS
STRUCTURE	Materials of Construction	Mixed
	System Serves	Humidifiers
OPERATION & CONDITION	System Water Temperature	<20°C
	Outlet Temperature	N/A
	Direct Spray Formation	No
	Degree of Dirt	None seen
	Degree of Biological Slime	None seen
	Extent of Corrosion	None
	Assessment of risk	Low

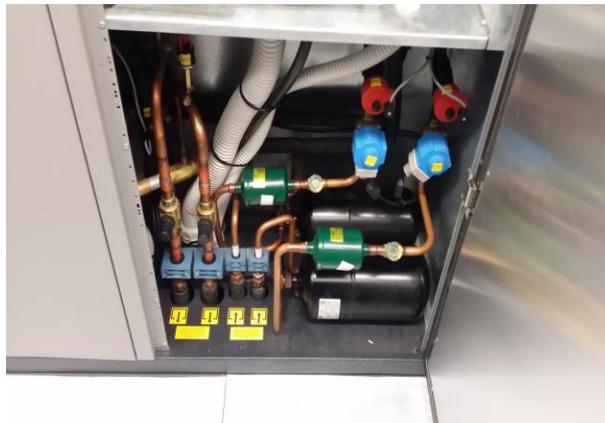
LOCATION	Location of outlet	Computer Suite
TYPE	Type of System	Humidifiers
IDENTIFICATION	Designation	HUM 1 to 5
STRUCTURE	Materials of Construction	Mixed
	System Serves	Humidity
OPERATION & CONDITION	System Water Temperature	N/A
	Outlet Temperature	N/A
	Direct Spray Formation	No
	Degree of Dirt	None seen
	Degree of Biological Slime	None seen
	Extent of Corrosion	None seen
	Assessment of risk	Low

TYPICAL HUMIDIFIER

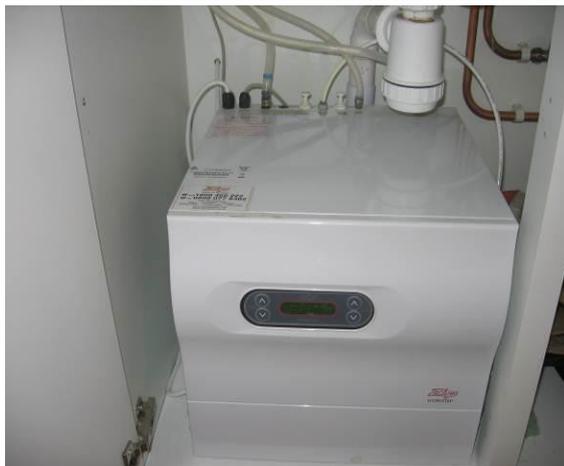
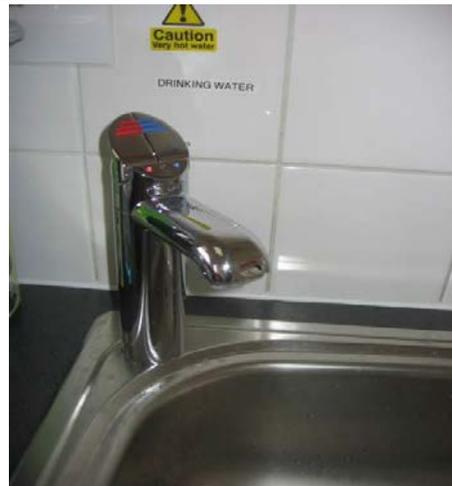
LOCATION	Location of outlet	First floor kitchen
TYPE	Type of System	Water Boiler / Chiller
IDENTIFICATION	Designation	WB / CW
STRUCTURE	Materials of Construction	Mixed
	System Serves	Beverages
OPERATION & CONDITION	System Water Temperature	>50°C / <20°C
	Outlet Temperature	N/A
	Direct Spray Formation	No
	Degree of Dirt	None
	Degree of Biological Slime	None
	Extent of Corrosion	None
	Assessment of risk	Very low / negligible

COMBINED WATER BOILER / CHILLER

**BOILING WATER / CHILLED WATER
TAP**

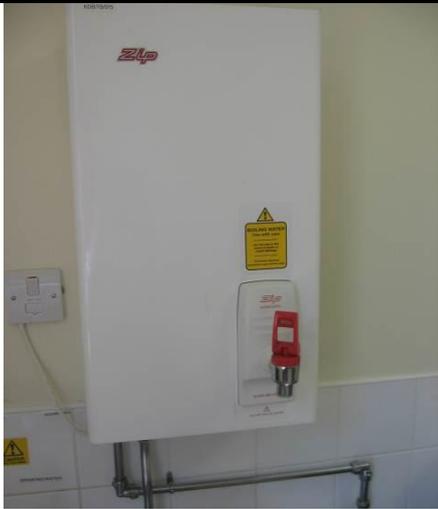
LOCATION	Location of outlet	Ground floor tea points Rooms J036 & J037
TYPE	Type of System	Water Boiler
IDENTIFICATION	Designation	WB
STRUCTURE	Materials of Construction	Mixed
	System Serves	Beverages
OPERATION & CONDITION	System Water Temperature	>50°C
	Outlet Temperature	N/A
	Direct Spray Formation	No
	Degree of Dirt	None
	Degree of Biological Slime	None
	Extent of Corrosion	None
	Assessment of risk	Very low / negligible

Observations:		
The boiling of the water sterilises the water system and these units do not present a legionella risk.

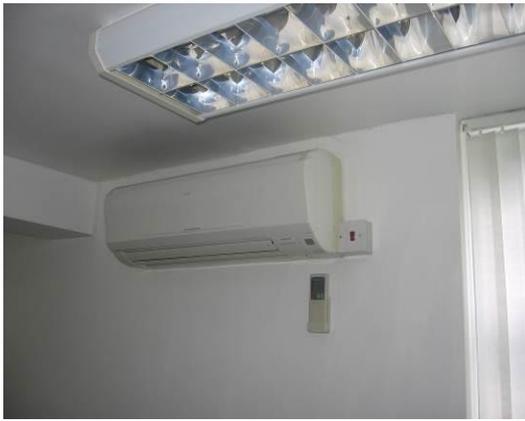
LOCATION	Location of outlet	Gym area
TYPE	Type of System	Air cooling unit
IDENTIFICATION	Designation	ACU
STRUCTURE	Materials of Construction	Mixed
	System Serves	Gym cooling
OPERATION & CONDITION	System Water Temperature	N/A
	Outlet Temperature	N/A
	Direct Spray Formation	No
	Degree of Dirt	Not inspected
	Degree of Biological Slime	Not inspected
	Extent of Corrosion	Not inspected
	Assessment of risk	Low

Observations:		
<p>Water condensing from the cooled air may create conditions suitable for bacteria to grow if units are not regularly cleaned and serviced. Cooling coils and drainage trays of these units could support bacteria growth and should be regularly inspected and maintained in a clean condition.</p>

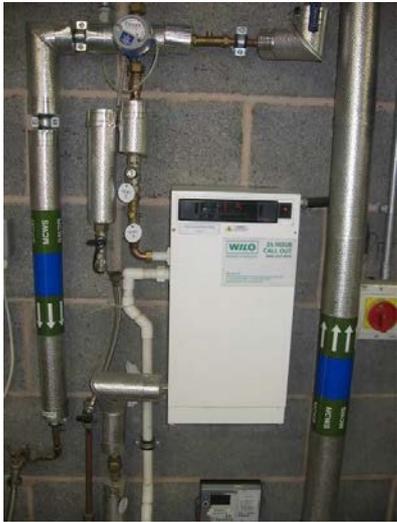
LOCATION	Location of outlet	Plant Room
TYPE	Type of System	Pressurisation unit
IDENTIFICATION	Reference	PU 1
	Labelled	Yes
STRUCTURE	Materials of Construction	Mixed
	System Serves	LPHWS (heating)
OPERATION & CONDITION	System Water Temperature	Ambient
	Outlet Temperature	-
	Direct Spray Formation	None, closed system
	Degree of Dirt	Not inspected
	Degree of Biological Slime	Not inspected
	Extent of Corrosion	Not inspected
	Assessment of Risk	Very low

Observations:		
The unit supplies a closed system and presents negligible or no risk from legionella. There may be a low risk when the units are maintained.

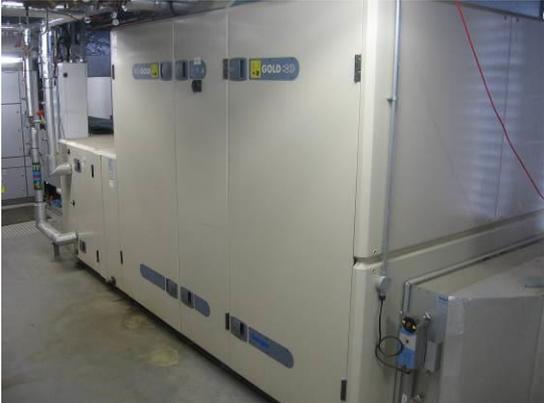
LOCATION	Location of outlet	Plant Room
TYPE	Type of System	Air handling units
IDENTIFICATION	Designation	AHU
STRUCTURE	Materials of Construction	Mixed
	System Serves	Heating, cooling & ventilation
OPERATION & CONDITION	System Water Temperature	N/A
	Outlet Temperature	N/A
	Direct Spray Formation	No
	Degree of Dirt	None
	Degree of Biological Slime	None
	Extent of Corrosion	None
	Assessment of Risk	Low

AHU 1		
Observations:		
<p>Water condensing from the cooled air at the cooling coils in the air handling units may create conditions suitable for bacteria to grow. The cooling coils and drainage trays of these units could support bacteria growth and should be regularly inspected and maintained in a clean condition.</p>

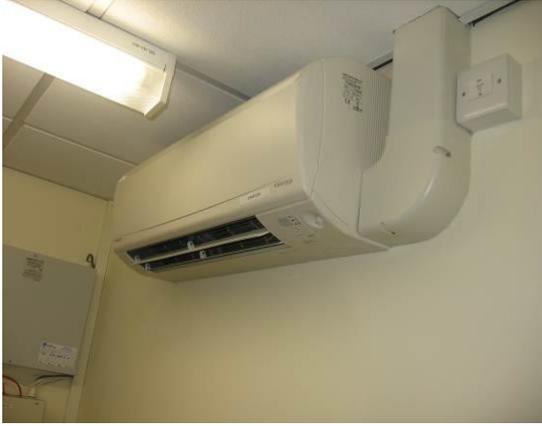
LOCATION	Location of outlet	Server room
TYPE	Type of System	Air cooling unit
IDENTIFICATION	Designation	ACU
STRUCTURE	Materials of Construction	Mixed
	System Serves	Computer server cooling
OPERATION & CONDITION	System Water Temperature	N/A
	Outlet Temperature	N/A
	Direct Spray Formation	No
	Degree of Dirt	Not inspected
	Degree of Biological Slime	Not inspected
	Extent of Corrosion	Not inspected
	Assessment of risk	Low

Observations:		
<p>Water condensing from the cooled air may create conditions suitable for bacteria to grow if units are not regularly cleaned and serviced. Cooling coils and drainage trays of these units could support bacteria growth and should be regularly inspected and maintained in a clean condition.</p>

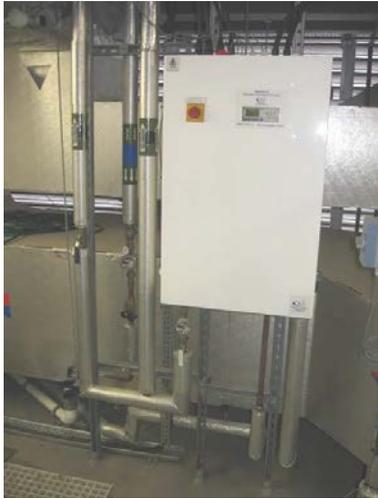
LOCATION	Location of outlet	Outside under ground
TYPE	Type of System	Rain water harvesting tank
IDENTIFICATION	Designation	RWT
STRUCTURE	Materials of Construction	Mixed
	System Serves	Rain water system
OPERATION & CONDITION	System Water Temperature	Ambient
	Outlet Temperature	Not accessed, system isolated at roof tank
	Direct Spray Formation	No
	Degree of Dirt	None seen
	Degree of Biological Slime	None seen
	Extent of Corrosion	None seen
	Assessment of risk	Very low / negligible

<p style="text-align: center;">RAIN WATER CONTROL UNIT</p>		
Observations:		
<p>The stored temperatures are not believed to be generally high enough to encourage bacterial proliferation, but it is likely bacteria will be present. Commonly rain water systems have an ultra violet unit on the supply to the service tank to kill bacteria in the supply, but there is no such system here.</p>

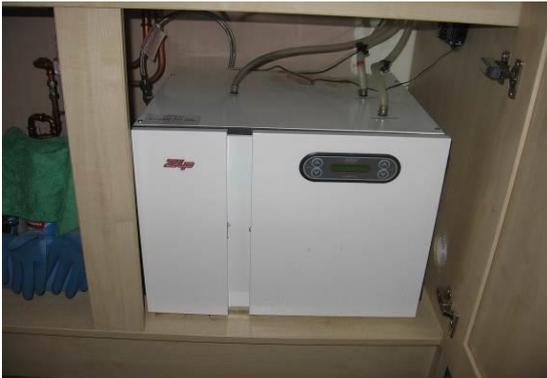
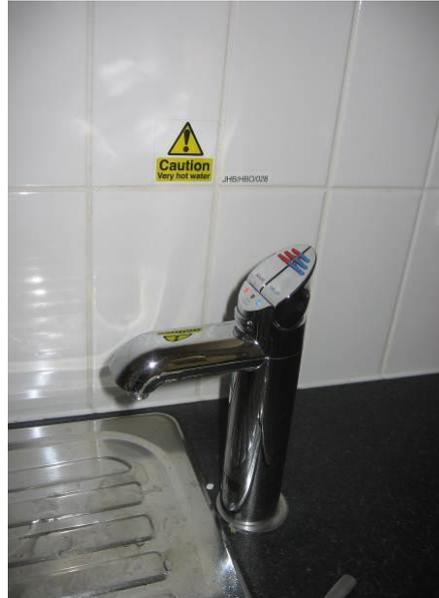
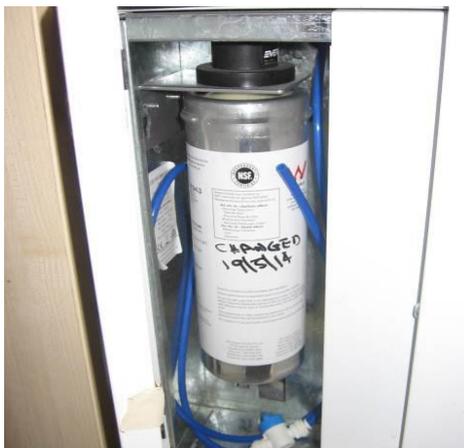
LOCATION	Location of outlet	Ground & first floor tea points
TYPE	Type of System	Water Boiler / Chiller
IDENTIFICATION	Designation	WB / CW
STRUCTURE	Materials of Construction	Mixed
	System Serves	Beverages
OPERATION & CONDITION	System Water Temperature	>50°C / <20°C
	Outlet Temperature	N/A
	Direct Spray Formation	No
	Degree of Dirt	None
	Degree of Biological Slime	None
	Extent of Corrosion	None
	Assessment of risk	Very low / negligible

COMBINED WATER BOILER / CHILLER

BOILING WATER / CHILLED WATER TAP

SUB MICRON FILTER

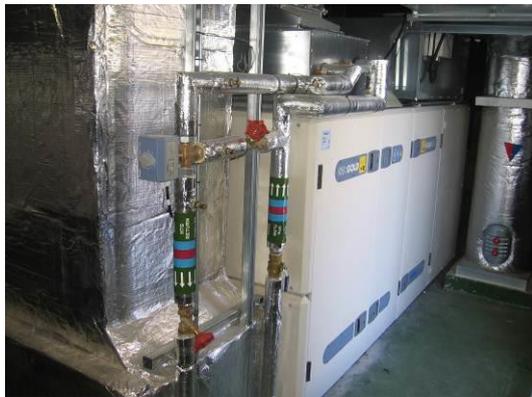
LOCATION	Location of outlet	Roof Plant Room
TYPE	Type of System	Air handling units
IDENTIFICATION	Designation	AHU 1 & 2
STRUCTURE	Materials of Construction	Mixed
	System Serves	Heating, cooling & ventilation
OPERATION & CONDITION	System Water Temperature	N/A
	Outlet Temperature	N/A
	Direct Spray Formation	No
	Degree of Dirt	Not inspected
	Degree of Biological Slime	Not inspected
	Extent of Corrosion	Not inspected
	Assessment of Risk	Low

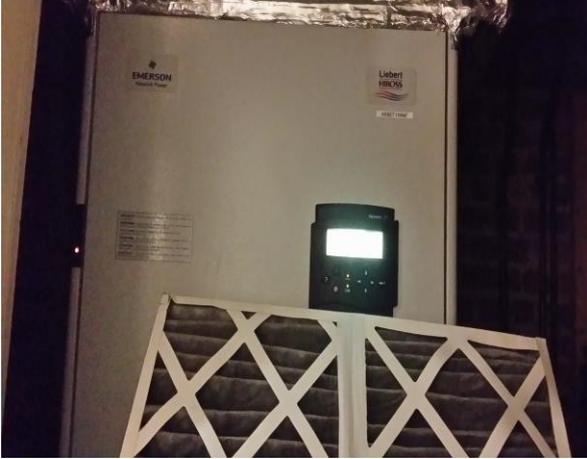
LOCATION	Location of outlet	Ground floor library entrance
TYPE	Type of System	Humidifier
IDENTIFICATION	Designation	HUM
STRUCTURE	Materials of Construction	Mixed
	System Serves	Humidity
OPERATION & CONDITION	System Water Temperature	-
	Outlet Temperature	N/A
	Direct Spray Formation	No
	Degree of Dirt	None seen
	Degree of Biological Slime	None seen
	Extent of Corrosion	None seen
	Assessment of risk	Low

HUM 1		
<p>Currently the unit is not fully in working use. Site are to investigate location of incoming mains supply to the unit.</p>

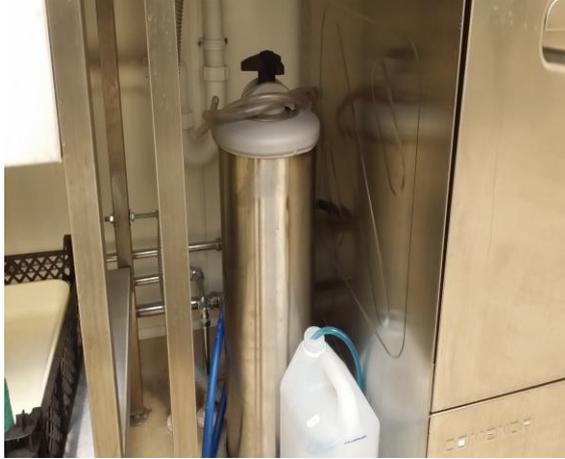
LOCATION	Location of outlet	1st floor staff kitchen
TYPE	Type of System	Water Softener
IDENTIFICATION	Designation	WS 1
STRUCTURE	Materials of Construction	Mixed
	System Serves	Dishwasher
OPERATION & CONDITION	System Water Temperature	<20°C
	Outlet Temperature	N/A
	Direct Spray Formation	No
	Degree of Dirt	None seen
	Degree of Biological Slime	None seen
	Extent of Corrosion	None seen
	Assessment of risk	Very low

WS 1		
Observations:

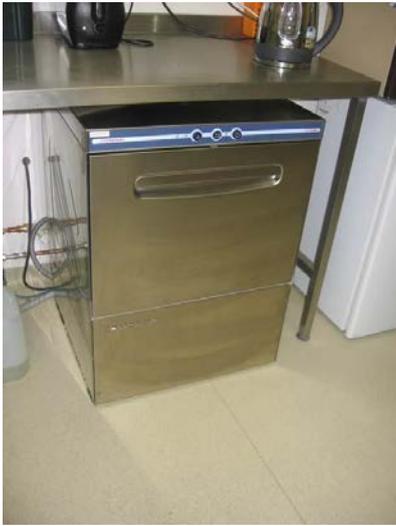
LOCATION	Location of outlet	1st floor staff kitchen
TYPE	Type of System	Dish washer
IDENTIFICATION	Designation	DW
STRUCTURE	Materials of Construction	Mixed
	System Serves	Dish washing
OPERATION & CONDITION	System Water Temperature	>50°C & <20°C
	Outlet Temperature	N/A
	Direct Spray Formation	Contained
	Degree of Dirt	None
	Degree of Biological Slime	None
	Extent of Corrosion	None
	Assessment of risk	Very low / negligible

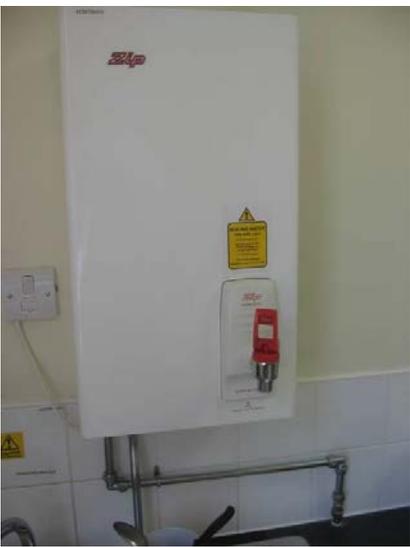
LOCATION	Location of outlet	1st floor kitchen and 1st & ground floor rotunda tea points and 1st floor rear stairwell tea point
TYPE	Type of System	Water Boiler
IDENTIFICATION	Designation	WB
STRUCTURE	Materials of Construction	Mixed
	System Serves	Beverages
OPERATION & CONDITION	System Water Temperature	>50°C
	Outlet Temperature	N/A
	Direct Spray Formation	No
	Degree of Dirt	None
	Degree of Biological Slime	None
	Extent of Corrosion	None
	Assessment of risk	Very low / negligible

Observations:		
The boiling of the water sterilises the water system and these units do not present a legionella risk.

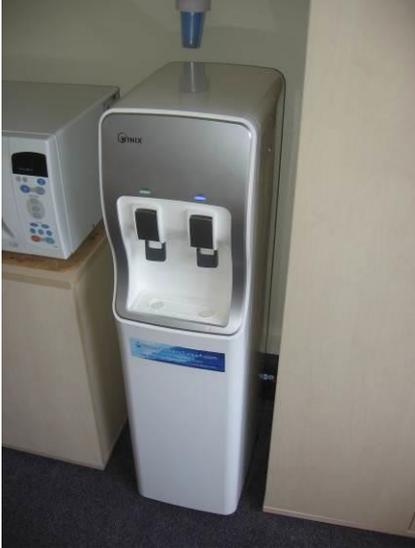
LOCATION	Location of outlet	Reception area & first floor rotunda tea point
TYPE	Type of System	Chilled Water Dispensing
IDENTIFICATION	Designation	CW
STRUCTURE	Materials of Construction	Mixed
	System Serves	Chilled drinking water
OPERATION & CONDITION	System Water Temperature	<20°C
	Outlet Temperature	N/A
	Direct Spray Formation	No
	Degree of Dirt	None seen
	Degree of Biological Slime	None seen
	Extent of Corrosion	None seen
	Assessment of risk	Very low / negligible

ROTUNDA UNIT		
Observations:		
Due to their filtering effect in-line filters on the supply can harbour bacteria and should be regularly changed during services.
