PARADE REFURBISHMENT WORKS

CORBY BOROUGH COUNCIL

THE JAMB

7489 / 06

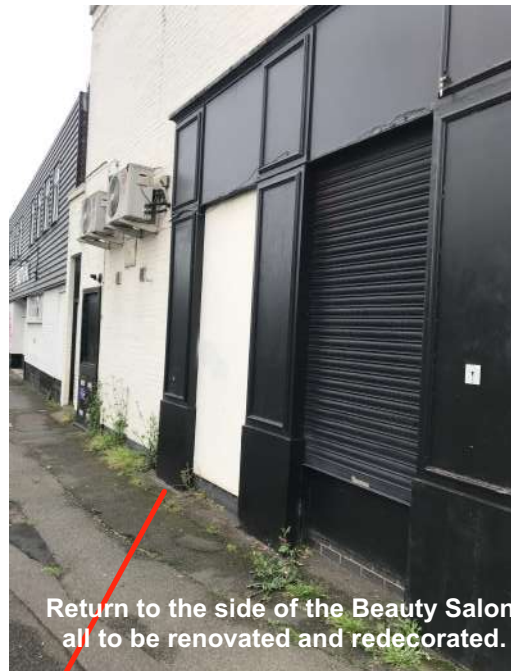
Return to the side of the Beauty Salon, all to be renovated and redecorated.

Contractor to allow for the cost of preparing the walls, repairing any loose brickwork, cleaning down and making ready for redecoration, redecorate with 2 coats suitable masonry paint in white. Allowing for all scaffold access and associated licences.

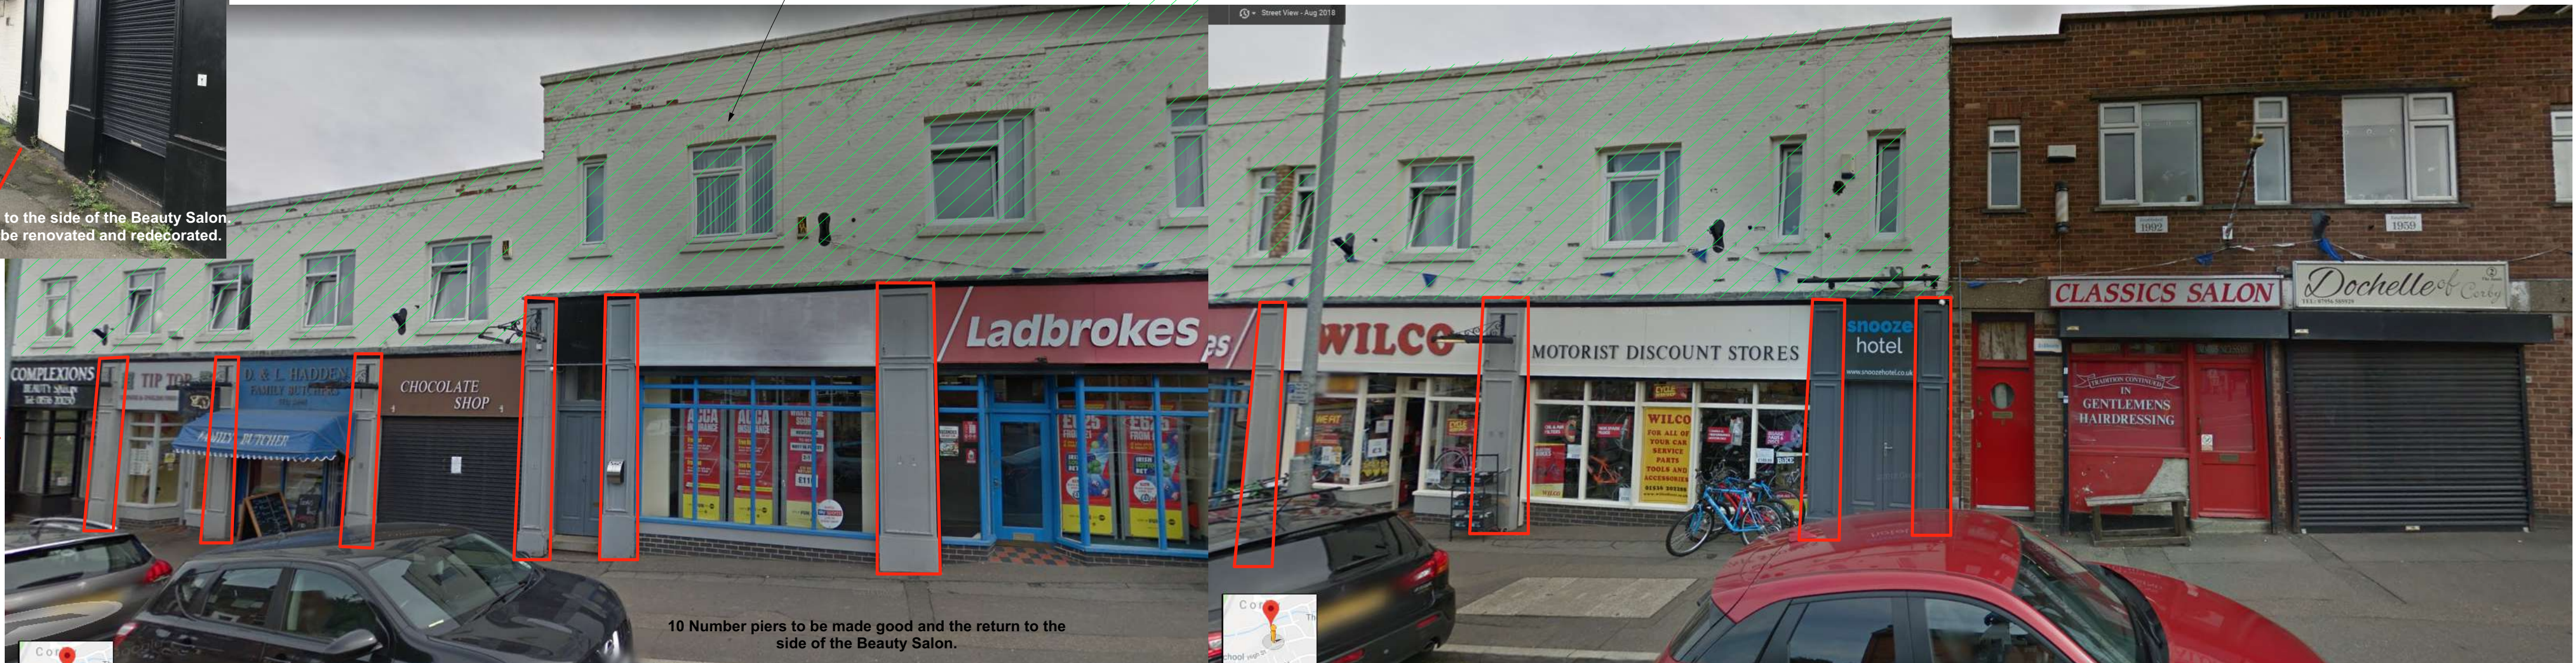
10 Number piers to be made good and the return to the side of the Beauty Salon.

Timber surrounds and piers requiring redecorating and making good

Entire area to be redecorated as required. Colours to match the existing, allow for 1 coat suitable primer and 2 coats external quality gloss. This is generally the pier sections and the return to the corner as indicated.

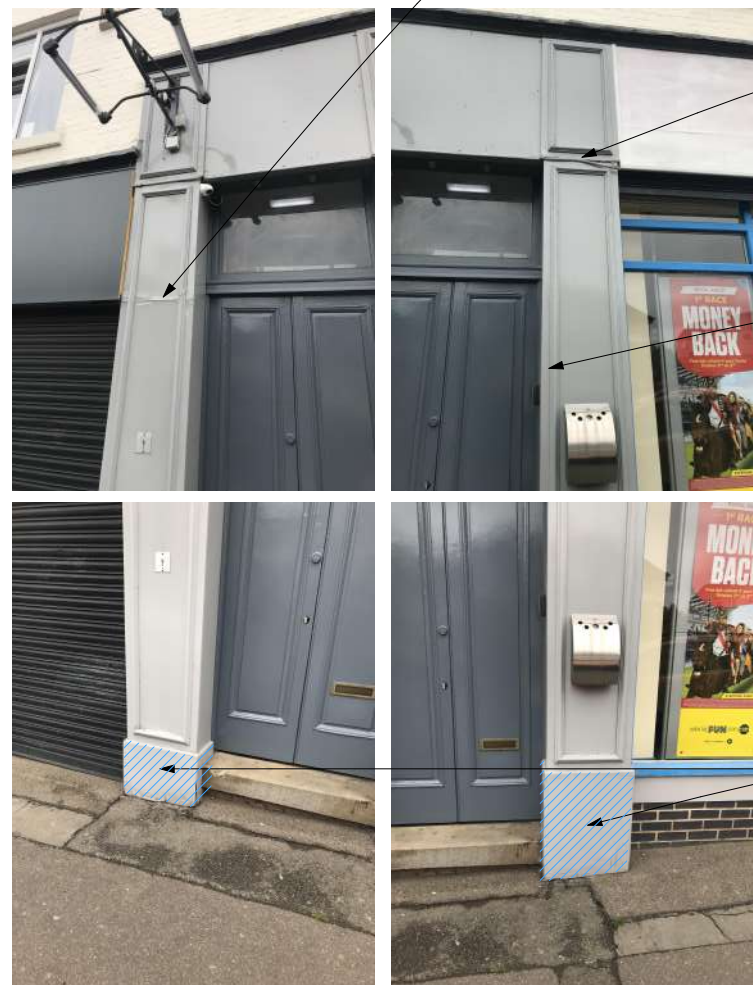
Water damaged sections and joints are to be removed and replaced with new, all joints sealed and redecorated.

Small sections of damaged beading to be replaced with new to match, do not slice the sections if a piece needs removal replace the whole section.

Existing lower section to all of the timber piers to be removed, timber battens behind to be replaced with new treated timbers. Install new marine plywood timbers to the faces to match the existing and redecorate.
