LAURELS, MEMORIAL CROFT WAR MEMORIAL CROMFORD ROAD

A	02/02/2024	GS	-	Listed Building Consent
Rev	Date Drawn	Chkd		Amendment
BOLEHILL AND STEEPLE GRANGE WAR MEMORIAL				
ELEVATIONS PROPOSED				
Drawn	GS	Checked	-	
Scales	1:500 @ A3			
Drawing No	1305/P06	Rev	A

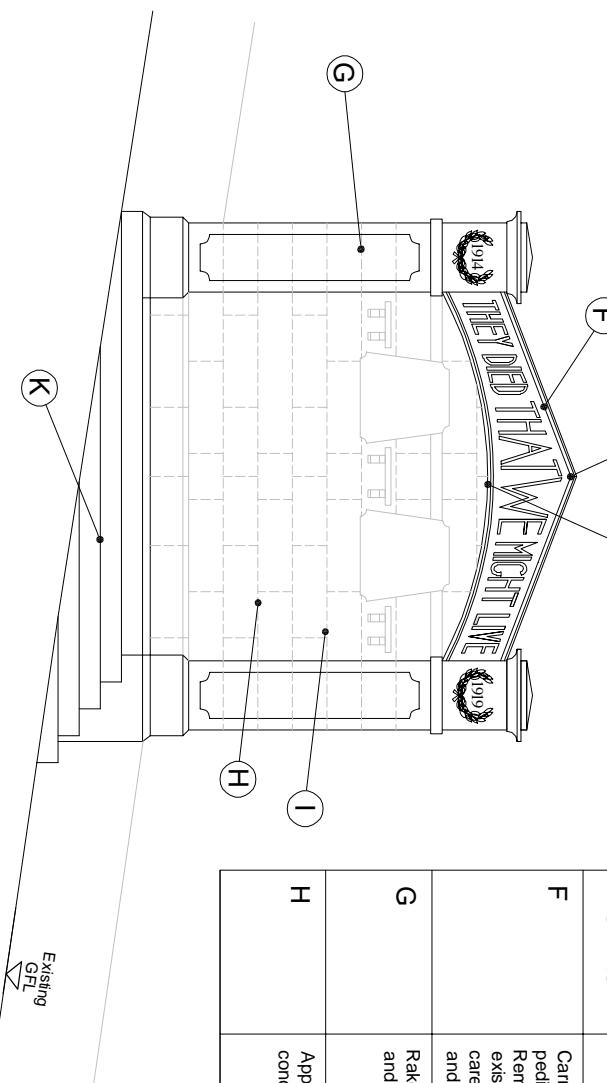
FRONT (NORTH WEST) ELEVATION

Significant spalling to the top of the pediment
Location of greatest delamination/spalling to the underside of the pediment

Proposed Work Item	Work Description
F	Carry out delicate concrete repairs to the pediment and other required areas with existing, using skilled trades people, to carefully reproduce the colour, texture, profiles and lettering of the monument.
G	Rake out mastic/dirt filled gaps and open joints and fully infill with mortar.
H	Apply a migration corrosion inhibitor to all concrete surfaces.
