Soldier Gallery - Section 1.4

Project Title: 1.4 Plinths

Drawing Title: General Arrangement

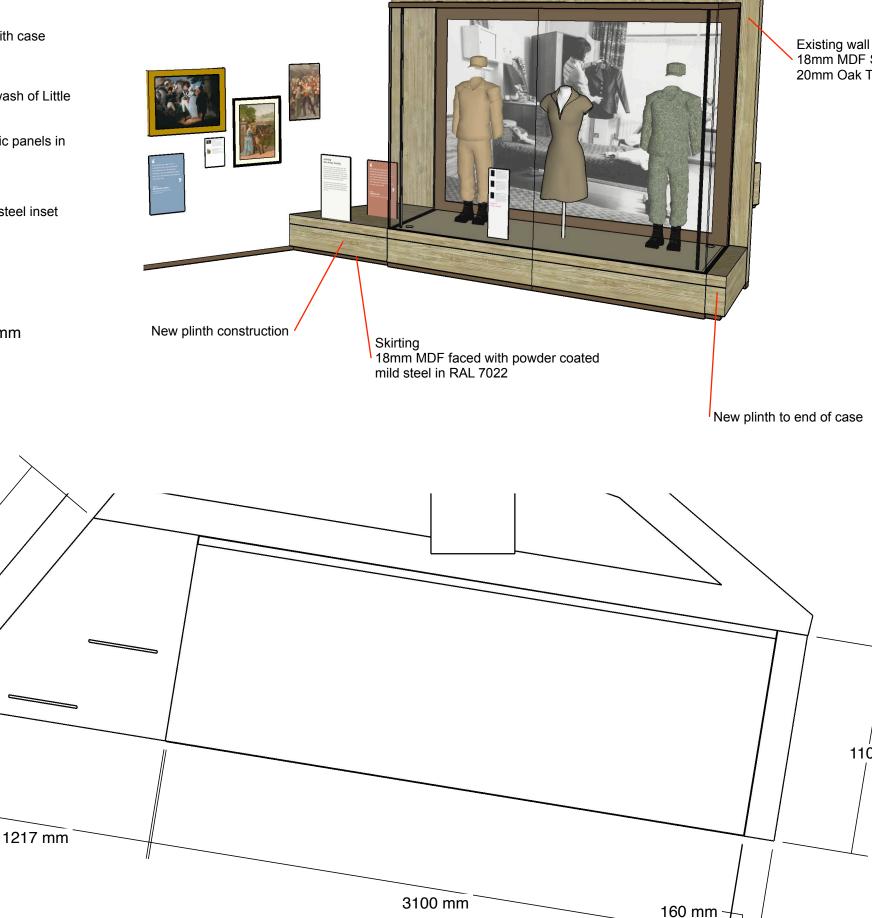
Elevation 1:10 @ A3

Plinths to left and right side of case

Front of plinth to be removable to secure graphic panels in place from underneath.

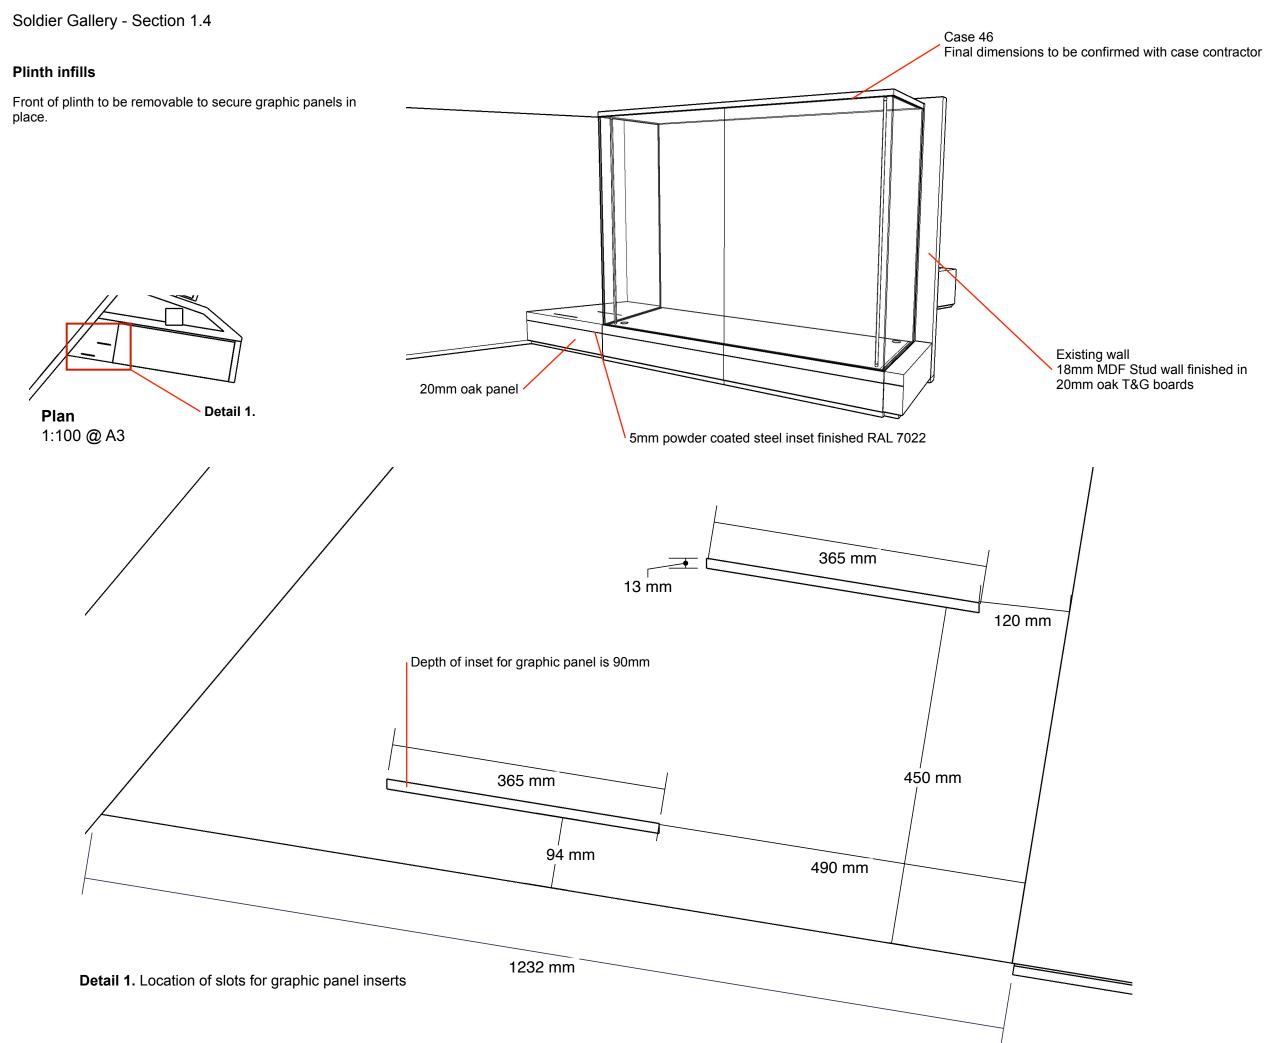
Plan 1:20 @ A3

1298 mm

Existing wall 18mm MDF Stud wall finished in 20mm Oak T&G boards

1100 mm
