Specification: Snag Valley Lower – Fen & peatland restoration

Dorset Peat Partnership

Lower Snag Valley

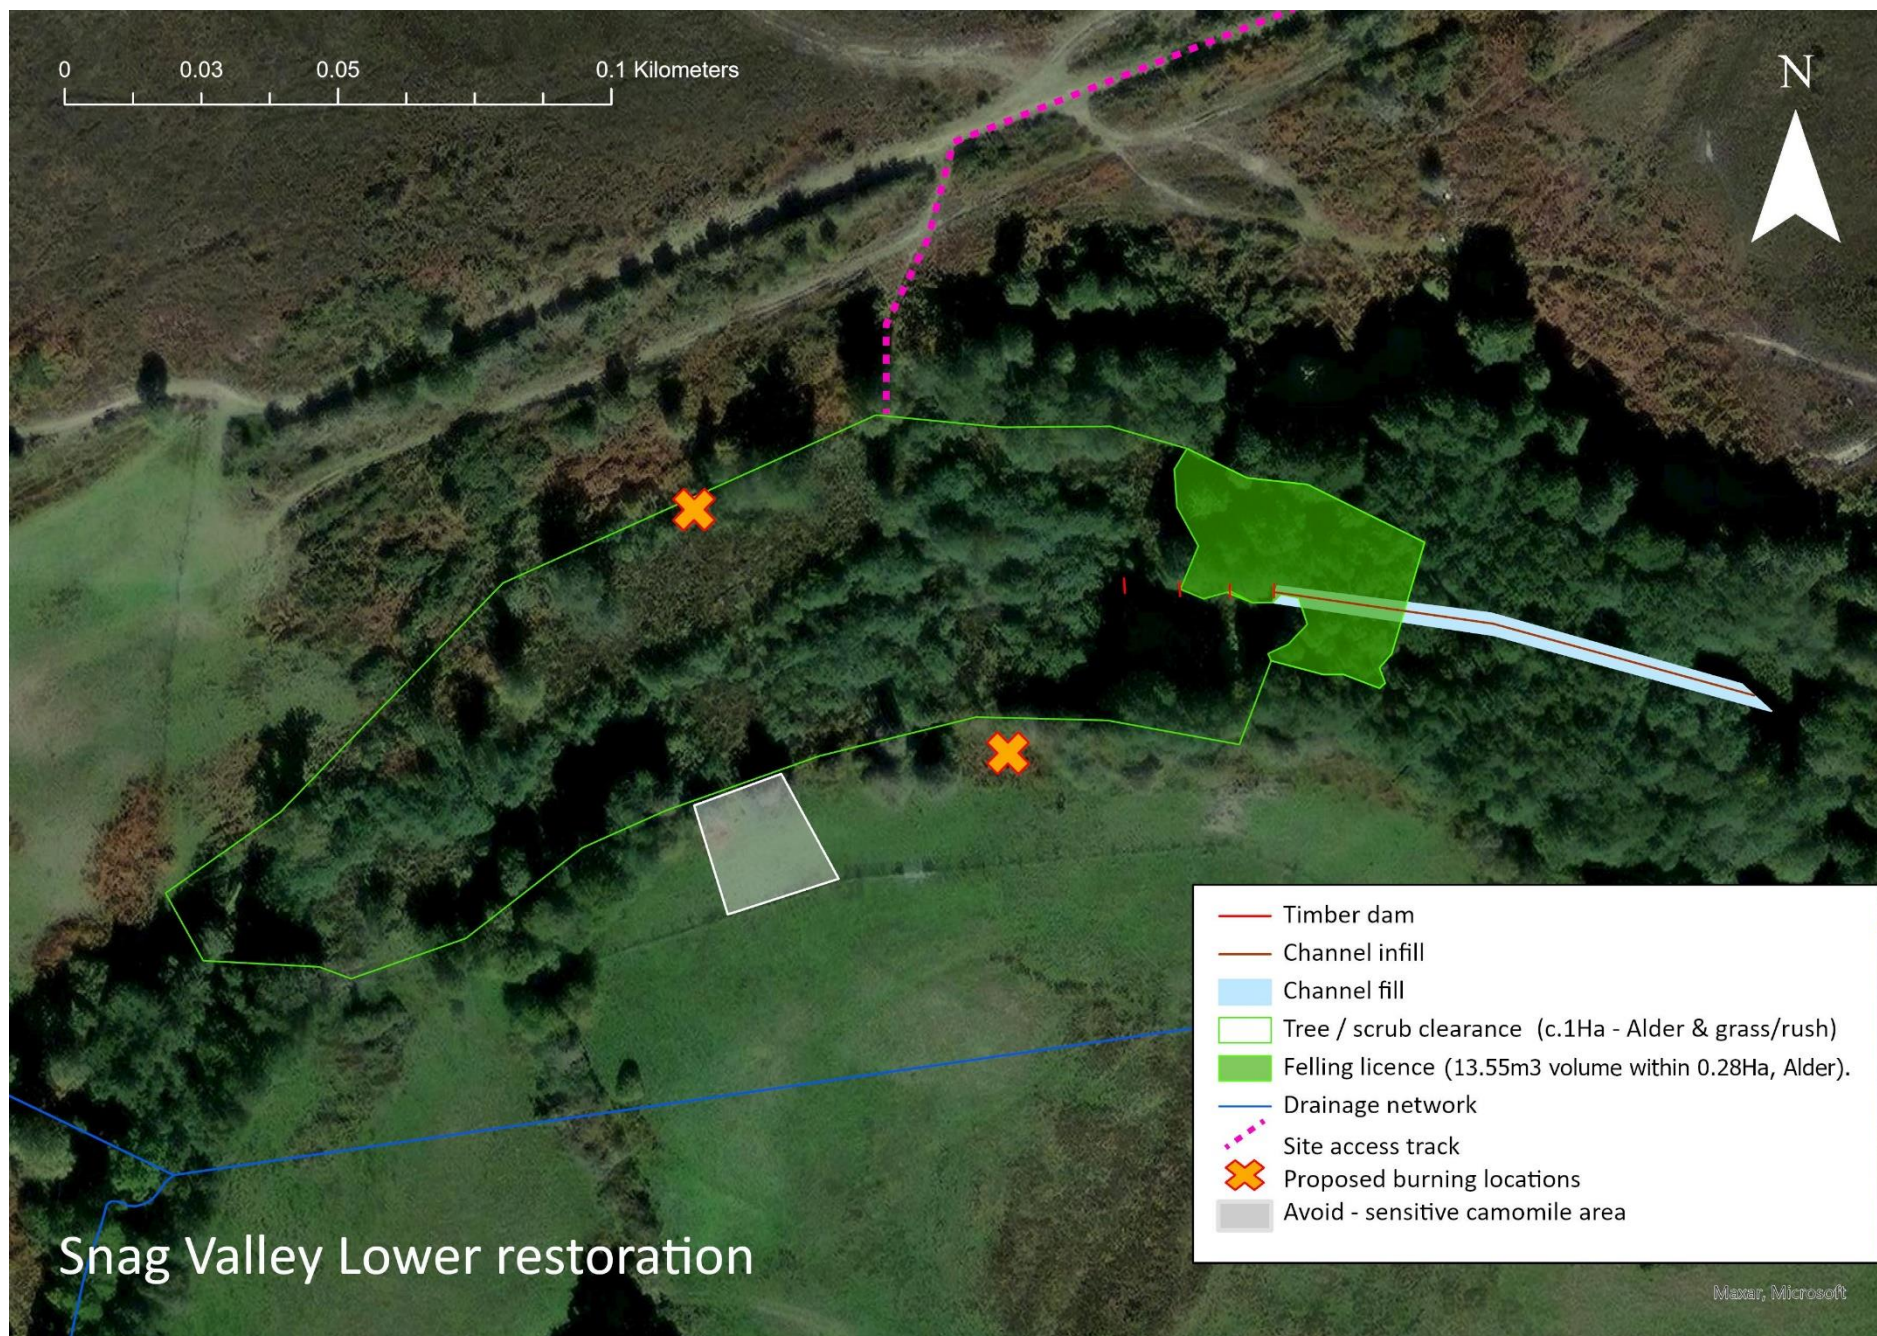
Section	Task (see methodology and site photos below)	Grid reference	Ha/no/m
1. Tree / scrub clearance	<ul style="list-style-type: none"> Remove Alder regrowth, including root balls (to prevent regrowth and limit the effect of obstacles to diffused flow. Burn brash at selected locations to be agreed. 	SY 95516 84643 Centre point	1 ha

2. Tree / scrub clearance	<ul style="list-style-type: none"> Mulch grass/rush vegetation (within the same area) to increase diffused flow distribution across the valley floor. 	SY 95516 84643 Centre point	1 ha

3. Mature trees	<ul style="list-style-type: none"> Fell an area of mature trees as mapped to expand the open fen habitat. Trees measure c.8m tall with av.dbh 16cm. Volume estimated at 13.55m³. Burn brash at selected locations to be agreed. 	SY 95612 84658 Centre point Trees marked with green spray.	0.28 ha

4. Incised single channel	<ul style="list-style-type: none"> 4 x Natural timber leaky dams, constructed from on-site materials. Spaced c.10m apart to create new flow pathways and diffuse flow. Structures should be staked in, or keyed in and backfilled with spoil where possible. 	SY 95578 84650 SY 95588 84650 SY 95597 84649 SY 95605 84649	4x <3m wide x 1m high

5. Incised single channel (straight channel)	<ul style="list-style-type: none"> Channel infilled using removed trees and root balls placed directly into the channel - root balls upstream, forming the main blockage of the channel with the trunk providing further channel infill – to encourage flow to reconnect to the floodplain in an unconstrained way. 	From SY 95605 84649 - downstream 100m.	<2m wide <1m deep c.100m reach to form a continuous infill.

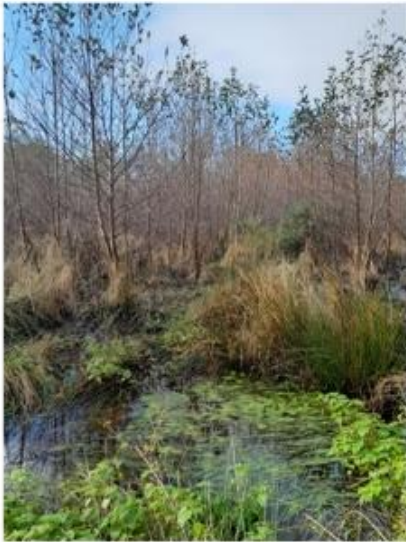
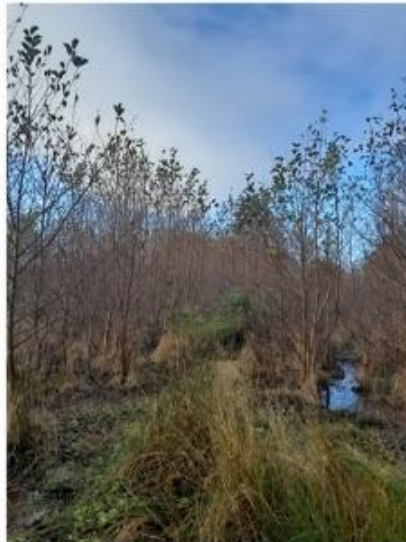
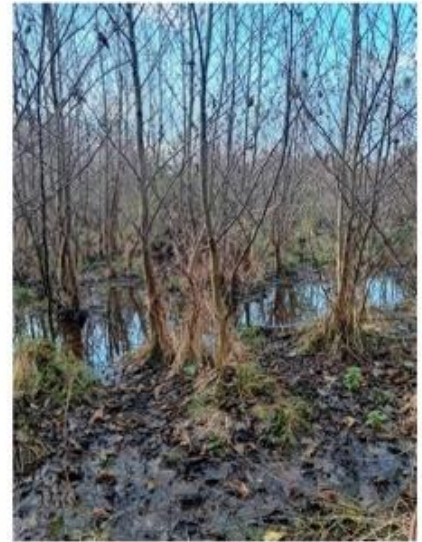
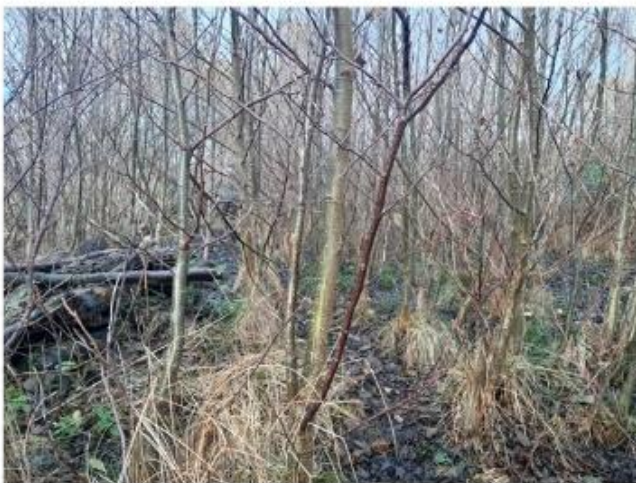
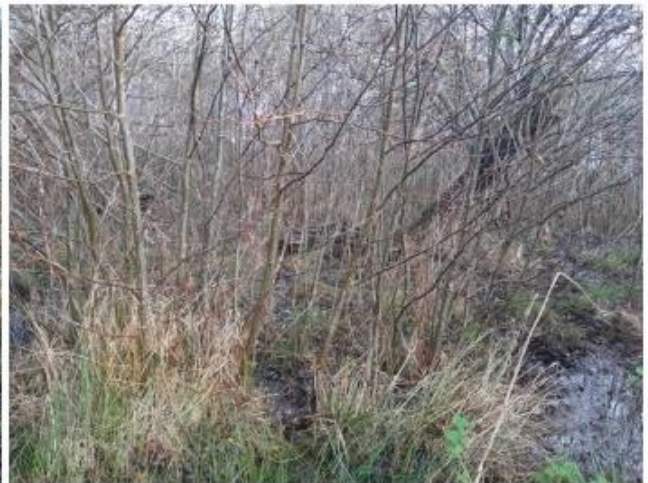
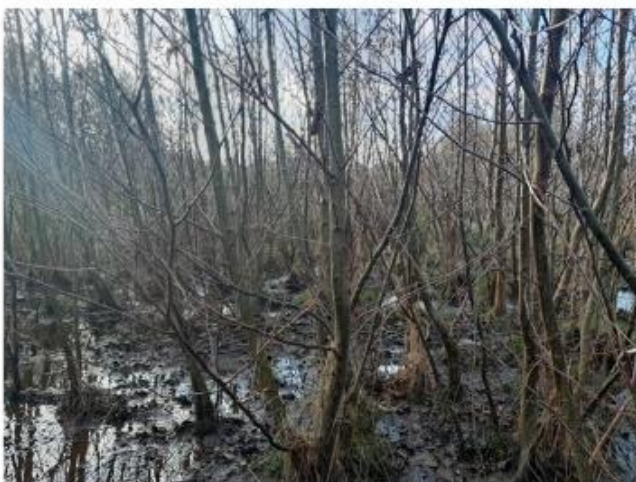
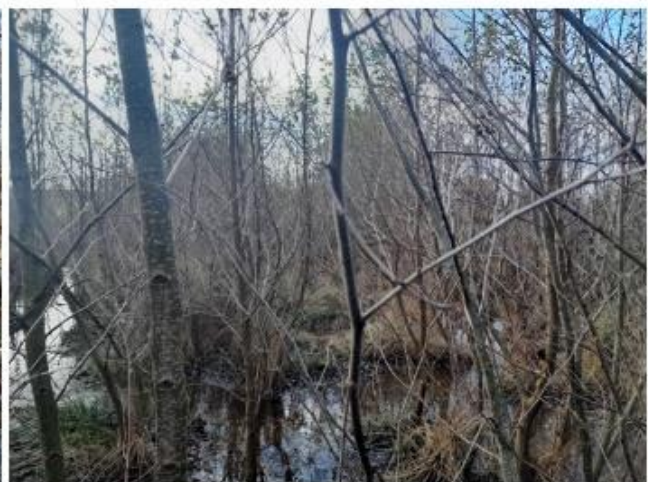
Site photos:

During summer months, the site is largely dry and densely covered in vegetation. During heavy rains in the winter months, the site floods, disguising drainage channels. The following images were captured in November 2023 and show the main channels, with wet ground conditions in between.
