Our Ref: 07C200919  
Your Ref: 3070053971

4 April 2022

### **Bradney Depot, Bawdrip, Bridgwater – Storm Damage Review to Storage Shelter**

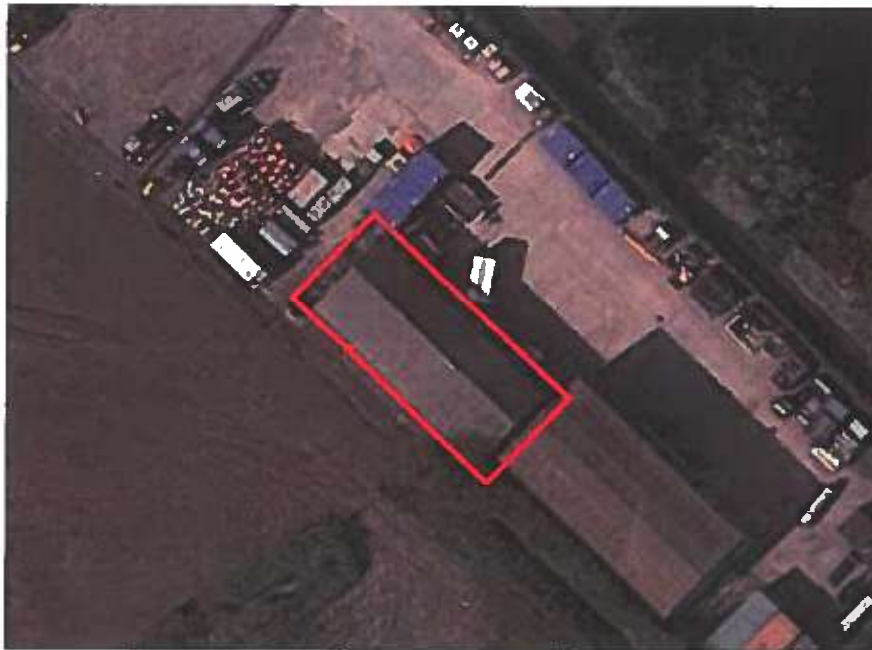
Bradney Depot – Storage shelter outlined in red

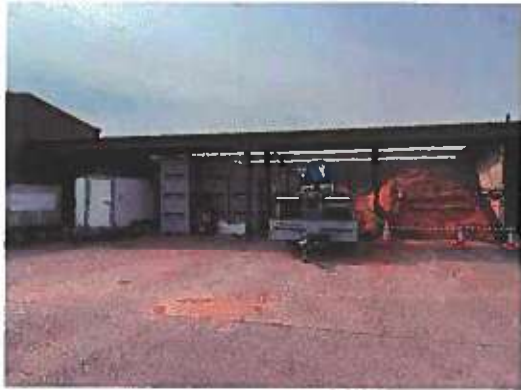
Photo No	Photograph Description	Photograph
1.	General view of storage shelter to southern end of Bradney Depot

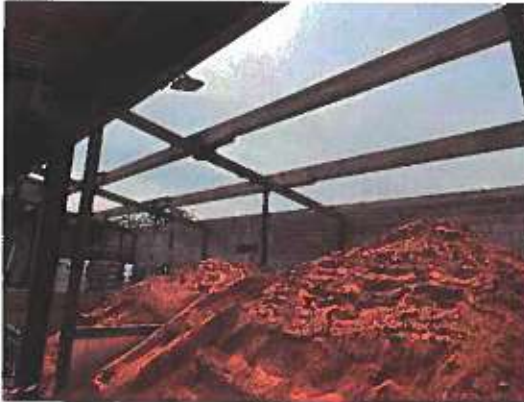
It was clear during our inspection that the profiled metal roof sheets to the original masonry section of the shelter have been completely ripped off by high winds. Only two roof sheets remain in place to this section, one at either end of the building. One other roof sheet is still present on site but has been lodged between the storage shelter and the Carpentry Shed and is heavily damaged / buckled.

A key difference between the two roof sections appears to be the type of fixing used. Roof sheets to the newer steel framed section are fixed using heavy duty 'Tek' screws, whilst the original sections have been fixed using standard screws fixed into timber purlins. Evidently, these basic screw fixings are insufficient and were unable to withstand the force of high winds. In addition,

the rear of the building faces the prevailing south westerly winds and may therefore be more susceptible to wind uplift than the front section.

2.	Missing roof sheets to masonry section due to high winds

The missing roof sheets will require replacement with a modern equivalent, similar to that installed to the steel framed section. We recommend the use of additional and/or heavy duty fixings (subject to the roof sheet manufacturer's recommendations) to reduce the likelihood of a similar event in the future. The existing timber joists can be retained but these should be checked to ensure there are securely fixed.

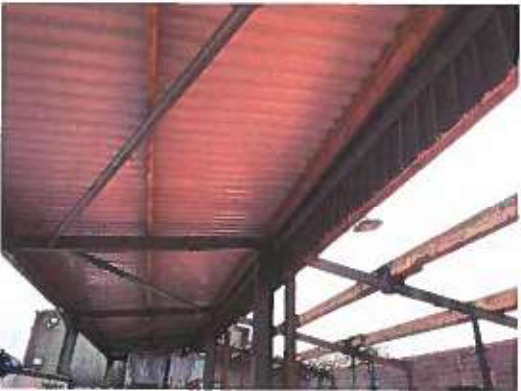
The profiled metal roof sheets to the newer steel framed section are still fixed in place and appear to be undamaged.

3.	Roof sheets to steel framed section still in place and unaffected

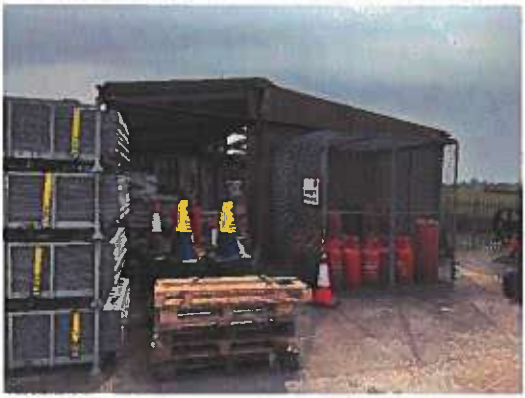
Photo No	Photograph Description	Photograph
4.	North western end of building

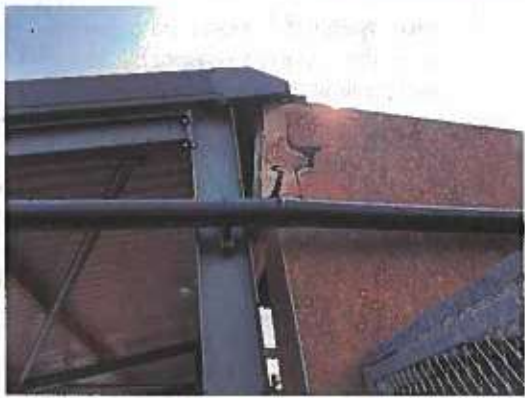
In addition to the missing roof sheets, there is cracking / damage evident to the rendered blockwork wall to the north western end of the building. The cracking is isolated to a small area at high level. No other storm damage was evident.

In regards to the cracked section of masonry blockwork at the north western end of the shelter, this appears to be a consequence of the force of the roof sheets being torn off in this location.

5.	Damage to masonry at north western end of building at high level

Minor repairs are required to the cracked / damaged section of blockwork. Loose sections should be removed and replaced with new blockwork.

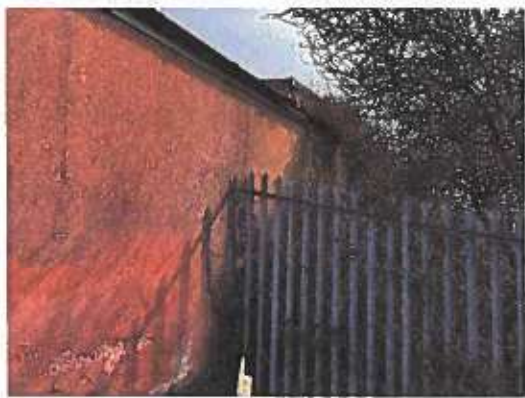
Access was available to all required areas, however, we could not view the south eastern parts of the building as these areas are obscured by overgrown vegetation.

6.	Overgrown vegetation at south eastern end of building

In addition to the storm damage repairs, we recommend cutting back the overgrown vegetation at the south eastern parts of the building and undertaking general maintenance to the gutters to ensure they are securely fixed and free of debris. The fascias should also be checked to ensure they are securely fixed and there are no gaps which may create wind uplift.
