CAMOGLI HEALTH FACILITY REDEVELOPMENT

Concept Design Proposal for a new Health Facility on
Tristan da Cunha

WORKS INFORMATION

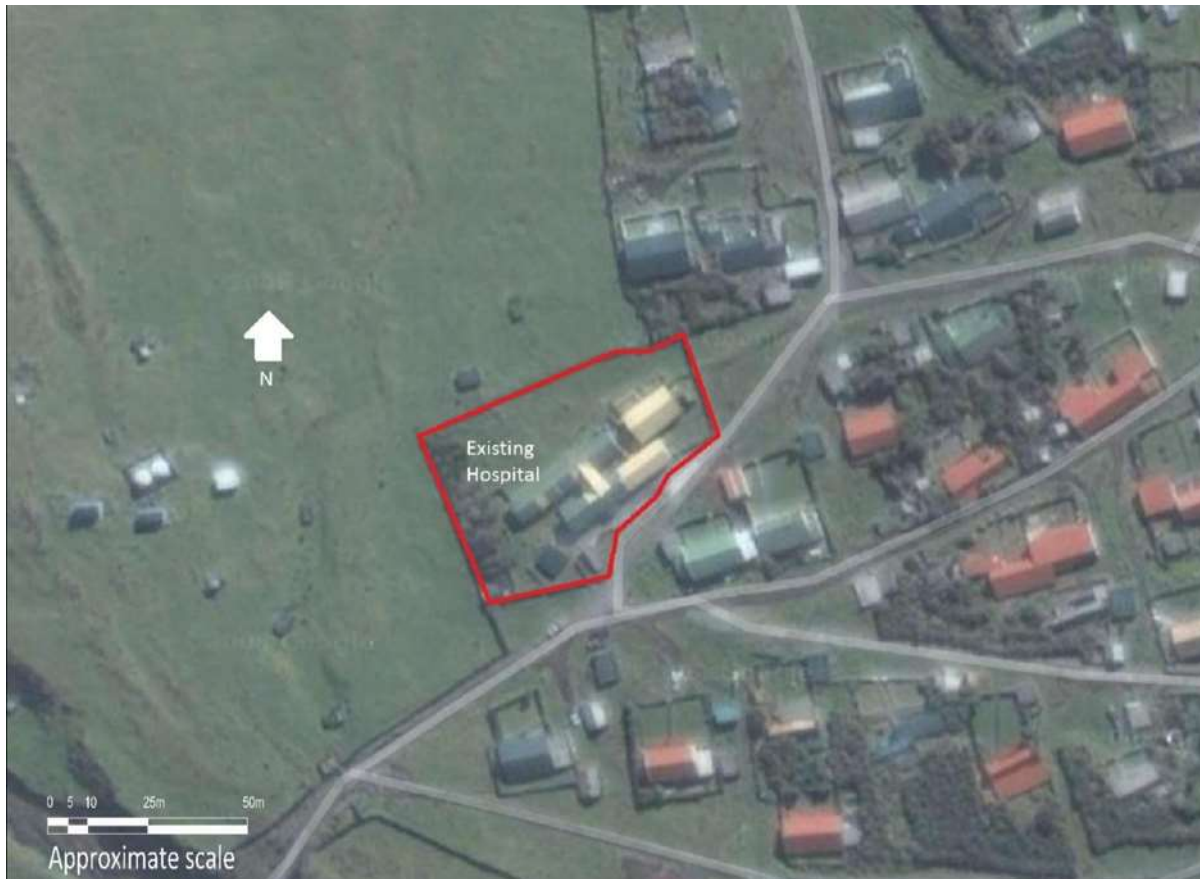
Figure 1: Aerial view of Camogli Hospital.

The hospital is located on the outskirts of the Island's only settlement, Edinburgh of the Seven Seas. It can be seen in the centre of the photograph below.

The site of the hospital comprises approximately 2,000 m² (0.5 acres). It is generally rectangular and flat but with a gentle fall of approximately 1 metre in its width of 34 metres, which also provides the road access to the hospital. The location provides spectacular sea views and has no immediate adjacent development.

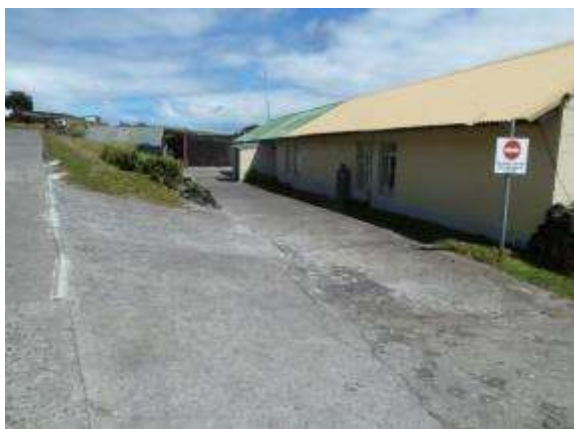
Figure 2: South view of Hospital

The hospital was built in 1971 to replace the original Station Hospital which dated back to 1942. It is of single storey construction, planned as an H block with one wing generally accommodating outpatient services and the other accommodating inpatient services. However, some internal planning has resulted in outpatient activity, particularly dental services, being inappropriately located in the inpatient wing. The limited laundry facilities are located in an outbuilding as is the ambulance garage that also provides some storage for decommissioned medical equipment and furniture. The Doctor's house is located immediately adjacent to the hospital.

The Hospital and Doctor's house were re-roofed and re-furbished following serious damage incurred during a hurricane in 2001.

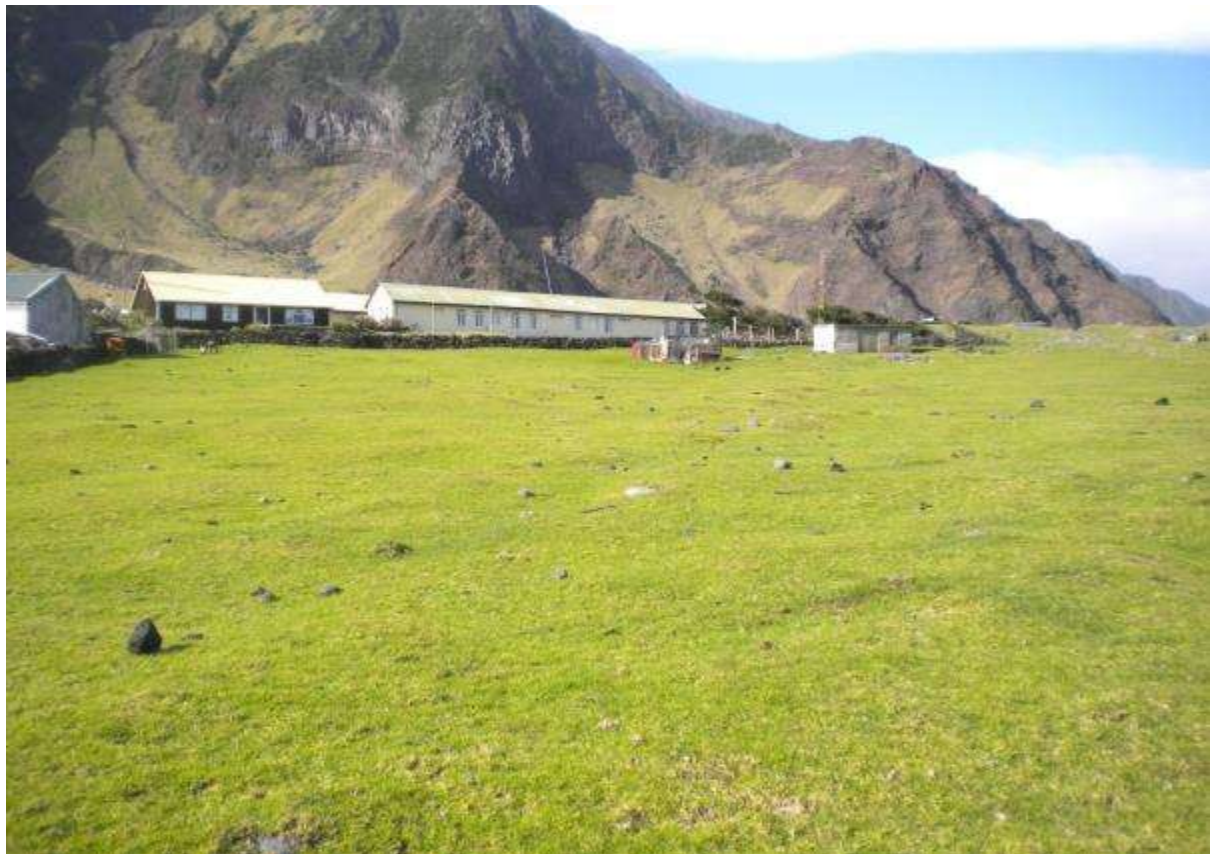
Figure 4: View of Hospital with Doctor’s house to the left and the site for the new Health Facility in the foreground

The island has an existing small hospital that is no longer fit for purpose and thus a new health facility that is more suited to modern medical standards is intended to be built adjacent to the existing hospital location.
