PROJECT: Bramcote Leisure Centre Health Suite refurb

TITLE: Existing plan, Demolitions & Existing Services

DWG No: CW17.001.003

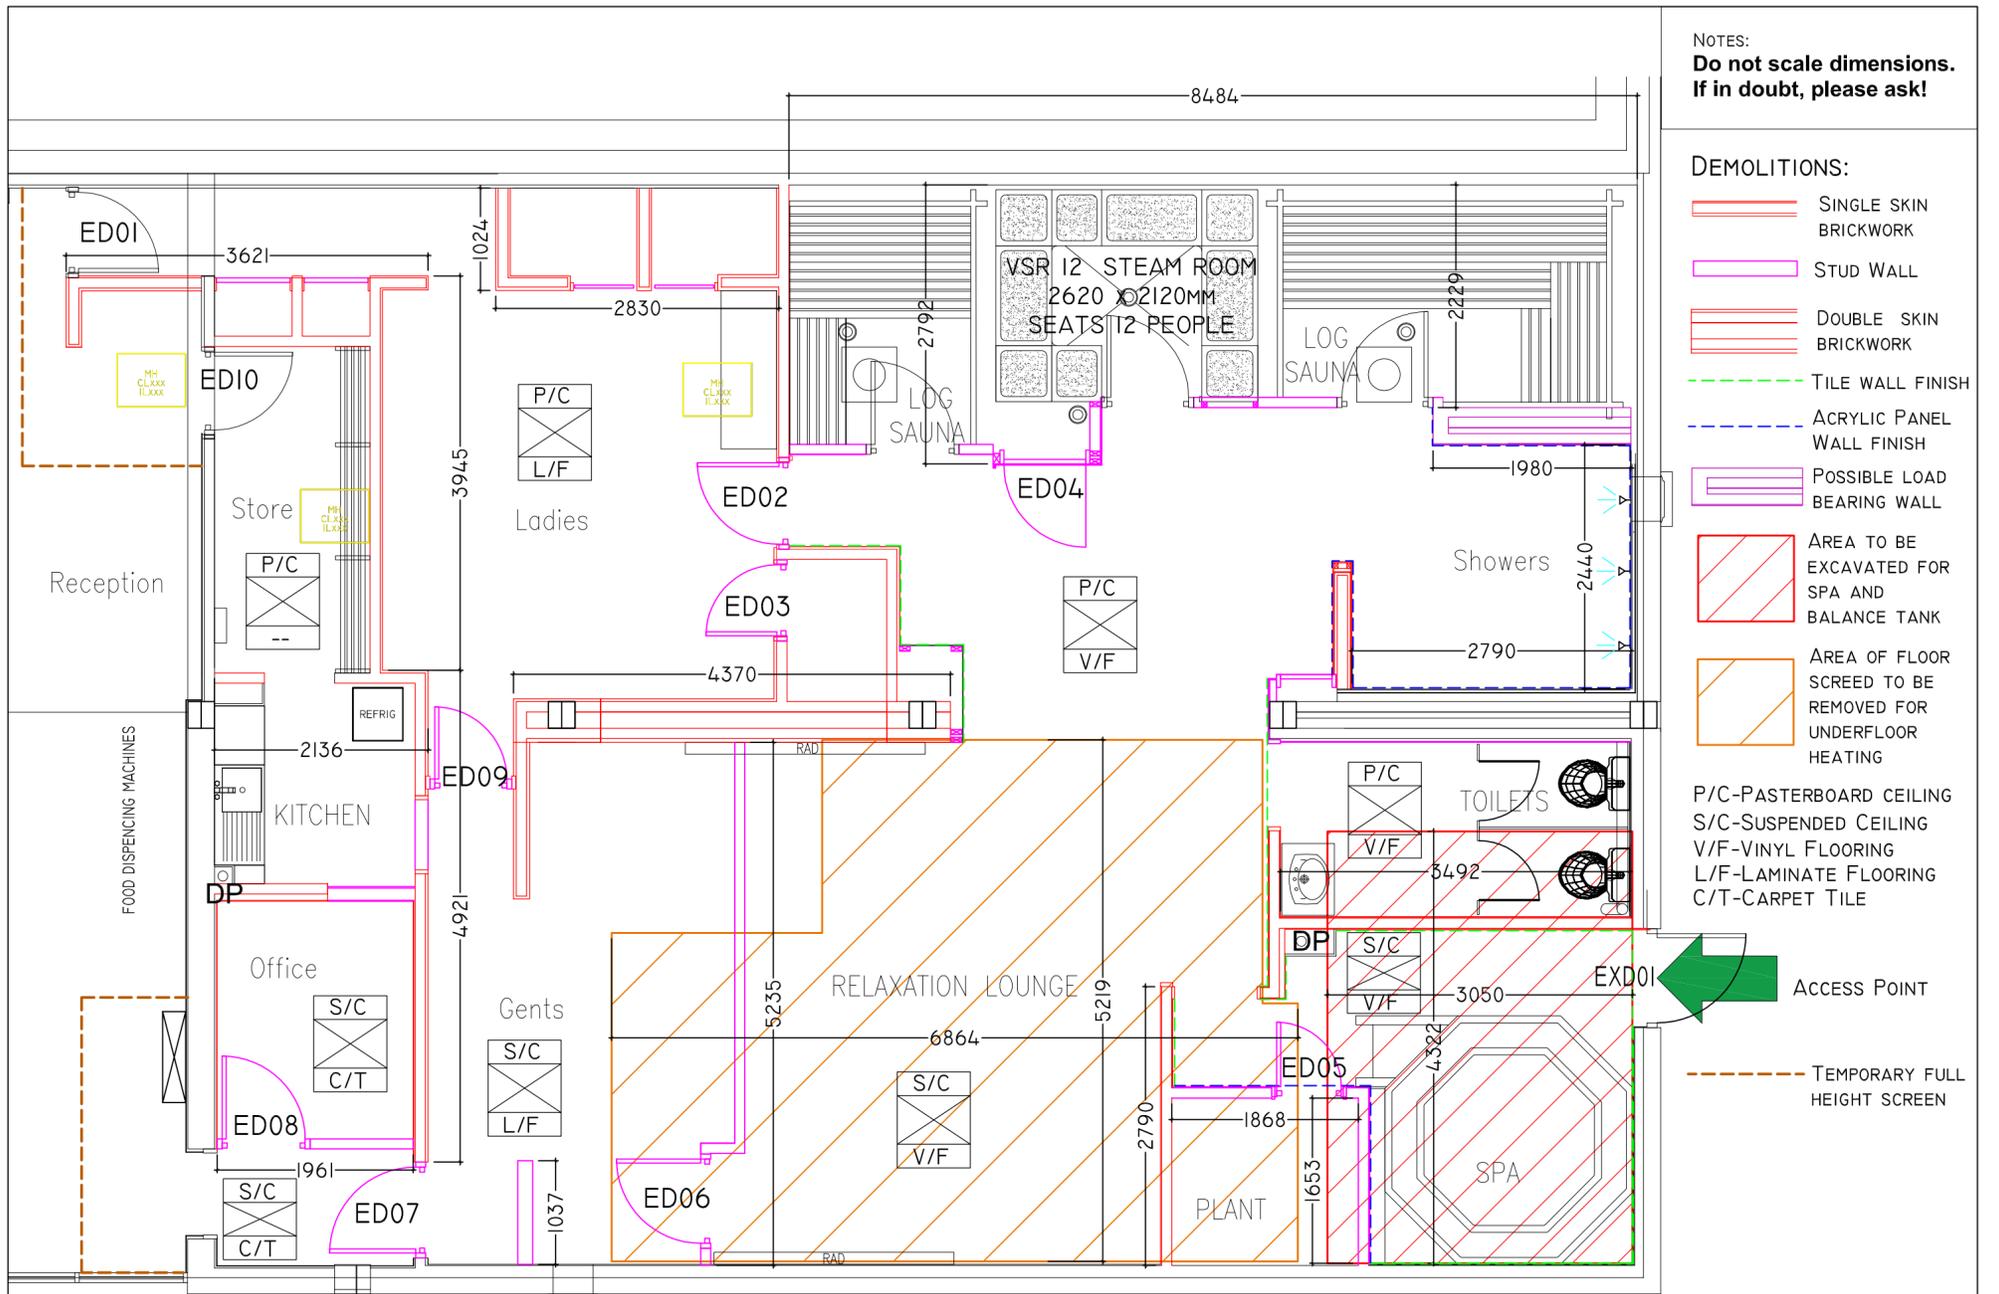
Existing Layout & Demolitions 1:50

- DEMOLITIONS:**
- SINGLE SKIN BRICKWORK
 - STUD WALL
 - DOUBLE SKIN BRICKWORK
 - TILE WALL FINISH
 - ACRYLIC PANEL WALL FINISH
 - POSSIBLE LOAD BEARING WALL
 - AREA TO BE EXCAVATED FOR SPA AND BALANCE TANK
 - AREA OF FLOOR SCREED TO BE REMOVED FOR UNDERFLOOR HEATING
- P/C-PASTERBOARD CEILING
 S/C-SUSPENDED CEILING
 V/F-VINYL FLOORING
 L/F-LAMINATE FLOORING
 C/T-CARPET TILE
- ➔ ACCESS POINT
- TEMPORARY FULL HEIGHT SCREEN

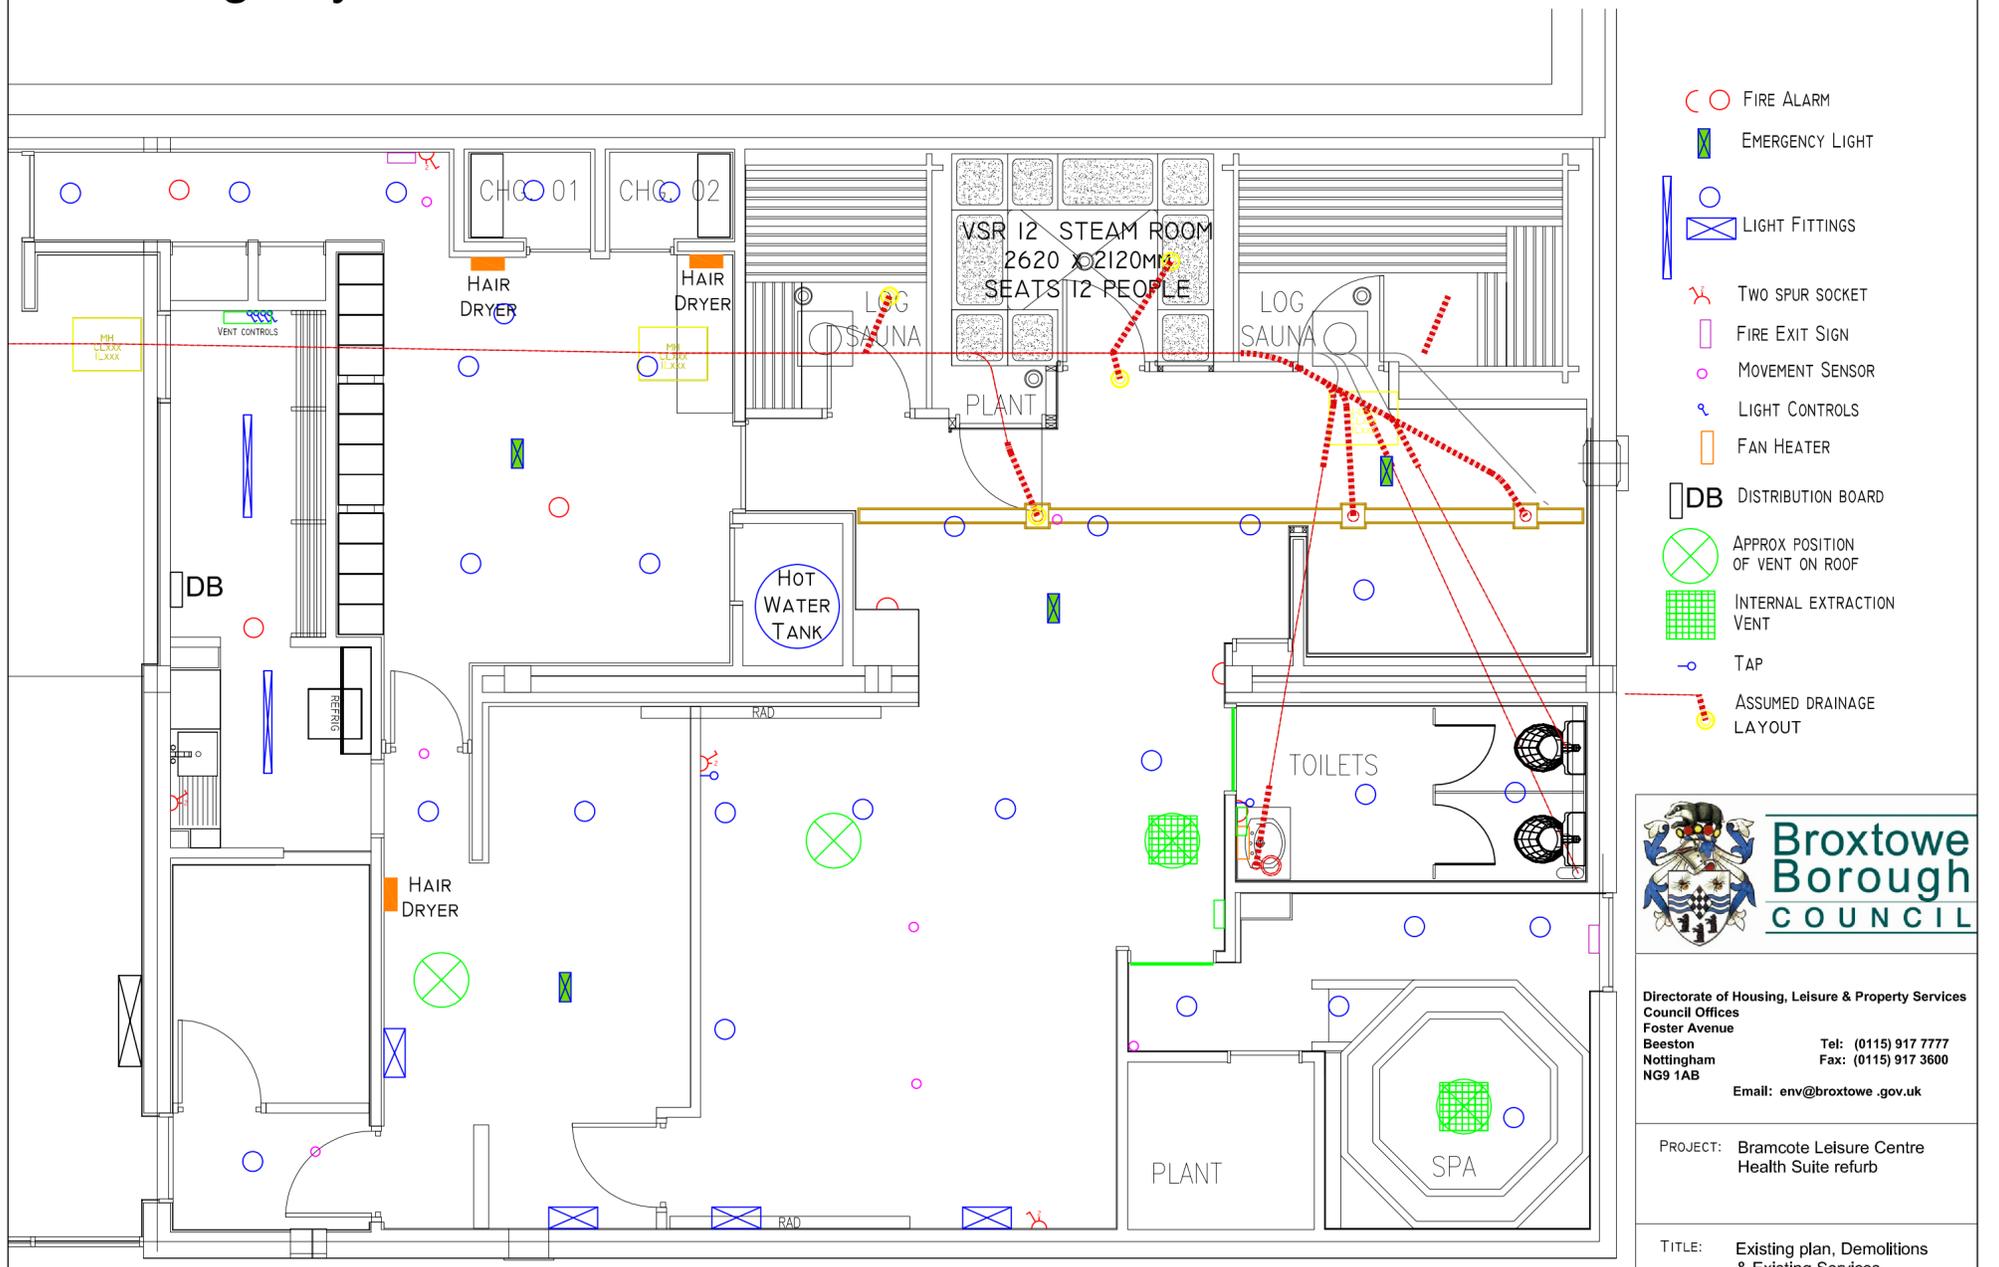
Existing Services 1:50

- FIRE ALARM
- ▭ EMERGENCY LIGHT
- ▭ LIGHT FITTINGS
- Y TWO SPUR SOCKET
- ▭ FIRE EXIT SIGN
- MOVEMENT SENSOR
- LIGHT CONTROLS
- ▭ FAN HEATER
- DB DISTRIBUTION BOARD
- ⊗ APPROX POSITION OF VENT ON ROOF
- ▭ INTERNAL EXTRACTION VENT
- TAP
- ASSUMED DRAINAGE LAYOUT
