SECTION E - SITE INFORMATION

Introduction

The island has an existing small hospital that is no longer fit for purpose and thus a new health facility that is more suited to modern medical standards is intended to be built adjacent to the existing hospital location.

The purpose of this exercise is to create a concept design for the building to give an indication of a possible solution to the requirements. This comprises a preliminary layout of the proposed health facility and surrounding area, and includes the access road, main entrance, footpaths, likely out-buildings, a parking area for the ambulance and other vehicles, relocation of services and utilities.

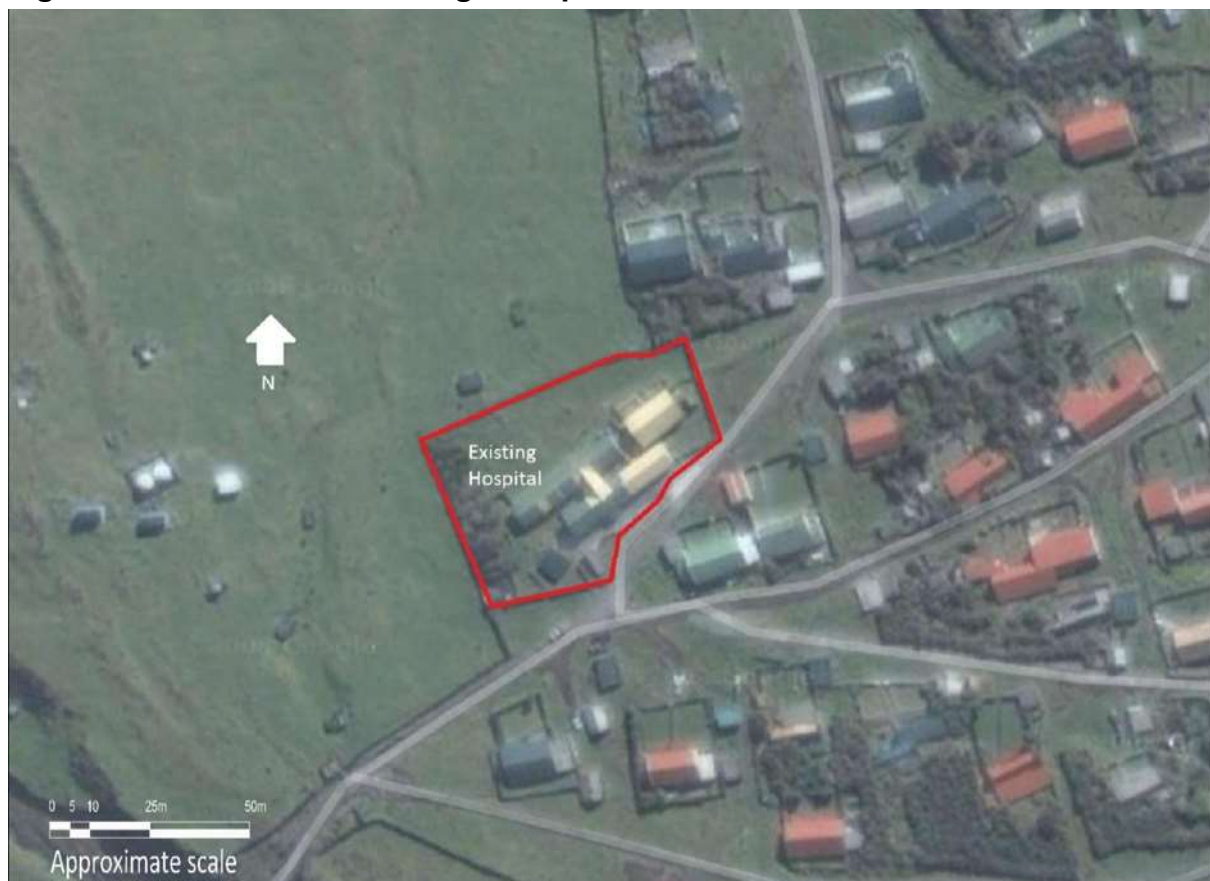
The hospital is located on the outskirts of the Island's only settlement, Edinburgh of the Seven Seas. It can be seen in the centre of the photograph below.

Figure 1: Aerial view of Camogli Hospital.

The site of the hospital comprises approximately 2,000 m² (0.5 acres). It is generally rectangular and flat but with a gentle fall of approximately 1 metre in its width of 34 metres, which also provides the road access to the hospital. The location provides spectacular sea views and has no immediate adjacent development.

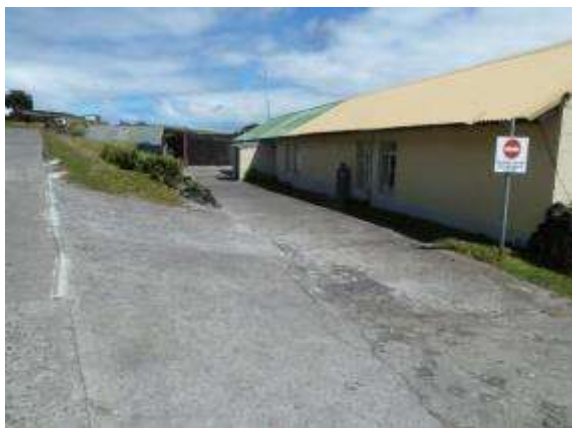
Figure 2: South view of Hospital

The hospital was built in 1971 to replace the original Station Hospital which dated back to 1942. It is of single storey construction, planned as an H block with one wing generally accommodating outpatient services and the other accommodating inpatient services. However, some internal planning has resulted in outpatient activity, particularly dental services, being inappropriately located in the inpatient wing. The limited laundry facilities are located in an outbuilding as is the ambulance garage that also provides some storage for decommissioned medical equipment and furniture. The Doctor's house is located immediately adjacent to the hospital.
