SCHEME NAME  
**M5 J11 A40 EB ON SLIP**

DRAWING TITLE  
**EXPLORATORY HOLE LOCATION PLAN (SHEET 1 OF 2)**

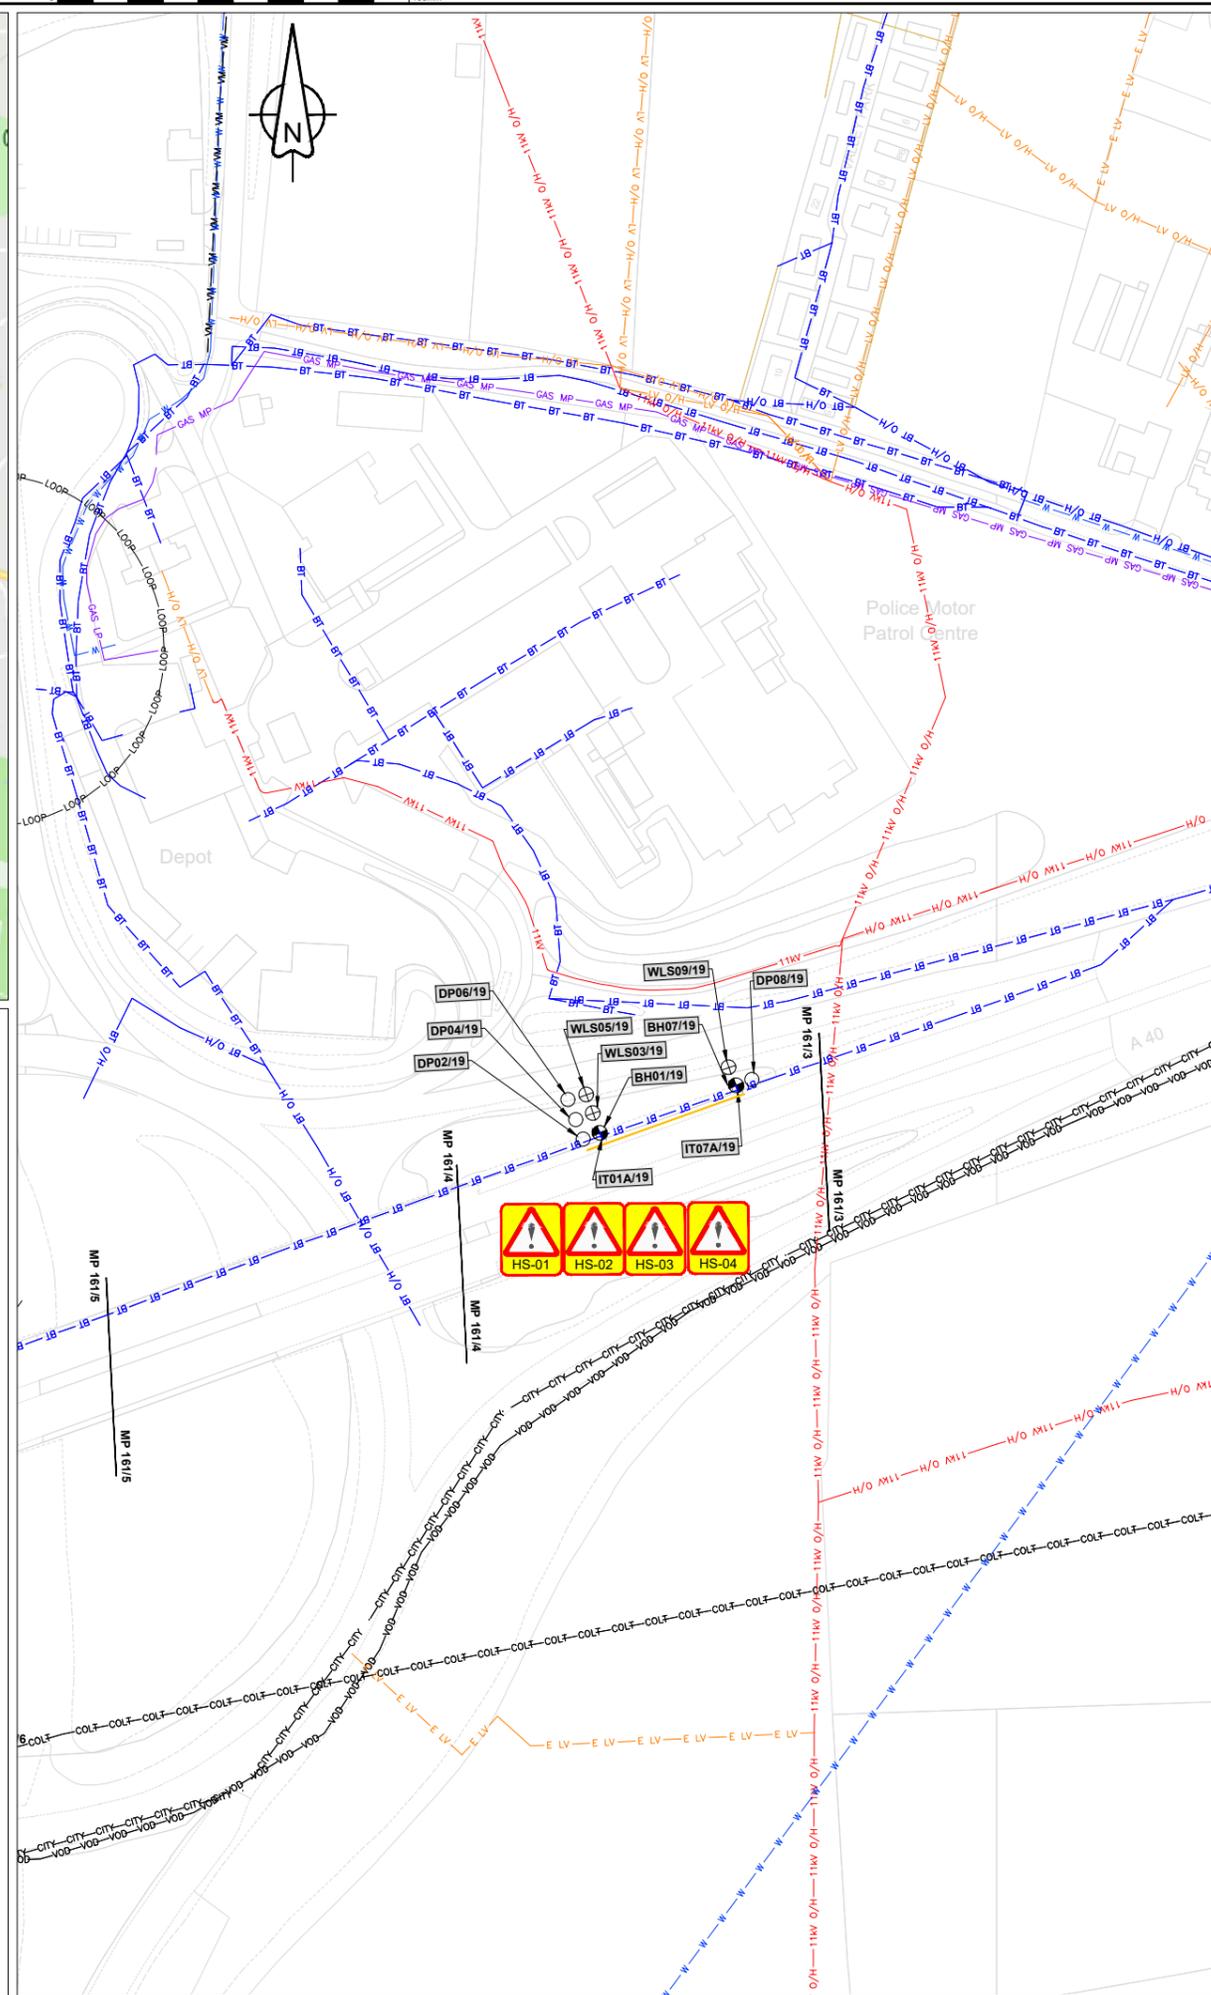
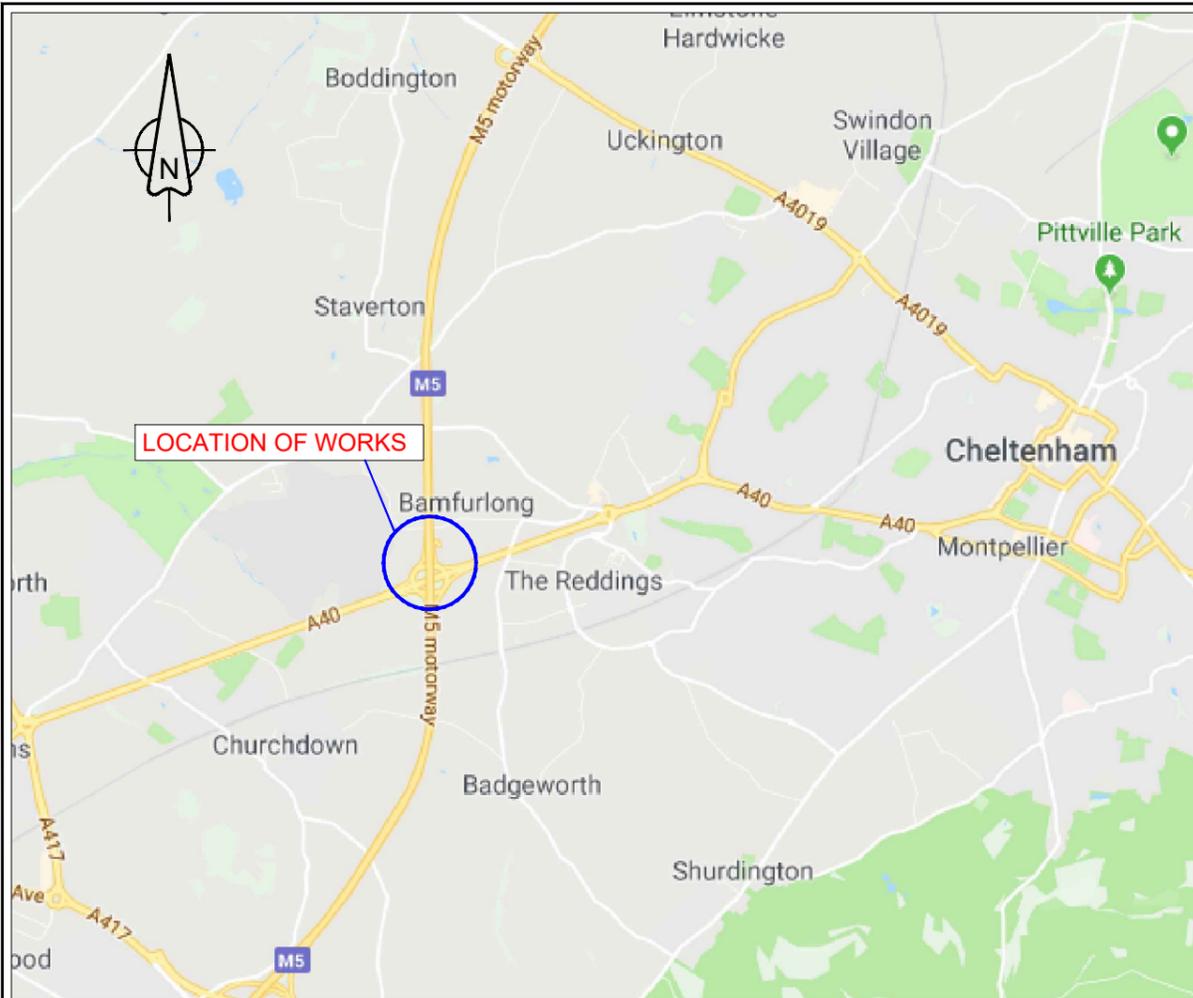
Exploratory hole reference	Position relative to slope	BH Type	Provisional Depths (m bgl)	Coordinates	Approximate Ground Level (m OD)	Provisional Instrument Types & Depths (m bgl)	Remarks
BH01/19	Crest	Percussion	10	E:389887 N:221329	39	Remotely read vibrating wire piezometer with tip at 4.00	Located in the eastbound Verge of the A40 at embankment crest.
IT01A/19	Crest	Hand dug inspection trench	1.2	E:389887 N:221329	39	None	To positively identify underground services and NRTS cables within the verge.
DP02/19	Crest	Dynamic Probe	6	E:389882 N:221328	39	None	Located in the eastbound Verge of the A40 at embankment crest.
WLS03/19	Mid	Dynamic (Windowless) Sampler	4	E:389885 N:221335	37	Remotely read vibrating wire piezometer with tip at 3.00	Located on the mid slope of the embankment in line with the defect.
DP04/19	Mid	Dynamic Probe	4	E:389880 N:221333	37	None	Located on the mid slope of the embankment in line with the defect.

WLS05/19	Toe	Dynamic (Windowless) Sampler	4	E:389883 N:221340	35	Remotely read vibrating wire piezometer with tip at 3.00	Located at the toe of the embankment within the verge of the A40 Eastbound on slip.
DP06/19	Toe	Dynamic Probe	4	E:389878 N:221339	35	None	Located at the toe of the embankment within the verge of the A40 Eastbound on slip.
BH07/19	Crest	Percussion	10	E:389825 N:221343	39	Remotely read inclinometer to 6.	Located in the eastbound Verge of the A40 at embankment crest.
IT07A/19	Crest	Hand dug inspection trench	1.2	E:389825 N:221344	39	None	To positively identify underground services and NRTS cables within the verge.
DP08/19	Crest	Dynamic Probe	6	E:389929 N:221346	39	None	Located in the eastbound Verge of the A40 at embankment crest.
WLS09/18	Mid	Dynamic (Windowless) Sampler	4	E:389923 N:221348	37	None	Located on the mid slope of the embankment.
