+St. Osyth Priory, Essex

**Repairs and Alterations
to the
Tithe Barn, Dairy and Cart Lodge**

Outline Schedule of Work

September 2022

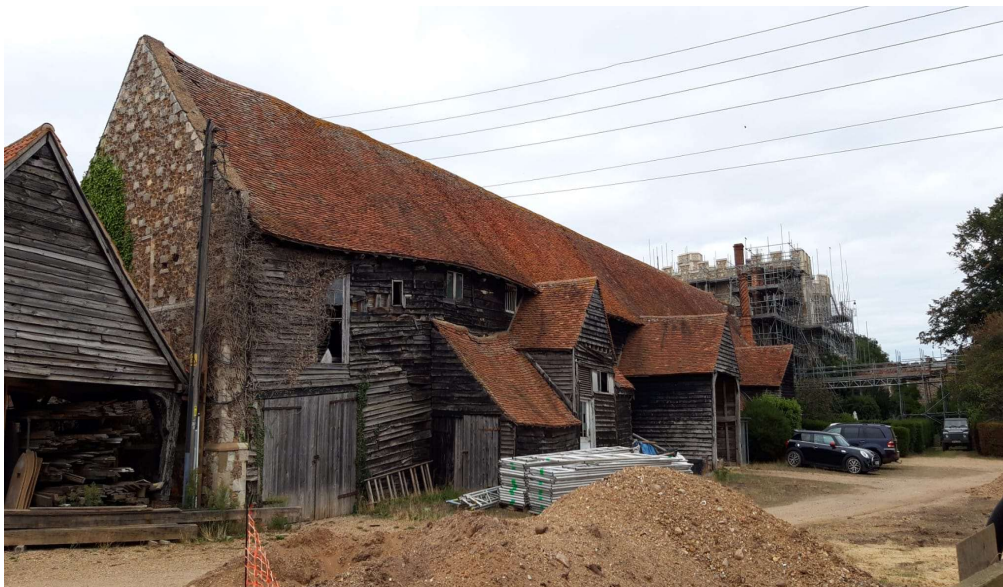
2.1 The Tithe Barn

- 2.1.1 Replace decayed or missing oak sole plate at base of timber frames. Provisionally allow for replacing 50% of the full length plate along the south elevation and its return walls.

2.1.2 To the main south side oak frame principal posts, prop and cut away their decayed bases average 1500mm from the sole plate, form halved and ledged joints and replace the decayed bases in well-seasoned oak. Repair prov. 12 no. principal posts in this way.

2.1.3 To the western bay of the barn, replace the decayed and collapsed Principal tie beam like for like in seasoned oak and reform mortices and (slip) tenon joints to connect tie beam to the north and south principal rafter feet and wall plates.

2.1.4 To the Barn's north wall roof bearings, supply and reinstate 2no. missing wall/ashlar posts and braces to principal truss no's 6 and 7 from the east.

2.1.6 To the Barn's north wall bearings, supply and insert seasoned oak packing wedges between the pulled wall posts and the north wall masonry, 9no repairs in total (nos/ 6 and 7 to be fitted close against the wall, as originally.) to all 11no. north wall bearings, supply and fit discrete forged steel anchor brackets bolted back to wall and wall plate, to augment the existing iron staples.

Include for rebuilding the wall plinth on existing shallow footings where replacing the sole plate, therefore allow for 50% rebuild to wall plinth.

2.1.5 To the Barn's 11 no. principal trusses, allow for simple reinforcement of connections to the south wall plate by use of discrete forged steel purpose-made anchor brackets, to augment the iron staples.

2.1.7 Include a contingency for unknown further repairs and possible replacements to the roof carpentry and its joints.

2.1.8 Strip and salvage the roof tiles from all slopes, sort them and set aside provisionally 60 % sound tiles for re-use on the barn's south slopes. Supply and lay the balance of 40% new matching hand-made plain clay tiles on the Barn's north slope.

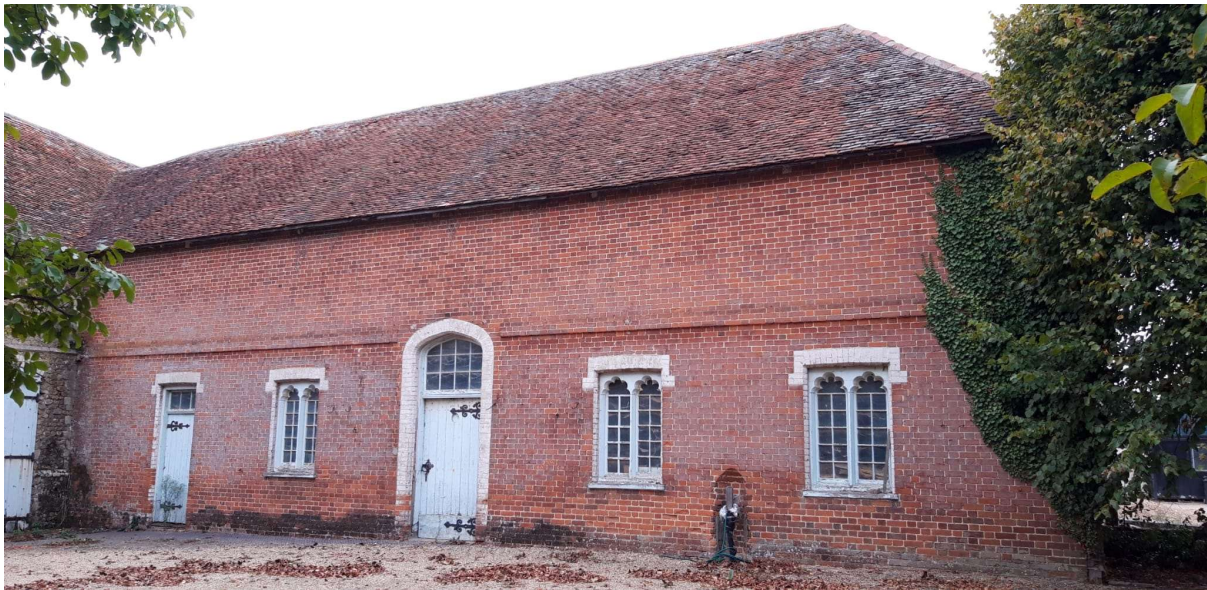
2.2 The Dairy

2.2.3 To the external brick walls, carry out local crack-filling, brick replacements and repointing to east and west elevations, approx.. 8Sq metres.

2.2.5 To the 1st floor structure, re-form the bearings of prov. 6no. main beams, and form spliced extensions to 3no. rotten beam ends.

2.2.1 Strip the plain clay roof tiles, salvage the hips and ridge tiles and set aside provisional 60% of the plain tiles for re-use. Supplement with 40% new matching hand made clay plain tiles, to go on the long east slope. The salvaged tiles to go back on the long west slope and north hip. Supplement 40% hips and ridges.

2.2.4 Repair all windows and doors as existing, with thorough overhaul and tightening of joints, ironmongery, re-weathering of sills, deep surface preparation and repainting inside and out.

Allow for strengthening the joints between the floor and principal E-W beams using galvanized steel angles, concealed within floor void.

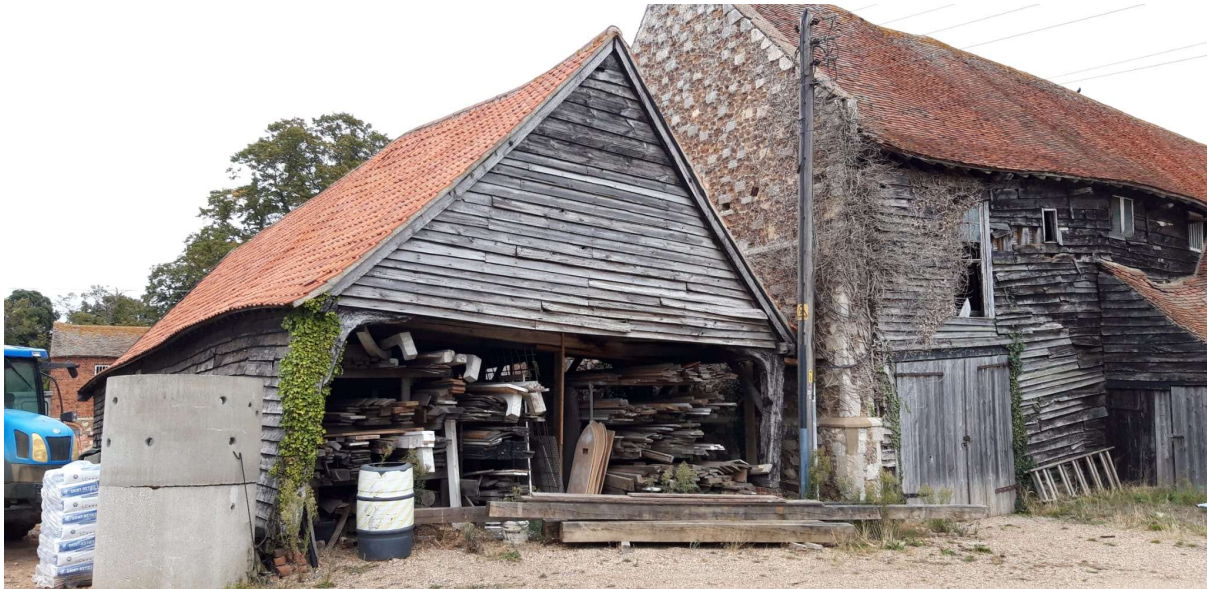
2.3 The Cart Lodge

2.3.4 Cut out and form spliced and ledged extensions to the principal posts, prov. 900mm high, and thereby replace the decayed bottoms of prov. 10no. posts, joined with mortice and tenon as originally. Pull the south frame back to vertical and renew Southeast brace and strengthen joints.

2.3.1 Once the lodge has been cleared of storage and subject to further detailed examination of the internal carpentry, including the roof, allow for propping of the building all around the perimeter, in stages, from solid ground to the undersides of wall plate and principal tie beams.

2.3.3 Working in alternate sections, cut out and replace the oak sole plate, using matching section and lengths of new well-seasoned oak.
