Safety Inspection Report

Annual Inspection

Mill Road

Leighton-Linslade Town Council

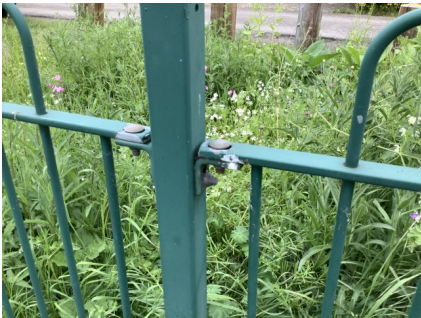
Maintenance Finding

Description
Fixtures loose or missing.
Tasks
Tighten.
Note
There are a number of loose fence bolts.

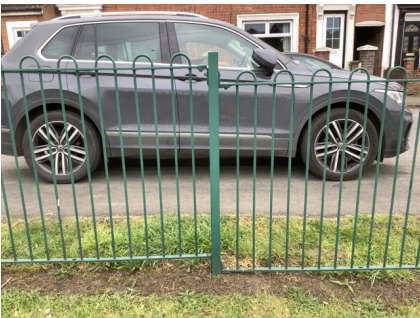
Maintenance Finding

Loose in ground.

Very low

No reasonably practicable action is identified.

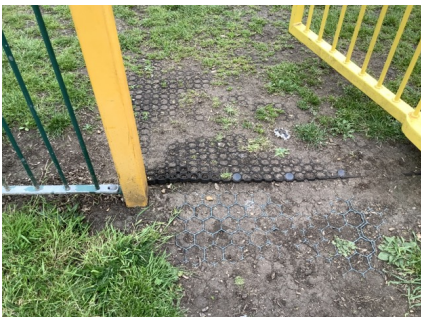
Maintenance Finding

Description
Trip points on the surface.
Tasks
Make level.
Note
Raised grass mat creating potential trip point.

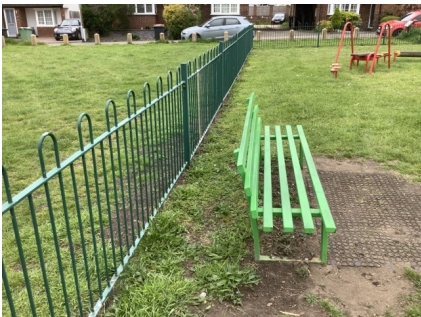
Maintenance Finding

Description
RoSPA recommend a minimum distance of 1 m between seat and fence. This is to reduce the likelihood of children vaulting the fence via the seat.

Tasks
No reasonably practicable action is identified.

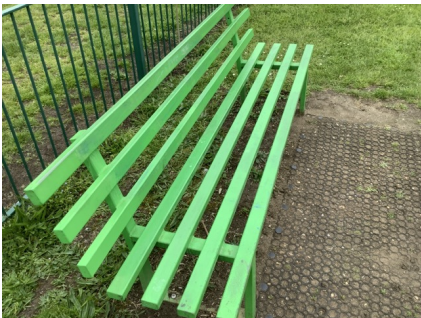
Maintenance Finding

The gaps between the slats exceed 30 mm and are known to cause entrapments.

Low

No reasonably practicable action is identified.

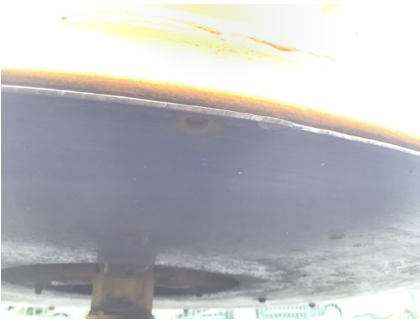
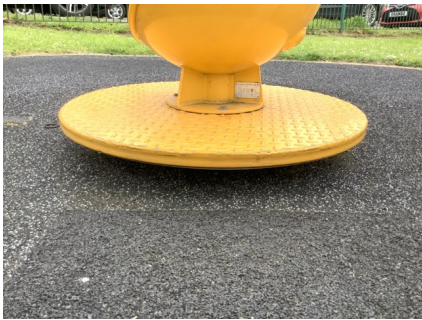
Maintenance Finding

Bolt(s) missing.

Bolt missing from underside of platform.

Low

Replace missing bolt(s).

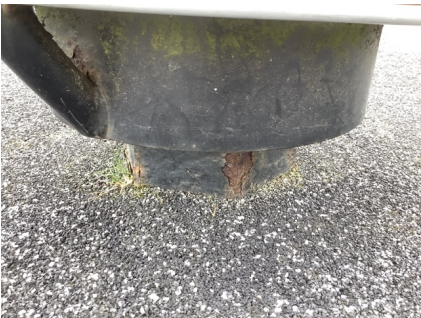
Maintenance Finding

Description
Item is rusting in places.
Tasks
Repair.
Note
The base of the unit is rusting. De-scale and treat.

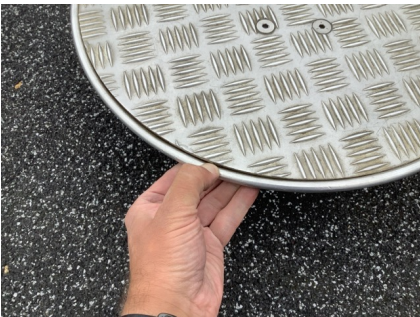
Maintenance Finding

Minor repairs are needed.

Rim is loose on stand.

Low

Repair.

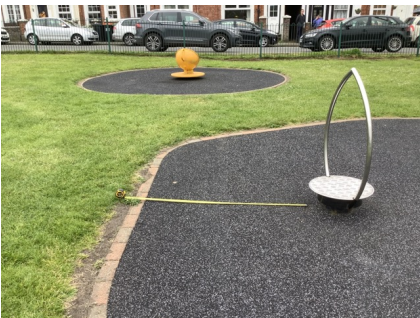
Standard Compliance Finding

Insufficient protective surfacing extent has been provided.

Very low

No reasonably practicable action is identified.

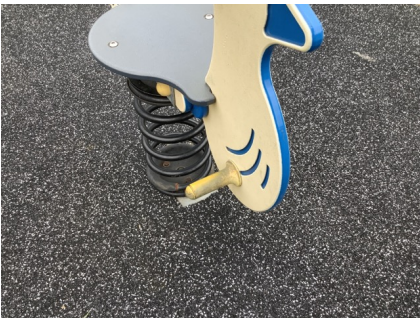
Standard Compliance Finding

Description
Protruding handles / foot rests.
Tasks
No reasonably practicable action is identified.
Note
Foot rests.

Very low

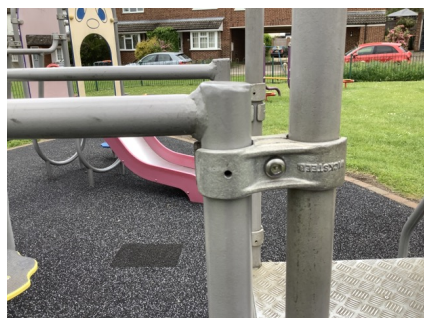
Maintenance Finding

Fixtures loose or missing.

Panel locking pins missing. Replace.

Low

Replace.

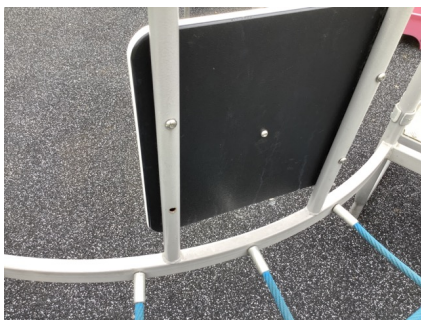
Maintenance Finding

Bolt is missing.

Rear of clock panel.

Low

Replace.

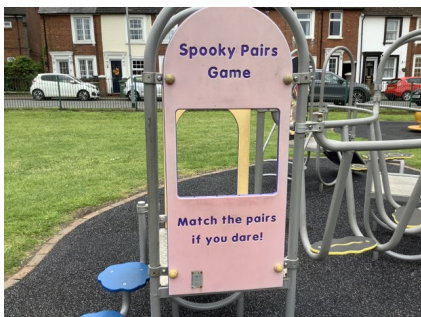
Maintenance Finding

Item has some parts missing.

Infill panel of "Match the Pairs" game.

Low

Replace the missing parts.

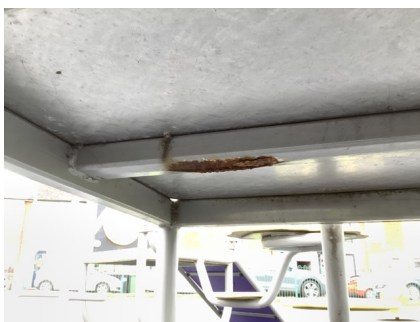
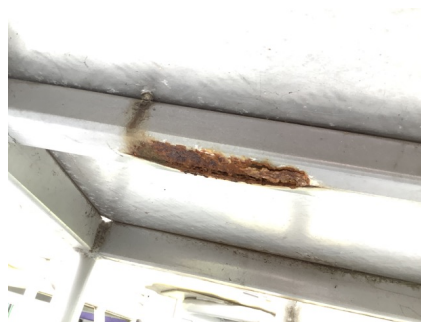
Maintenance Finding

There is significant corrosion on this item.

Item rusting on the underside of the middle platform exposing sharp edges.

Medium

De-scale back to good metal and coat with lead free paint, using appropriate precautions. Repairs may be necessary where corrosion is severe.

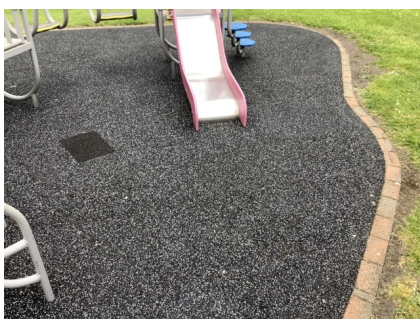
Maintenance Finding

The surface is damaged.

The surface is cracking in places. Monitor and repair as required.

Low

Read the notes for further action.

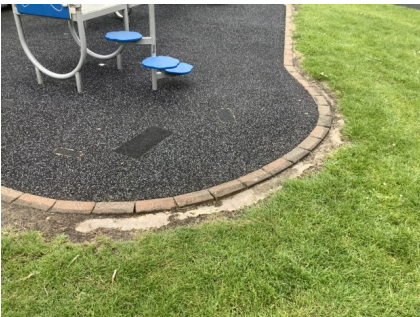
Maintenance Finding

Trip points on the surface.

At brick edgings. Build up earth slightly to remove trip hazard.

Low

Make level.

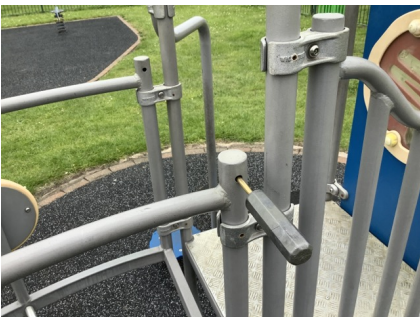
Standard Compliance Finding

Finger entrapment.

Frame holes at ends of rope bridge.

Low

Eliminate the entrapment.

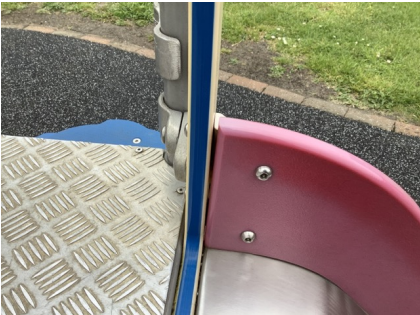
Standard Compliance Finding

There is a toggle entrapment.

Slide entry sides have opened.

Low

Eliminate the entrapment.

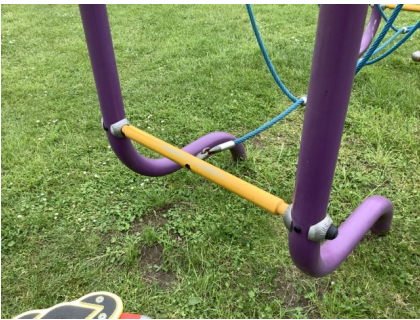
Maintenance Finding

Bolt(s) loose.

The crossbar bar rotates.

Low

Tighten.

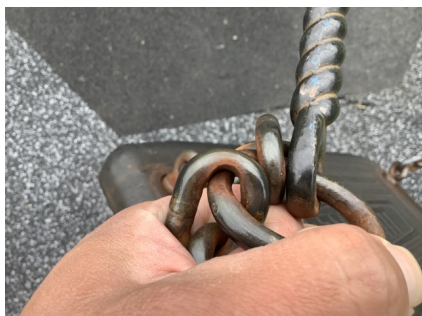
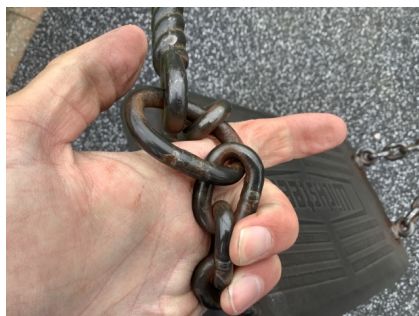
Maintenance Finding

Some chain wear.

Low

Monitor for further deterioration and replace before 40% wear.

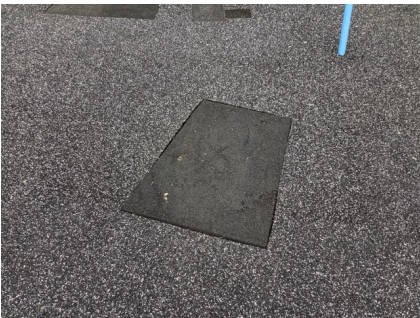
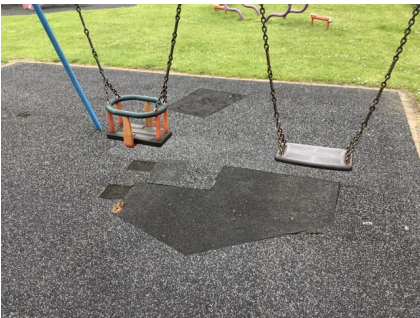
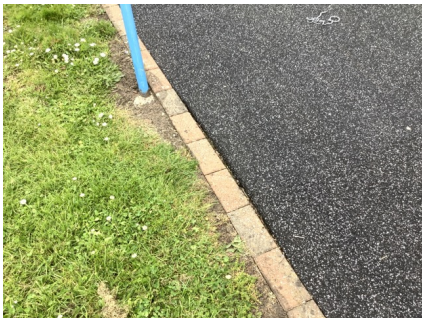
Maintenance Finding

The wet pour surface is separating at the joints.

There are gaps and cracks starting to open up in the surfacing. Monitor and repair as required.

Low

Repair.
